Career Fire Fighter Dies from Fall off Fire Escape Ladder – Illinois

Executive Summary

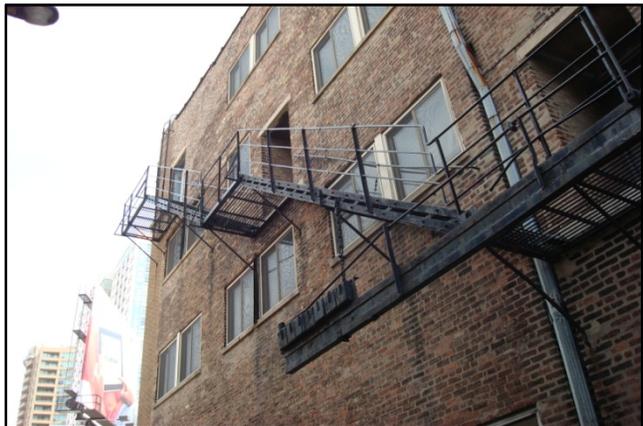
Fire Escape – Post Incident

- *Using a fire escape to access the roof rather than a safer means such as an aerial ladder or interior stairway*
- *Victim unable to maintain contact with the vertical portion of fire escape due to carrying the hand pump.*

- *Ensure that standard operating guidelines (SOGs) on the use of fire escapes are developed, implemented, and enforced*
- *Ensure that tactical level accountability is implemented and enforced*
- *Ensure that companies are rigorously trained in safe procedures for roof operations and climbing ladders of any type*
- *Ensure that fire fighters are rigorously trained in safe procedures for carrying and/or hoisting equipment when ascending or descending elevations*
- *Evaluate the fire prevention inspection guidelines and process to ensure that they address high hazard occupancies, such as restaurant, and incorporate operational crew participation.*

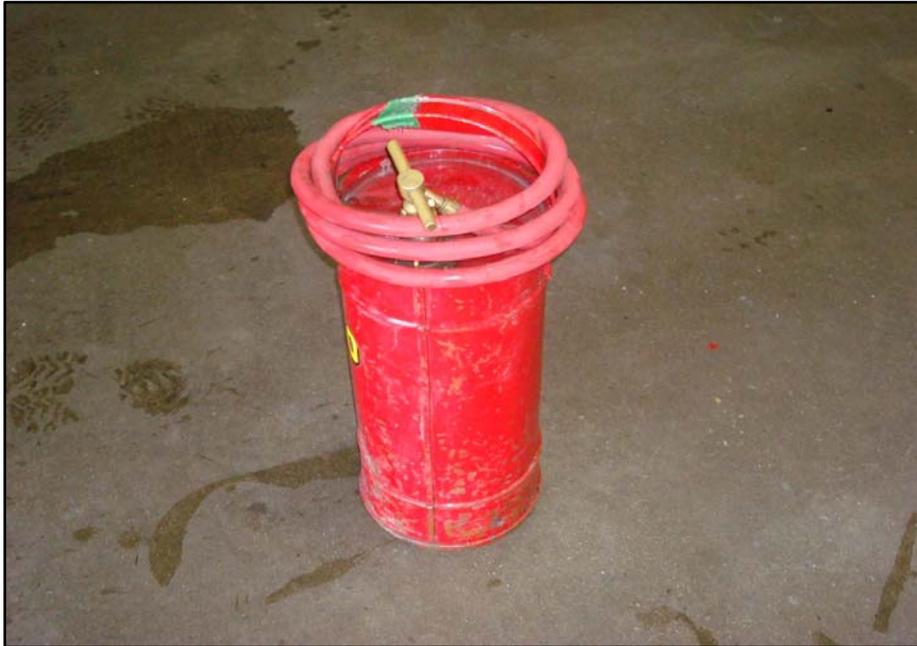
**An example of a hand pump carried by the victim.
The hand pump is a manually pressurized fire
extinguisher.**

In this incident, the victim opted to ascend the gooseneck ladder portion of the fire escape while carrying the hand pump instead of hoisting it from the landing to the roof with a rope or webbing. This resulted in the inability to maintain 3-point contact with the ladder.

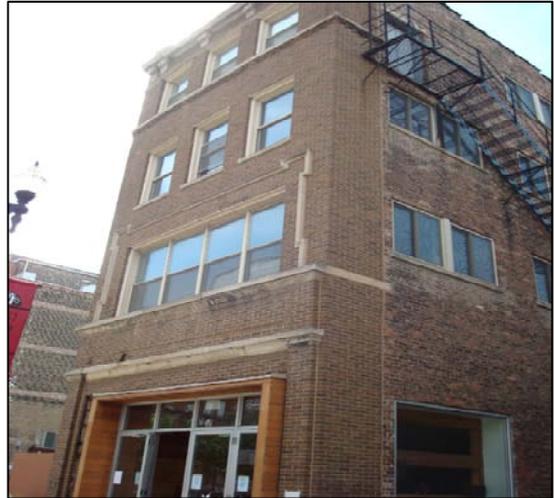
Photo 1: Four-story Incident Structure
NIOSH Photo

The incident involved an 8,500 square foot four-story mixed-occupancy structure that was built in 1882 (see Photo 1). The ground level contained a restaurant with the kitchen in the rear. The remaining three floors contained numerous small business office spaces and apartments. The structure had a large cargo elevator to the fourth floor and a stairwell from the ground floor to a bulkhead door to the roof. The exterior was brick with windows and doors on each floor providing access to an iron fire escape on the D-side of the structure. The fire escape had a vertical goose neck ladder from the fourth floor to the roof. The rungs on this vertical goose neck ladder were approximately 4 inches from the vertical wall, but in several locations the fire escape rungs were approximately 2 to 3 inches from the exterior brick wall trim. The membrane flat roof housed the elevator motor and electrical panel, provided access to the restaurant grease chute cleanout and was accessible through a bulkhead door from the stairwell.

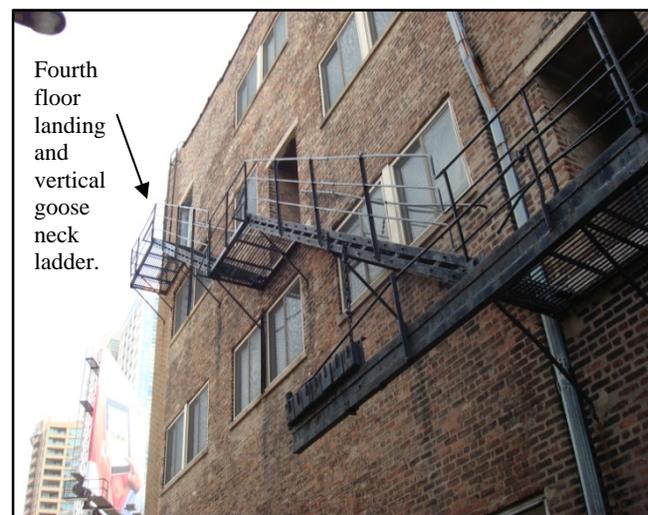
Photo 2: The Exterior Fire Escape
(NIOSH Photo)

At approximately 0045 hours, the victim, on the fourth floor landing, started to ascend the vertical ladder portion of the fire escape to the roof carrying a 63 pound hand pump in his right hand while being supported by the candidate fire fighter on the landing (see Photo 2). The victim continued up the ladder out of reach of the supporting candidate fire fighter. The victim's foot knocked the candidate fire fighter's helmet off as he tried to make another rung and was unable to maintain his grip on the ladder. The victim released his grip on the hand pump, which hit the candidate fire fighter on the landing, with no reported injury, and the victim fell 53 feet to the pavement. The victim landed on his

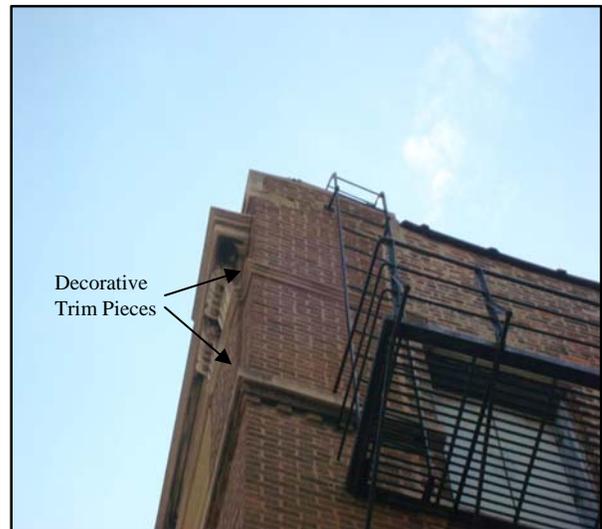
Photo 3: It is estimated that the victim’s footing made the seventh rung near the decorative trim piece where there was a minimal 2” to 3” boot clearance from the wall and ladder rung.
(NIOSH Photo)

During this incident, the victim accessed the fire escape while the roof crew had set the aerial to make access. Although the fire escape was structurally sound, the primary access method to the roof was the aerial ladder by unwritten fire department procedures. The victim was wearing rubber fire fighter boots, and in conjunction with the small wall clearance, there would have been minimal footing on the ladder rungs. In several locations the fire escape rungs were approximately 2 to 3 inches from the exterior wall due to the decorative concrete trim (see Photo 3). *Note: Per the Occupational Safety and Health Administration (OSHA) 3124-12R 2003, the minimum perpendicular clearance between fixed ladder rungs, cleats, and steps and any obstruction behind the ladder must be 7 inches (18 cm), except that the clearance for an elevator pit ladder must be 4.5 inches (11 cm).*¹⁰ Although fire escapes are not specially mentioned in the referenced OSHA publication, ensuring sufficient clearances between the fixed ladder portion of fire escapes and buildings would be a good safety practice for fire departments in the event that fire escapes have to be used.
