Volunteer Fire Fighter Killed When Pressurized Water Tank Explodes During Fire Suppression at a Brush Fire – Ohio

Executive Summary

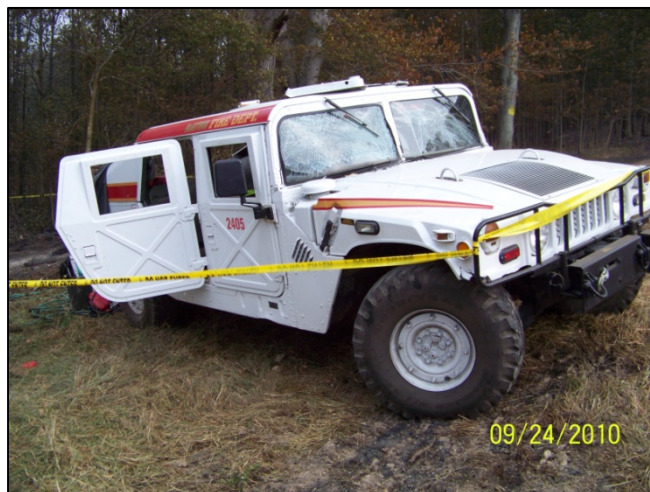
1986 Humvee was obtained by the fire department in 2009 through the state's surplus fire fighter property program.

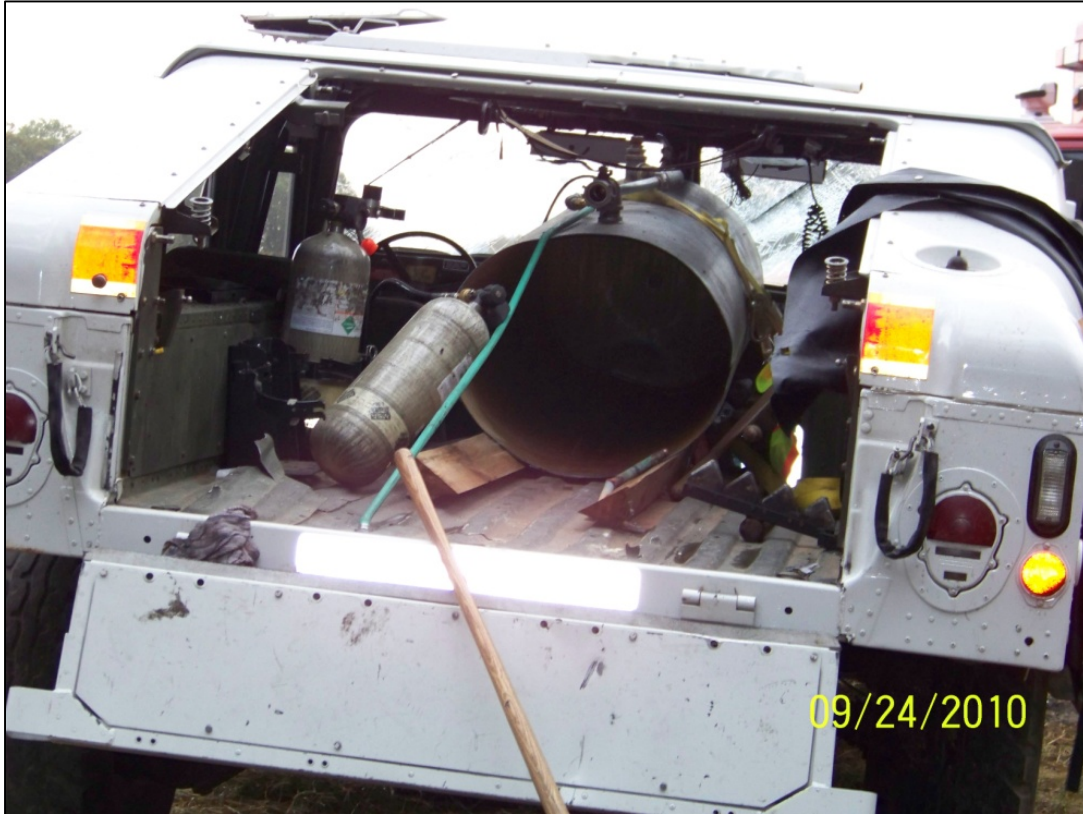
Photo shows a rear view of the Humvee following the explosion. The water tank is seen in the center of the photo. Note that the bottom of the tank has completely separated from the rest of the tank. A motorized hose reel was mounted just in front of the tailgate.
(Photo Courtesy of Sheriff's Office)

The victim was standing at the rear of the Humvee near the center of the tailgate when the water tank exploded. The force of the explosion caused the bottom of the tank (closest to the rear end of the vehicle) to separate from the rest of the tank (see Photo 5 and Photo 8). The tank was pushed forward into the dashboard, breaking the pneumatic airlines and connections in multiple locations. The Humvee's front windshield was shattered (see Photo 9). The bottom of the water tank was propelled into the motorized hose reel. The force ripped the hose reel's mounting bolts through the Humvee's bed (see Photo 10). The hose reel struck the vehicle's tailgate and then flipped over the tailgate, striking the victim. The victim was thrown backward approximately 20 feet (see Photo 11 and Photo 12), and was killed instantly. The hose reel came to rest in close proximity to the victim (see Photo 13) while the end of the water tank was propelled into the woods (see Photo 11). The fire fighter who had been operating the hoseline nozzle was knocked down by the force of the explosion but was not seriously injured. Two other fire fighters narrowly escaped injury.

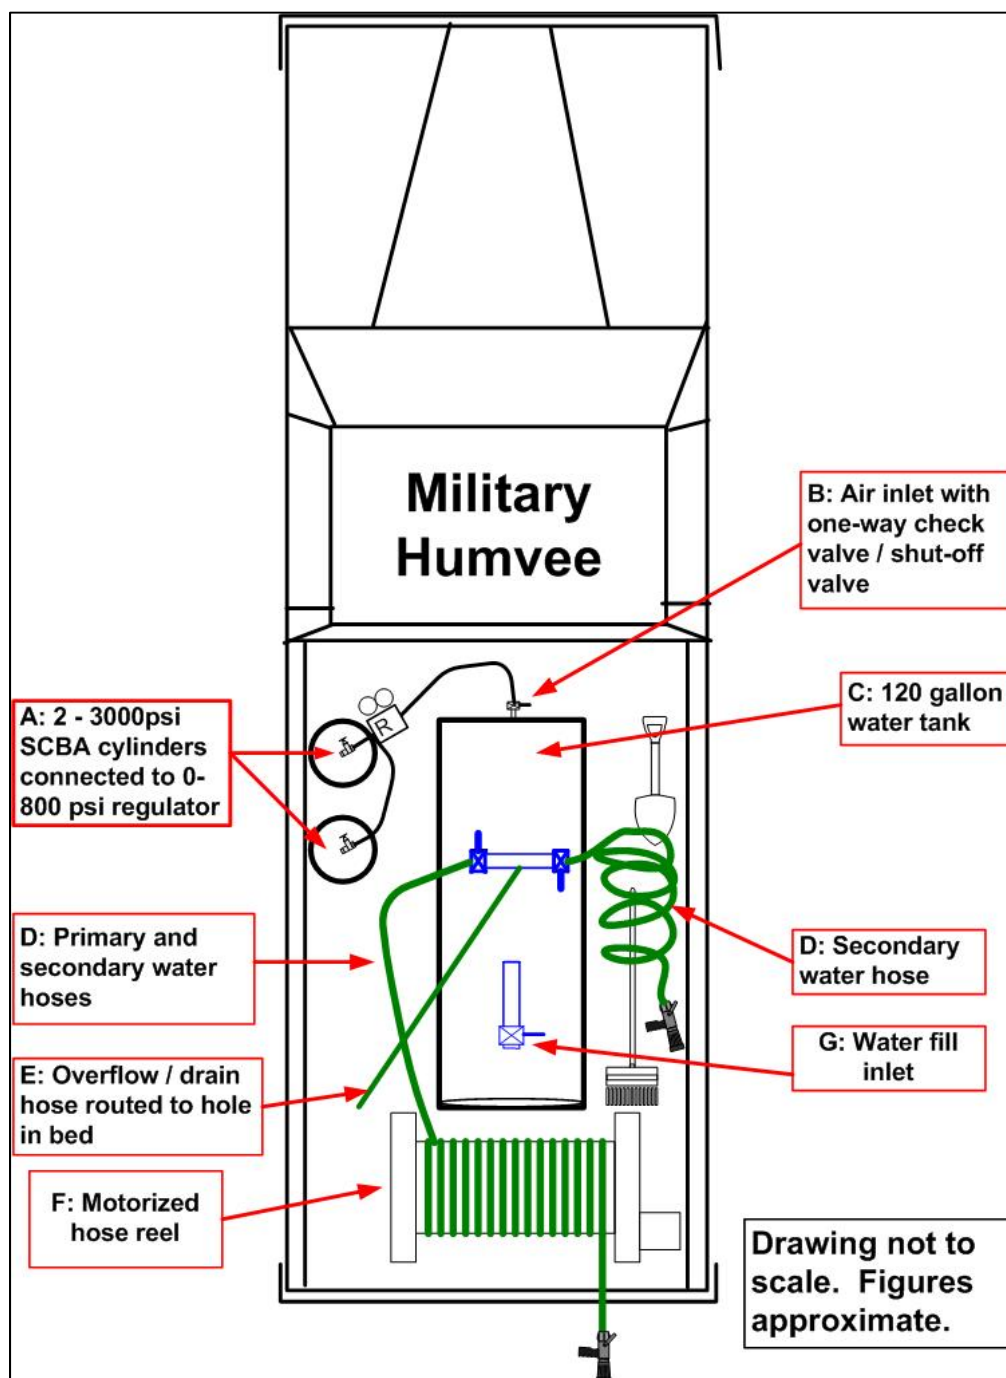
Diagram 1. Water Delivery System.

Table 1 and Diagram 1 describe the water delivery system. The system was an “air over water” delivery system. The system used air pressure, instead of a pump, to force the water from the tank and deliver it to hand-held hoses. The system used two standard 3,000 psi self-contained breathing apparatus (SCBA) air cylinders as the pressurized air source. Two standard CGA cylinder hand wheel connectors were connected in parallel with a ¼-inch high pressure hose to a pressure regulator. This allowed the system to be pressurized by either one or both SCBA cylinders. The fire department involved in this incident reported that when they took possession of the Humvee, they replaced the two SCBA cylinders with their own cylinders since they used a different brand of SCBA cylinder. Their procedure was to use one cylinder at a time, with the second cylinder in reserve.

Table 1 – Water Delivery System Components	
Item (refer to Diagram 1)	Description
A	2 – 3,000 psi air cylinders served as the air source to pressurize the system. Air pressure was regulated with a non-vented pneumatic pressure regulator equipped with an 0 – 5,000 psi inlet and 0 – 800 psi outlet gauges.
B	Compressed air was delivered into the water tank through a 3/8-inch air brake hose to a 1/4-inch pipe inlet with a one-way check valve and a three-way shut-off valve that had one side plugged.
C	120 gallon galvanized metal water tank rated for 75 psi internal pressure
D	Water was delivered to two water hoses thru a manifold system made from a combination of 1 1/2-inch galvanized metal pipe fittings and soldered copper pipe fittings
E	Overflow / drain hose used to direct overflow underneath bed
F	The primary water hose was attached to a motorized hose reel that the fire department added in July 2009 after obtaining the Humvee in May 2009

The air pressure inside the tank forced the water through a 1½-inch copper pipe to an outlet at the top of the tank. The outside of the tank was fitted with a manifold constructed of a combination of various soldered copper pipe connectors and threaded pipe connectors. The manifold had two quarter-turn

shut-off valves that controlled water flowing to two separate hoses (see Diagram 1). The primary hose (located on the driver's side) was attached to a motorized hose reel that was bolted to the bed of the Humvee just in front of the tail gate. The secondary hose (located on the passenger side) was loosely coiled in the bed of the Humvee. The manifold also included a drain hose that delivered overflow through a hole in the Humvee's bed near the rear of the Humvee and behind the wheels (see Diagram 1). All three hoses were heavy-duty 5/8-inch garden hoses.

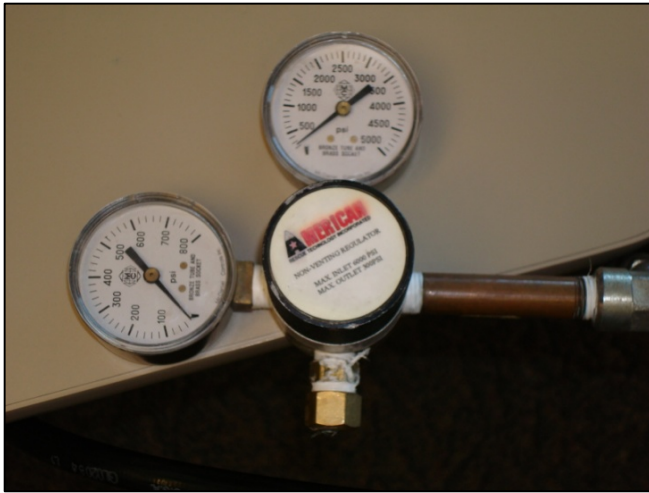
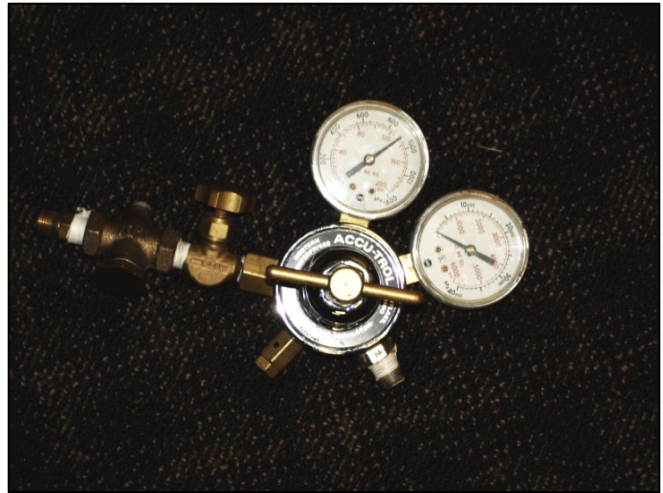
Photo 1 (left) and Photo 2 (right). Photo 1 is the regulator used at the time of the incident. Photo 2 was reported to be the regulator used by the fire department who originally constructed the water delivery system.

The pressure regulator manufacturer determined for NIOSH that the regulator was produced in 2001. The regulator was a non-venting type regulator rated for a maximum inlet pressure of 6,000 psi and a field-adjustable outlet pressure of up to 1,800 psi. The regulator was sold without gauges or other hardware attached, to a vendor of pneumatic tool kits commonly used by fire departments. At some point, an aluminum spacer ring was added between the hand control knob and the regulator body to limit the outlet pressure. When NIOSH investigators obtained the regulator, the regulator was labeled with a maximum inlet pressure of 6,000 psi and a maximum outlet pressure of 300 psi. The regulator inlet was equipped with a pressure gauge graduated from zero to 5,000 psi and the regulator outlet was equipped with a pressure gauge graduated from zero to 800 psi (see Photo 1). *Note: The SCBA cylinders and the pressure regulator are the critical parts needed to operate the system, and also the most expensive. When the fire department that originally constructed the system returned the Humvee to the state surplus property program, they removed their pressure regulator and SCBA cylinders. When the fire department involved in this incident obtained the Humvee, they had to add their own pressure regulator and cylinders in order to make the system functional. The first fire department used a different brand of pressure gauge that included a pressure relief valve (see Photo 2).*

NIOSH contracted with a forensic test facility to evaluate the performance of the regulator by measuring the outlet pressure in the “as-received” condition and then adjusting the regulator to measure the outlet pressure across the outlet pressure gauge scale. The forensic test facility pressurized the regulator and the supply pressure was slowly increased. It was observed that as the supply pressure was increased, the outlet pressure also increased. In other words, the regulator was not restricting or regulating the outlet pressure. The supply pressure was increased to 635 psi and the regulator outlet pressure (as measured by the regulator’s output pressure gauge) was recorded at approximately 630 psi. After adjusting the regulator a number of times, it was clear that the regulator “as received” was passing supply pressure through the regulator to the outlet. The forensic test lab contacted NIOSH and it was decided that the regulator should be disassembled to try and identify the cause of the regulator failure.

The regulator was disassembled and no major problems were identified. The interior of the regulator had a white film that appeared to be consistent with a spray-on dry lubricant. The seat retainer, seat and valve were also removed from the body of the regulator. A few small white particles were observed loose on the inlet side of the seat. The forensic test lab theorized that these particles could have lodged between the seat and valve, preventing the valve from closing fully, allowing air from the supply inlet to pass through the regulator. The regulator manufacturer reported that a spray-on dry film lubricant was not used in the production of this regulator series. The regulator manufacturer stated that the white film could have been from the media used or could have been an oxide from the aluminum stock. A small distortion of the valve pin was also noted, but this did not appear to be significant enough to prevent the valve from operating.

The regulator was reassembled and pressurized. Initially, the regulator did not allow inlet pressure to pass into the outlet. When the regulator was adjusted as low as possible, air leaked through the regulator, pressurizing the outlet side of the regulator. The regulator control knob was rotated clockwise and the air flow through the regulator increased. The regulator control knob was rotated counterclockwise and the flow of air through the regulator decreased but did not stop.

Based upon the forensic evaluation and testing, a malfunction of the regulator prevented the regulator valve from closing completely. It could not be determined if this condition was present prior to the fatal incident or if it occurred as a result of the incident. It is noted that the water delivery system was used the day of the incident and appeared to be operating as expected up to the time of the incident.

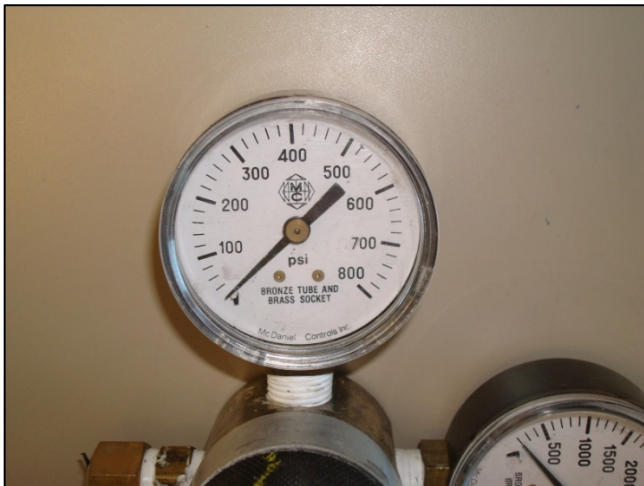
Photo 3 (left) and Photo 4 (right). Photo 3 shows a close-up of the regulator outlet pressure gauge that is graduated in 25 psi increments. Photo 4 shows the one-way check valve and shut-off valve used at the inlet to the water tank.

The regulated air was delivered from the pressure regulator to the tank through a 3/8-inch pneumatic hose of the type commonly used on air brake systems. The hose was labeled *SAE J844 Type B* and believed to be rated for 250 psi working pressure. The fire department reported that their procedure was to regulate the delivery pressure to the tank between 30 and 50 psi. The outlet pressure gauge was graduated in 25 psi increments from zero to 800. This would require the user to adjust the regulator so that the indicator needle was between the first two ticks on the gauge scale to obtain the desired outlet pressure (see Photo 3). The pressurized air was delivered to the tank inlet through a one-way check valve and a ¼-inch 3-way shut-off valve. One side of the shut-off valve was plugged off so the valve acted as an “on-off” valve to isolate the tank and prevent water from flowing back into the regulator (see Photo 4).

- The tank was clearly labeled as having a maximum working pressure of 75 psi. Compressed air from 3,000 psi SCBA cylinders was used to pressurize the system. A non-venting pressure regulator rated for a maximum inlet pressure of 6,000 psi and an outlet pressure of 800 psi was used to control the inlet pressure to the tank at 30 to 50 psi. The discharge side pressure gauge was graduated from 0 to 800 psi in 25 psi increments. When the regulator was adjusted to deliver a safe operating pressure between 30 to 50 psi, the gauge pointer rested near zero between the first and second ticks on the gauge scale (Photo 4). ASME B40.100-2005 Pressure Gauges and Gauge Attachments,⁶ stipulates that “*The pressure gauge selected should have a full-scale pressure such that the operating pressure occurs in the middle half of the gauge scale. The full-scale pressure gauge selected should be approximately 2 times the intended operating pressure.*” The gauge should have had a range of 0-100 or 0-150 psi.

- Air from the SCBA cylinders was routed to the forward head of the tank through tubing, a check valve, and a manually operated 3-way valve with two of the valve ports blocked so that it operated as a one-way shutoff valve. Forensic examination of the regulator after the incident revealed a malfunction due to an unidentified source that rendered the regulator incapable of controlling the air pressure introduced into the tank. This could have allowed the air pressure to exceed the water tank's safe capacity resulting in catastrophic rupture of the tank bottom. Incorporation of a properly sized pressure relief valve as recommended by the manufacturer's warning label and as stipulated by the ASME Boiler and Pressure Vessel Code⁷ may have safely vented the excessive pressure, maintaining the tank pressure below the 225 psi failure point.

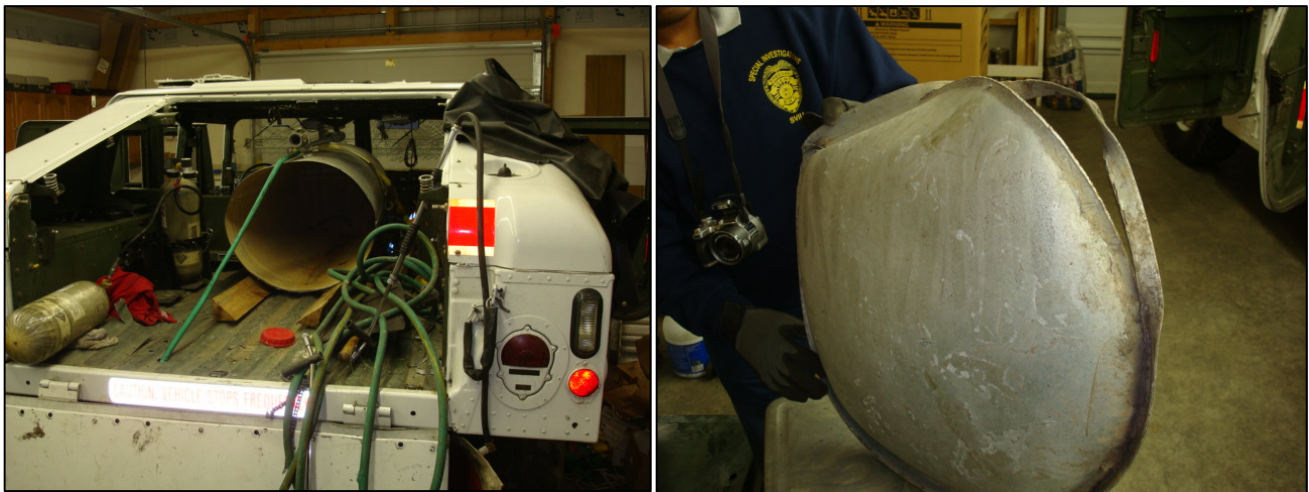
Photo 5 (left) and Photo 6 (right). Photo 5 shows the location of the 120-gallon water tank mounted horizontally in the bed of the Humvee. Note that the tank moved forward after the explosion. Photo 6 shows a close-up of the tank's bottom which separated.

The tank manufacturer reported to NIOSH investigators that the tank was designed as a hydro-pneumatic water storage tank for use in a home water well system. The tank's labeling stated it was designed to be used with ambient temperature water at a maximum pressure of 75 PSI. The tank was designed to be used in a vertical or up-right position but the tank was insensitive to position so mounting the tank in a horizontal position would not affect its performance (see Photo 5). The manufacturer reported that the tank was produced by rolling a sheet of steel into a cylinder and welding the edges together. Two tank heads were inserted into the ends of the cylinder and welded. The whole assembly, with various pipe connections welded in place, was then hot-dip galvanized. The bottom head was concave when installed and designed to fail at around 225 PSIG (failure being defined as a permanent deformation of the tank as opposed to tank rupture – see Photo 6).

Following the incident, inspections of the water delivery system showed that the system did not include a pressure relief valve or device that would relieve excess pressure to prevent the system from being over-pressurized. The fire department stated that their belief was that a pressure relief device was present. There was no explanation for why a pressure relief valve or device was not present during the post-incident inspections. The water tank did not contain any baffles or swash partitions; it

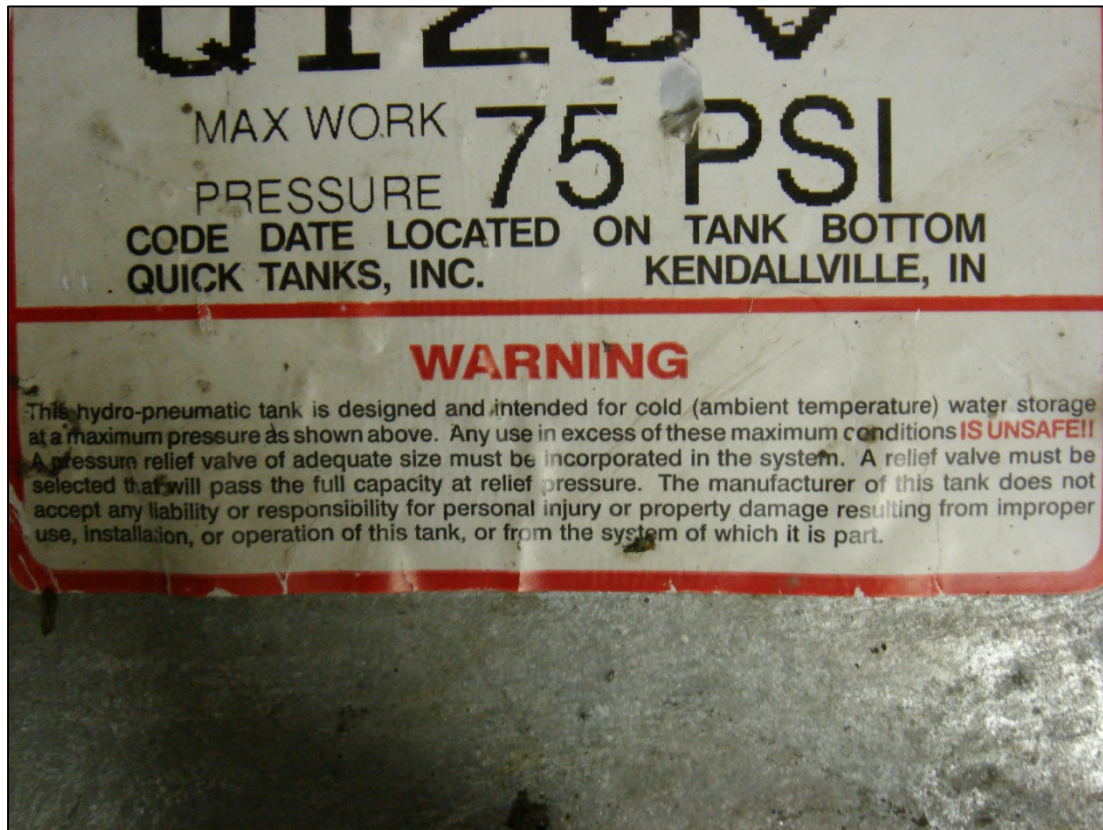
Photo 7. Photo shows warning label attached to 120-gallon water tank. The label states "Max Work Pressure 75 PSI," "Any use in excess of these maximum conditions IS UNSAFE!!" and "A pressure relief valve of adequate size must be incorporated into the system." (NIOSH Photo)

The tank's labeling stated "Any use in excess of these maximum conditions IS UNSAFE!!" and "A pressure relief valve of adequate size must be incorporated into the system" (see Photo 7). According to the manufacturer, the tank is not supplied with a pressure relief valve because pressure relief valves are extremely application sensitive.

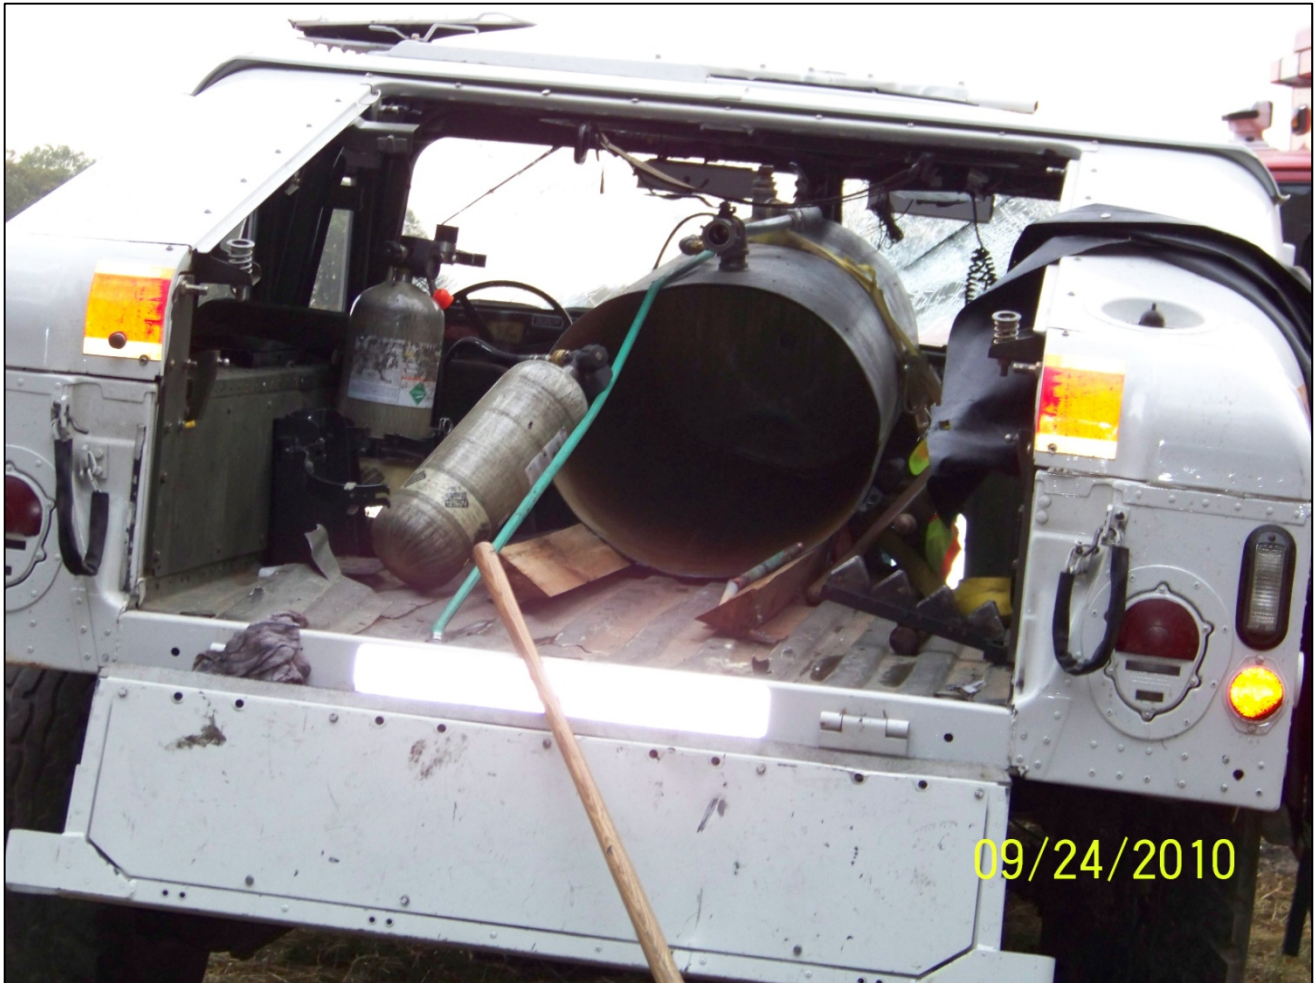
Photo 8. Photo shows remains of the water tank in the bed of the Humvee after the explosion. The bottom of the water tank separated and struck the hose reel, propelling the hose reel over the tailgate. The hose reel is believed to have struck and fatally injured the victim.
(Photo courtesy of the Sheriff's Office)

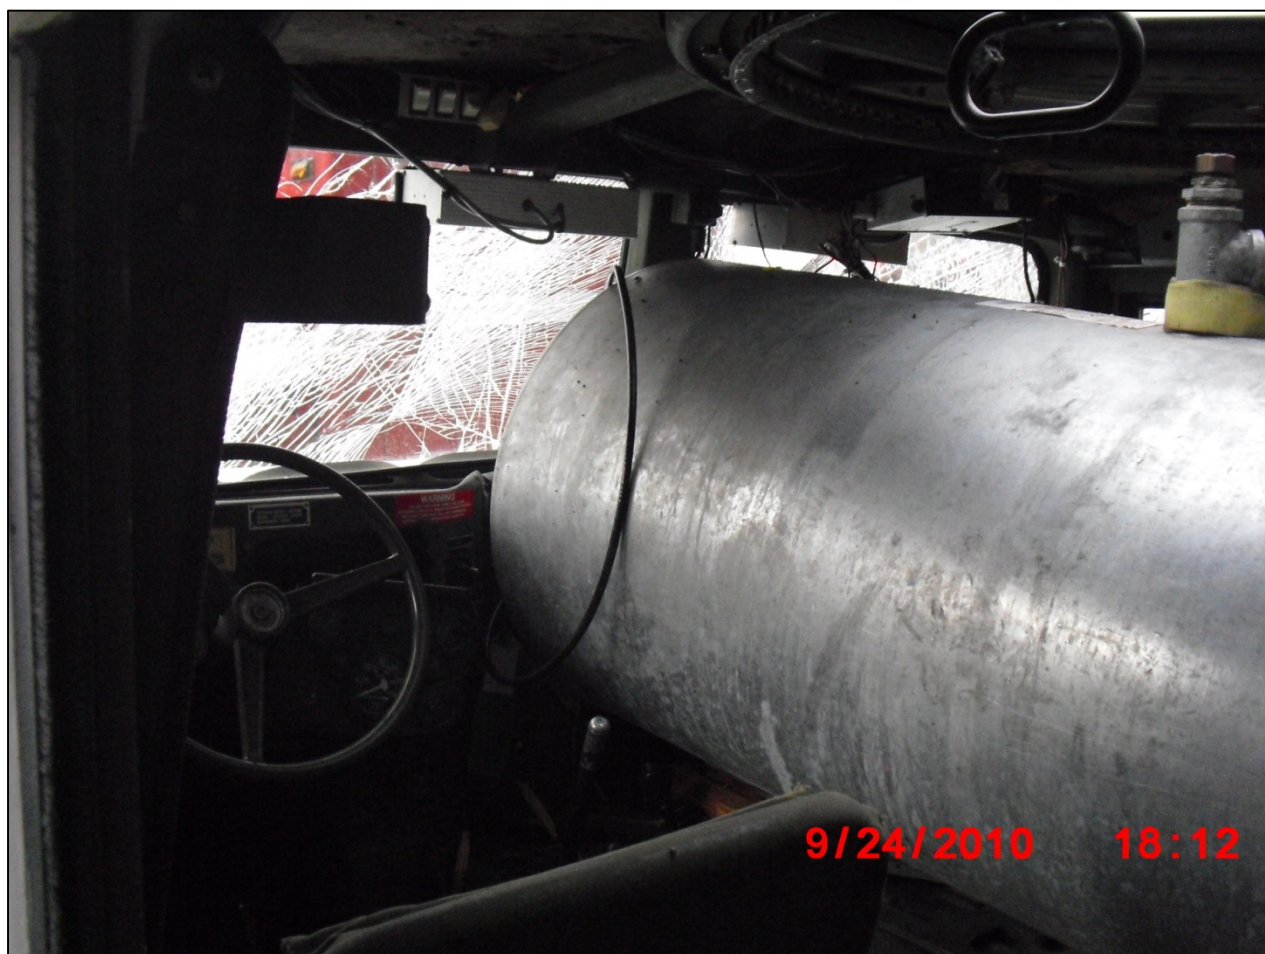
Photo 9. Photo shows how the explosion propelled the front end of the water tank against the Humvee's dashboard. The force of the water tank impacting against the dashboard shattered the windshield.

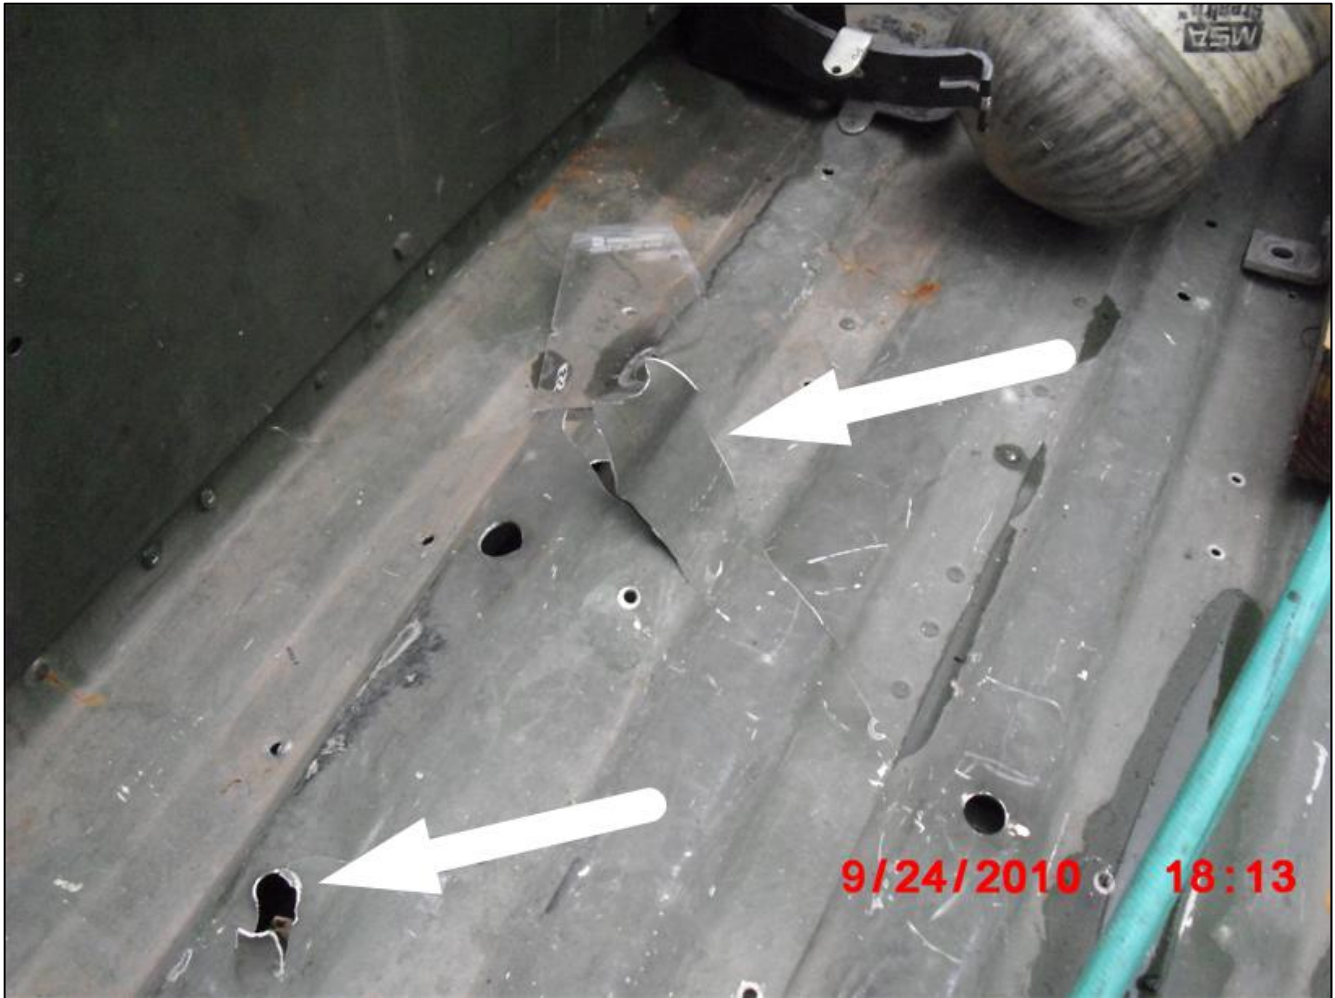
Photo 10. Photo shows the bolt holes through the bed of the Humvee where the motorized hose reel was mounted. The force generated by the end of the exploding tank striking the hose reel ripped the hose reel mounting bolts through the Humvee's bed. Ripped metal at the location of bolt holes indicated by the arrows.
(Photo courtesy of the Sheriff's Office)

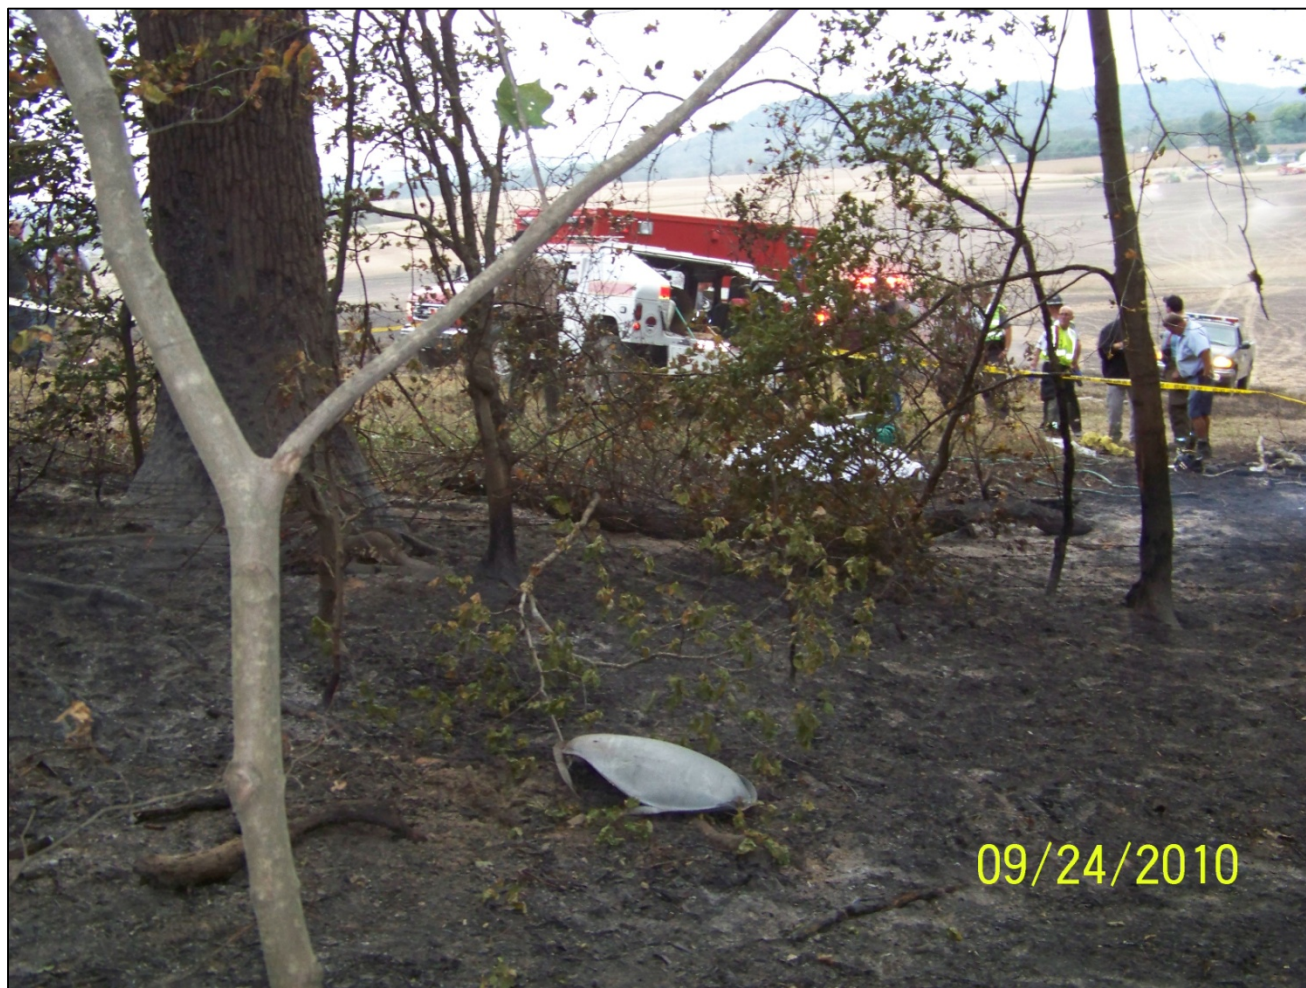
Photo 11. Photo shows the location where the bottom end of the water tank came to rest after the explosion. The Humvee is seen in the background. The victim and the hose reel were found near the wood line.

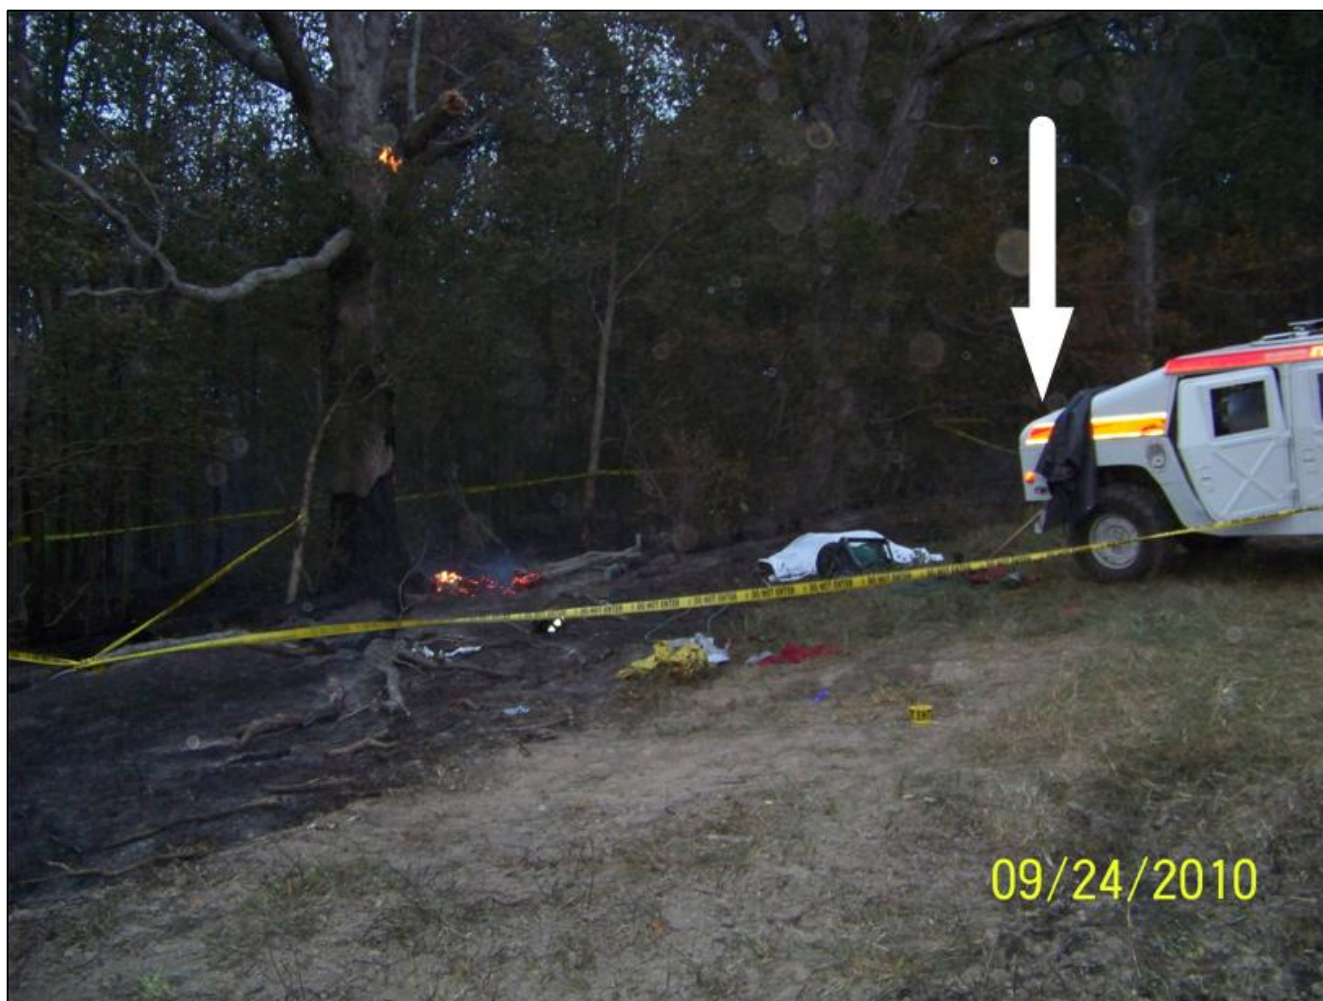
**Photo 12. Photo shows the location of the incident scene. Crews were working to extinguish hot spots burning on the dead tree when the water tank exploded. The victim was standing near the rear of the Humvee when the water tank exploded (location marked by arrow).
(Photo courtesy of the Sheriff's Office)**

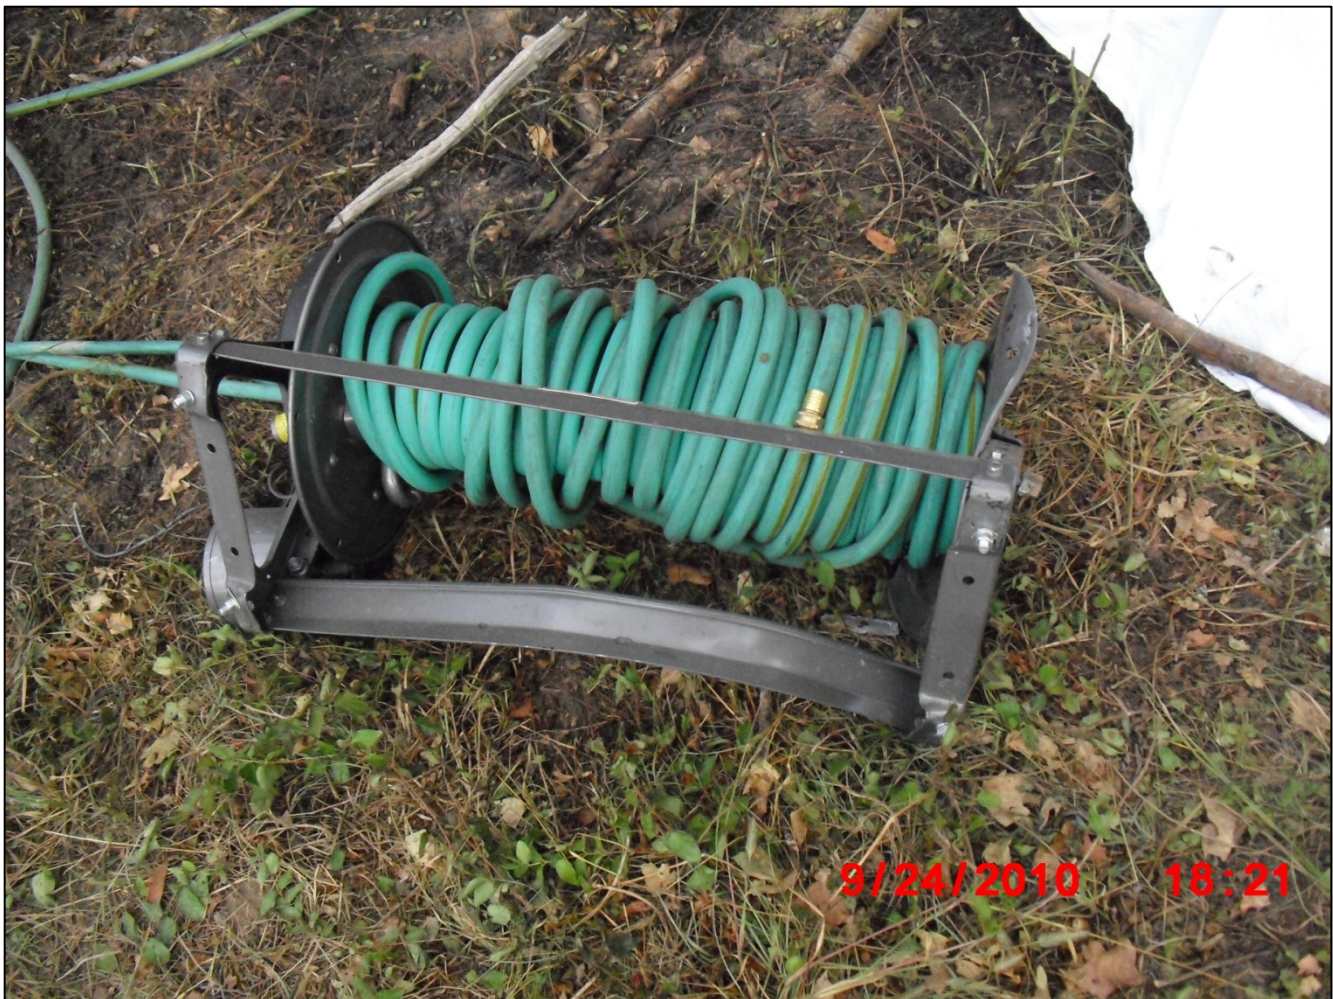
Photo 13. Photo shows the hose reel that was mounted in the bed of the Humvee. After the explosion, the hose reel was found approximately 20 feet behind the rear of the Humvee and in close proximity to the victim.
(Photo courtesy of the Sheriff's Office)
