## **A Career Lieutenant and Fire Fighter/Paramedic Die in a Hillside Residential House Fire – California**

### **Executive Summary**

On June 02, 2011, a 48 year-old career lieutenant and a 53 year-old fire fighter/paramedic died in a multi-level residential structure fire while searching for the seat of the fire. *Note: The residential structure where the fatalities occurred was built on a significantly sloped hillside common throughout the city. The fire floor was one floor below street level.* Six companies and three command chiefs were dispatched to a report of an electrical fire at a residential home. When Engine 26, staffed with a lieutenant, fire fighter/paramedic (the victims), and driver arrived at approximately 1048 hours, they noticed light smoke showing as they made entry through the front door, side A, street level, of the building. Minutes later, the incident commander (IC) tried contacting them over the radio, but received no response. A battalion chief (BC) assigned to “the fire attack group” followed the hoseline through the door and spoke to the victims on the street level floor. The lieutenant stated to the BC that the fire must be a floor below them. The BC st

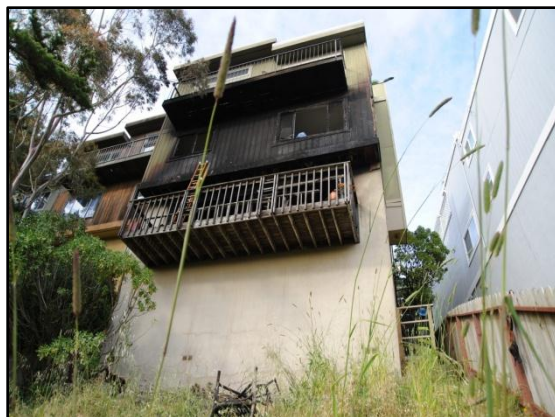
**The side C of the fire structure - the balcony is the fire floor which is below grade from street level.**  
*(Photo courtesy of Fire Department)*

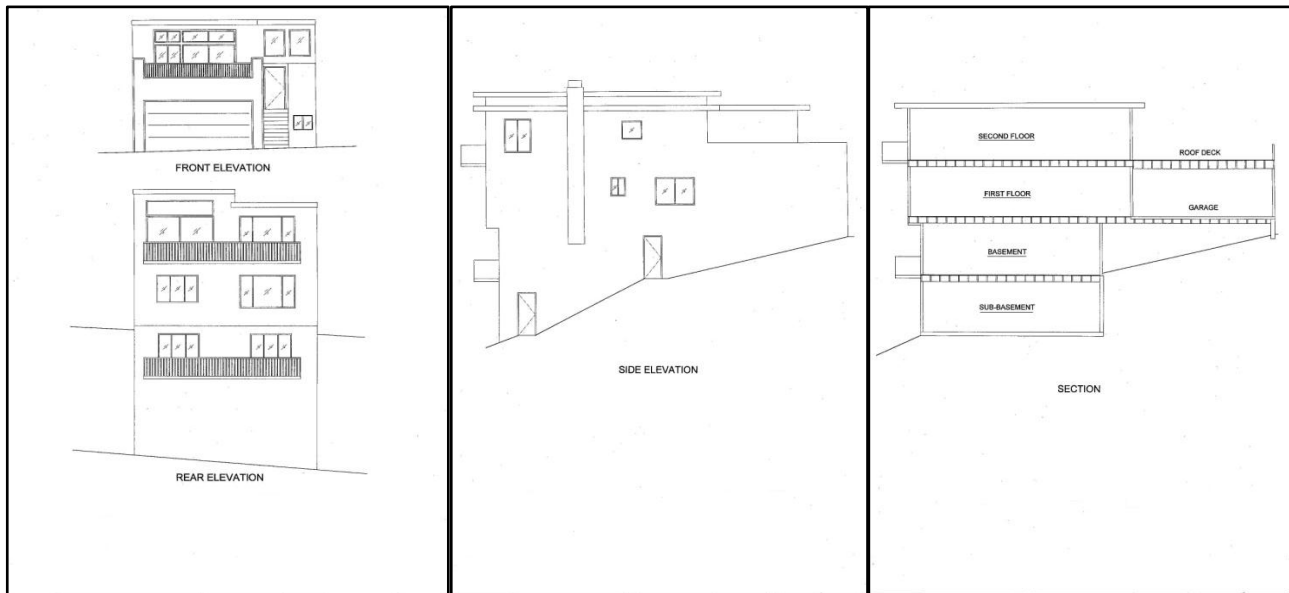
The incident involved a four-story residential structure that was completed in 1976 (see Diagrams #1, #2, and #3). The structure was built on a hillside with a significant slope and has two stories above the street level and two stories below the street level. The top two stories provided 1,468 square feet of living space. The first floor (street level) contained 3 bedrooms, 2 bathrooms, and a 2 car garage. The second floor contained a living room, dining room, kitchen, family room, and a deck over the garage. A laundry area was located on a large landing on the stairs between the first floor and basement (see Diagram #4 and #5). The basement (first level below the street) contained a finished living area with a large utilities area. The basement was accessible from an exterior door on side B of the structure and an interior set of stairs. In addition, the basement had a balcony on side C (see Diagram #6). The sub-basement (second level below grade) contained a living area that was only accessible by an exterior door on side B and had no windows (see Diagram #7). The residential structure had a flat roof that consisted of a bitumen membrane roof. The exterior was primarily stucco with large windows on the top 3 stories of side C of the structure. Side D of the structure shared a common fire wall with another residential structure. This large multi-level structure had smoke alarms but no residential sprinkler system/automatic fire suppression. *Note: The National Institute for Standards and Technology (NIST) will be doing a fire model on this incident which will be released in the future.*

**Diagram #1: Front (side A) and Rear (side C) of Fire Structure**  
(Courtesy of Fire Department)

**Diagram #2: Side B of Fire Structure**  
(Courtesy of Fire Department)

**Diagram #3: Floor Levels and Grade**  
(Courtesy of Fire Department)

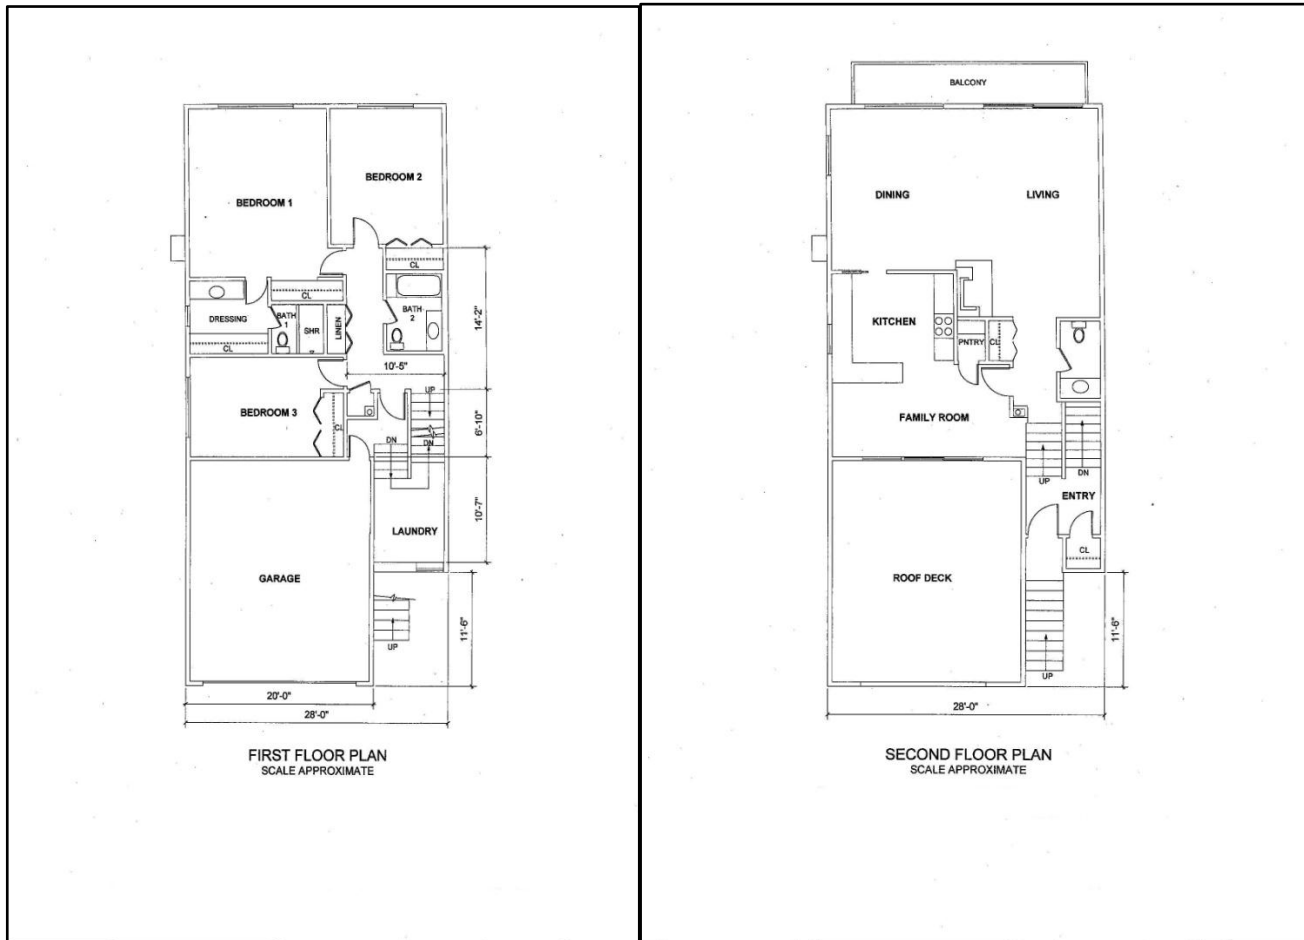
**Diagram #4: First Floor Layout  
(Street Level)**  
*(Courtesy of Fire Department)*

**Diagram #5: Second Floor Layout  
(Top Floor)**  
*(Courtesy of Fire Department)*

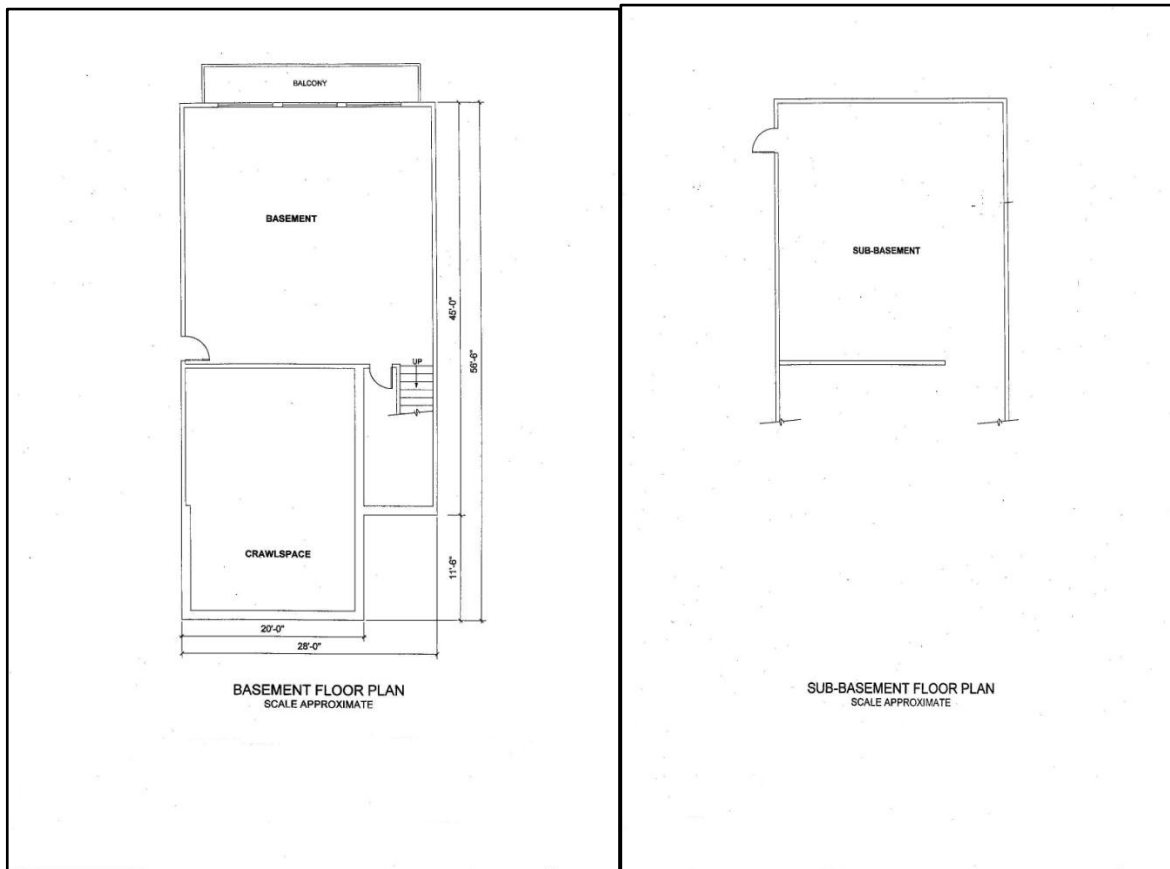
**Diagram #6: Basement Floor Layout**  
(Below Grade; Fire Floor)  
(Courtesy of Fire Department)

**Diagram #7: Sub-Basement Floor Layout**  
(Courtesy of Fire Department)

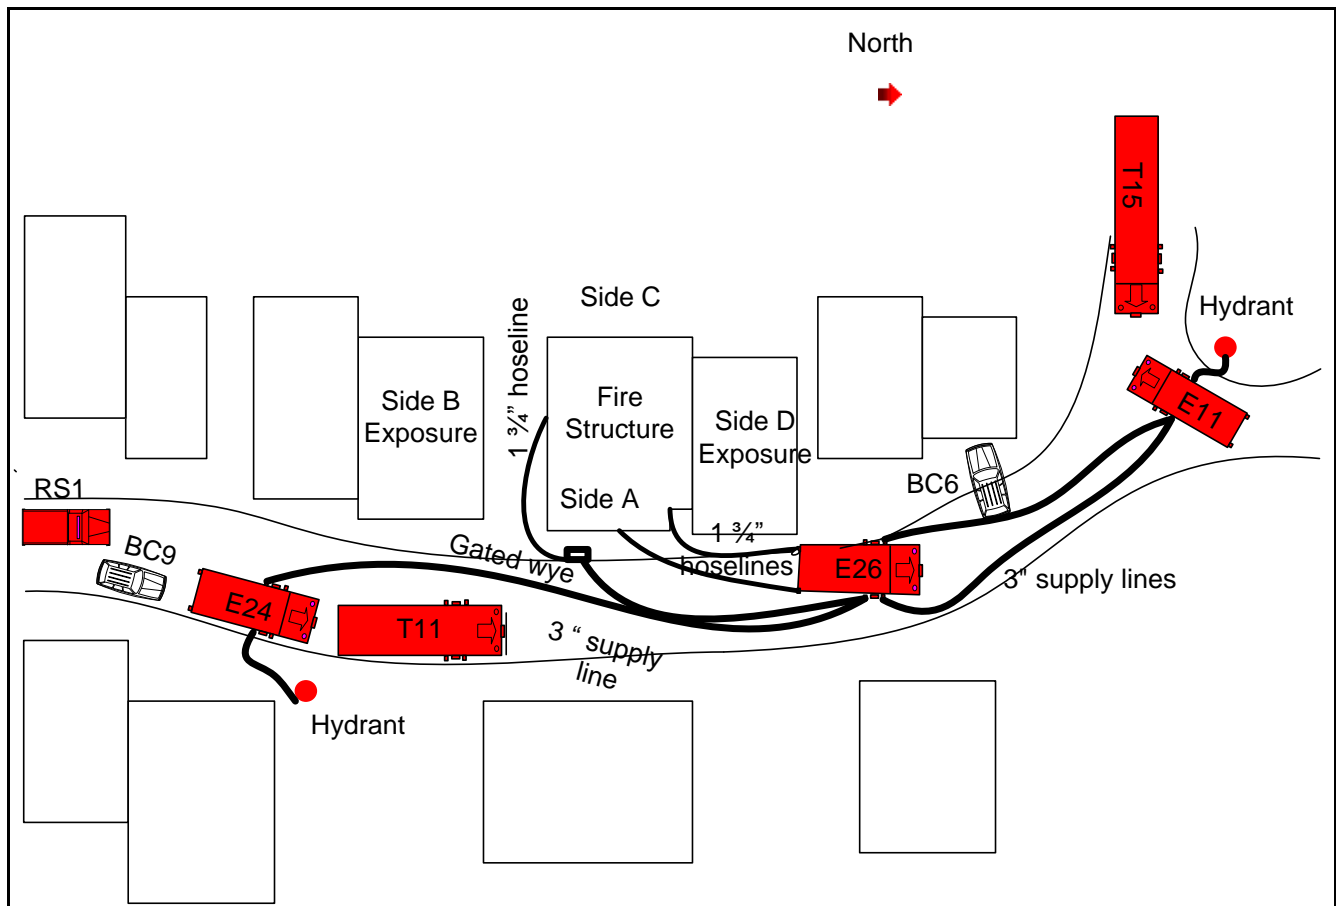
**Diagram #8: Initial Apparatus and Hoseline Placement**

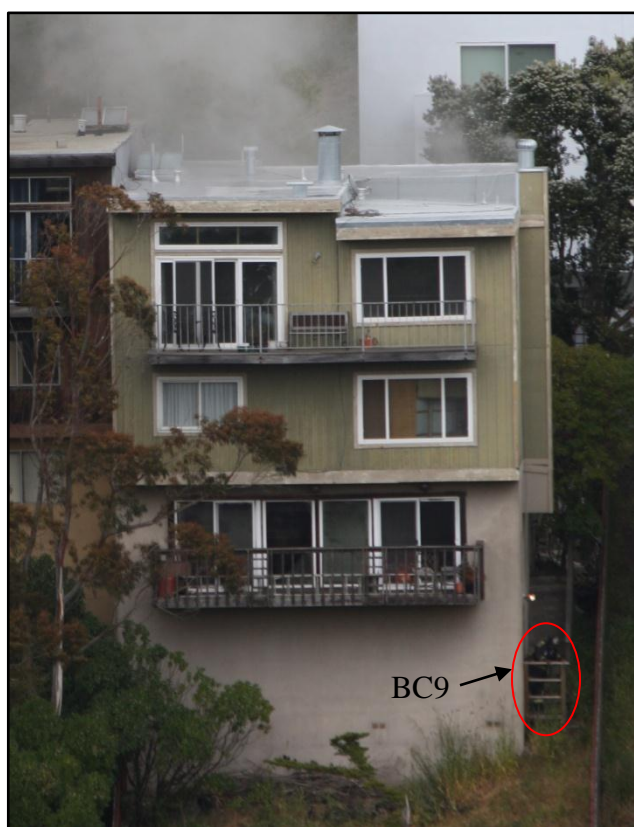
At approximately 1057 hours, BC9 went down a debris filled path along the outside of the structure on side B to the wooden stairs connecting the basement door to the sub-basement door. He went to the sub-basement and forced the door open (see Photo 1). After seeing the room filled with light smoke,

**Photo 1: BC9, lower right at bottom of external wooden stairs, kicking sub-basement door open. Light smoke showing at side A of fire structure.  
(Courtesy of Fire Department)**

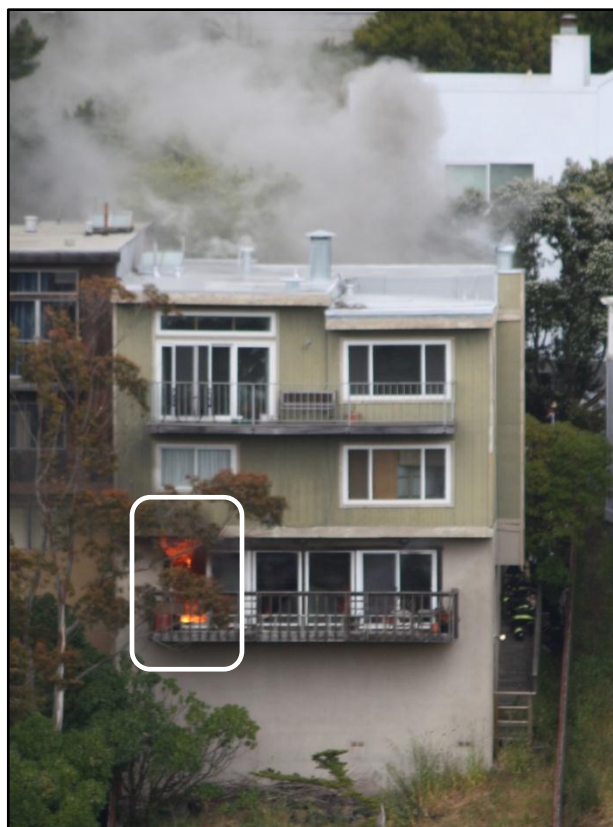
**Photo 2: Fire self-vents out the glass door of the basement balcony near the C/D corner. Note: Fire highlighted in white.  
(Courtesy of Fire Department)**

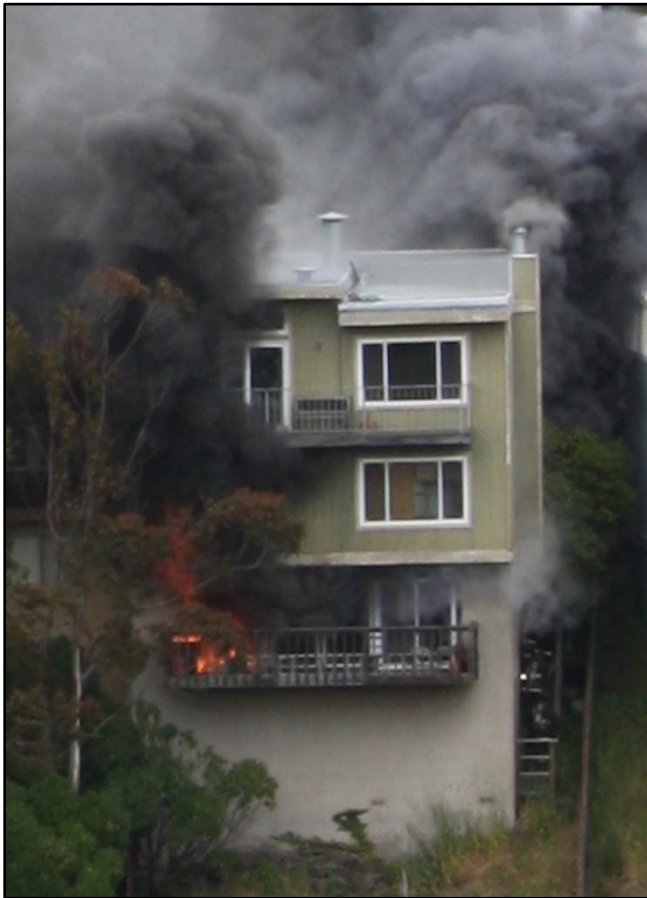
he looked around the B/C corner and saw smoke but no fire. BC6 located an older woman on the street, who resided at the fire structure and tried to get an understanding of the layout. At this point, dark smoke was observed about 2 feet off the ceiling in the garage. The smoke was not turbulent. At approximately 1058 hours, BC9 headed to the basement level man door. The fire self-vented out the glass door near the C/D corner (see Photo 2). BC9 forced the barred security door open with his halligan bar and then kicked the door open. The E11 crew advanced into the basement with the 1  $\frac{3}{4}$ " hoseline. At the door, they felt a blast of heat and observed heavy smoke in the fully involved room. The heat forced the E11 fire fighter operating the nozzle to back up. BC9 radioed, "We have heavy fire and smoke and need a second line on side B." (see Photo 3).

**Photo 3: BC9 and E11 open exterior basement door.**  
*(Courtesy of Fire Department)*

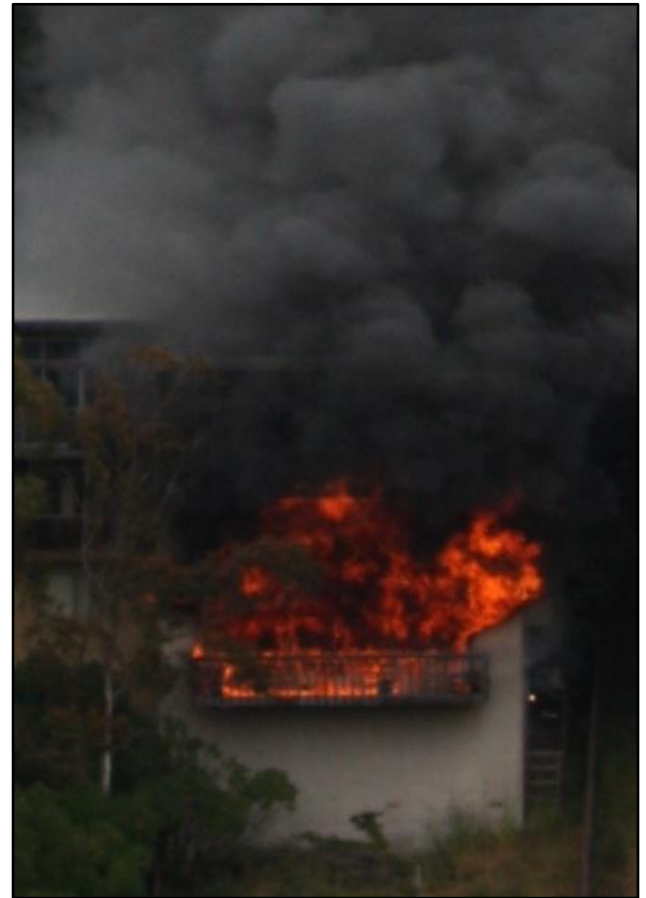
**Photo 4: Heavy fire and smoke increased as E11 tried to make entry through the basement man-door. RS1A and E24 tried to make entry through garage.**  
*(Courtesy of Fire Department)*

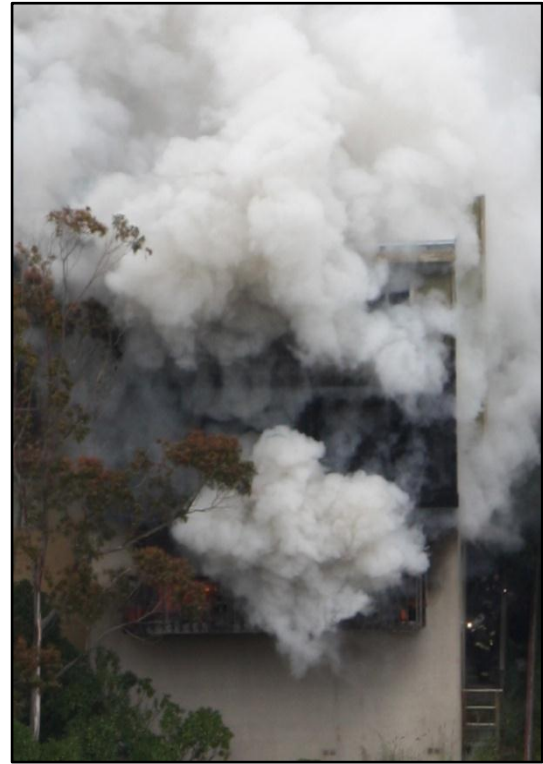
side B and made entry behind E11's crew and began to fight the fire (see Photo 5). The IC assigned BC6 to Division 3 (the second floor) and the crew from T11 to make entry at the front door to search the upper floors. When the T11 crew approached the door, RS1B had just come out. The two crews regrouped to go back in with BC6. E24 and RS1A backed out of the garage. RS1A proceeded to side B, E24 proceeded to the front door and met up with BC6, T11, and RS1B.

**Photo 5: Water is getting on the fire.**

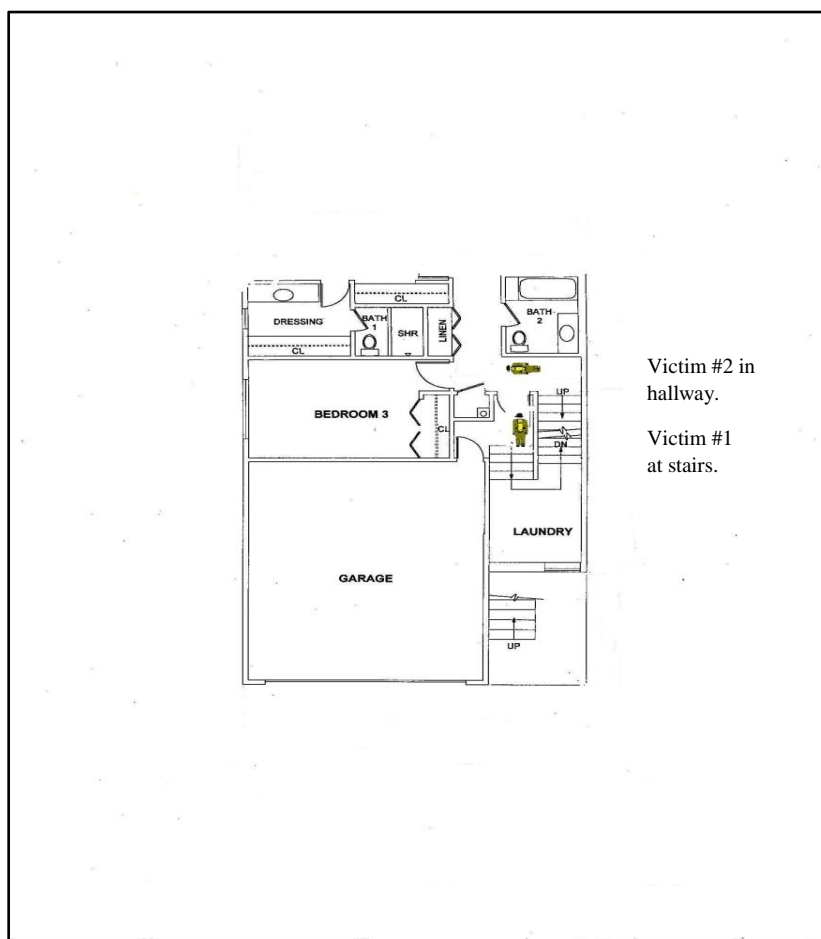
**Diagram #9: Location of Victims Found on First Floor, side A of Structure**

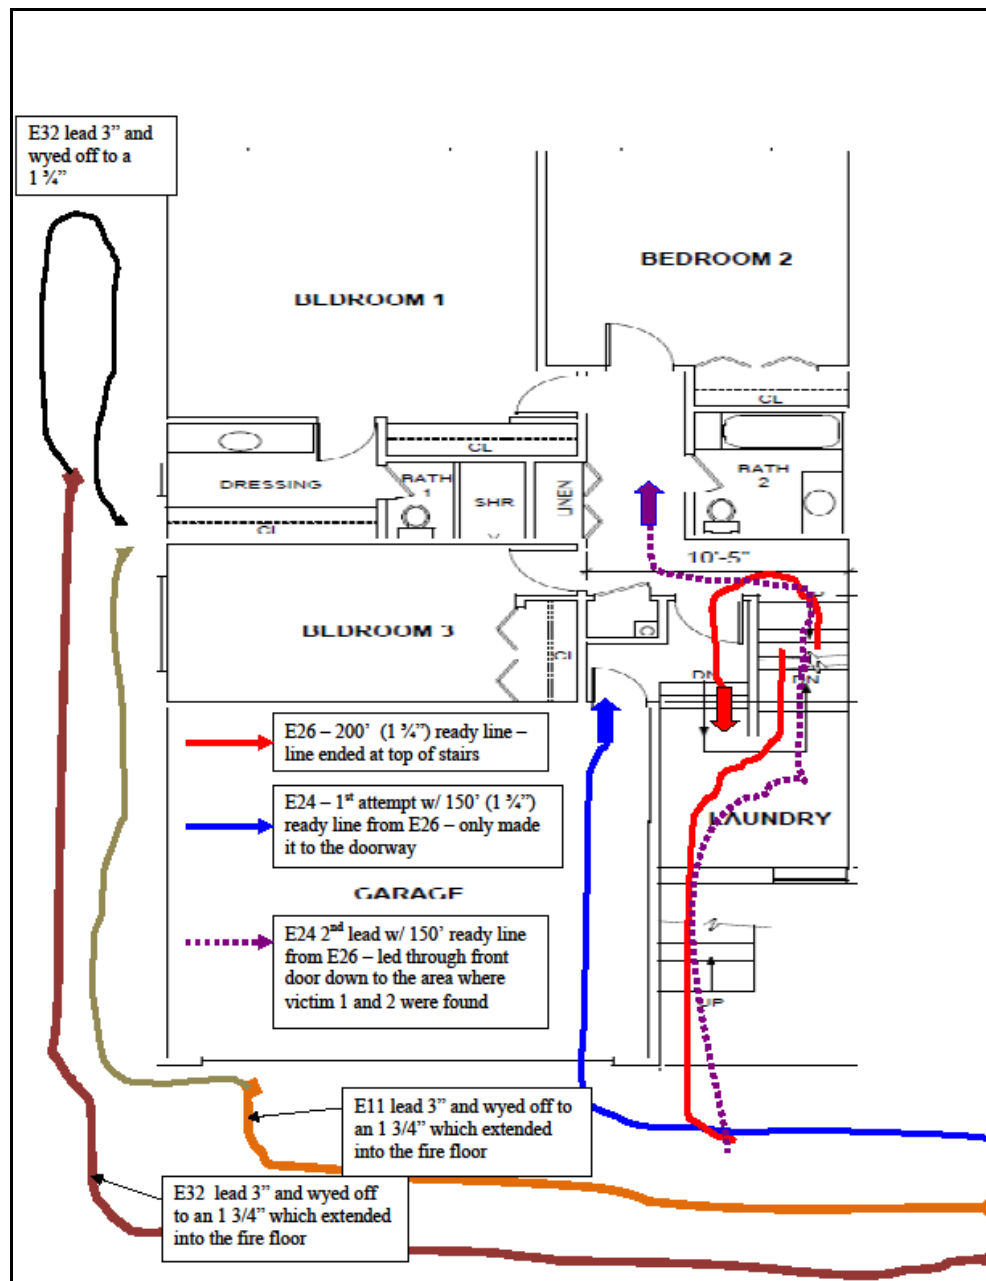
At approximately 1105 hours, T15 radioed the IC that they were ready to vertically ventilate. The IC gave T15 the go ahead. At about that same time, RS1A made entry on side B after the E11 crew knocked down the large room and contents fire. RSA1 radioed command that they were conducting a primary search. E24, T11 and RS1B regrouped at the front door, BC6 instructed T11 to stay at the front door and help feed the hoseline as BC6, E24 and RS1B made entry. After entering the front door, BC6, E24 and RS1B followed the E26 hoseline. BC6 had a thermal imaging camera, but the soot and smoke were so heavy he could not see the camera screen in the zero visibility. In zero visibility conditions, the E24 crew advanced to the bottom of the stairs of the first floor hallway. The E24 lieutenant followed E26's hoseline which led him to a metal door to the foyer which led to the garage and basement stairs. He pushed open the door and found Victim #1 in the first floor foyer at the top of the stairs to the basement. Then seconds later, E24's fire fighter/paramedic found Victim#2 a few feet away in the first floor hallway just past the doorway to the foyer (see Diagram #9). *Note: Victim #1 was found on his knees with his arms in a hunched over position in the foyer at the top of the basement stairs. Victim #2 was found face down in the hallway toward the bedroom. The E26 hoseline was found in the foyer with Victim #1 and the door partially closed on it (see Diagram #10).*

**Diagram #10: Hose Placement in and around Structure up to the Time of Incident**  
(Courtesy of the Fire Department)
