Death in the line of duty...

A summary of a NIOSH fire fighter fatality investigation

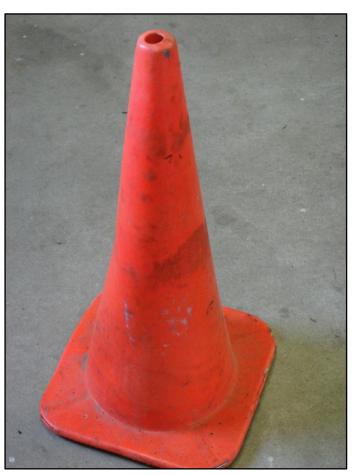
Photo 1. Cone used at the incident scene. (NIOSH photo.)

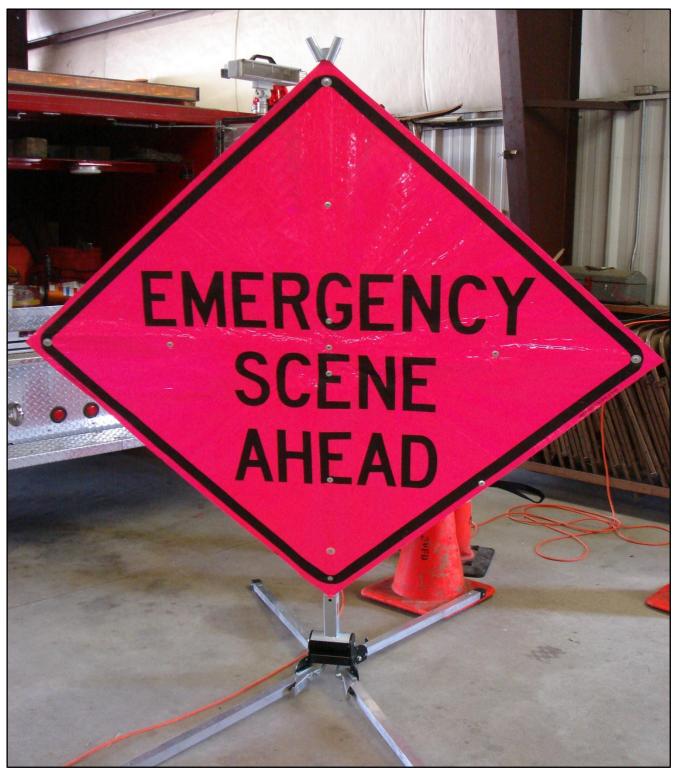
Photo 2. Emergency sign used at the incident scene. (NIOSH photo.)

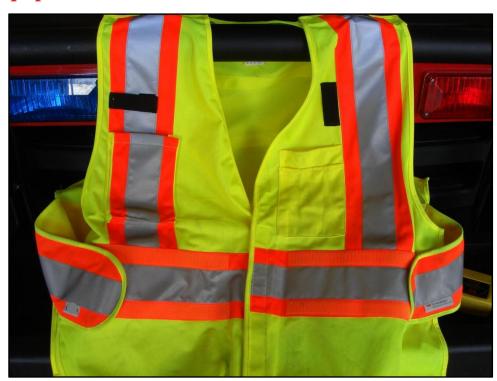
Photo 5. Vest similar to one worn by the victim. (NIOSH photo.)

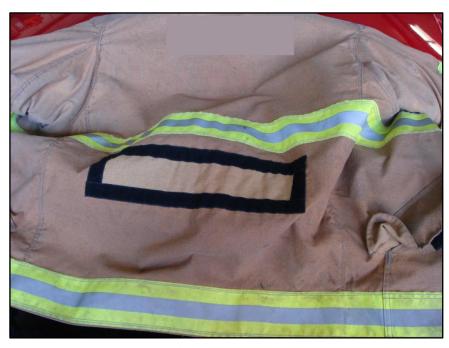
Photo 6. Turn out coat similar to one worn by the victim. $(NIOSH\ photo.)$

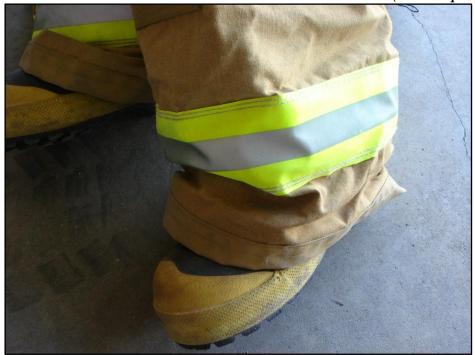
Photo 7. Bunker pants similar to those worn by the victim. (NIOSH photo.)
