## Career Fire Fighter Dies After Falling From Aerial Ladder During Training – Florida

### Executive Summary

On January 6, 2012, a 49-year-old male career fire fighter (the victim) died from injuries sustained after falling from the tip of a 105-ft aerial ladder during training. On January 9, 2012, the U.S. Fire Administration notified the National Institute for Occupational Safety and Health (NIOSH) of this incident. On January 23 – 27, 2012, a safety and occupational health specialist and a general engineer from the NIOSH Fire Fighter Fatality Investigation and Prevention Program traveled to Florida to investigate this incident. The NIOSH investigators met with the fire chief, assistant fire chief, the local union president, fire department's training commander, the city's risk manager, associate medical examiner, sheriff's office crime scene unit, and field representatives for the Florida State Fire Marshal, Bureau of Fire Standards and Training.

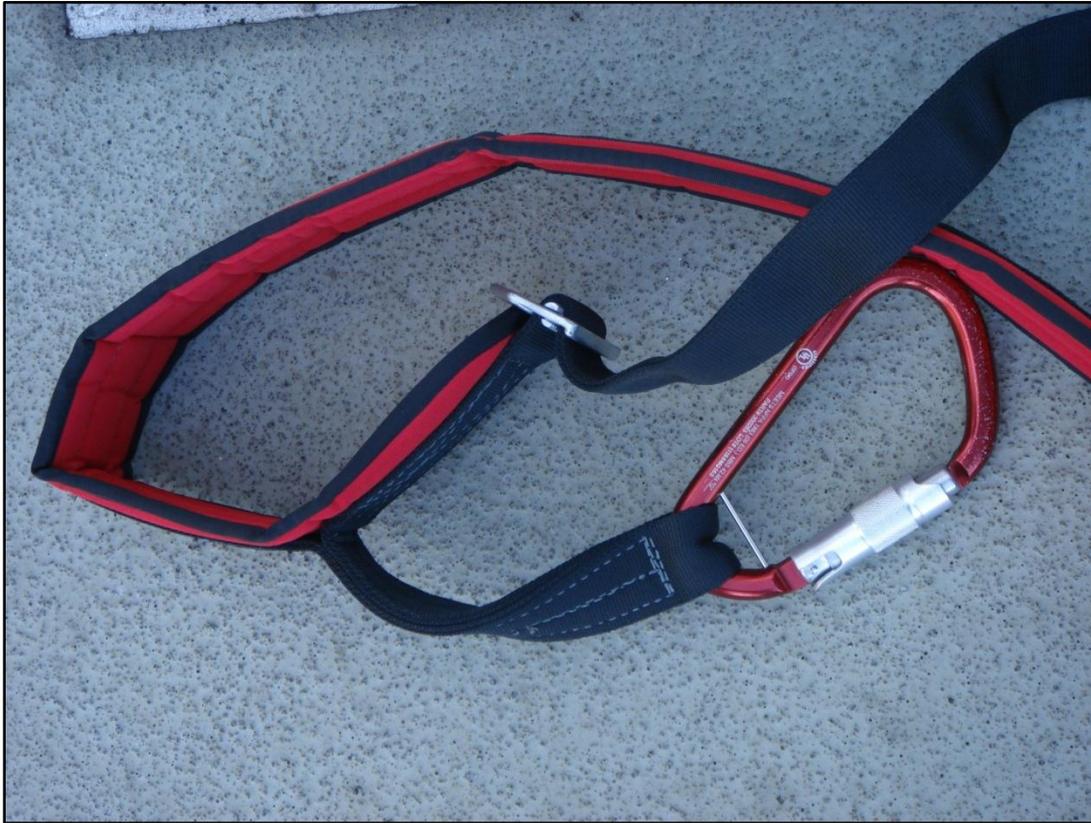
**Photo 1. Identical type of ladder safety belt worn by the victim and other fire personnel when climbing the ladder.**  
(NIOSH photo.)

During the incident, the front wheels were chocked with both sets of out-and-down stabilizers positioned correctly prior to operating the aerial ladder. The ladder rungs measured approximately 15½ inches apart, the left and right ladder rails (from the inside) measured approximately 21¾ inches across and the ladder rail height measured approximately 16¾ inches. The ladder rungs were coated with a slip-resistant application to enhance footing and hand grips for traversing the ladder. Two sets of foot pegs were also available on the fly section of the aerial ladder for individuals to stand on while working from the ladder. Also, on the inside of the right rail a 12-ft roof hook was placed in a bracket system (originally designed for a pike pole). It was located approximately 83 inches below the first set of foot pegs, which decreased the distance between the left and right rails to approximately 19 inches. *Note: Fire department personnel had complained of clothing getting snagged on the roof hook and bracket system when coming down from the tip of the ladder.*
