# ***Death in the line of duty...***

A summary of a NIOSH fire fighter fatality investigation

## ***Career Fire Captain Dies When Struck by a Pickup Truck While Working at the Scene of Two Traffic Incidents - California***

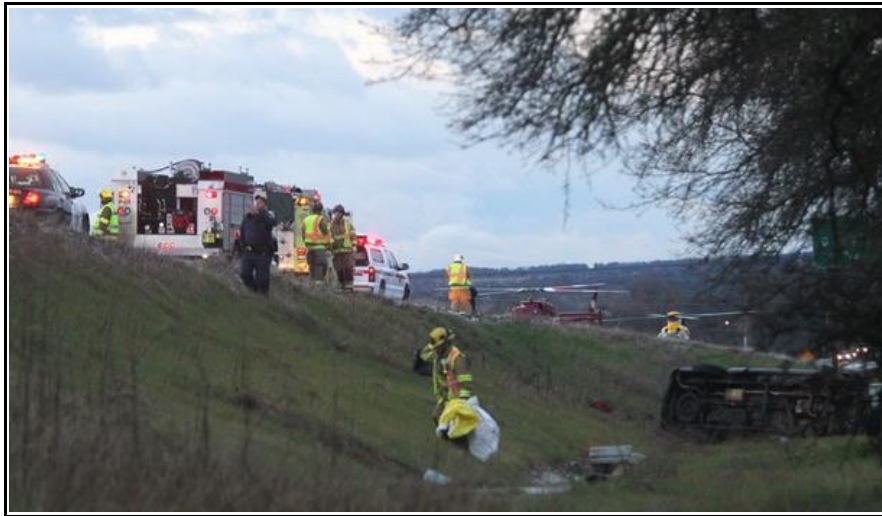
**Photo of the incident scene.**

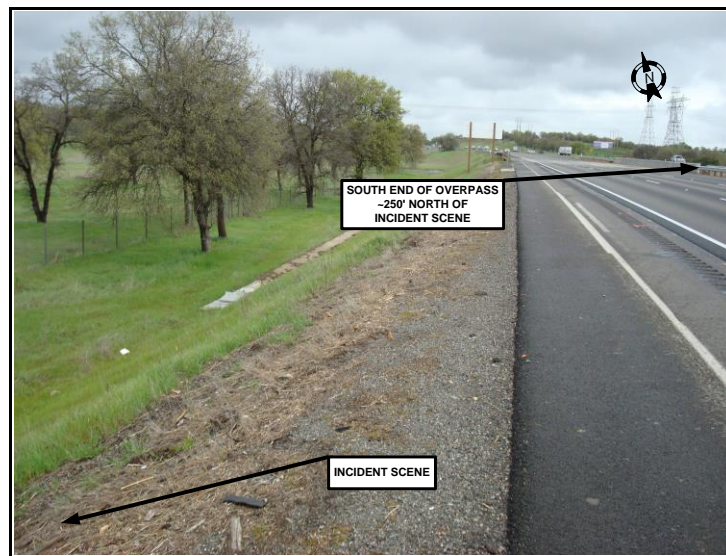
**Photo 1. Photo of the highway near the incident scene facing north.  
(NIOSH photo)**

The incident involved a major north-south interstate highway that had six travel lanes, three northbound and three southbound. In the area of the incident, the southbound lanes passed over a local roadway (see Photo 1). The original overpass was constructed in 1964 and the deck was covered with a polyester concrete overlay<sup>a</sup> in 2008. The overlay was tined<sup>b</sup>, which removed the smooth polyester surface and provided a granular wear surface.

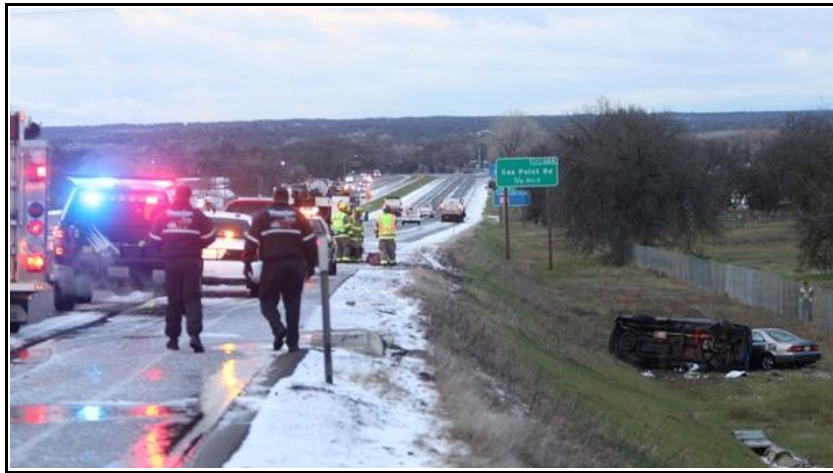
**Photo 2. Photo shows the incident scene facing south and hail accumulation on road shoulder.**  
*(Photo courtesy of Redding Record Searchlight. Photo by Andreas Fuhrmann)*

The temperature at the time of the incident was approximately 36°F with calm winds around 2 MPH. Area weather station records show that hail had fallen one hour and twenty-four minutes prior to the fatal incident, which would have been around the time the first crash occurred.<sup>1</sup> There was approximately one fourth to one inch of hail that had accumulated on Lane #1, left shoulder, and right shoulder of the southbound lanes according to witnesses who traveled through the collision scene at varying times (see Photo 2).

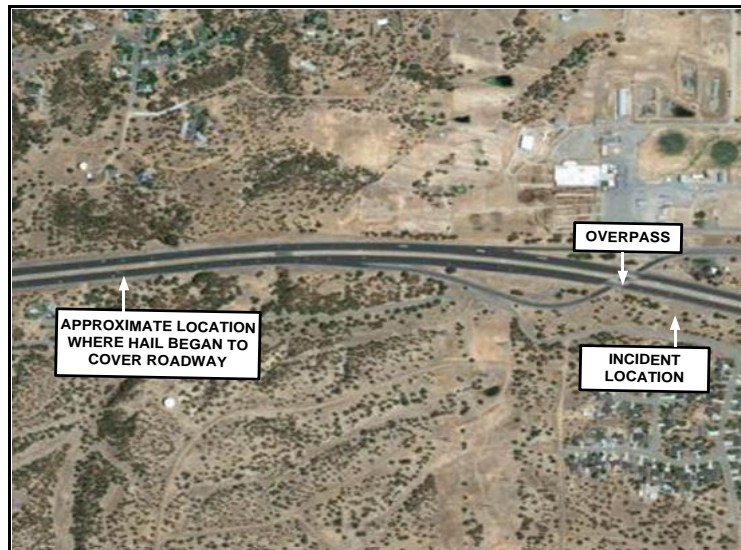
**Diagram 1. Showing aerial view of incident scene and location where hail began to cover the highway.**  
*(Depiction taken from Google Maps)*

On February 29, 2012 at approximately 0450 hours, a hail storm, which was an uncommon occurrence in the area, passed over a section of interstate highway (see Diagram 1). It was reported by drivers who were traveling through the area that there was not a gradual entry into the hail. They stated that the road was clear and then all of a sudden it was covered with hail. Police reported that immediately following the storm, numerous traffic incidents occurred in the area. The state highway department was dispatched to plow the hail and clear the road. A highway truck had passed through the area prior to the incident, plowing lanes #2 and #3 leaving lane #1 mostly hail covered.

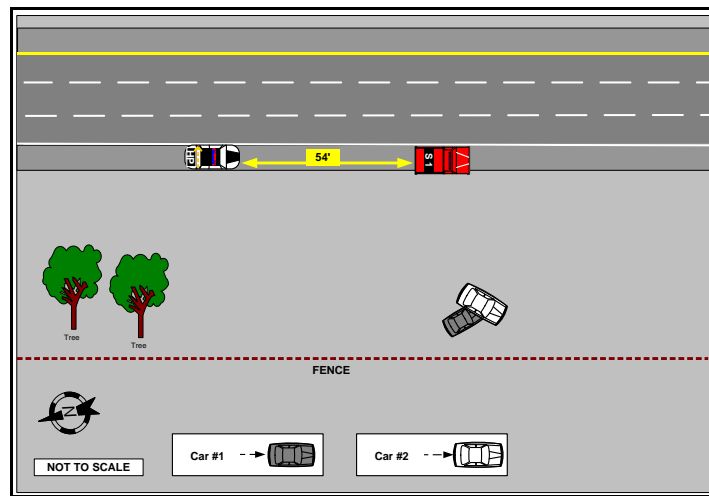
**Diagram 4. Diagram depicts the arrival of the victim to the incident scene at 0600 Hours.**

The Victim responded to the scene in a department utility truck with one additional fire fighter (FF) on board who was sitting in the front passenger seat. Upon arriving at the scene, he parked approximately 54 feet to the south of the highway patrol car (see Diagram 4).

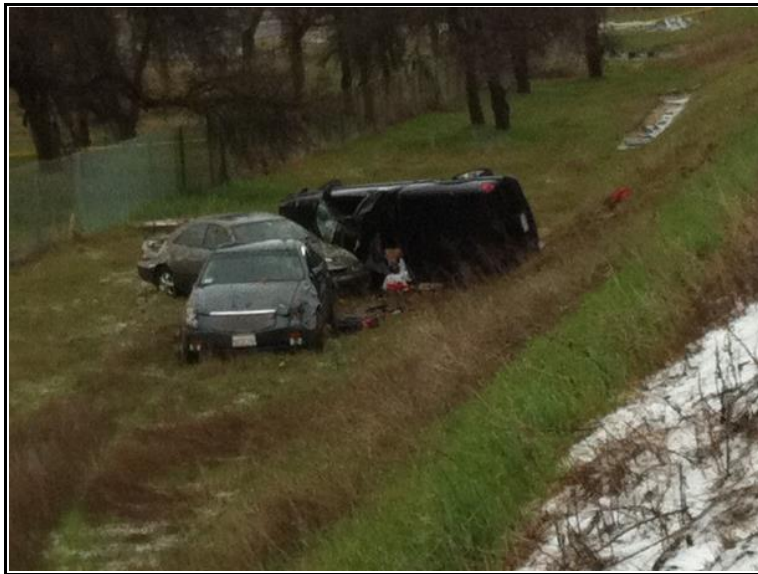
**Photo 3. Photo shows final location of all vehicles involved in the incident.**  
*(Photo courtesy of Redding Record Searchlight. Photo by Andreas Fuhrmann)*

The Victim continued to run in a northwesterly direction and was struck by the left side of the pickup truck which propelled him into the air and again into the truck's path. The truck continued to overturn in a southwesterly direction until coming to rest when it crashed into Car #1 and Car #2 (see Photo 3). The Victim and the driver of Car #2 were both found near the cab area of the pickup truck.

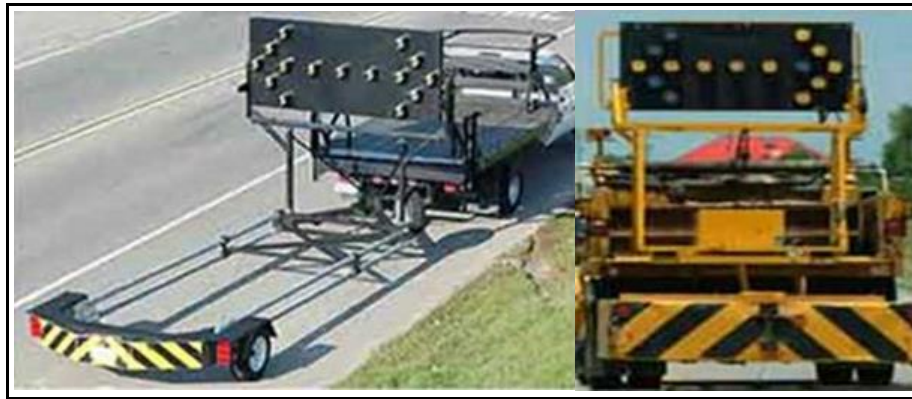
**Photos 4(left) and 5(right) show examples of truck mounted attenuators.**

Even though the hail storm and resulting slippery road conditions was a major factor in this incident, there are additional procedures that should be considered to further enhance the safety of responders who are working in a roadway emergency work zone. Had there been one available, it is possible that an upstream emergency vehicle could have alerted traffic to reduce speed prior to entering the roadway where the hail covered the road. Also a properly positioned heavy-duty truck that was equipped with a large flashing directional arrow and truck mounted attenuator ([see Photo 4 and Photo 5](#)) could have absorbed the impact of the truck prior to striking the victims. Many State and local highway departments have these types of trucks that are normally used for roadway maintenance, but can be called upon for use in emergency situations.

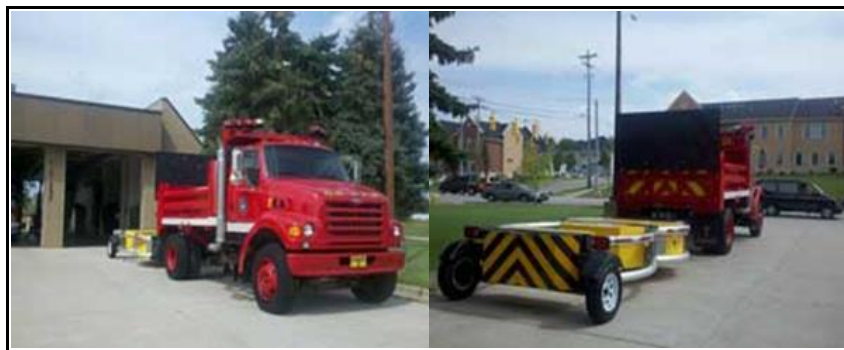
**Photos 6(left) and 7(right) show a surplus municipal dump truck that was converted into a truck mounted attenuator.**

Recently a fire department equipped a surplus municipal dump truck with lights, siren, reflective chevron strips on the back, a lighted road arrow sign, and a crash attenuator ([see Photo 6 and Photo 7.](#)) The truck was designed for use at roadway emergency incident scenes to protect the parked apparatus from moving traffic by placing it upstream directly to the back of the blocking apparatus. <sup>15</sup>

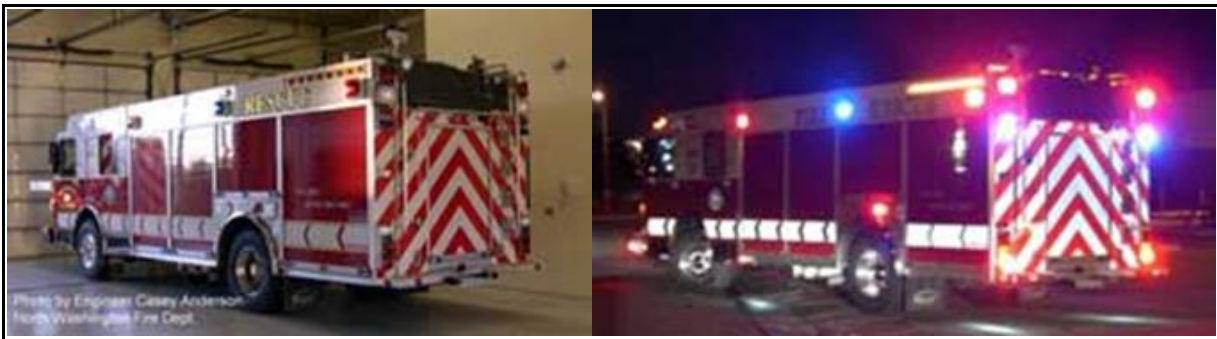
**Photos 8(left) and 9(right) show reflective directional arrow markings in daylight and darkness.**  
***(Photo courtesy of North Washington Fire Protection District, Denver, CO).***

The photos below (see [Photo 8](#) and [Photo 9](#)) show an example of reflective directional arrow markings that have been applied to the sides of a rescue unit. These side markings are arrow shaped to present a visual message that will direct motorists around and away from the emergency work zone. Amber directional lighting has also been installed on the upper rear sides to improve visibility when the truck is parked at an angle.
