Career Lieutenant and Fire Fighter Killed and Two Fire Fighters Injured by Wall Collapse at a Large Commercial Structure Fire - Pennsylvania

Executive Summary

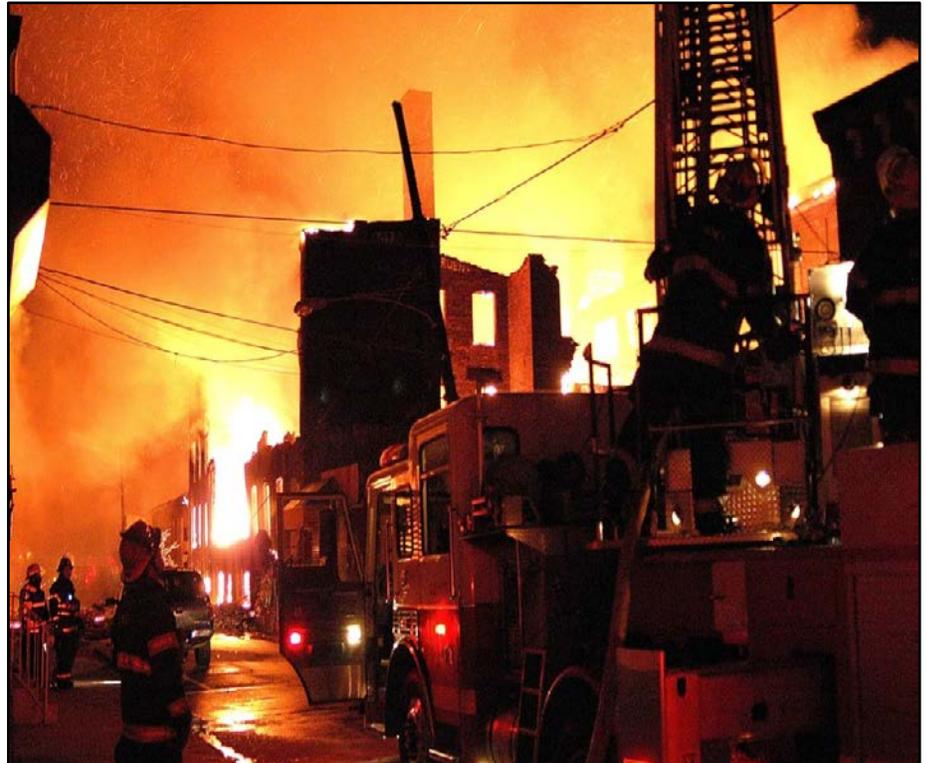
Ladder 10 is shown operating a ladder pipe on Side “A” of the fire. This photo is prior to the wall collapse that resulted in the fire fighter fatalities and injuries.
(Photo courtesy of the fire department)

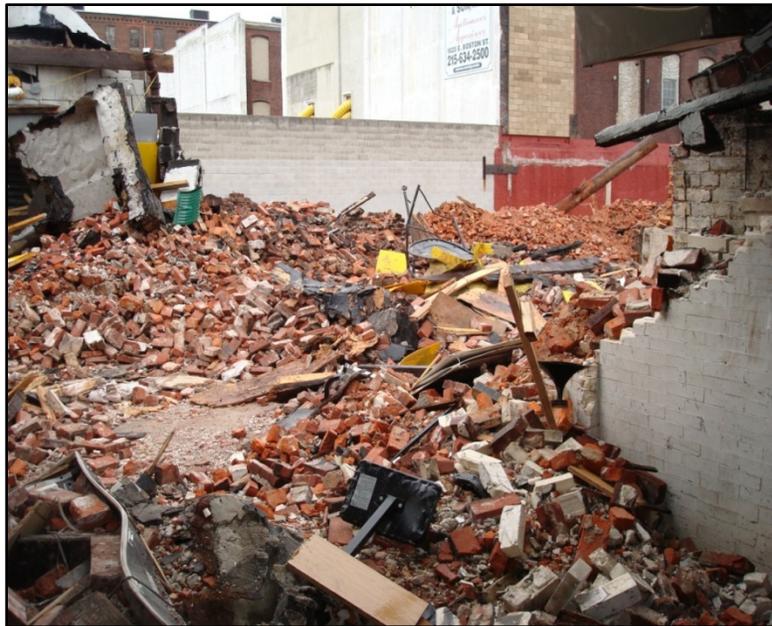
Photo 1: Location in the furniture store where the four members of Ladder 10 were located after the collapse of the adjacent warehouse.
(NIOSH Photograph)

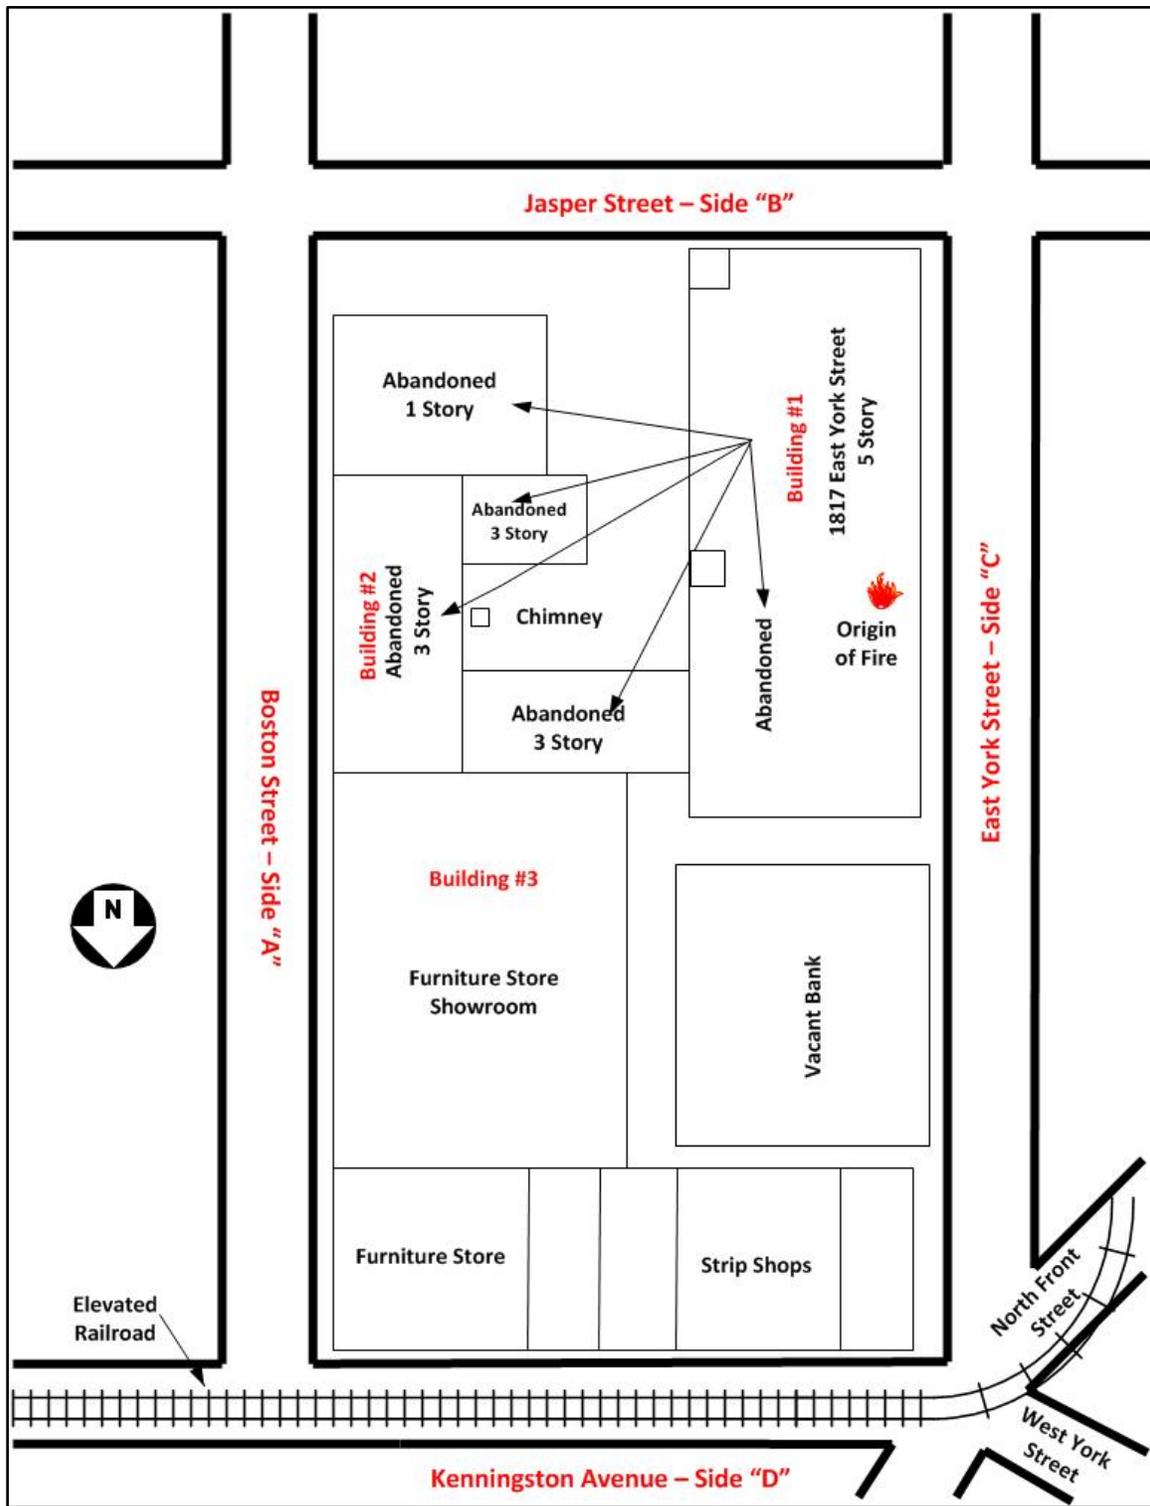
Figure 1. Diagram of the fire building and location where the fire originated.

The complex of buildings that encompassed the city block area were developed and constructed over a 140 year period. The north half of the city block was comprised of operating commercial occupancies of various vintage and building type and included a furniture store and warehouse, retail storefronts and a standalone vacant bank building (see Figure 1 and Photo 2).

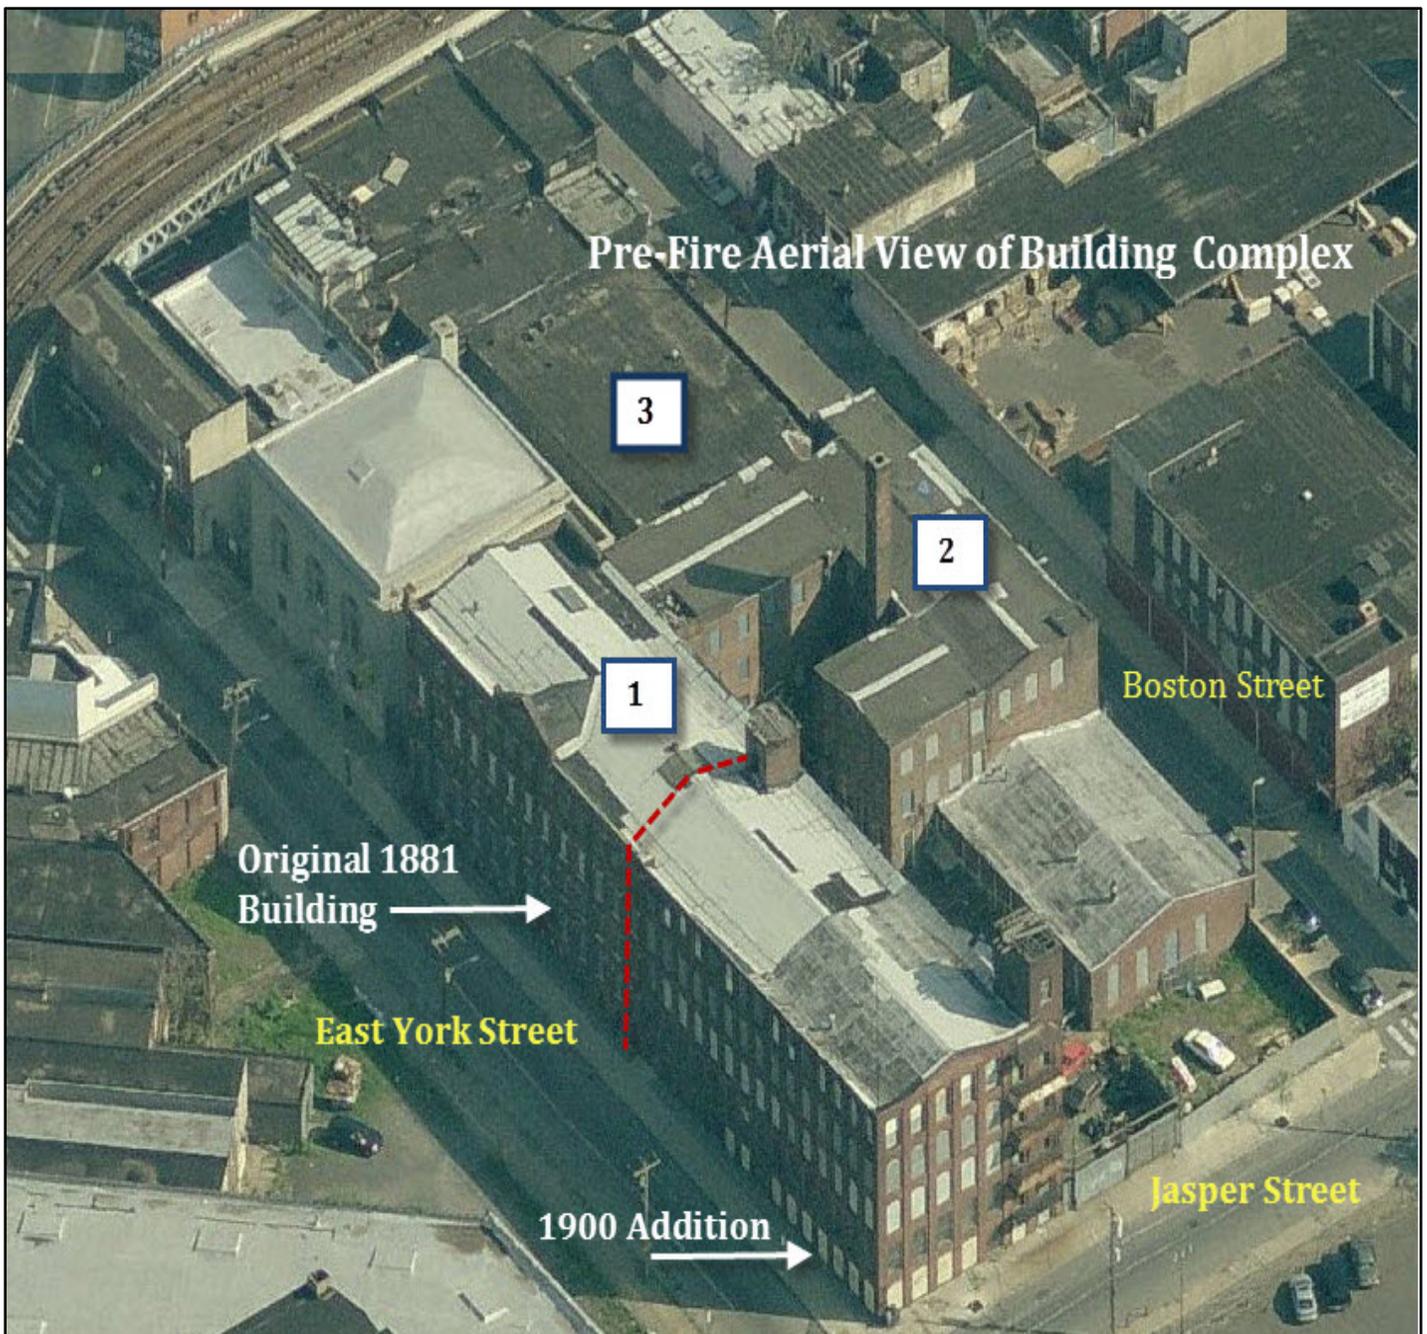
Photo 2. Pre-fire aerial view of building complex showing the building of origin (1), and the building that collapsed (2) onto the roof of the furniture store showroom (3).
(Bing.com Maps/ analysis diagram courtesy of Buildingsonfire.com.)

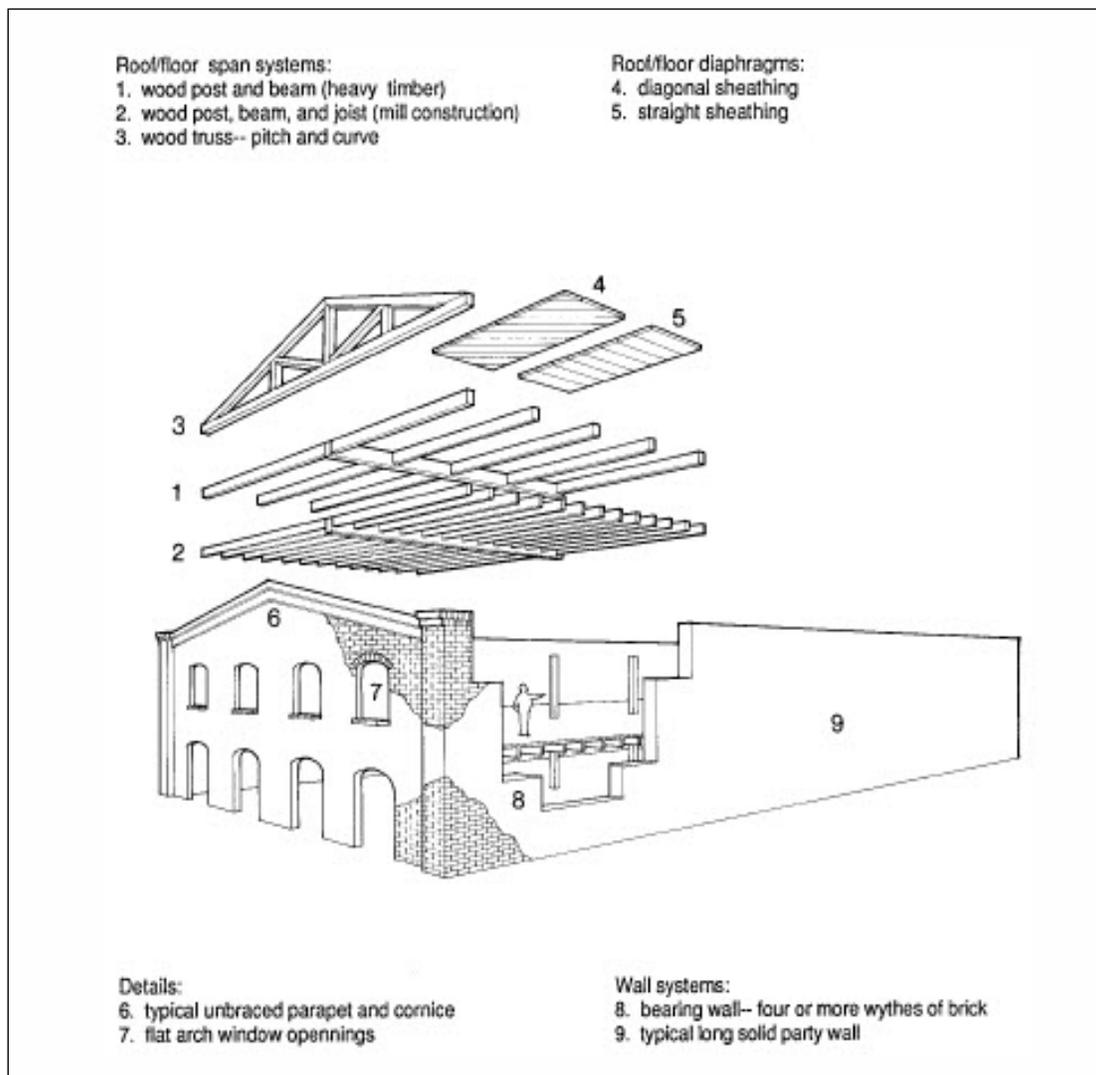
Figure 2. Common mill and heavy timber construction details
(Rapid Visual Screening of Buildings for Potential Seismic Hazards: A Handbook. Second Edition 2002.)

The various buildings were erected of Mill Construction and Semi-Mill Construction (similar to Type IV Heavy Timber), Heavy Timber (Type IV construction) and common Brick and Joist construction (Type III construction),³ all with common characteristics and features found in Heritage Construction^{4,5} (see Figures 2, and 3).

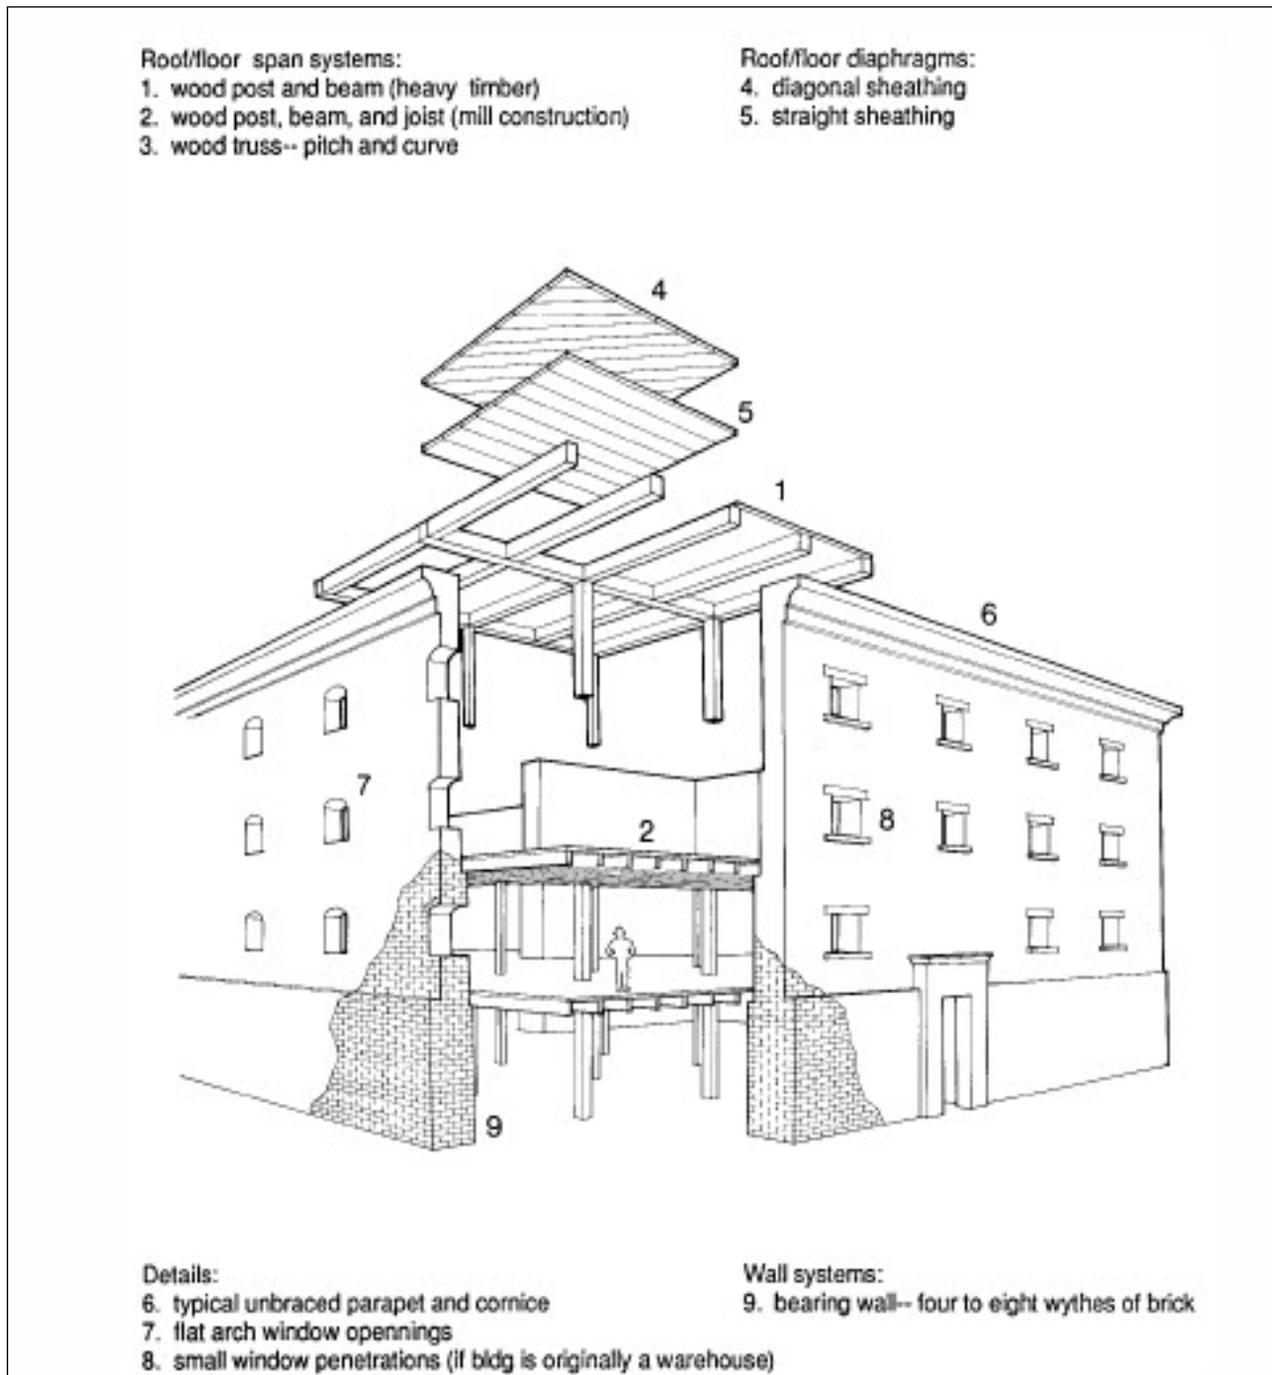
Figure 3. Common mill and heavy timber construction details
(Rapid Visual Screening of Buildings for Potential Seismic Hazards: A Handbook. Second Edition 2002.)

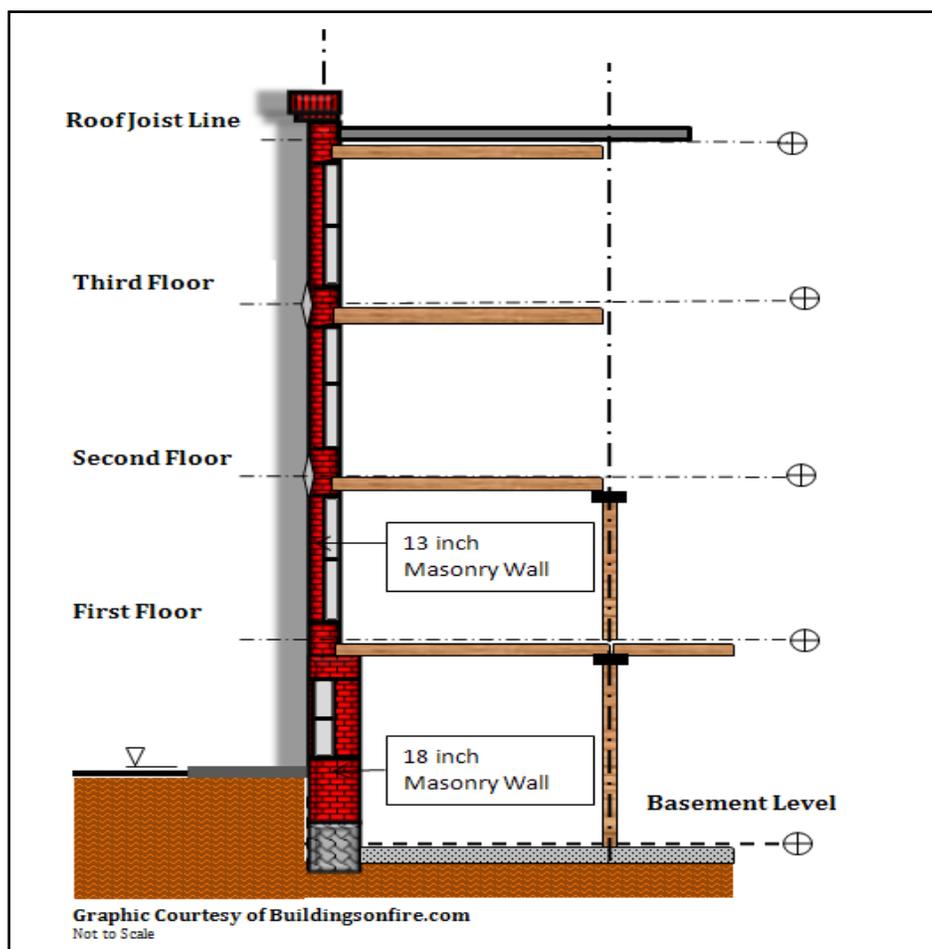
Figure 5. Masonry brick perimeter wall construction
(Graphic courtesy of Buildingsonfire.com.)

Building 2's masonry walls were constructed of an 18-inch wythe wall from the basement to the first floor level, bearing upon a stone rubble foundation with a cement floor. From the first floor level rising to the roof cornice, the wall consisted of a 13-inch wythe brick wall construction. The building's mill construction structural system was integrated into the bearing and non-load-bearing walls within the interior (see Figure 5).

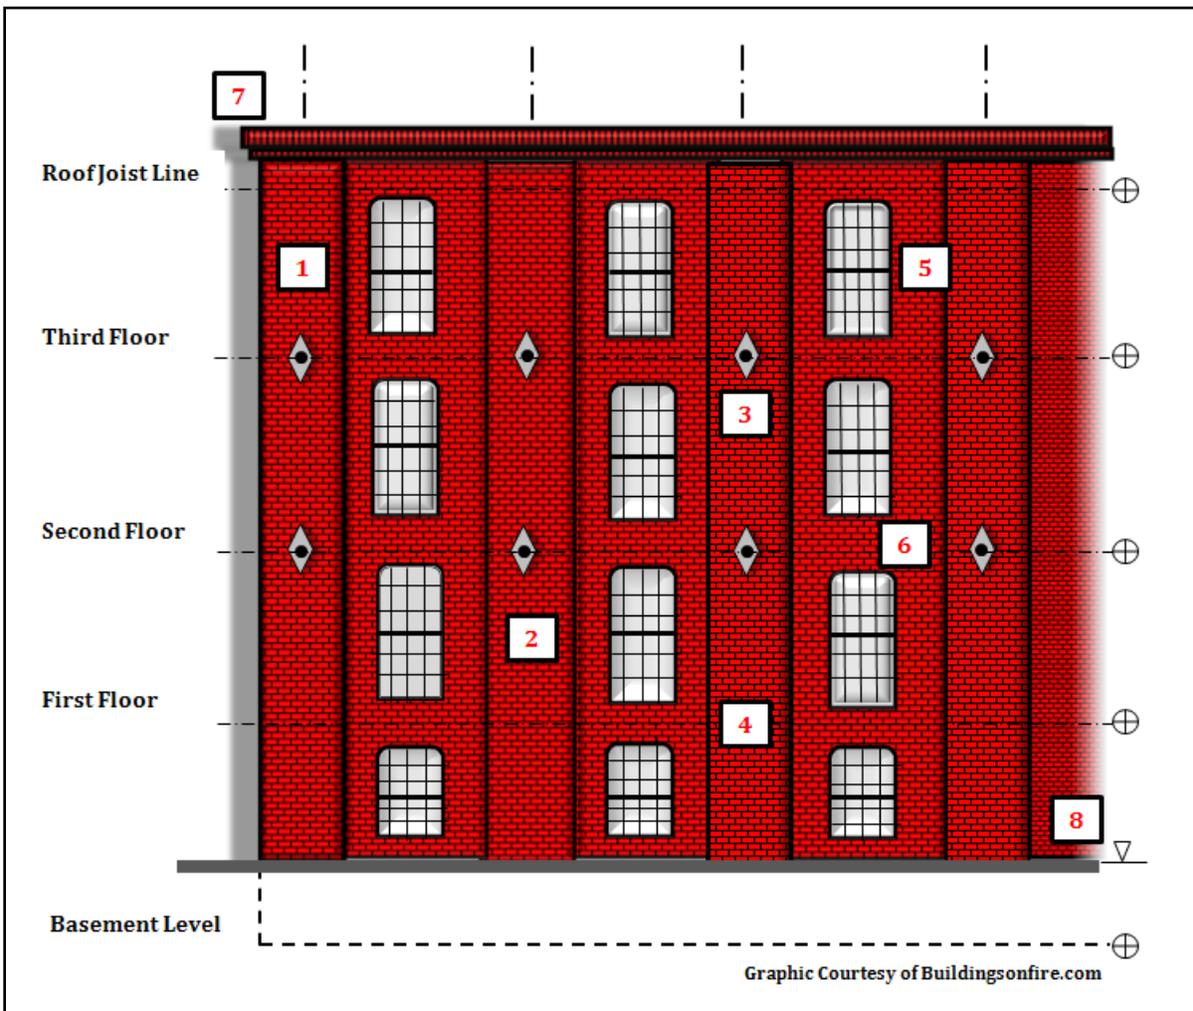
Figure 6. Masonry Brick Perimeter Wall Construction Floor Detail.
(Graphic Courtesy of Buildingsonfire.com.)

Building 2 incorporated URM construction with large 40-inch x 84-inch windows with 10-inch x 12-inch lights. This provided an approximate 23 square feet of glazing area per window treatment. Placed uniformly within the primary wall facing, the windows were inset within a 13-inch wythe brick infill area that spanned 5 feet between vertical masonry pilasters). A segmental brick arch and lintel spanned across each window opening and provided the structural support for the window opening and the brick wall above (see Figure 6).

Exemplifying Features of Building 2 noted in Figure 6.

Note 4: The existing face of Building 2, exhibited evidence of out-of- plane wall orientation with extensive deterioration or absence of mortar joints between brick courses, suggesting a relatively unstable or weakened perimeter wall. Efflorescence is evident in various views of the building face as were missing and loose bricks and brick courses (See Photo 3).

Note 7: Roof cornice was a decorative brick treatment on the street face, common to most buildings constructed in this era. Materials and construction features are highly susceptible to deterioration due to age, weathering and exposure, movement and loss of alignment, thus compromising structural integrity, and becoming a collapse hazard.

Note 8: URM perimeter walls incorporated large spans of window treatments, pilaster construction and infill brick at the spandrel areas. (*Note: A spandrel is the space between two arches or between an arch and a rectangle enclosure, see Photo 3*). These areas are susceptible to curtain-fall wall-collapse conditions versus monolithic segmental wall failures and collapse, resulting in collapse debris piles within the vertical wall plane proximal to the base at the sidewalk/curb location of the building.

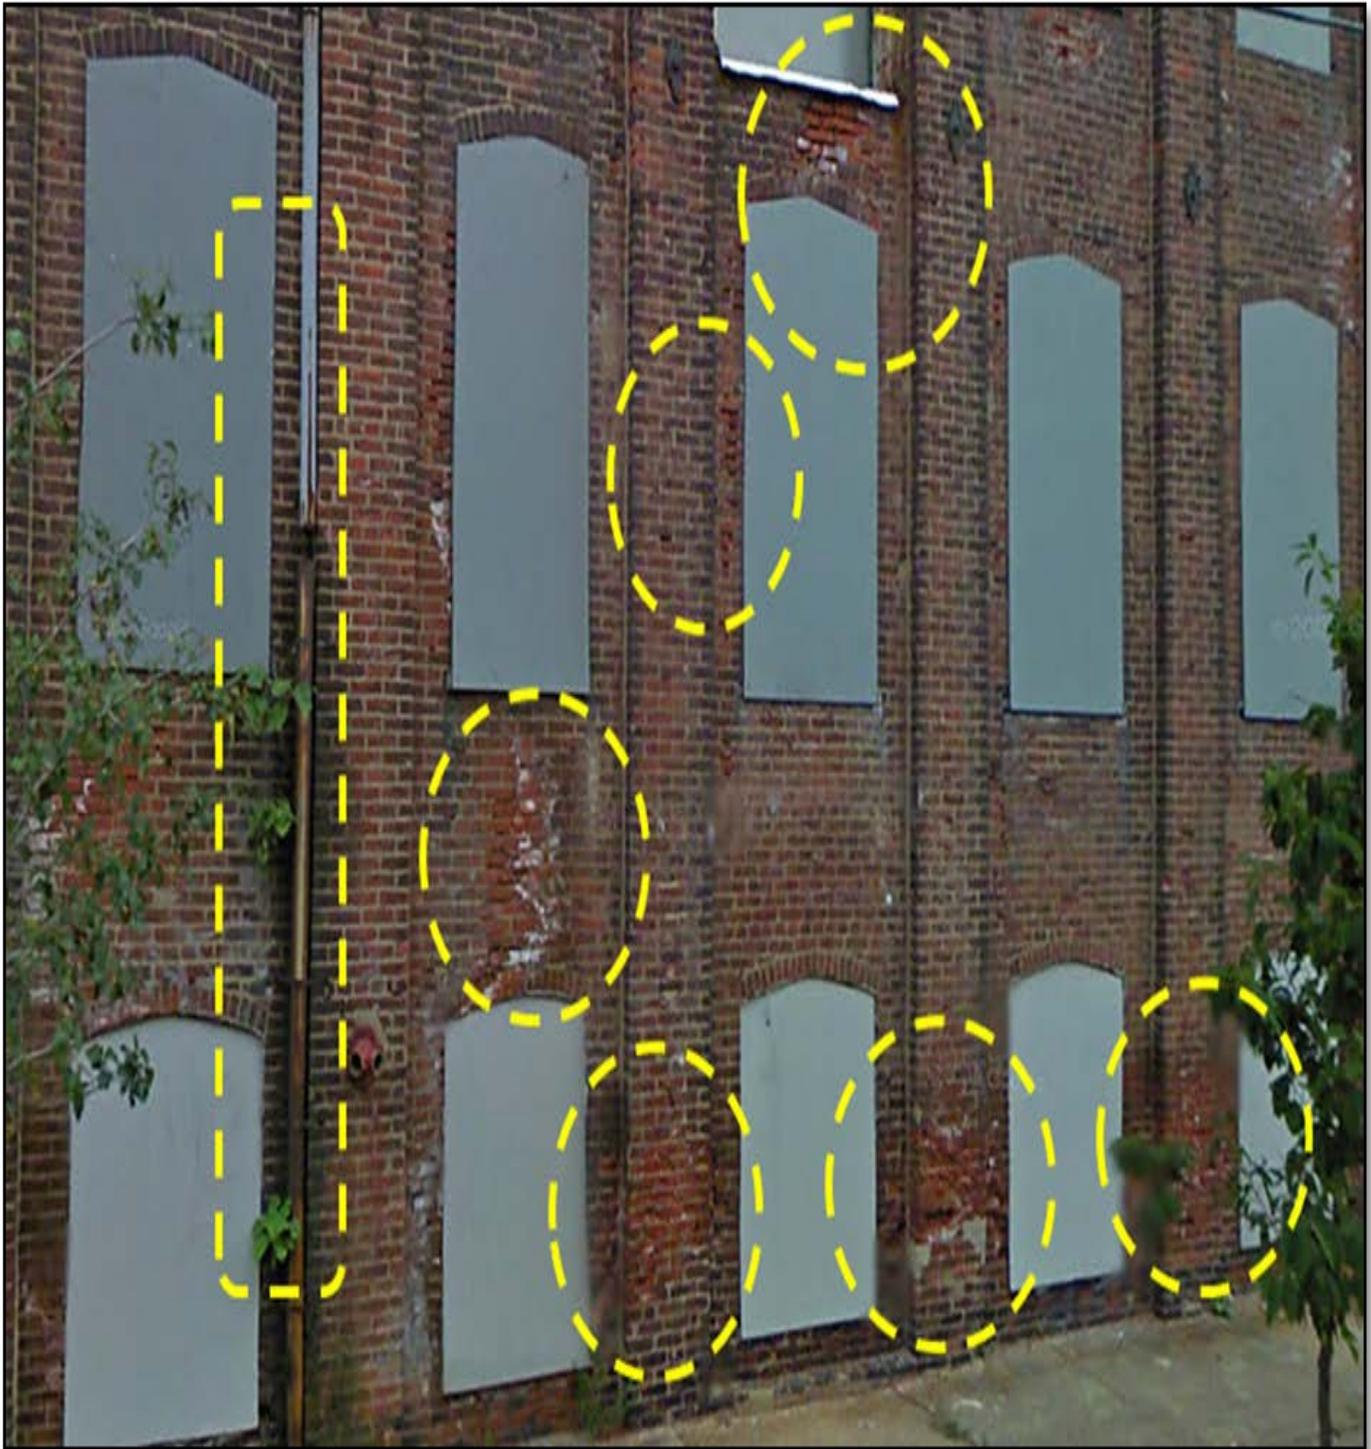
Photo 3. Building 2 Masonry Perimeter Wall Deficiencies – Side “Alpha”.
(Photo Google Street Maps/ analysis diagram courtesy of Buildingsonfire.com.)

The loss of bonding integrity of mortar joints and deficient brick facing suggests a heightened degree of awareness would be prudent during subsequent fire department operations. Efflorescence (white discoloration of the brick) is evidenced in various views of the building face as were missing and loose brick courses. Efflorescence is a fine, white, powdery deposit of water-soluble salts left on the surface of masonry as the water evaporates (See Photo 3).

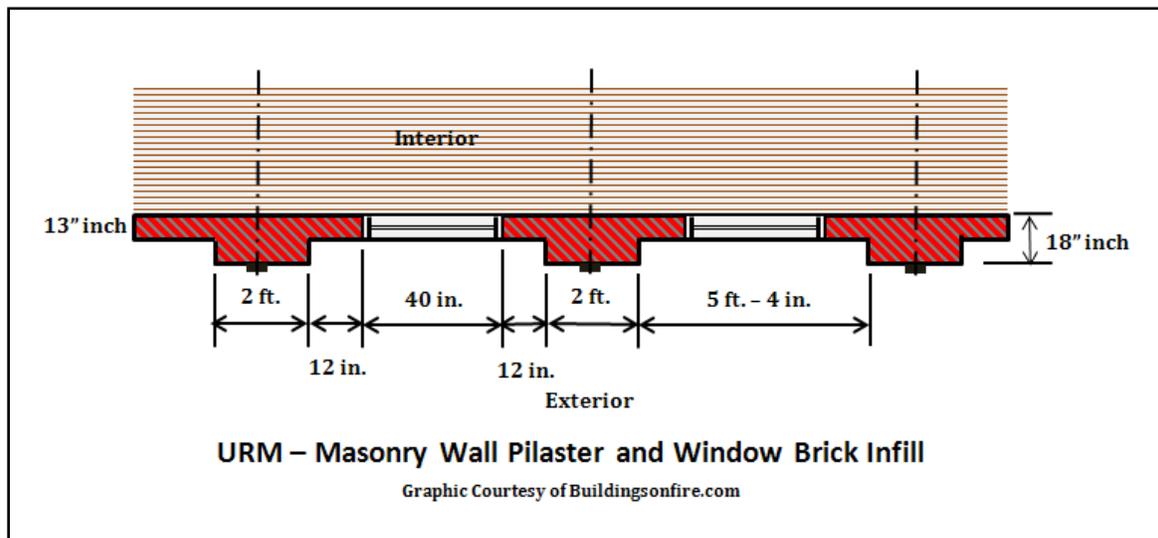
Figure 7. URM-Masonry Wall Pilaster and Infill Plan
(*Graphic courtesy of Buildingsonfire.com.*)

The east and west face of Building 2 incorporated masonry vertical pilasters that formed 12 bays across the width of the building (See Figure 7). The pilasters provided wall stability to the building face with an increased wall thickness for the bearing and attachment points of the heavy timber wood girders that comprised the structural floor system of the building. Metal diamond spreader plates were evident on the Side Alpha of Building 2 facing Boston Street and were installed at the 2nd- and 3rd-floor levels.

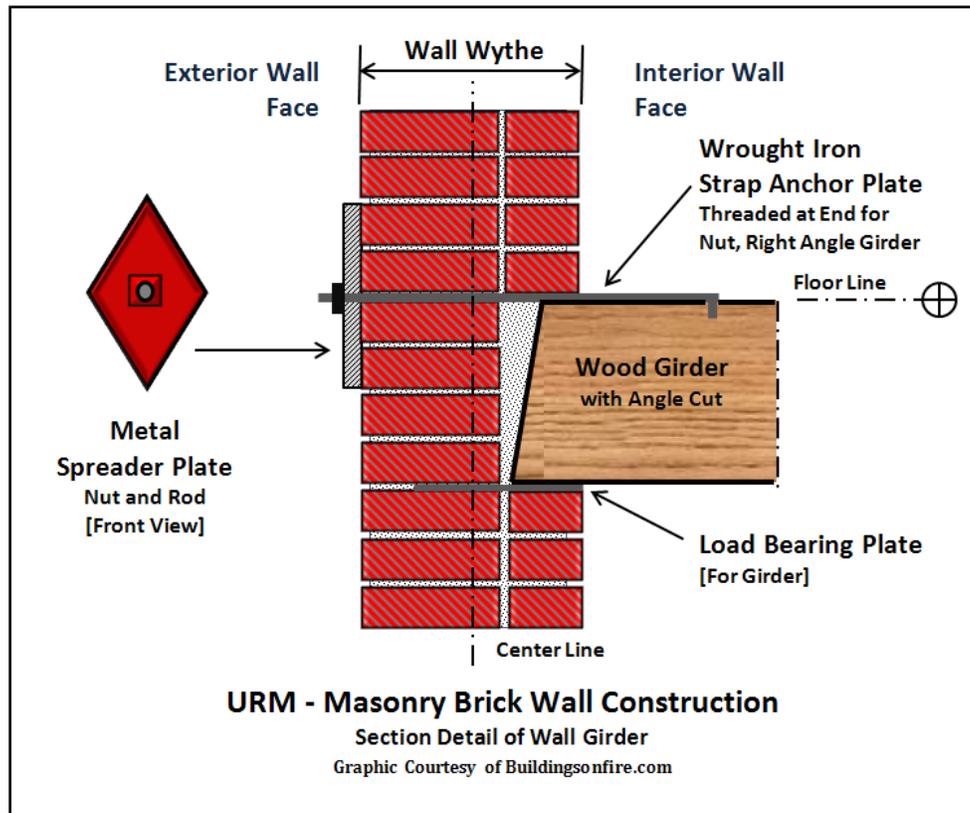
Figure 8. URM- Masonry Brick Wall Construction and Girder Detail
(Graphic courtesy of Buildingsonfire.com.)

The heavy timber wood girder had an angle cut to its end, commonly referred to as a fire cut (See Figure 8). This design feature allowed the wood girder to fail and fall free from the masonry wall in the event of a fire and collapse without causing collateral damage to the masonry wall, increasing the

likelihood that the perimeter wall would maintain its structural integrity and lessen the potential for injury to fire-fighters operating in the street areas.

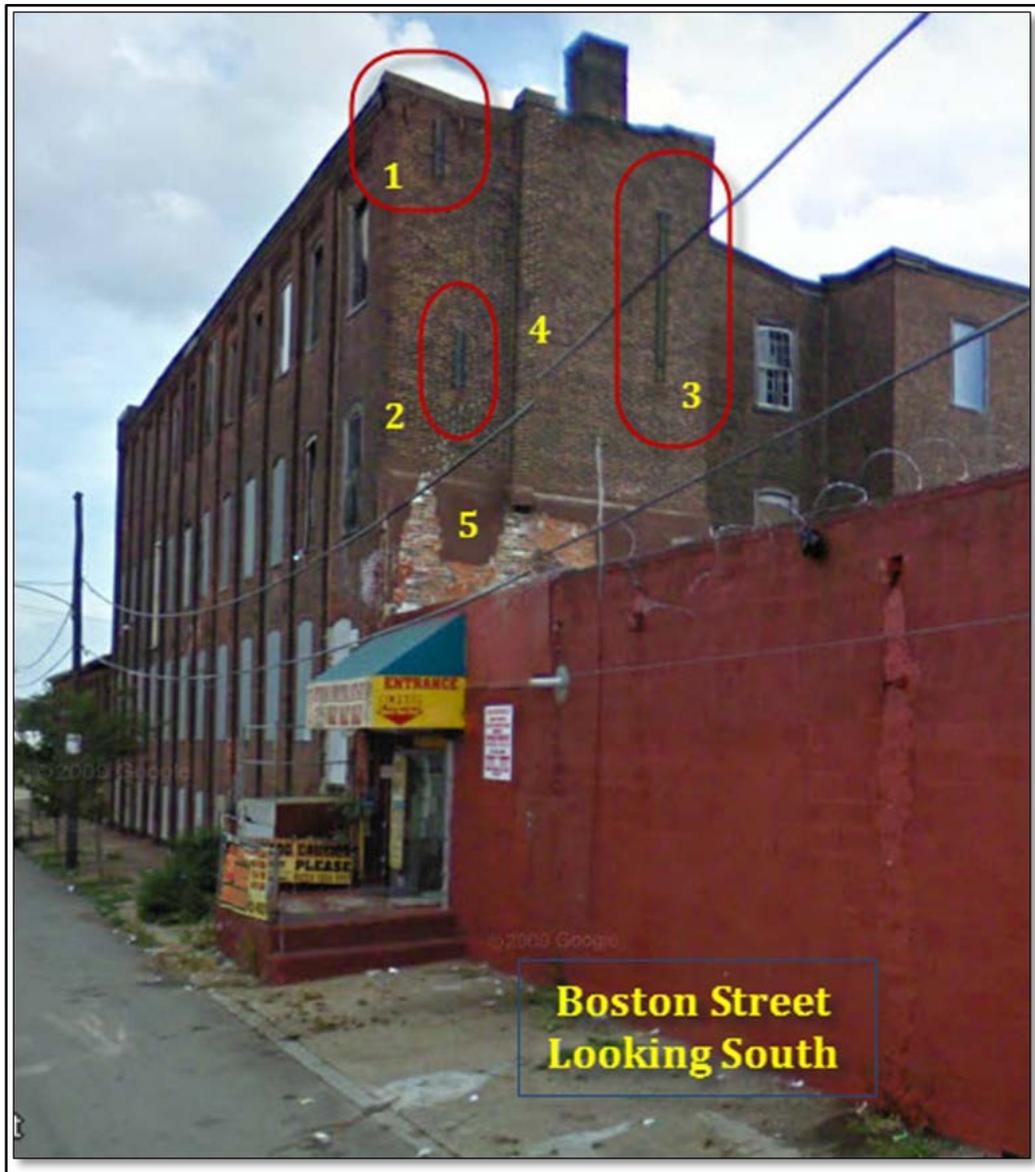
Photo 4. Wall collapse indicators of north perimeter of Building #2, Side A exposure.
(Photo Google Street Maps/ analysis diagram courtesy of Buildingsonfire.com.)

Building 2 North Wall Collapse Precursors (See Photo 4, 5 and 6)

Note 5: The wall area located directly under the chimney and spanning the width of the north perimeter wall (18 feet), consisting of approximately 150 square feet of brick face, exhibits signs of deterioration, compromise, and weathering. Evidence is present of mortar erosion, joint deterioration, loss of course bonding, and efflorescence. Further deterioration was likely caused by concentrated water erosion caused by the open chimney flue pathway from the upper roofline to the wall area below. This wall deterioration affects perimeter wall integrity and resiliency from the effects of fire, flame, heat, and environmental duress, resulting in an inherently unstable and susceptible wall that is prone to collapse or compromise (also see photos 5, 6 and 7).

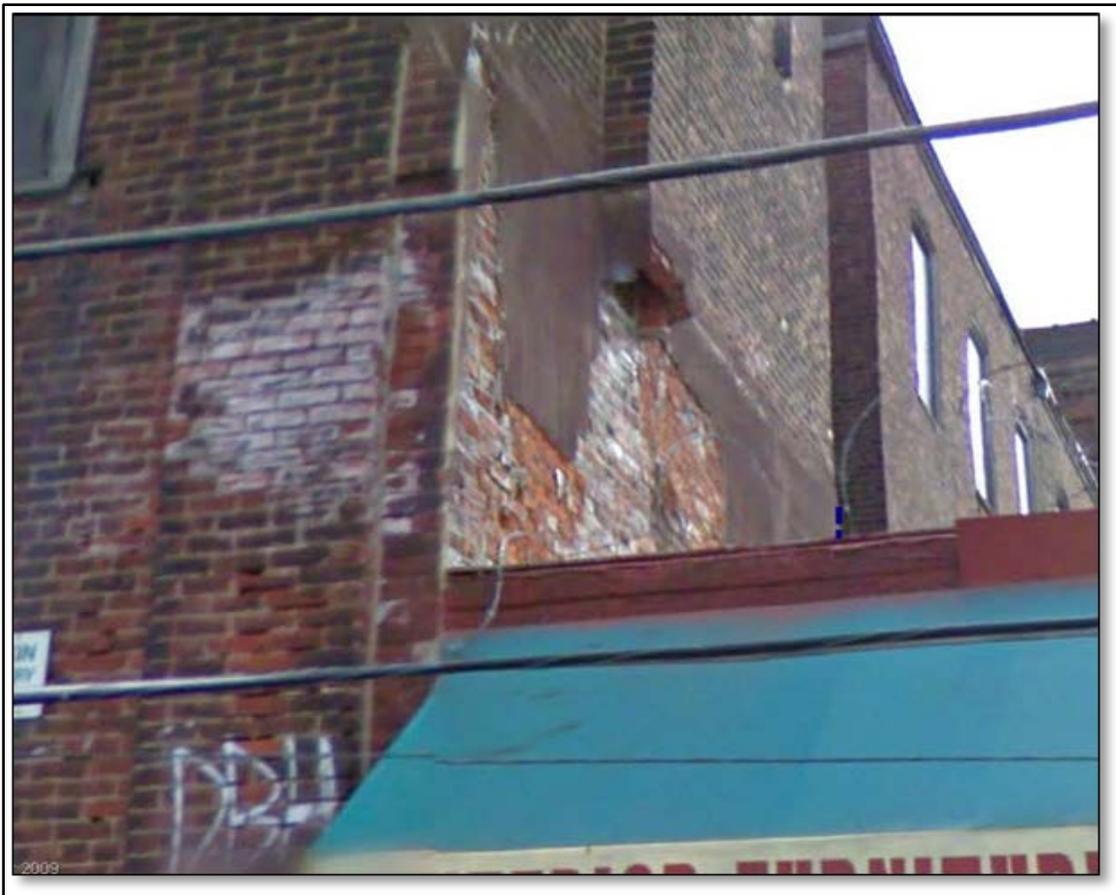
Photo 5. Pre-fire detail of north perimeter of Building #2, Side A exposure.
(Photo Google Street Maps/ analysis diagram courtesy of *Buildingsonfire.com*.)

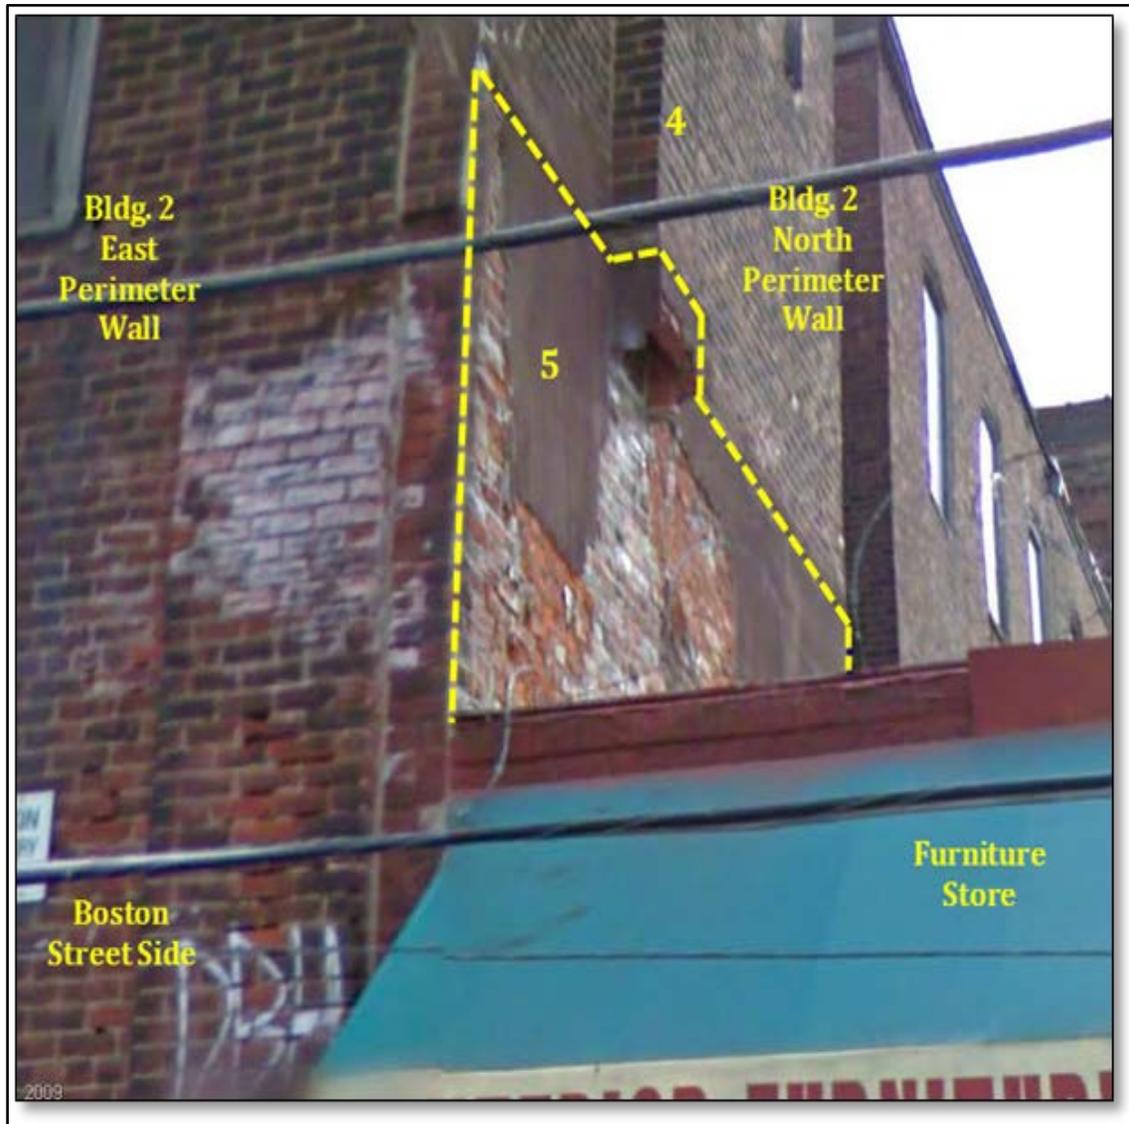
Photo 6. Collapse indicators detail of north perimeter of Building #2, Side A exposure.
(The numbers 4 and 5 above refer to the notes for Photo 4 on page 33).
(Photo Google Street Maps/ analysis diagram, courtesy of Buildingsonfire.com.)

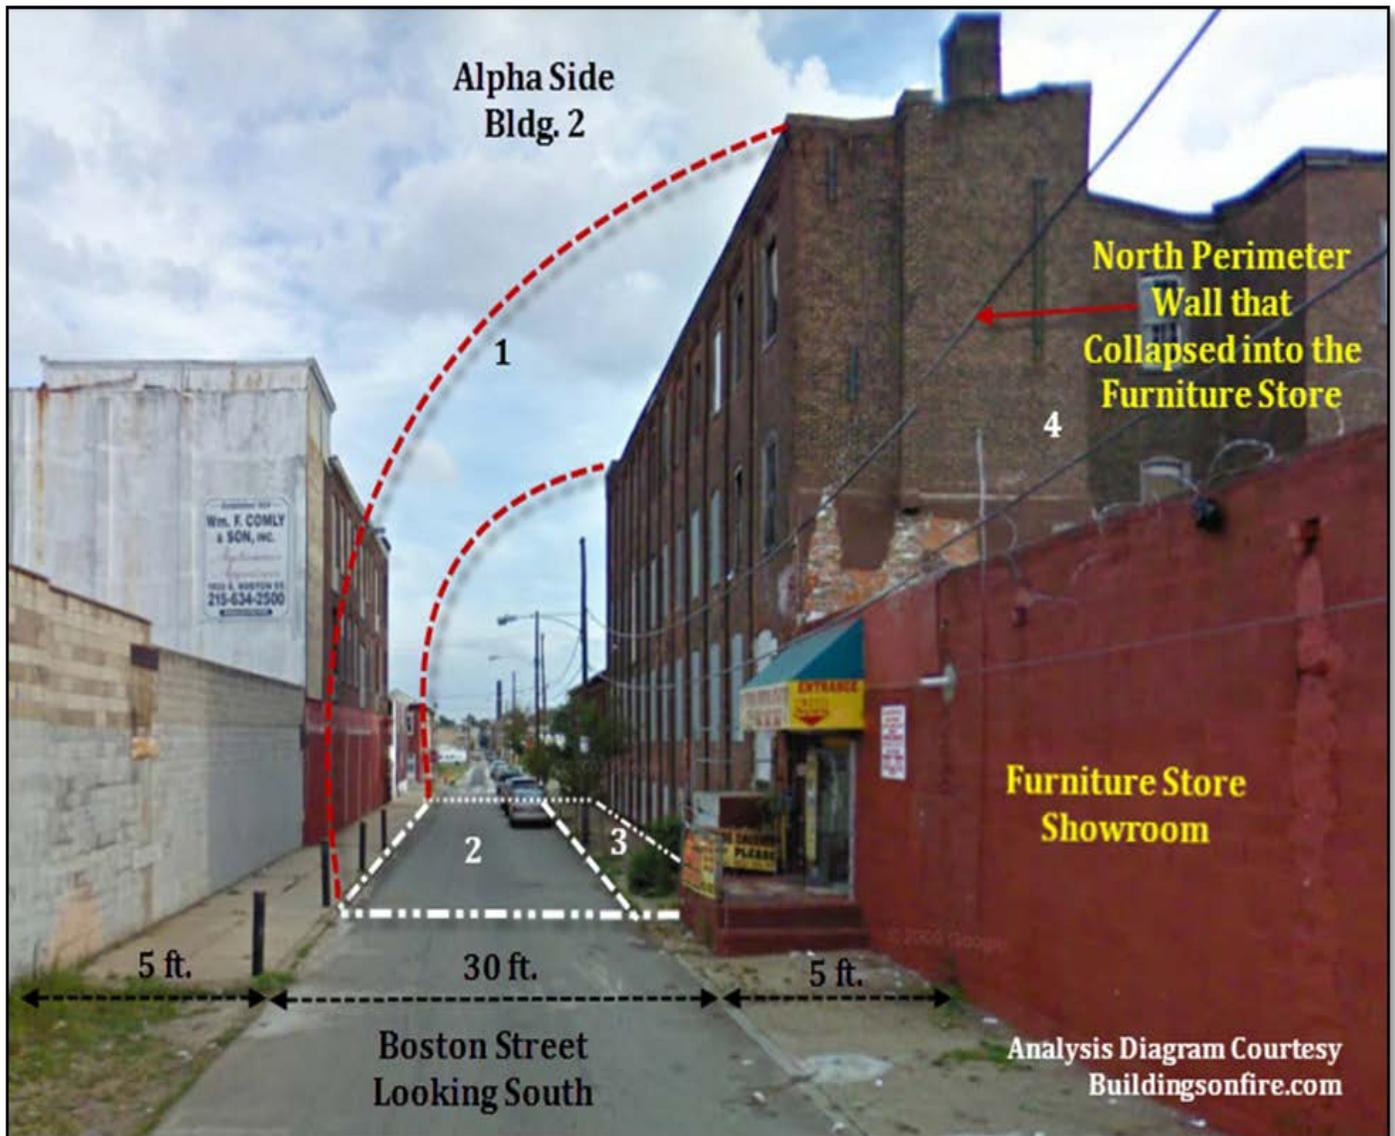
Photo 7. Alpha Side –Wall Collapse Zones
See Notes Below

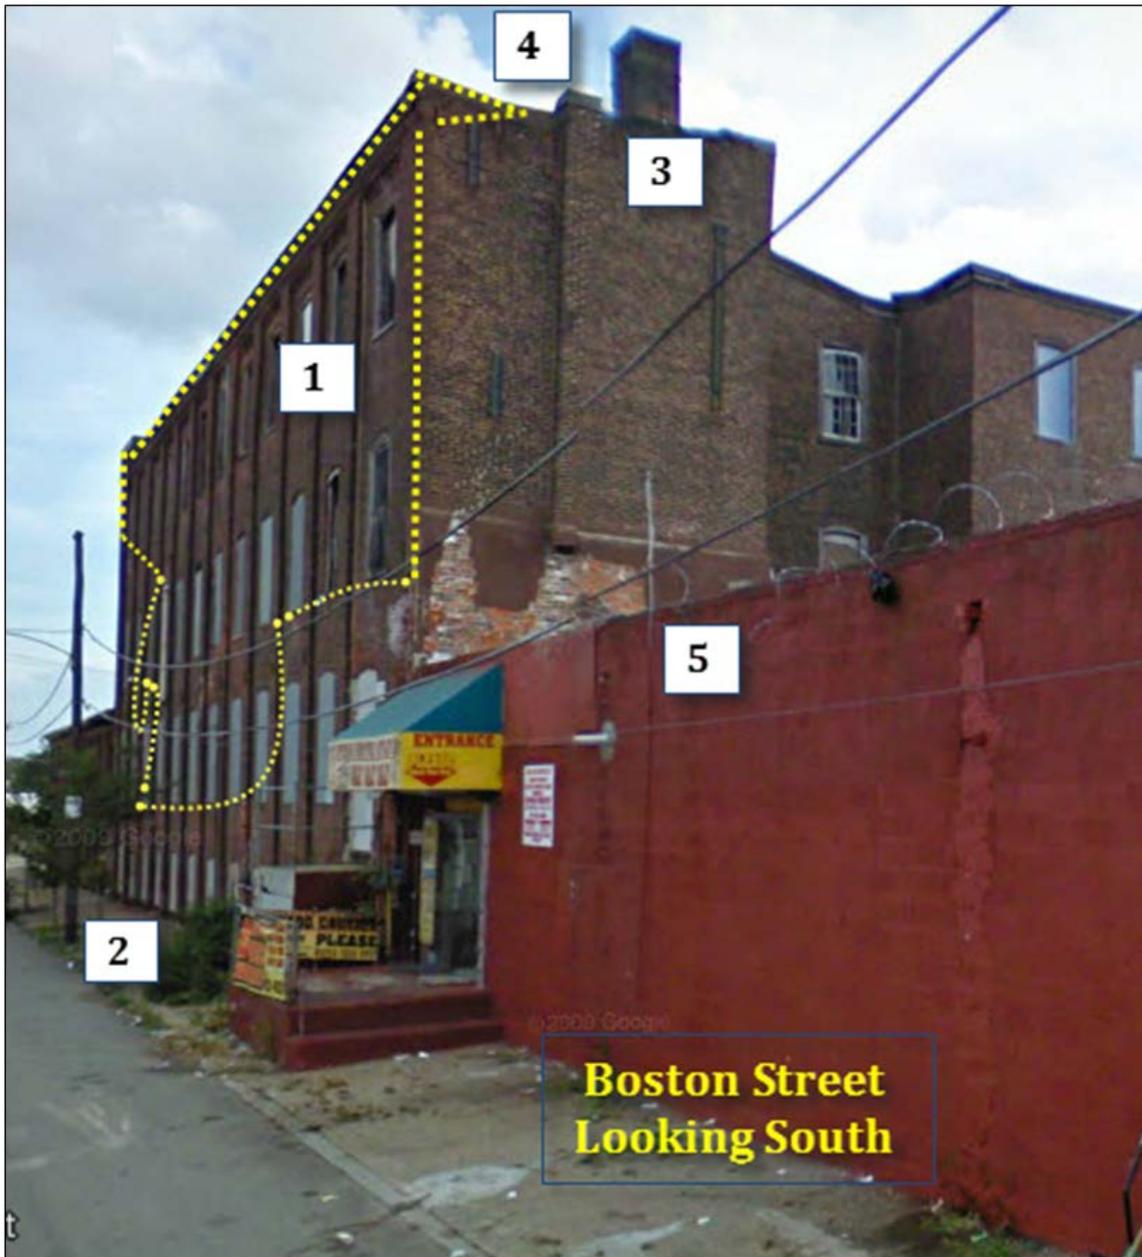
Photo 8. Side A wall collapse area of Building 2, see notes below.
(Photo Google Street Maps/ analysis diagram courtesy of Buildingsonfire.com.)

Note 1. Unreinforced Masonry wall construction (URM) masonry brick face along Boston Street. 3.5 story curb to cornice height approximately 46 feet. Given a 1.5 x building height rule of thumb for collapse zone, the minimum, collapse zone (CZ) for the perimeter wall (PW) would be approximately 69 feet. The Building edge at sidewalk level to face of the building across the street was approximately 40 feet. The outline depicts the degree of wall that collapsed or was compromised. The URM east and west masonry wall faces of Building 2 contained a masonry wall surface area of 3800 square feet (est.) representing 70% of the solid area of these perimeter walls.
