Career Lieutenant and Fire Fighter Killed and Two Fire Fighters Injured by Wall Collapse at a Large Commercial Structure Fire - Pennsylvania

Executive Summary

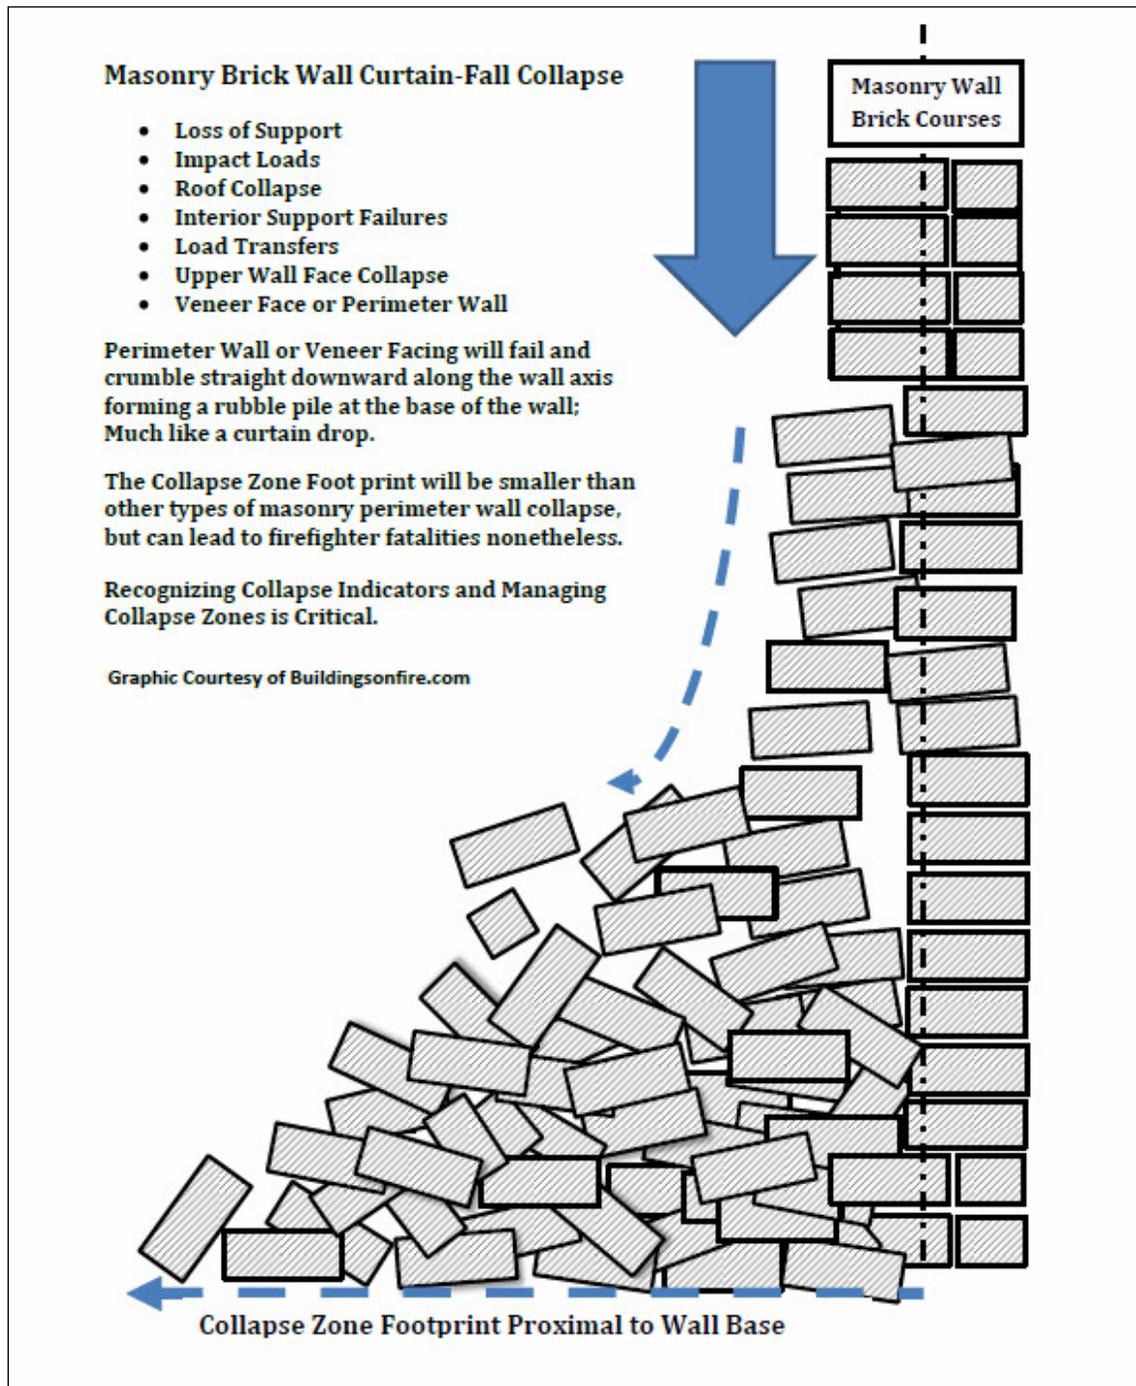
Figure 9. Masonry brick curtain-fall collapse.
(Graphic courtesy of Buildingsonfire.com.)

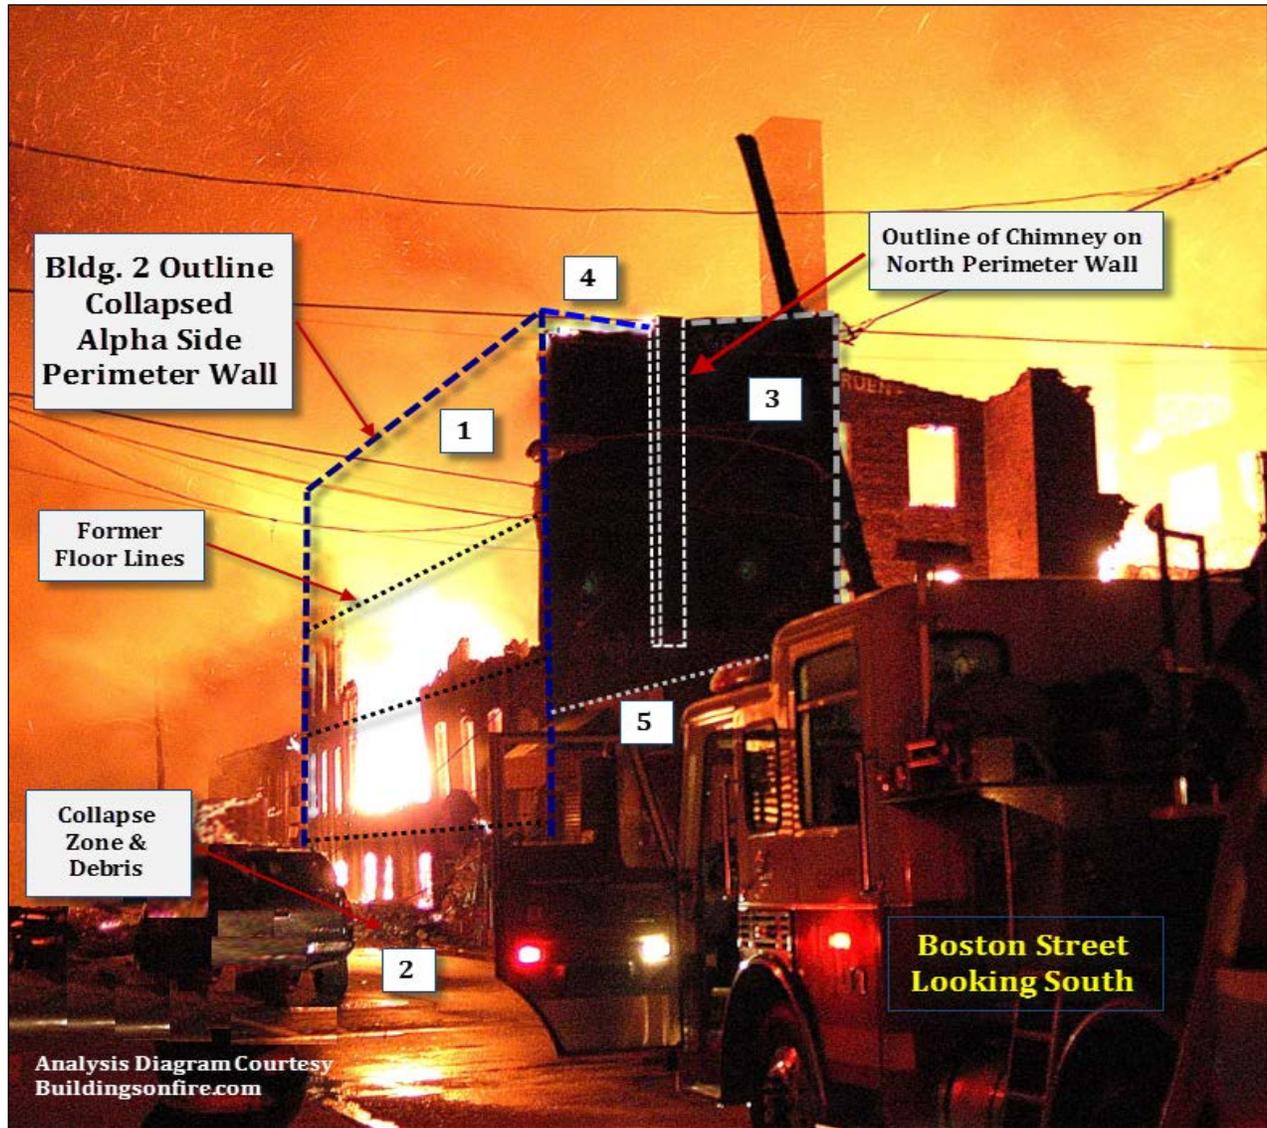
Photo 9. Collapse Assessment of Building 2, Alpha Side.

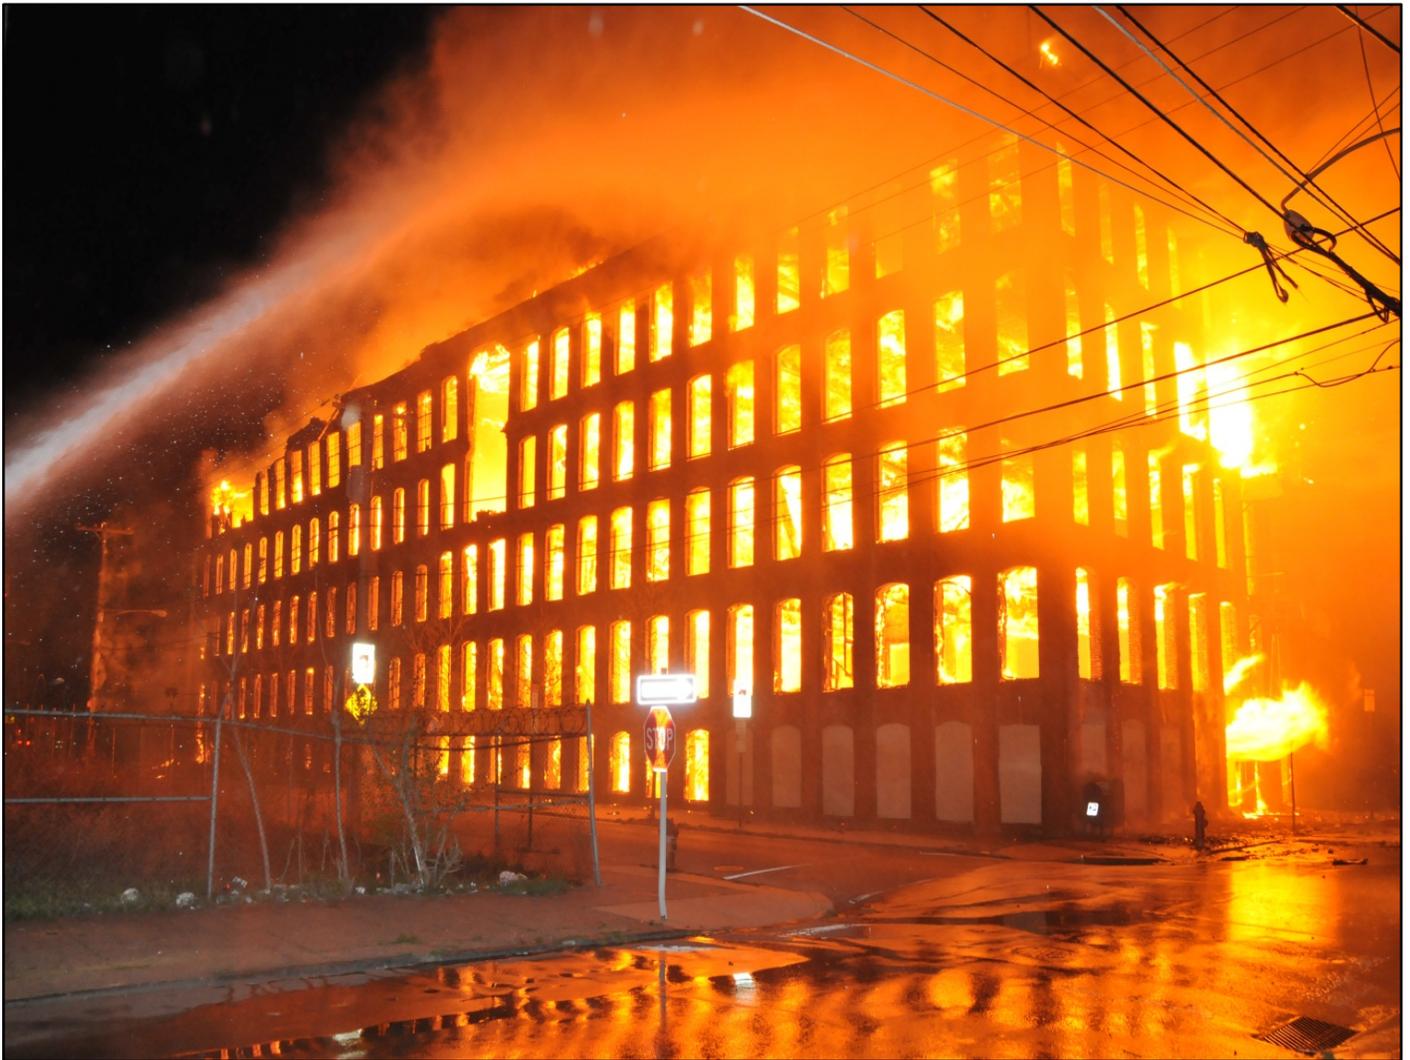
Photo 10. Charlie Division during the peak of the fire, viewed from the B-C corner.
(Photo courtesy of fire department.)

At 0330 hours, Charlie Division advised “Command” that an exterior structural collapse had occurred. The collapse zone in Charlie Division was the length of the street. At 0331 hours, “Command” advised Charlie Division that he had the 2nd Alarm companies going along Side “A”. “Command” asked Charlie Division if there are any instructions for the 3rd Alarm companies. Charlie Division informed “Command” that master streams needed to be set up on the corners of the structure due to the exterior collapse of the structure (see Photo 10).

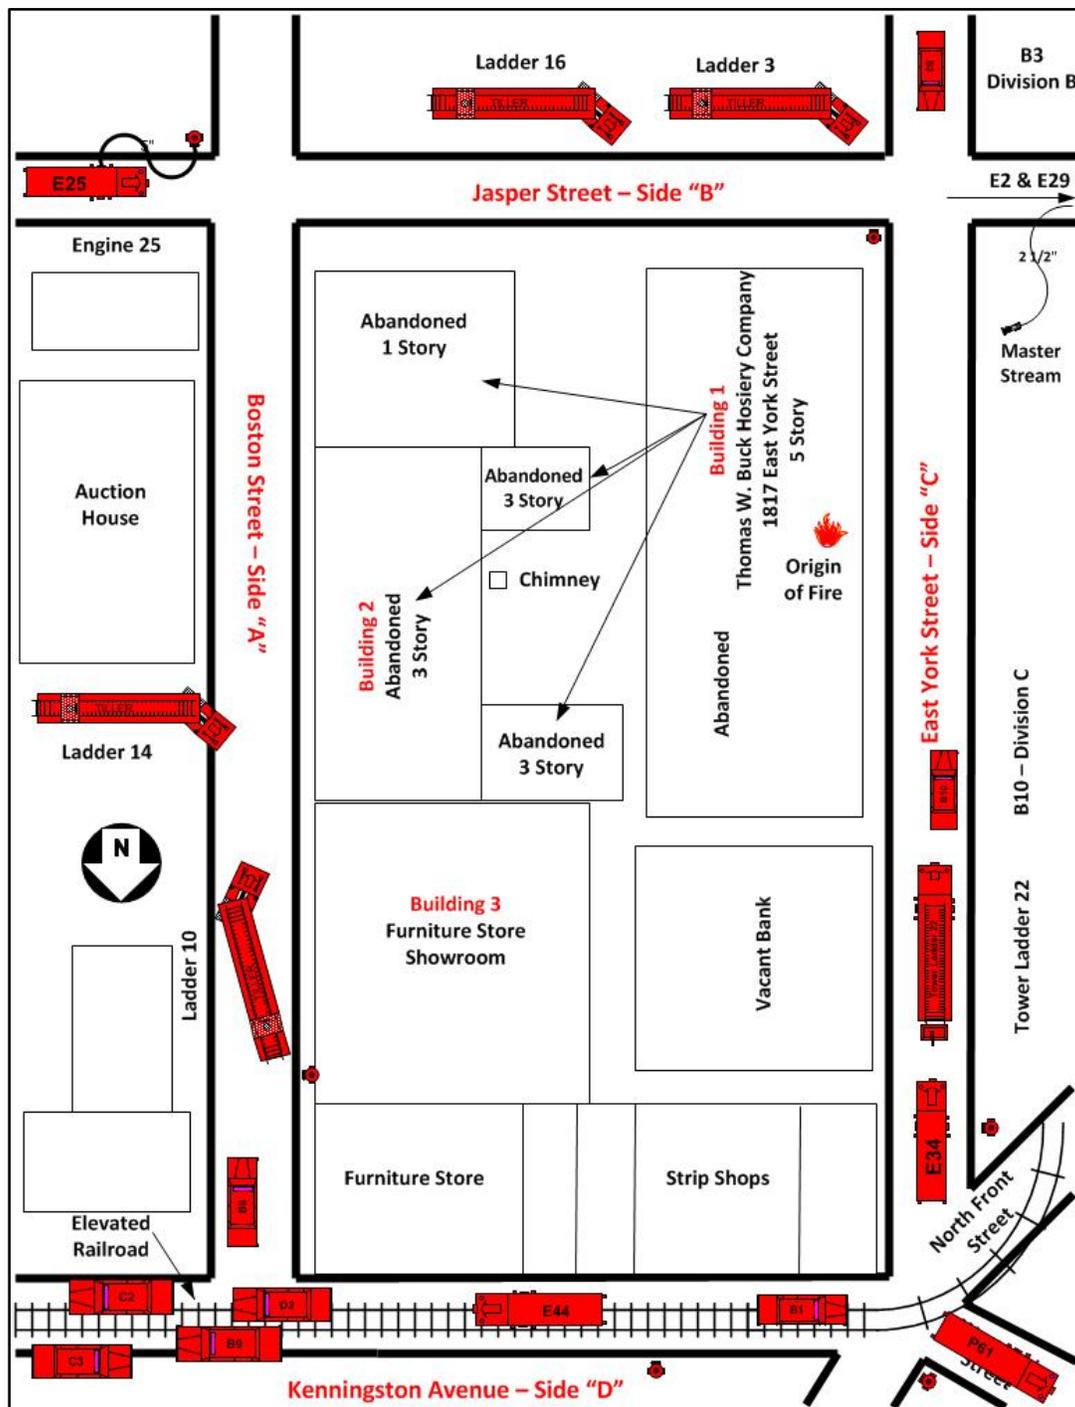
Figure 10. View of the fire building with apparatus placement. Note: the train tracks are elevated and apparatus are actually parked underneath the elevated tracks.

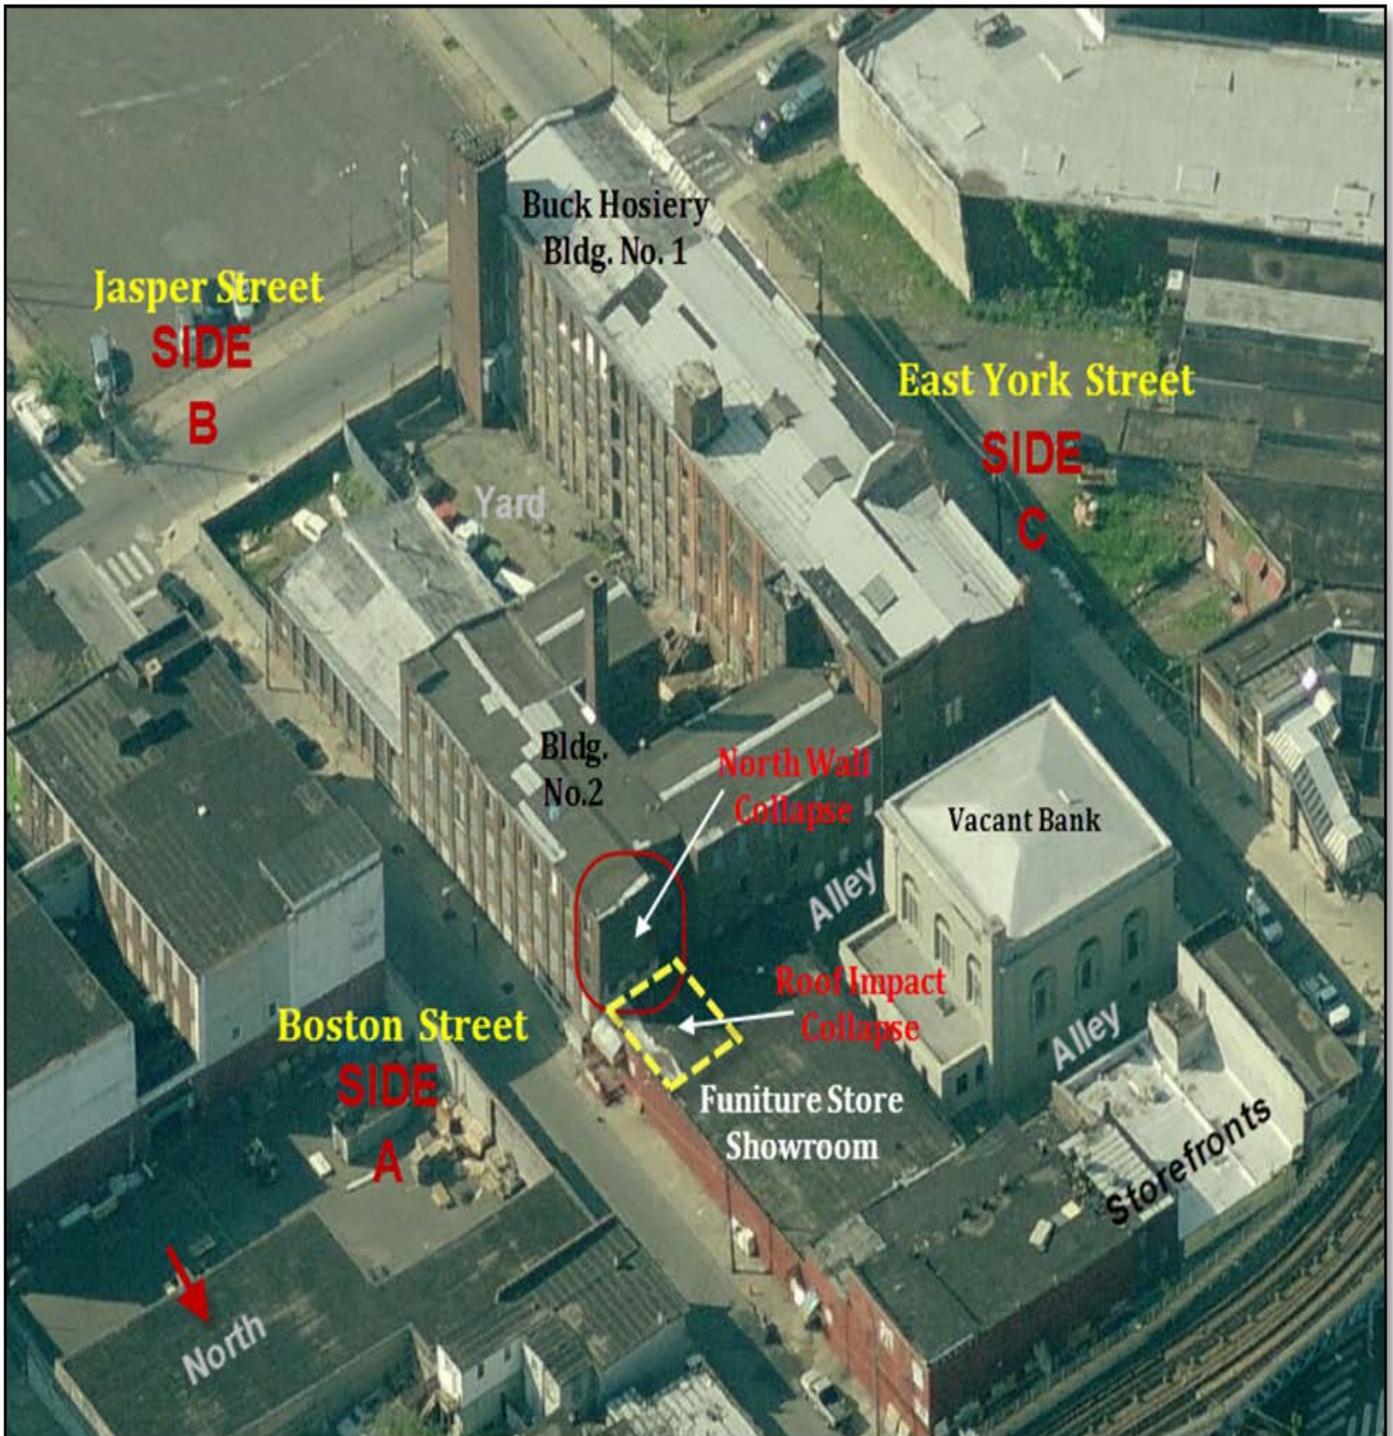
Photo 11. Aerial View of building complex, exposure and north wall collapse.
(Photo Bing.com Maps Image/ analysis diagram courtesy of Buildingsonfire.com)

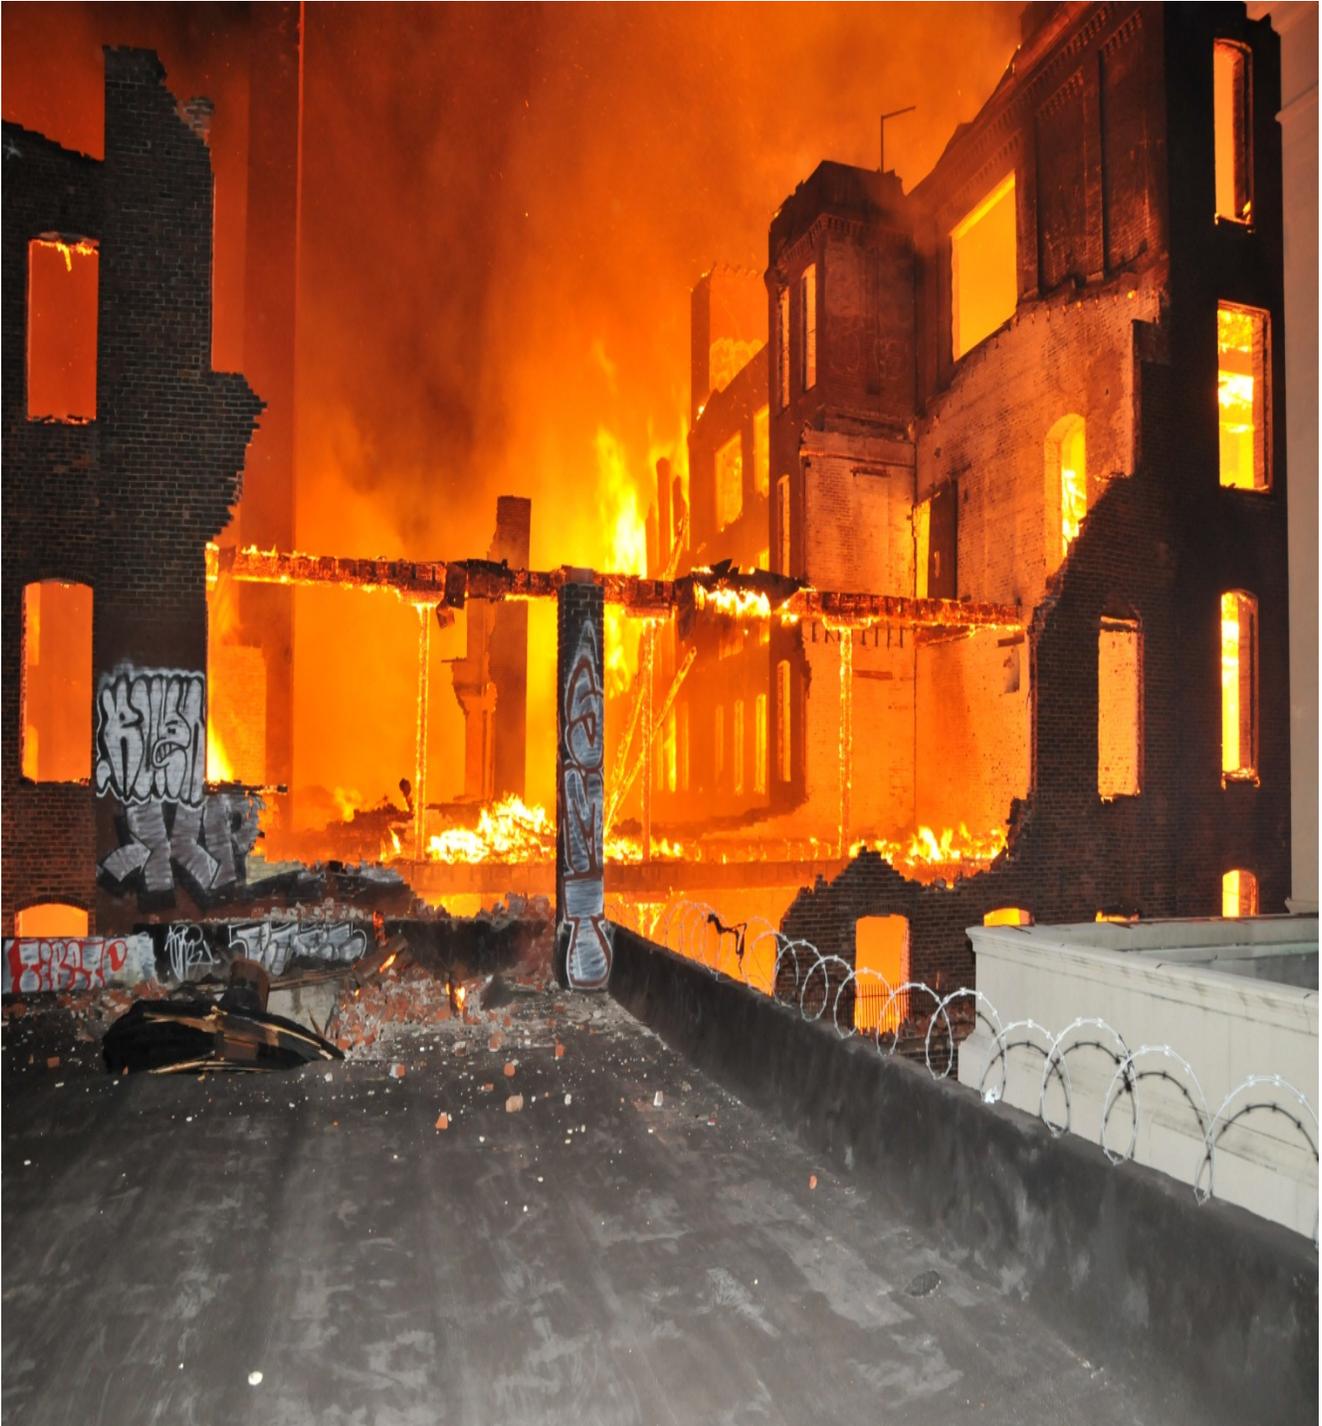
Photo 12. Roof of the furniture showroom showing damage from a partial wall collapse that started the original fire inside the furniture showroom. (Photo courtesy of fire department.)

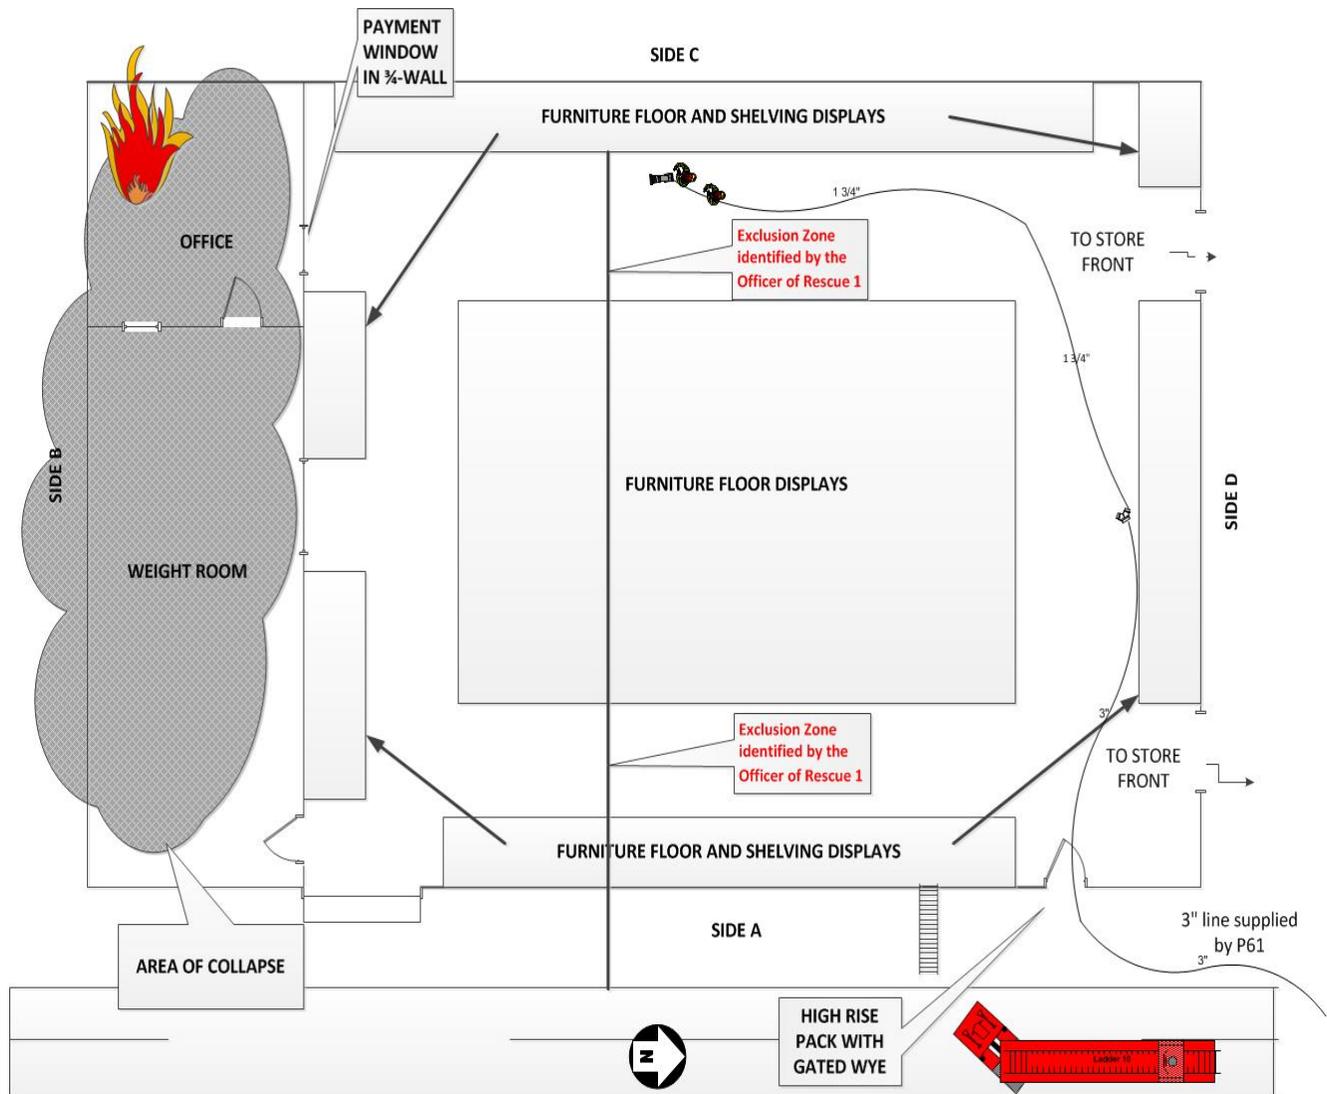
Figure 11. Original position of interior hand line by Rescue 1 in the furniture store showroom.

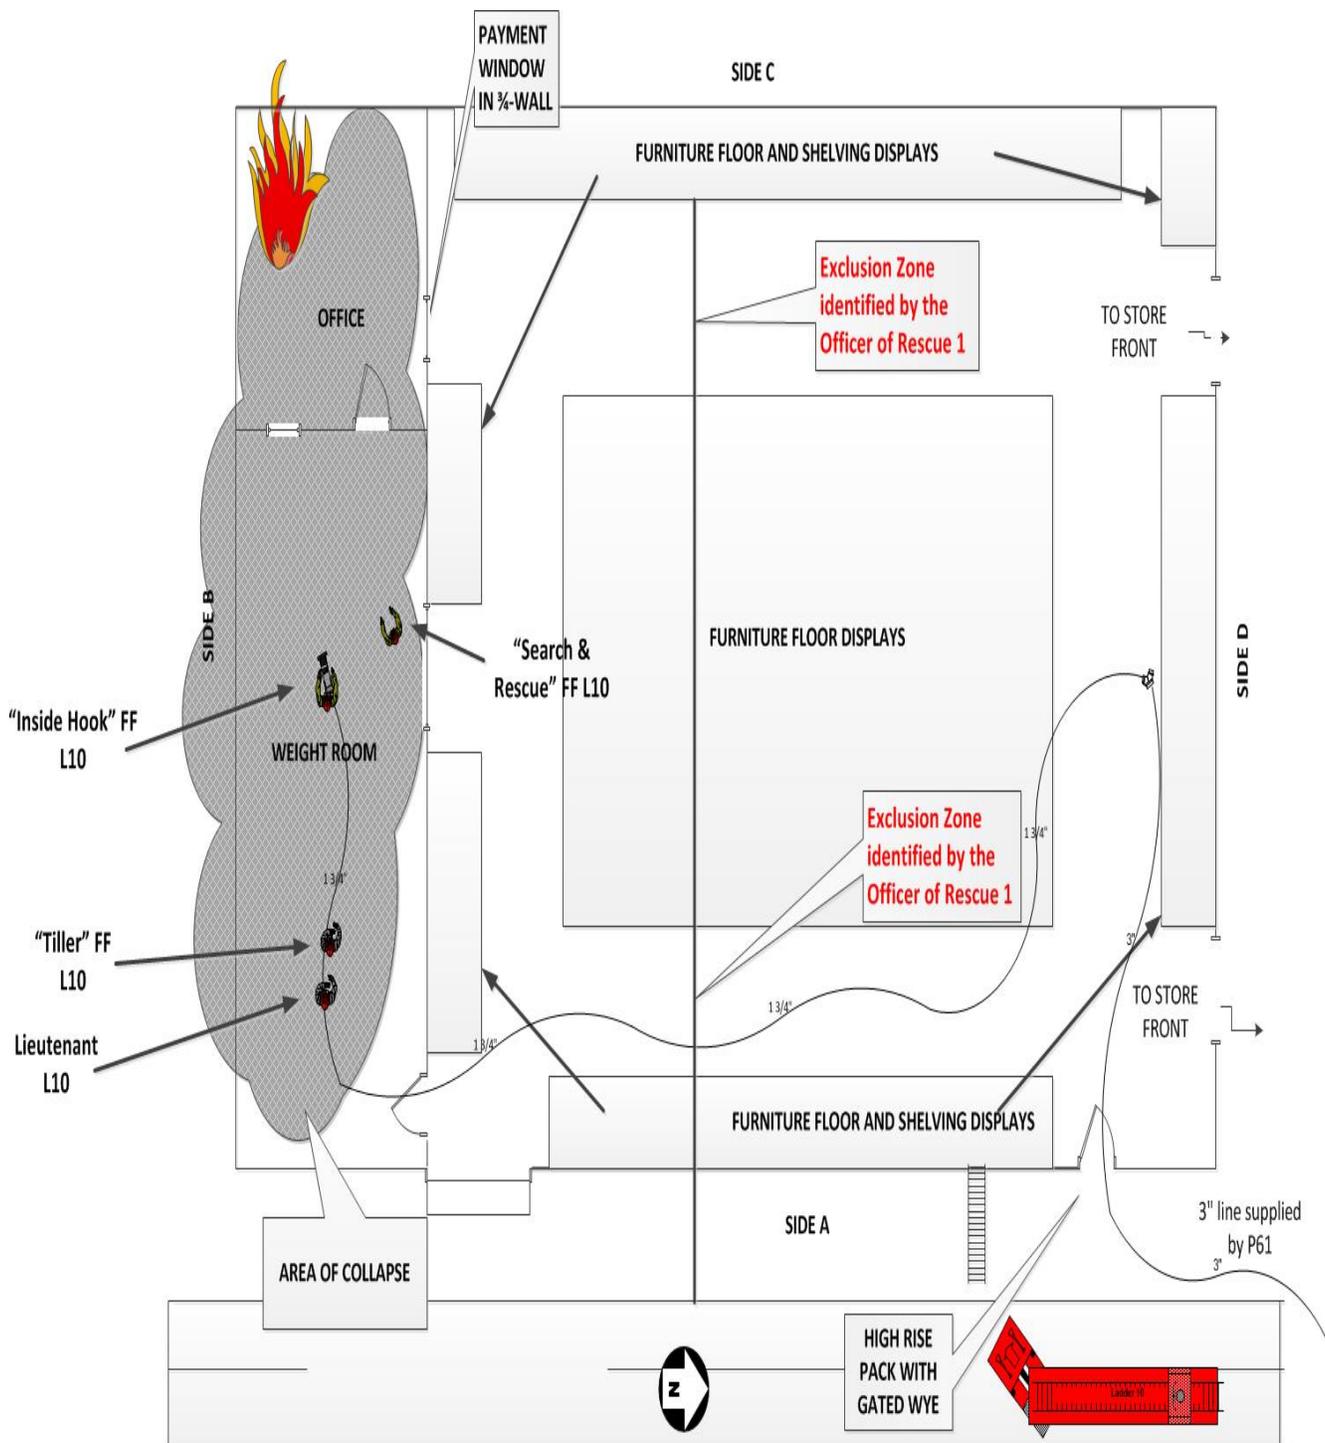
Figure 12. Handline repositioned by Ladder 10 to better access the fire in the rear office of the furniture store showroom.

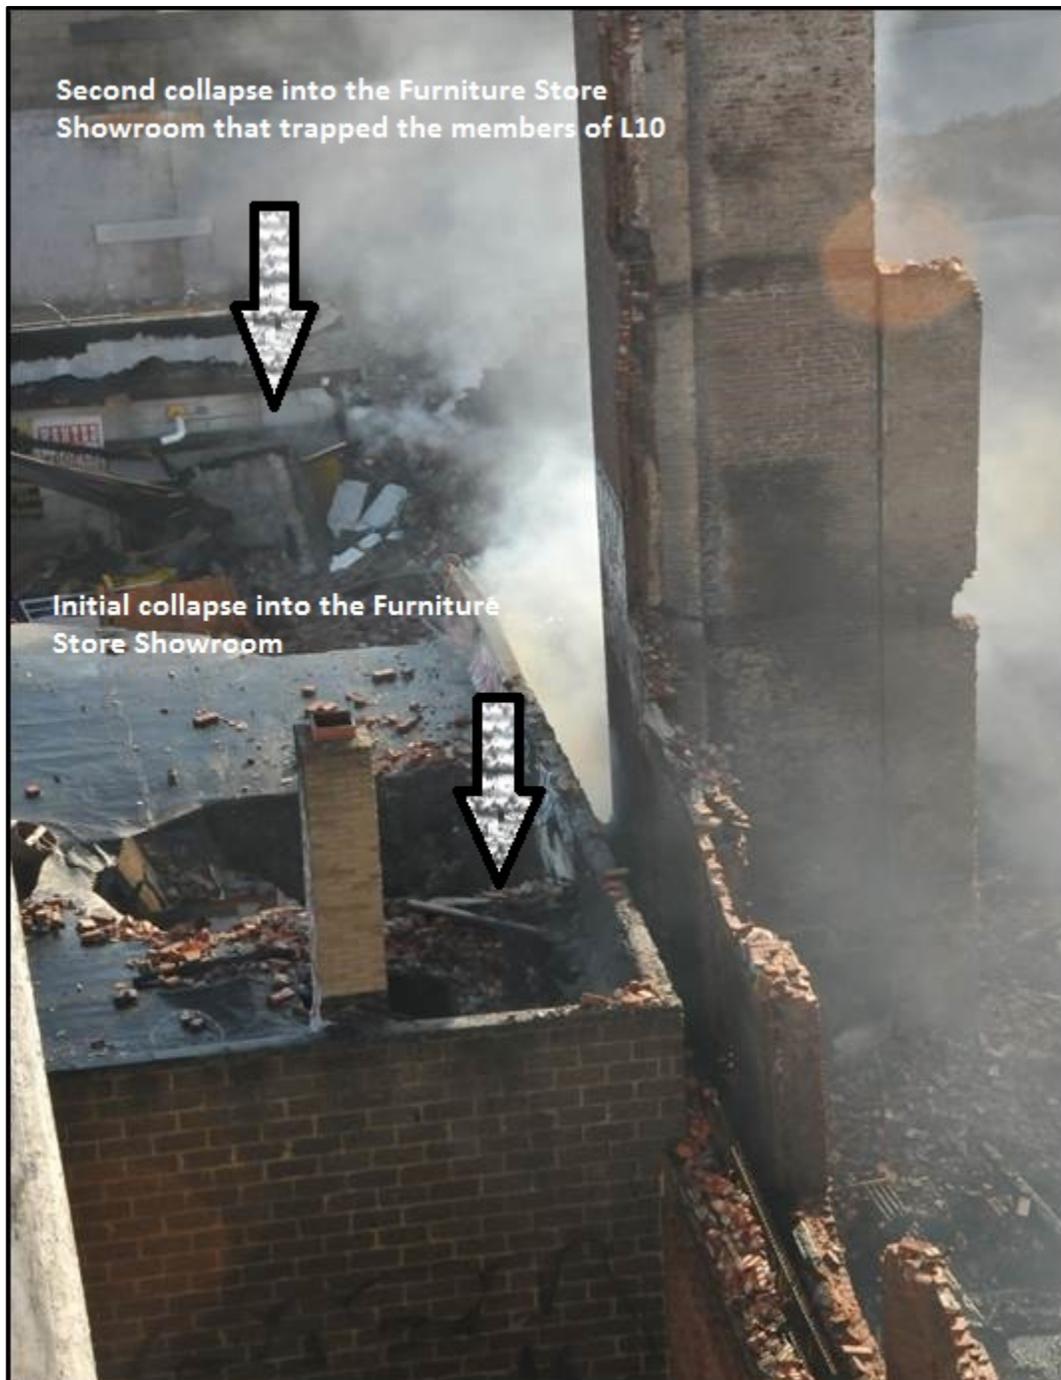
Photo 13. Post collapse photo of furniture showroom roof showing the two holes made by the two different wall collapses.
(Photo courtesy of fire department.)

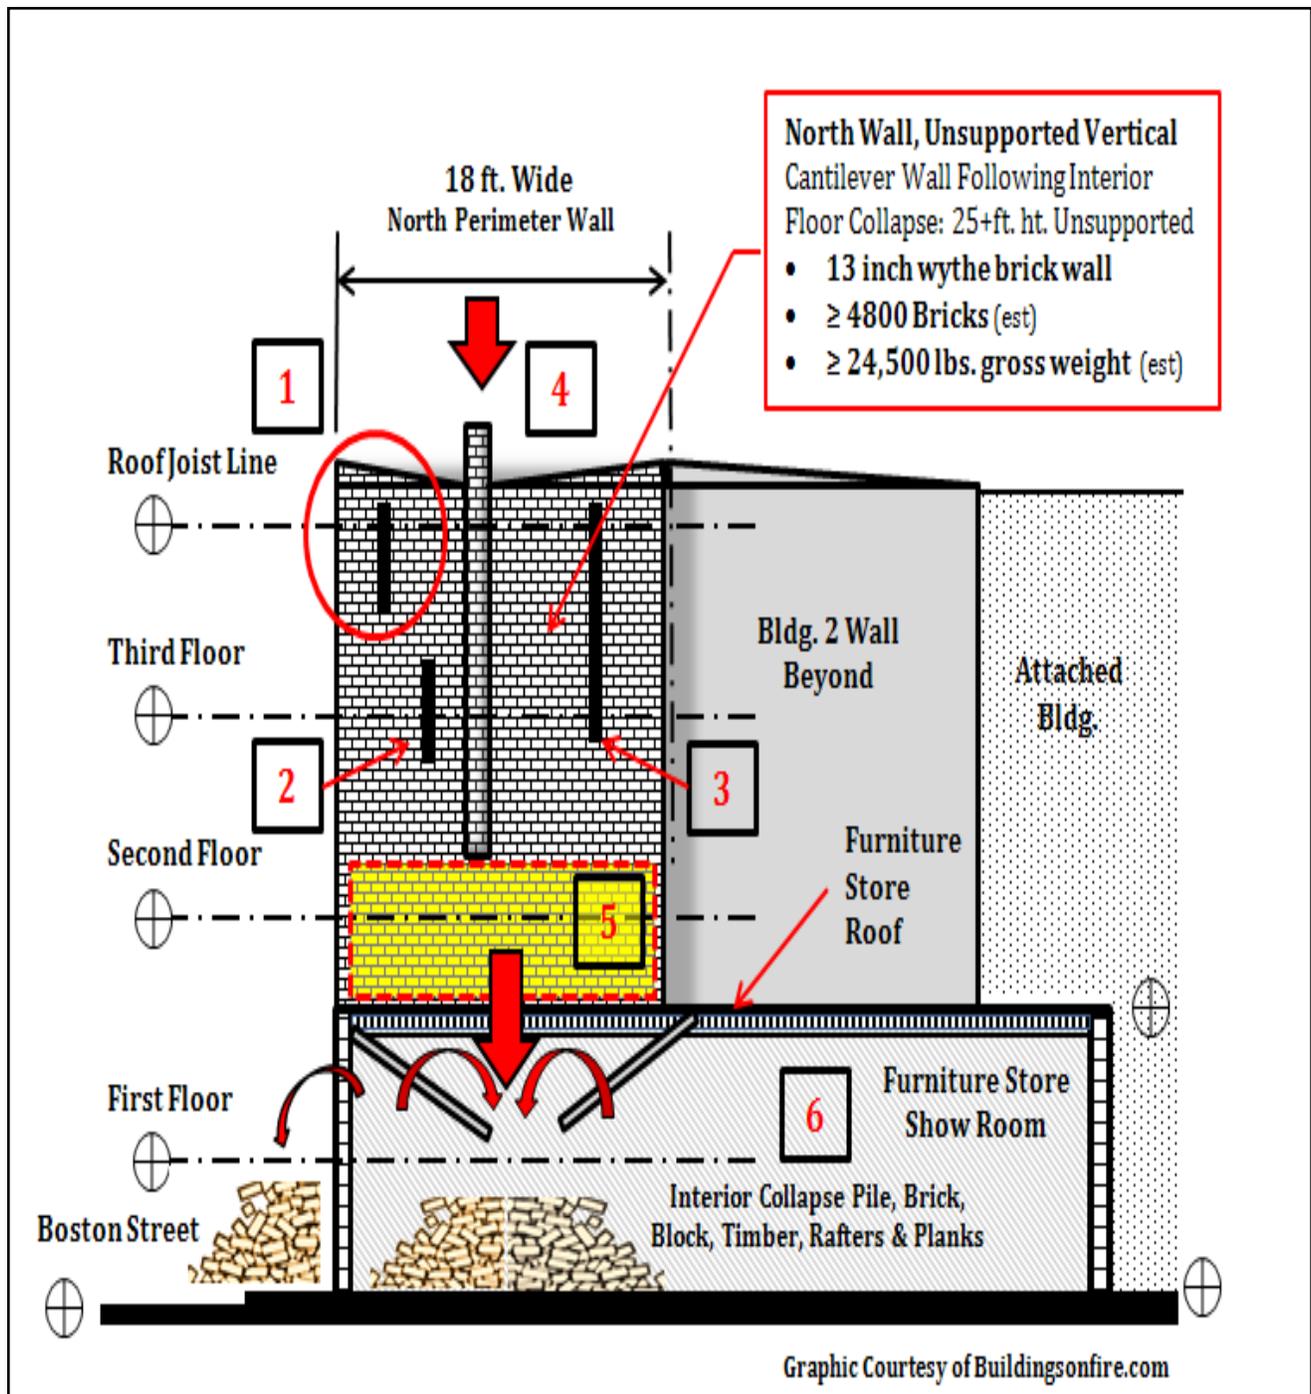
Figure 13. North wall of Building 2 collapse and furniture store sectional view. (Note: for explanation of notes 1-5, refer to page 37. Graphic analysis diagram courtesy of Buildingsonfire.com.)

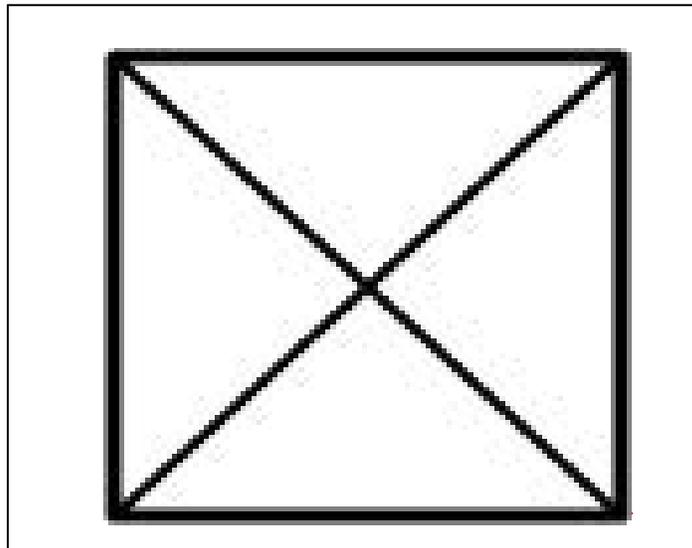
Figure 14.

Warning placard used by FDNY to identify hazards in vacant buildings. This 18-inch by 18-inch Square box with 2-inch wide lines is only a small portion of the FDNY Vacant Building Fires Procedures. Departments should consider building marking as part of their overall strategy for fighting fires in Vacant Buildings.

departments to consider requiring an exterior placard or markings on abandoned and vacant structures to inform fire fighters of the structure's status and identify potential hazards.^{13,14} Figure 14 illustrates symbols used on warning placards developed and used by the New York City Fire Department (FDNY).¹¹ Fire departments should develop additional policies that specifically cover the hazards encountered with these structures, such as training in size-up, building construction features present in typical buildings and construction methodologies characteristic of this era, safety considerations, tactics and strategy, and risk-versus-gain profiles.^{5,8}
