Career Probationary Fire Fighter Runs Out of Air and Dies in Commercial Structure Fire—Michigan

Executive Summary

On May 8, 2013, a 29-year-old male career probationary fire fighter died after running out of air and being trapped by a roof collapse in a commercial strip mall fire. The fire fighter was one of three fire fighters who had stretched a 1½-inch hoseline from Side A into a commercial strip mall fire. The hose team had stretched deep into the structure under high heat and heavy smoke conditions and was unsuccessful in locating the seat of the fire. The hose team decided to exit the structure. During the exit, the fire fighter became separated from the other two crew members. The incident commander saw the two members of the hose team exit on Side A and called over the radio for the fire fighter. The fire fighter acknowledged the incident commander and gave his location in the rear of the structure. The fire fighter later gave a radio transmission that he was out of air. A rapid intervention team was activated but was unable to locate him before a flashover occurred and the roof collapsed. He was later recovered and pronounced dead on the scene.

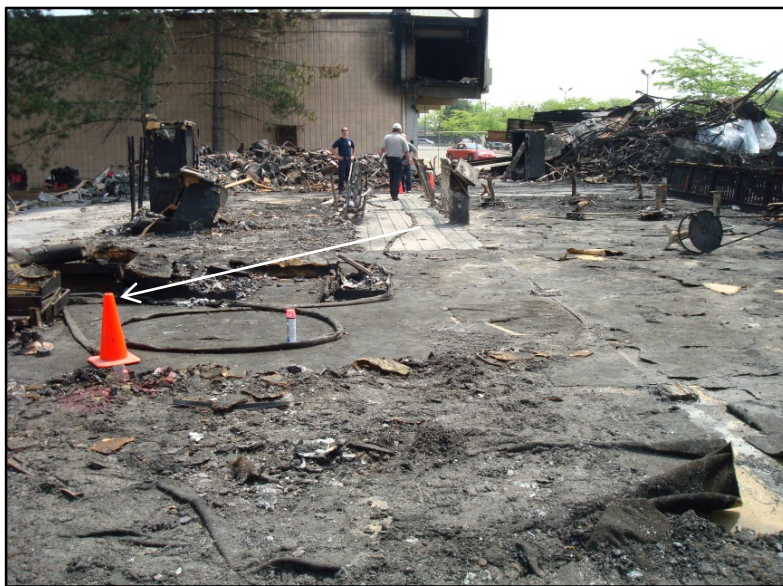
The fire fighter was located in this area after the collapse.

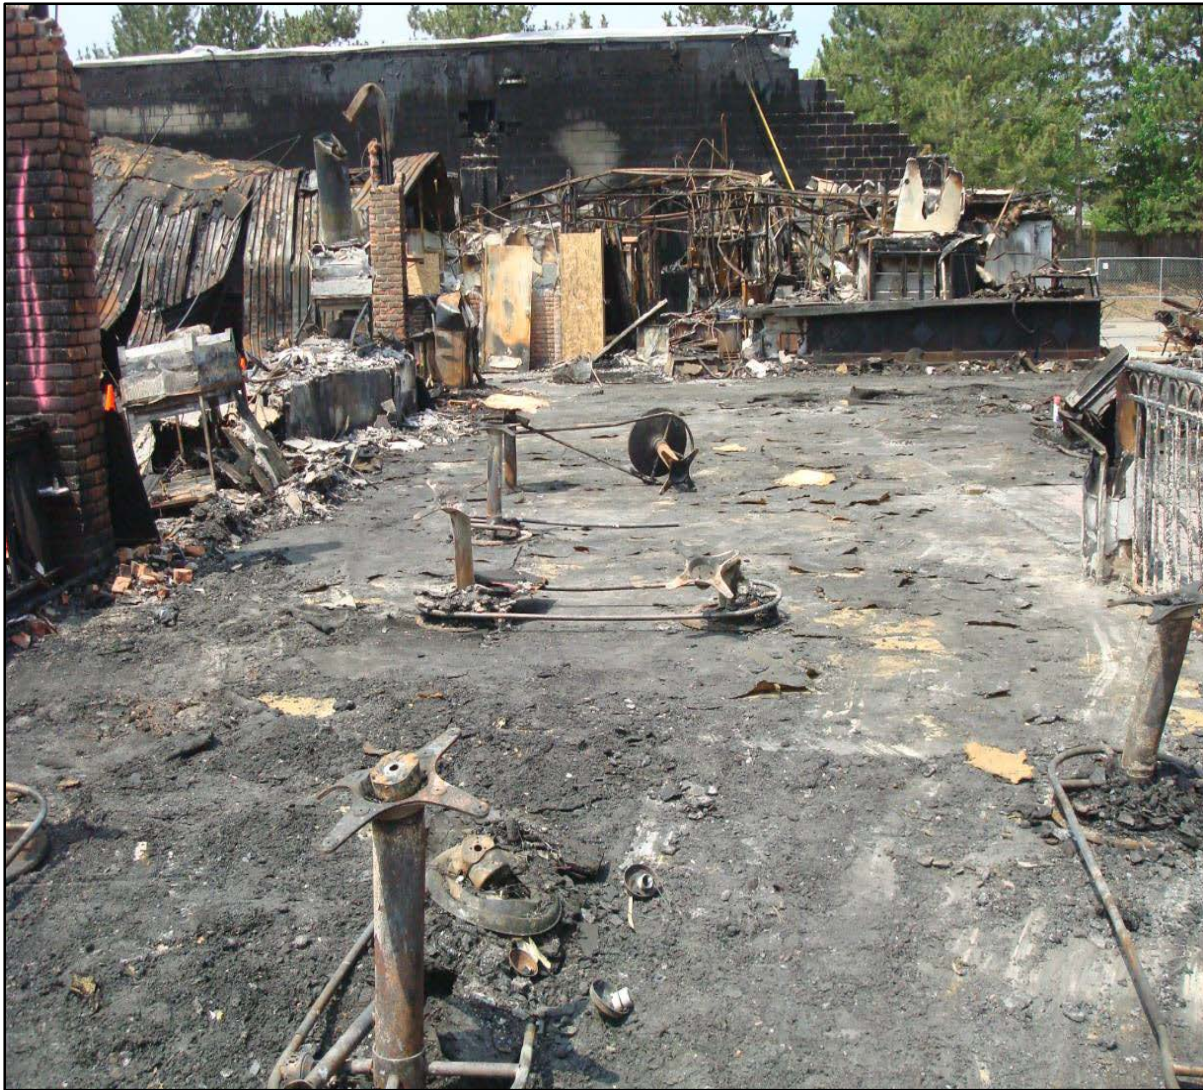
Photo 3. Post fire collapse interior view of pool hall building occupancy. Interior view looking toward the west, post-fire.
(NIOSH Photo)

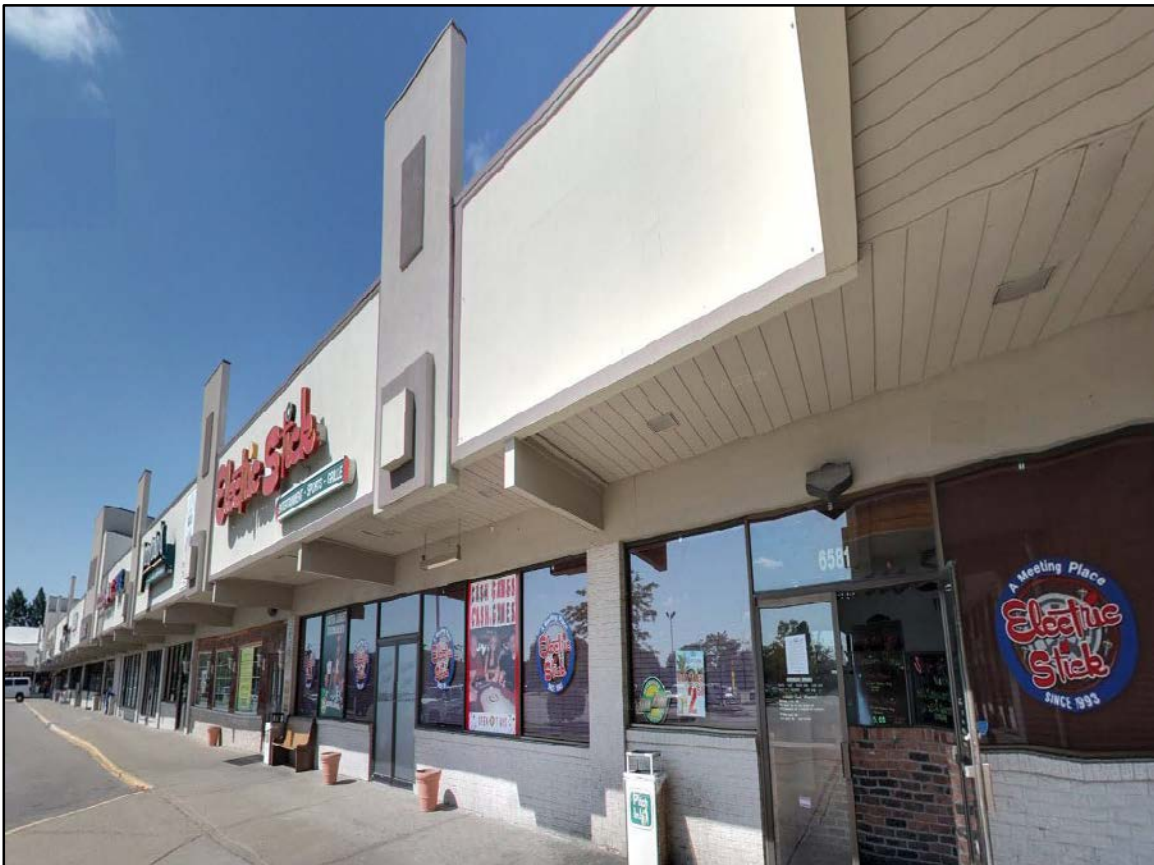
The store fronts on Side A were set back from the road and parking lot by a 10-foot-wide concrete sidewalk and larger framed façade and overhang. The façade included large decorative panel treatments, metal roof perimeter screen walls for aesthetic treatment, and wood soffits. The concealed area of the façade and overhang included unprotected steel beams with bolted connections. The store fronts varied with either full-height glass doors and metal-framed panel windows or a combination of partial brick walls and metal-framed panel windows (See Photo 7.)

Photo 7. Pre-fire street level view of fire building entrance; pool hall Alpha Division.
(Courtesy of *Buildingsonfire.com*.)

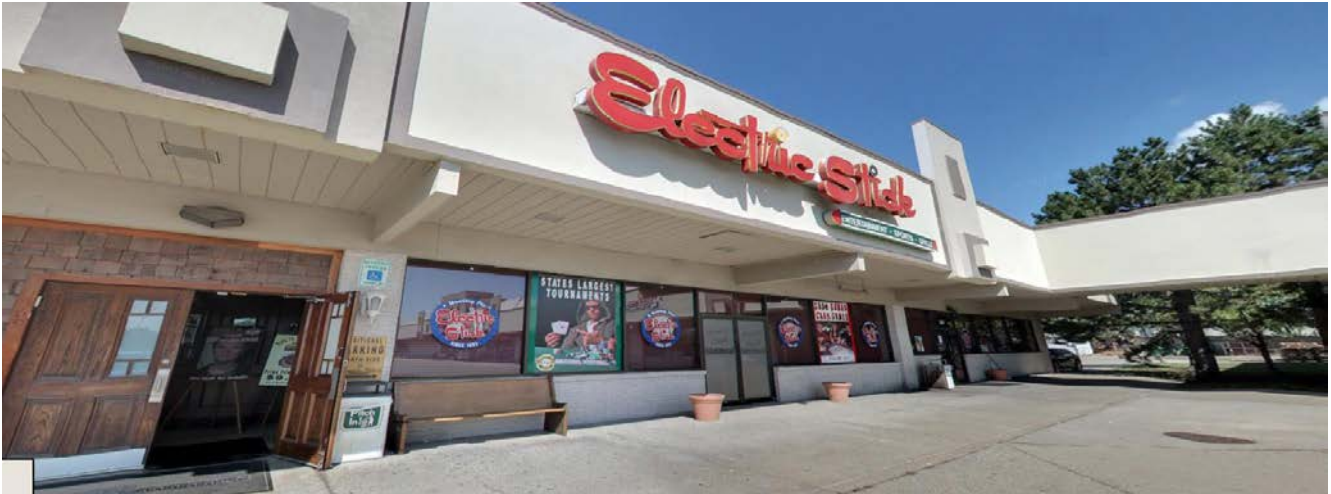
Photo 4. Pre-fire View of Fire Building Entrance-Pool Hall, Alpha Division.
(Photo: Luna Tech 3D (2012)/ Analysis Diagram Courtesy of Buildingsonfire.com.)

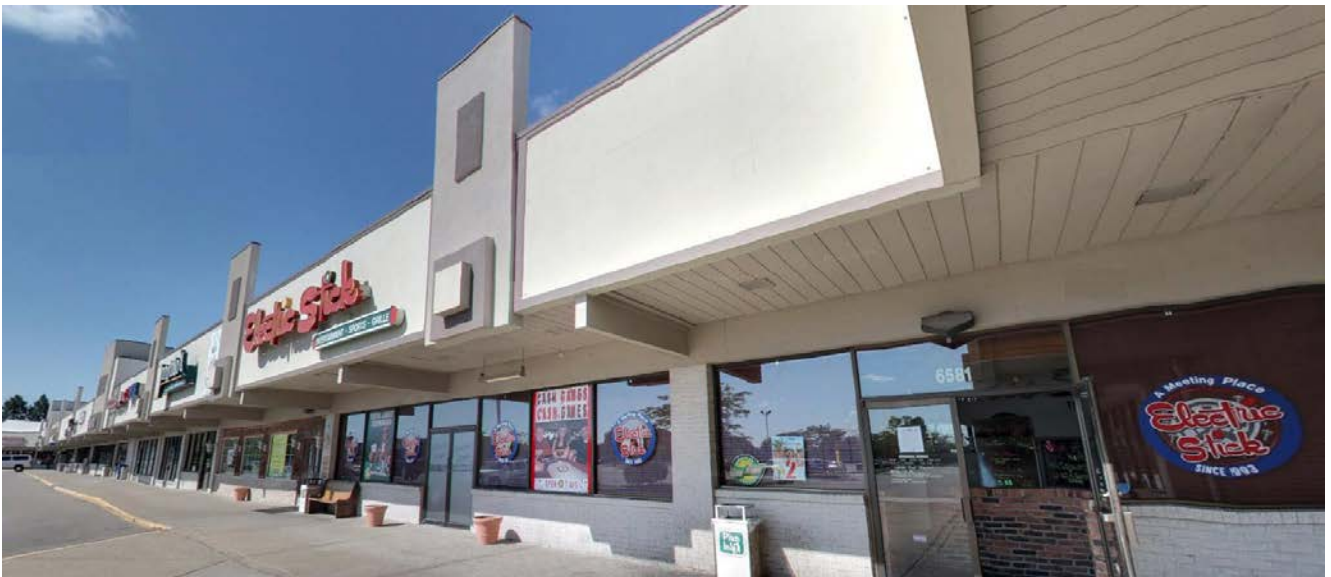
Photo 5. Pre-fire View of Fire Building Entrance-Pool Hall Alpha Division.
(Photo: Luna Tech 3D (2012) /Analysis Diagram Courtesy of Buildingsonfire.com.)

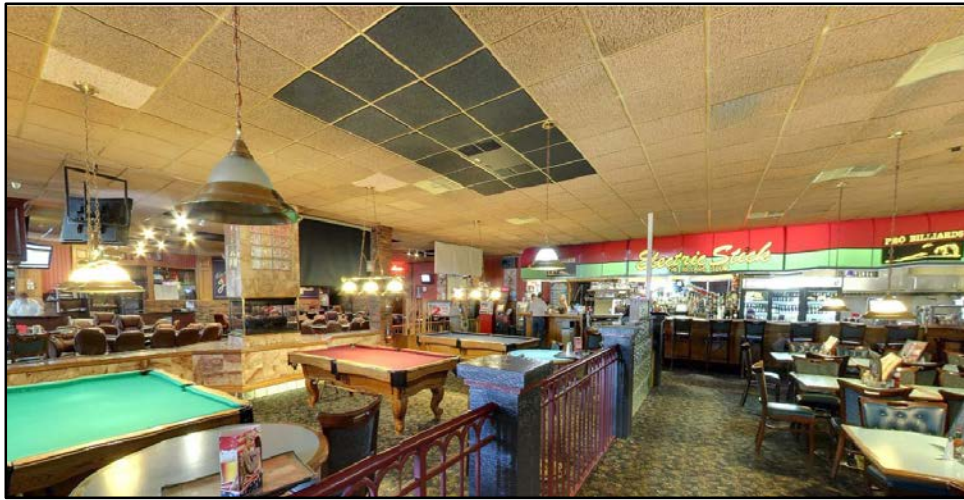
Photo 6. Pre-Fire Interior View of Pool Hall Building Occupancy.
*(Photo: Luna Tech 3D (2012)/ Analysis Diagram Courtesy of Buildingsonfire.com
Interior view looking towards the west-Pre-fire.)*

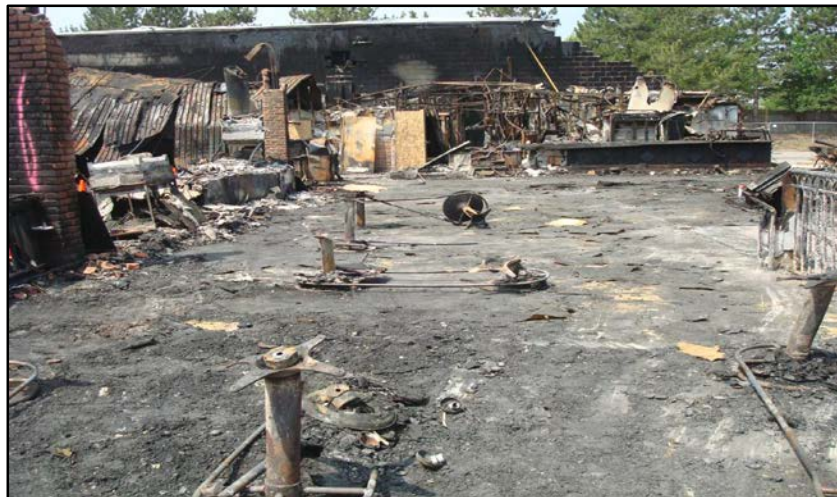
Photo 7. Post Fire Collapse Interior View of Pool Hall Building Occupancy.
*(Photo: NIOSH/ Analysis Diagram Courtesy of Buildingsonfire.com
Interior view looking towards the west: Post-fire.)*

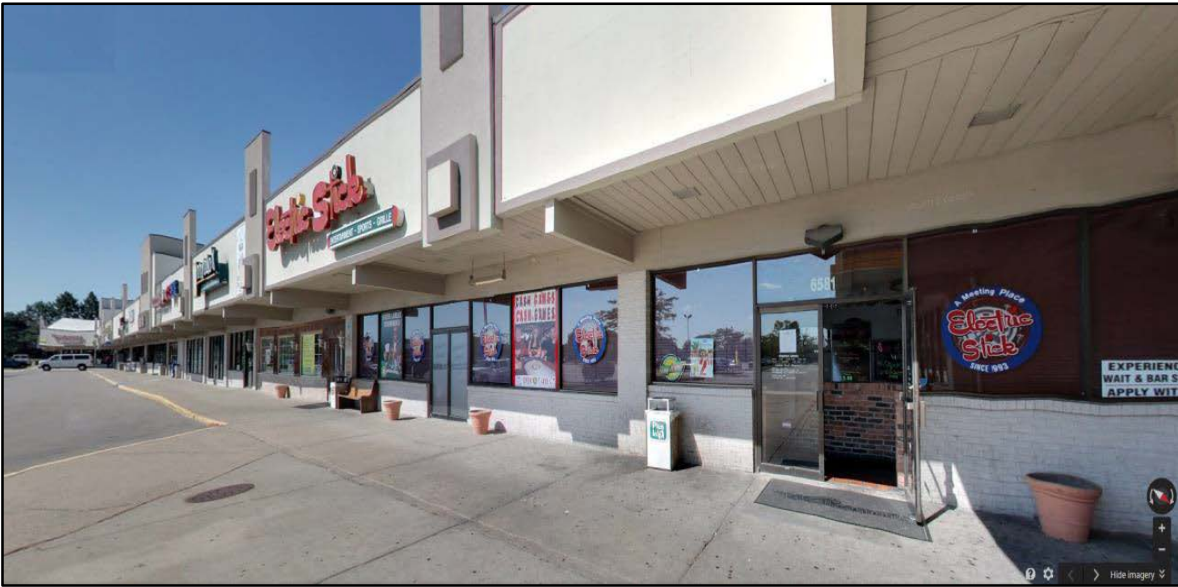
Photo 8. Pre-fire Street View of Restaurant Building Entry Alpha.
(Photo: Luna Tech 3D (2012)/ Analysis Diagram Courtesy of Buildingsonfire.com.)

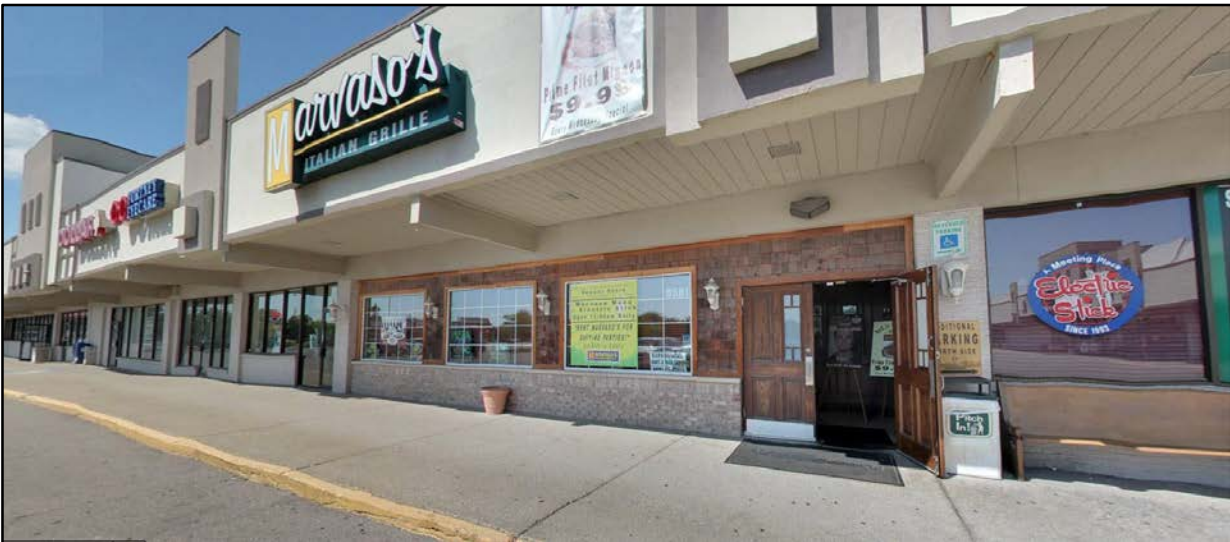
Photo 9. Pre-Fire Street View of Restaurant Building Entry Alpha.
(Photo: Luna Tech 3D (2012 / Analysis Diagram Courtesy of Buildingsonfire.com.)

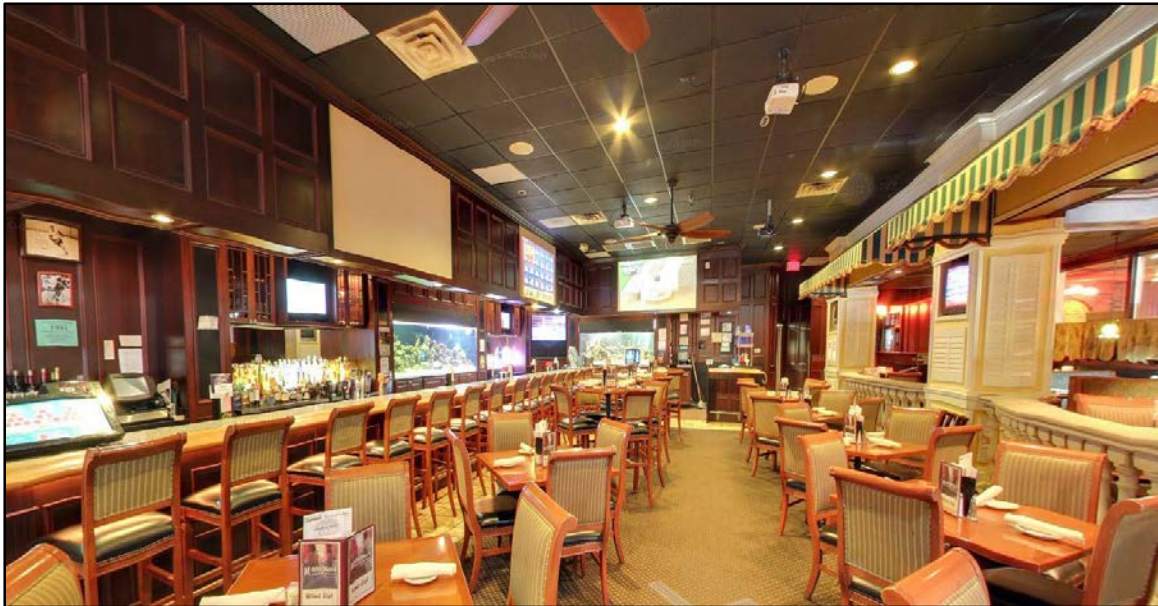
Photo 10. Pre-Fire Interior View of Restaurants Occupancy.

(Photo: Luna Tech 3D (2012)/ Analysis Diagram Courtesy of Buildingsonfire.com.)

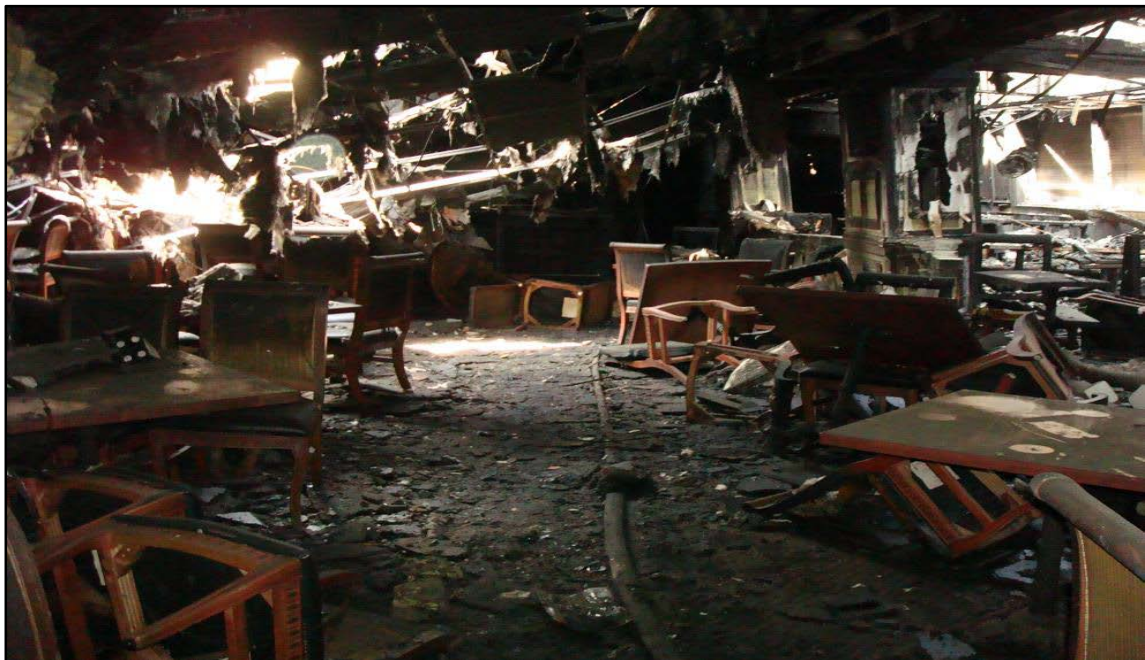
Photo 11. Post Fire Collapse Interior View of Restaurant Occupancy.

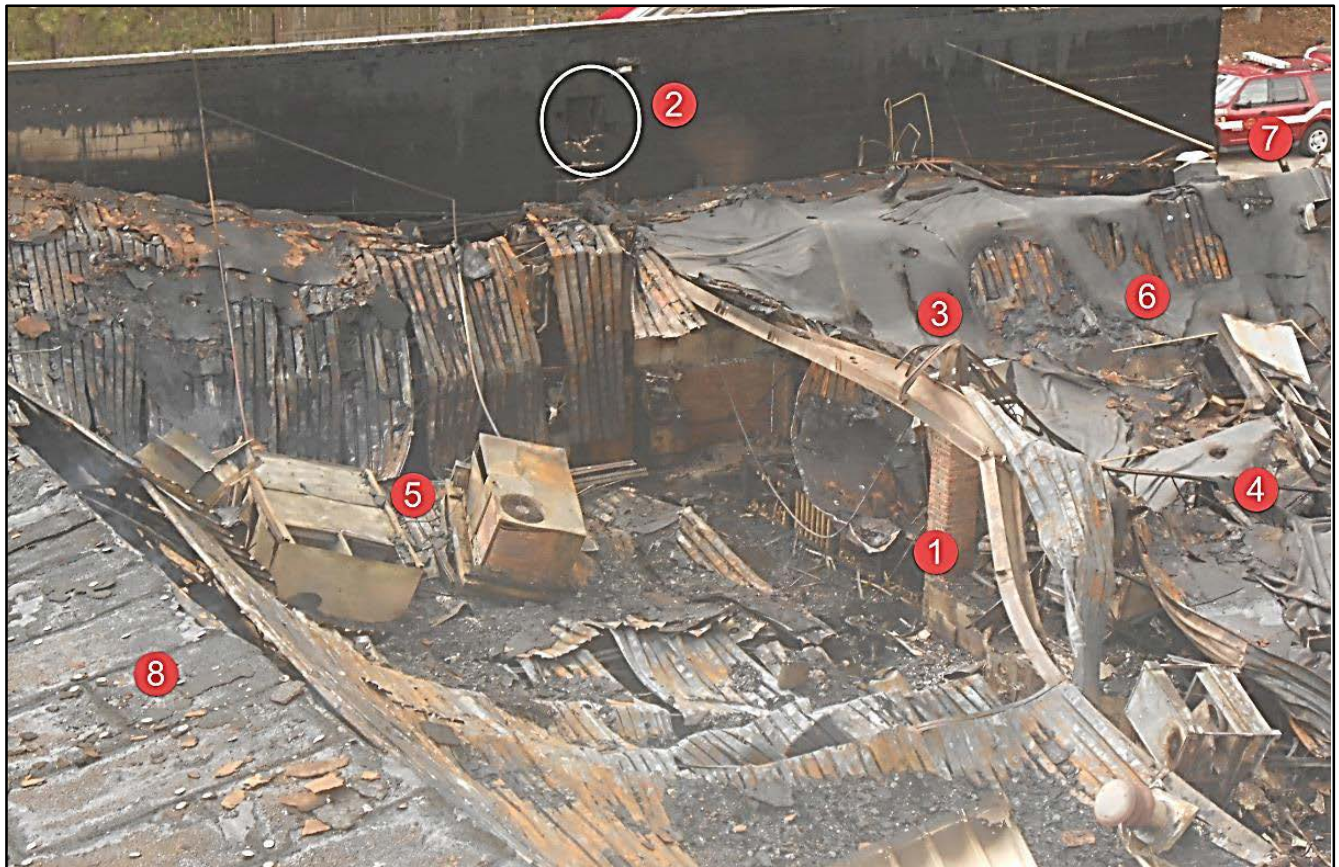
Photo 15. Pool Hall Roof Diaphragm Collapse –Charlie Wall and Delta Corner.

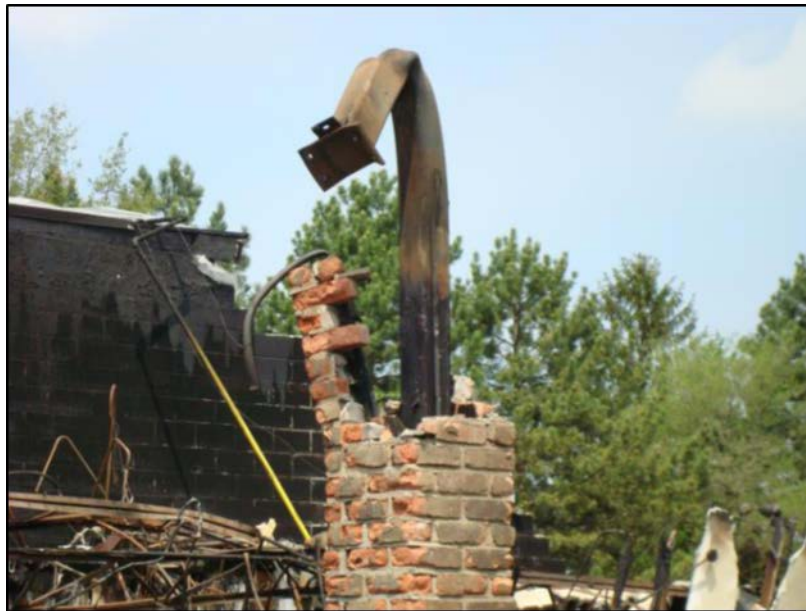
Photo 18. Tube Steel Column Failure- Roof Collapse.
(Photo: NIOSH/ Analysis Diagram Courtesy of Buildingsonfire.com.)

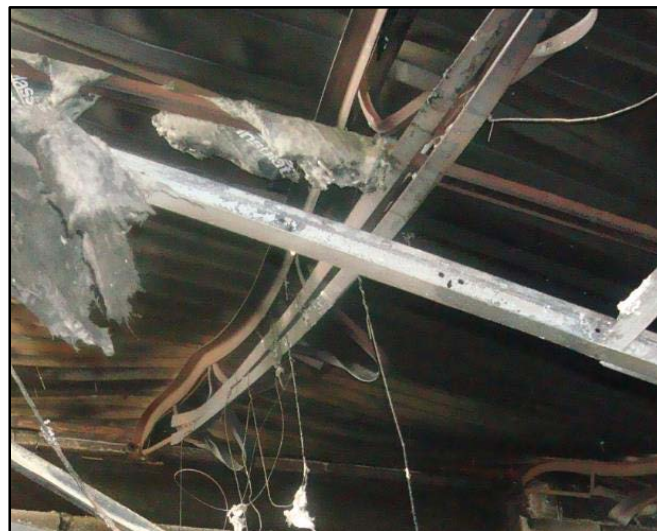
Photo 21. Detail of Truss Compromise and Roof Collapse.
