## Volunteer Fire Fighter Killed Rescuing Injured Construction Worker When Struck by Collapsing Cell Phone Tower – West Virginia

A summary of a NIOSH fire fighter fatality investigation

January 20, 2015

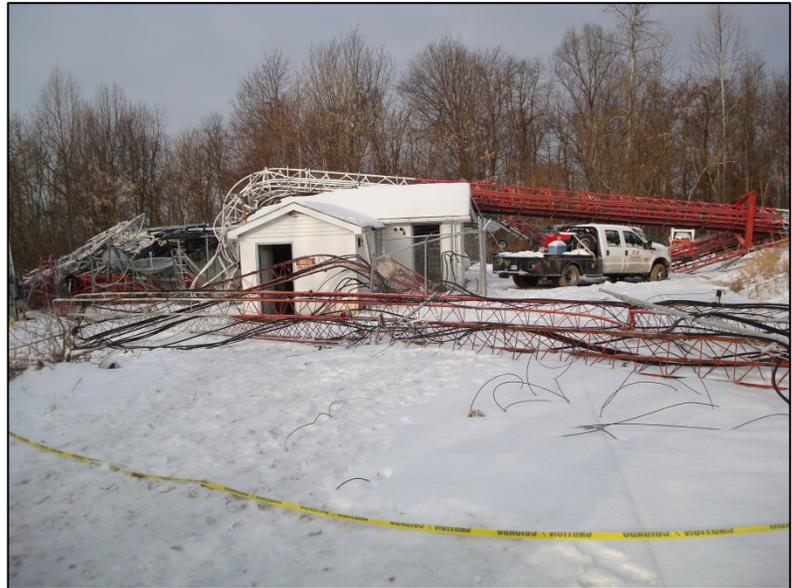
Site of collapsed cell phone towers.  
(NIOSH photo)

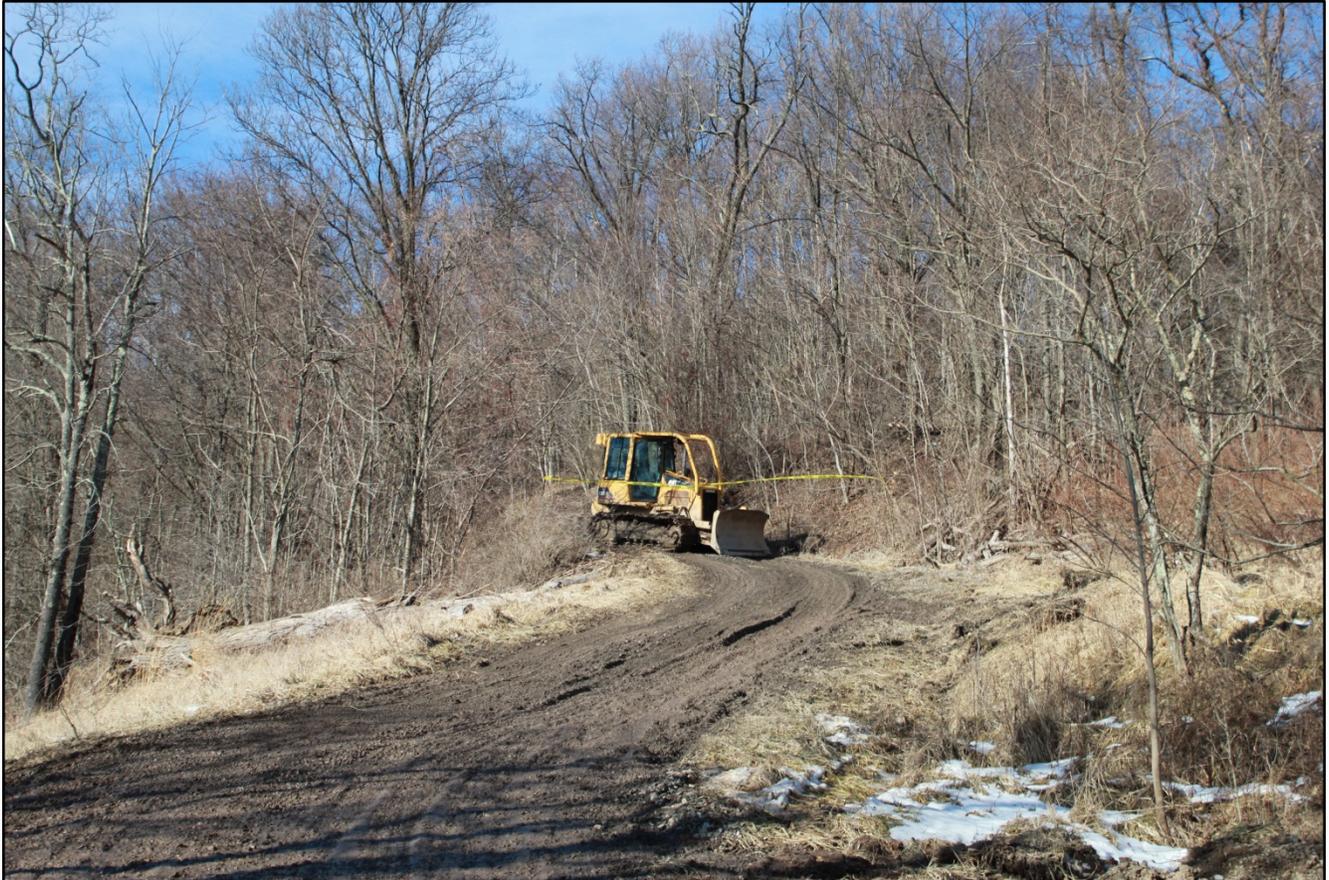
**Photo 1. Road conditions up hill to cell tower collapse site.**  
*(Photo courtesy of WV State Police.)*

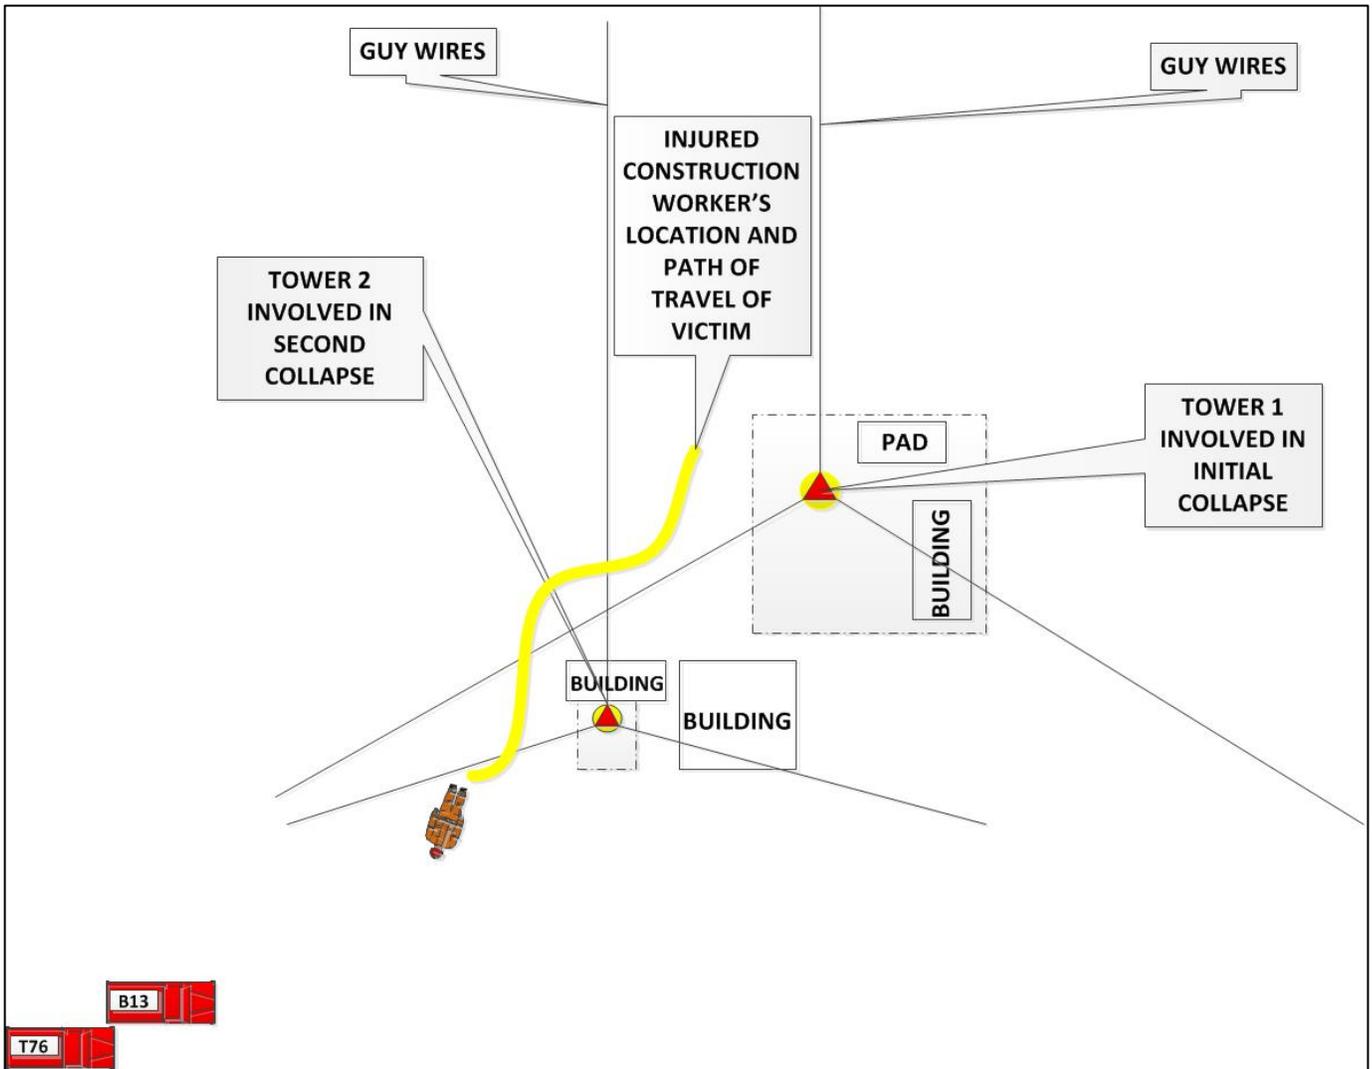
Diagram. Site layout.

The site covered more than 2.5 acres on top of a hill that was located within the jurisdiction of Company 13, the first due fire department. There were two cell phone towers and three structures that housed electrical components and a generator to support the operation of the cell phone towers. Access to the towers was up a muddy, partially graveled road requiring use of a four-wheel drive vehicle (Photo 1). The owner of the site had contracted a company to improve the site access road to accommodate tower maintenance work.

Tower 1 was 343 feet tall. It consisted of three 41" sides and three round legs that were fastened together with diagonal braces forming the shape of a triangle. The tower was secured with guy wires connecting it to ground anchoring points inserted into concrete slabs (see Diagram). The guy wires were attached to Tower 1 at elevations of 80 feet, 160 feet, 240 feet, and 320 feet. Tower 1 was the first tower to collapse.

Tower 2 consisted of three sides approximately 16" wide and three round legs fastened together with a continuous 3/8" solid bar welded to the legs in a diagonal pattern along its entire 312-foot length. Tower 2 was also secured with guy wires attached to it and to ground anchoring points inserted into

concrete slabs (see Diagram). During the collapse of Tower 1, the top portion of Tower 2 also collapsed most likely from some of the guy wires on Tower 1 contacting the top of Tower 2 and pulling it to the ground. There was approximately 180 feet of Tower 2 still standing when the first due companies arrived.

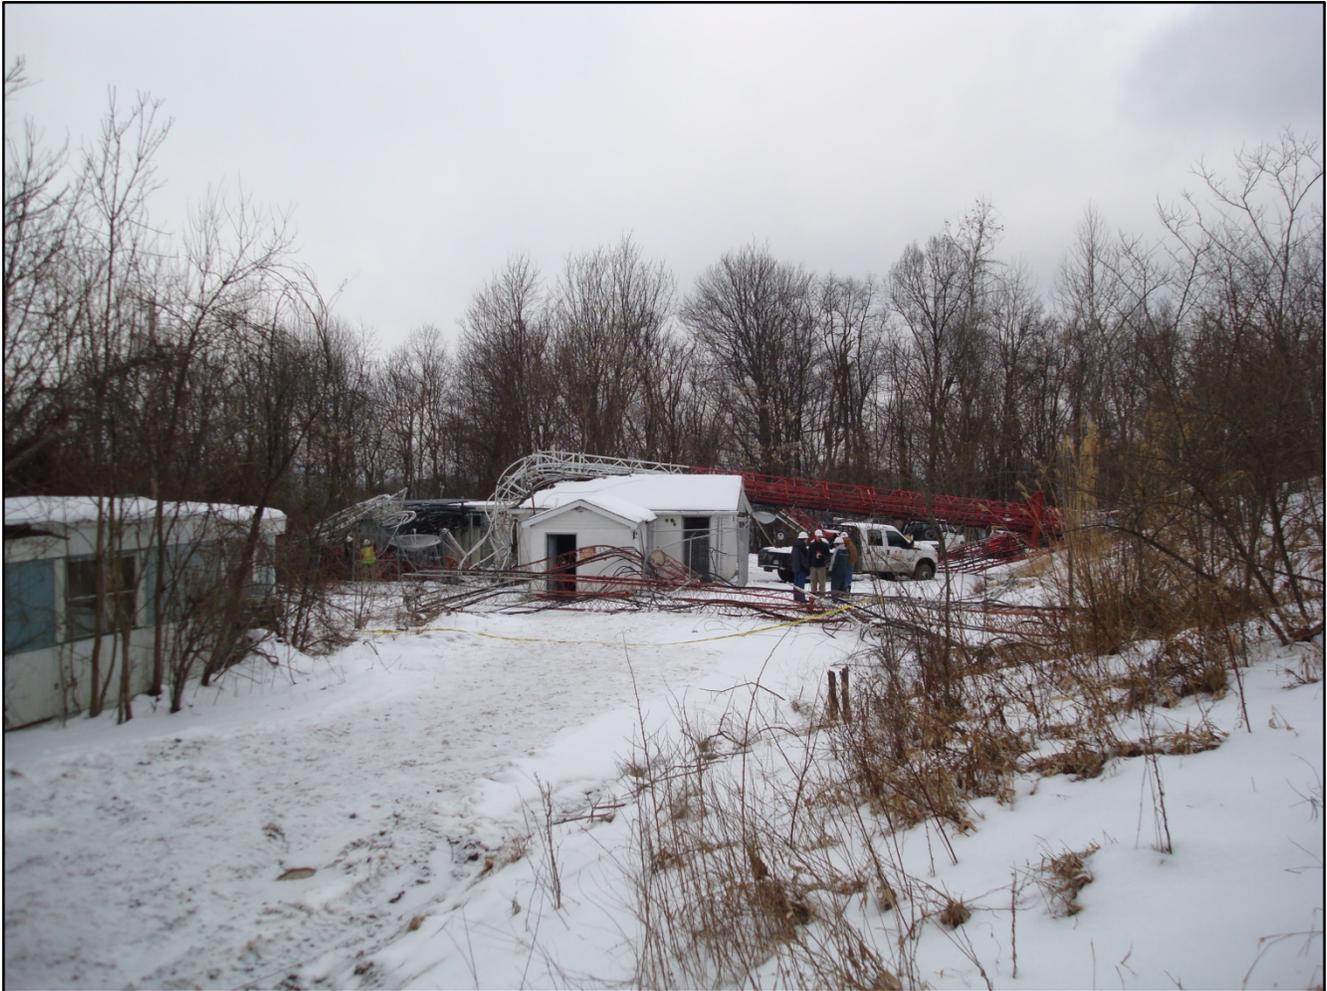
**Photo 2. Area of road where the IC and responding units parked.**  
*(Photo NIOSH)*

The second due volunteer department, Company 7 (including the Victim), arrived at the bottom of the hill at approximately 1149 hours, just behind Company 13. A captain from Company 7 arrived via a four-wheel drive brush truck (T76) while the fire fighter and two other Company 7 members responded in an ambulance, Squad 7 (SQ7). The county ambulance squad also arrived at approximately the same time in ambulance A612 staffed with an EMS lieutenant and two paramedics. Shortly after that, ambulance Squad 631 (A631) arrived with the EMS captain and his driver who, was an EMT. Due to the condition of the access road, the Company 7 fire fighters parked SQ7 at the bottom of the hill. They rode in T76 to the top of the hill which was approximately 600 yards up the access road. The EMS captain and his driver parked A631 and also rode in T76 to the top of the hill. Ambulance A612 staged at the bottom of the hill. The assistant chief of operations for the county EMS arrived at the bottom of the hill along with an officer from the state Department of Natural Resources. Both drove their 4-wheel drive vehicles up to the incident scene and parked behind T76 about 100 feet away from the tower site (Photo 2).

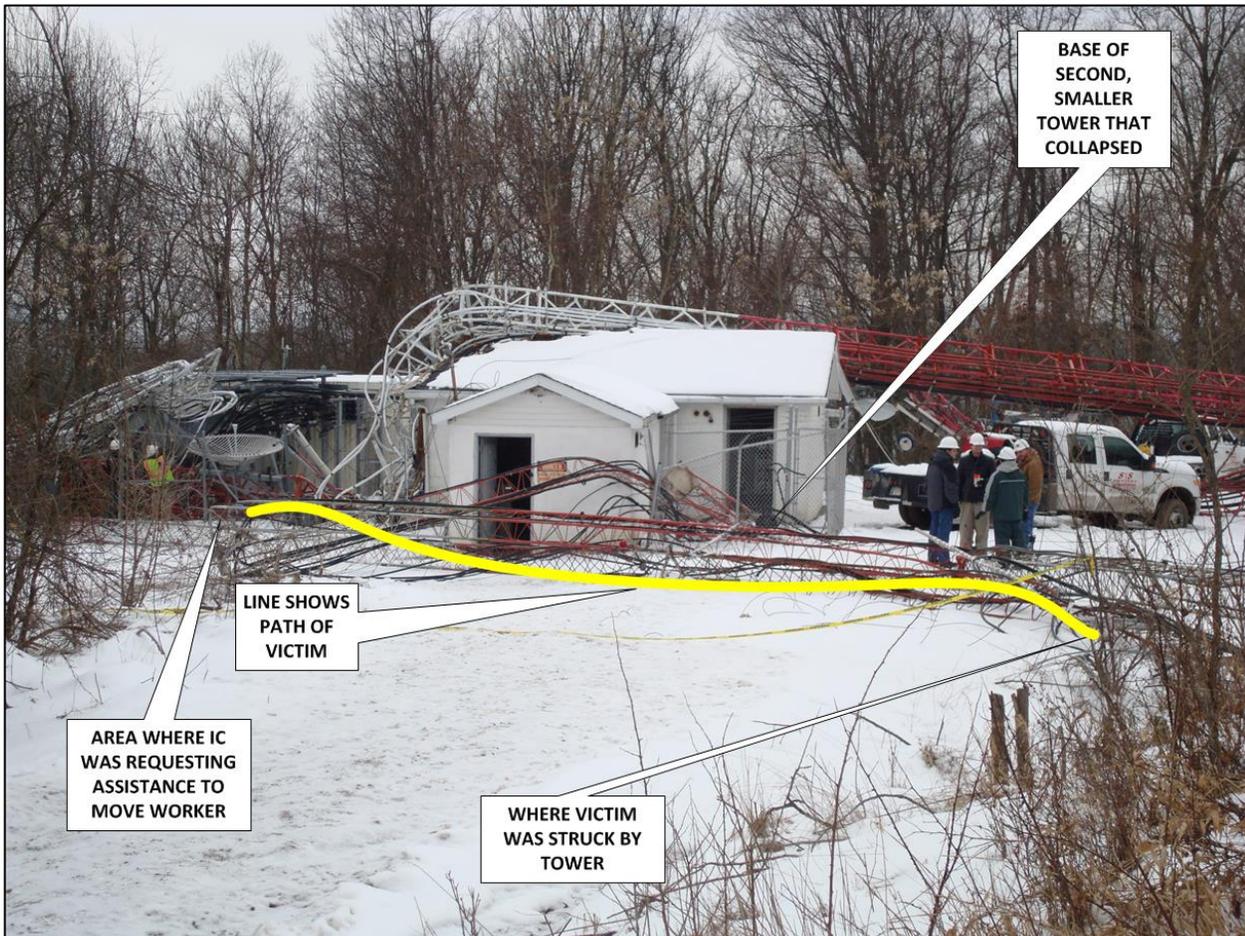
**Photo 3. Locations of operations inside danger zone.**  
(Photo NIOSH)

During this time, the Company 7 fire fighters (including the Victim) had exited T76 and were on the driver’s side donning and securing gear. They did not hear their captain or any of the discussion he had with the foreman. At this time, the Company 13 chief, who was near the collapsed Tower 1 with her fire fighter, continued attempting to move one of the injured maintenance workers. She yelled to the Company 7 fire fighters to provide her assistance immediately. They responded to the Company 13 chief’s request and entered into the collapse zone to remove the injured worker who had previously freed himself from the wreckage. They had begun dragging the injured maintenance worker to safety when the EMS assistant chief of operations heard a noise and then saw Tower 2 begin to collapse. He yelled to the fire fighters dragging the injured worker to run. As the fire fighters were escaping, the tower collapsed to the ground (see Photo 3) , striking one of the Company 7 fire fighters (the Victim) on the head, breaking his helmet. The tower collapse barely missed the injured maintenance worker and the other 3 fire fighters. The fire fighters on the scene immediately provided assistance and the downed fire fighter was taken off of the hill to an awaiting ambulance. He was transported to a local hospital where he was pronounced dead.
