# Death in the line of duty...

## Single-Family Dwelling Fire Claims the Life of a Volunteer Fire Fighter - Indiana

Fatality Assessment and Control Evaluation  
Investigative Report #99F-02

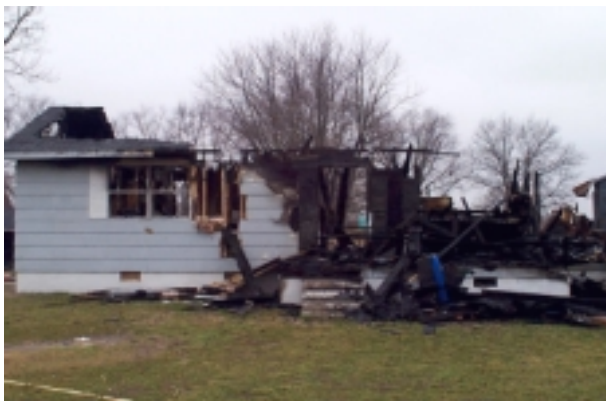
House where fatality occurred

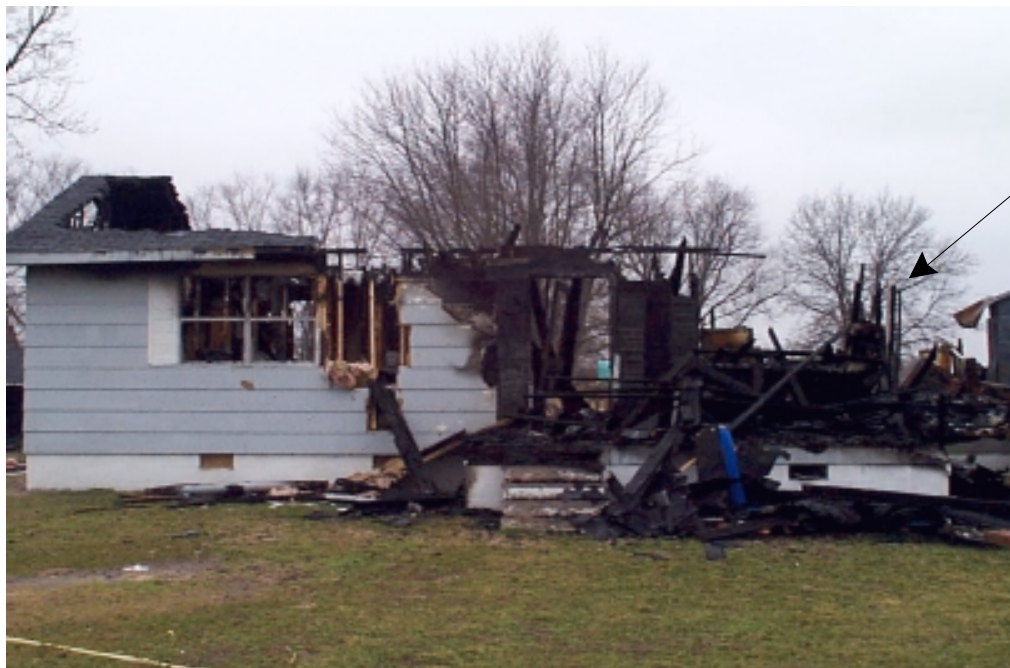
Figure 1  
House where fatality occurred

The site of the incident was a 20-year-old, one-story, ranch-style home with no basement, of approximately 1,100 square feet (see Figure 1). It was constructed of wood with a pitched, shingled roof.

Area of Furnace  
(origin of fire)

His turnout gear was destroyed and his helmet was missing. His legs were partially under a couch and a coffee table which were located in the living room (see Figure 2). Additionally, the Chief stated that the conditions for a flashover existed, i.e., simultaneous ignition of all combustibles in the room and high heat level from the floor to the ceiling. A post-incident investigation revealed the point of origin of the fire was in the furnace area.
