A Summary of a NIOSH fire fighter fatality investigation

Aluminum Regulator Fire Injures One Fire Fighter-Nevada

Fatality Assessment and Control Evaluation Investigative Report #99F-07

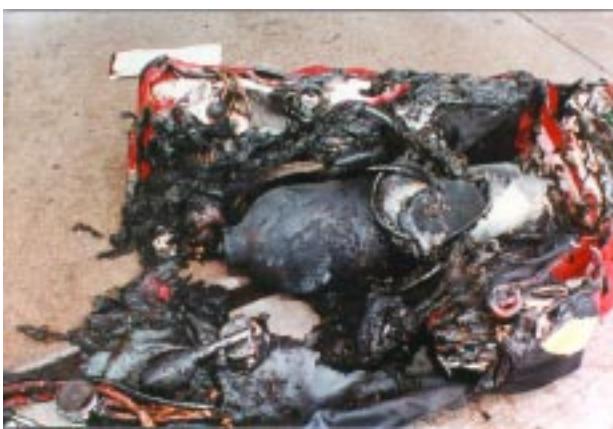
Damaged Oxygen System
