# SERIOUS INJURY REPORT

F2025-11 • September 2026

## ***Firefighters Injured Following Toxic Exposure During Electric Vehicle Lithium-ion Battery Thermal Runaway Event – California***

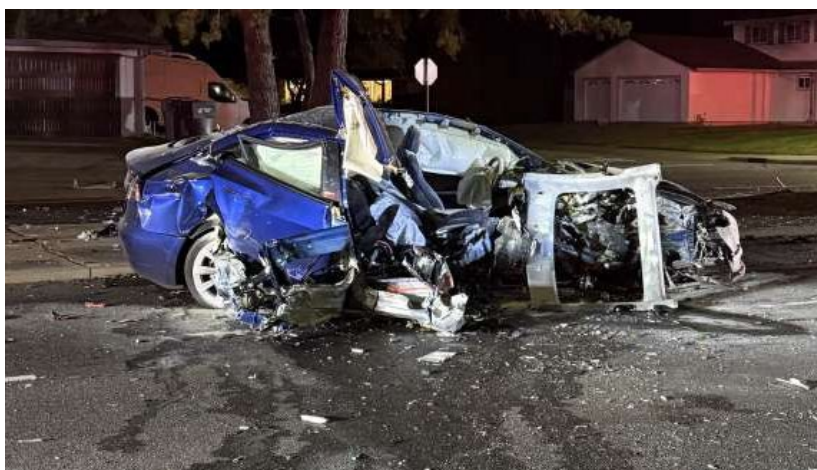
**Figure 1. Damaged electric vehicle at the scene of the incident. Photograph provided by the fire department.**

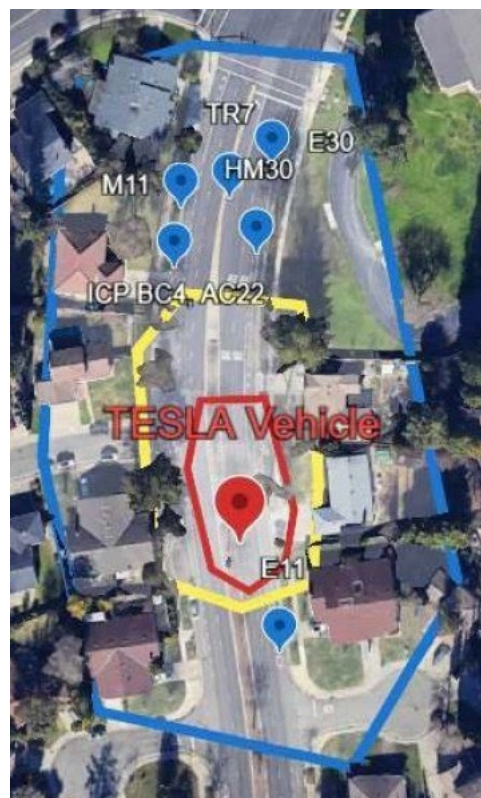
As shown in Figure 2, a hot zone was created at 50–75 feet (within the red line), as well as a 150-foot support zone (yellow line), and a full evacuation zone at 300 feet (blue line). The decision was made not to notify area residents because “sheltering in place” was already occurring due to the late hour and street access being blocked at both ends.

**Figure 2. Map of the incident indicating the zones established around the damaged vehicle, as well as the locations of personnel. (Image provided by the fire department.)**

Discussion: Consider establishing EV/LIB incident hazard control zones based on incident-specific hazard assessments rather than fixed distances. The department's current protocol of establishing a 75-foot exclusion zone perimeter for EV fire response may not be adequate for all responses, as demonstrated in this incident during which affected FFs were located 150 feet or more from the vehicle at the time of exposure. The Department of Transportation (DOT) Emergency Response Guidebook (ERG) is often used as a resource to establish initial hazard control zones at HAZMAT incidents. For incidents involving LIBs, the DOT ERG recommends an initial isolation distance of 75 feet in all directions [DOT 2024]. However, the guide also notes that LIB fires can produce toxic hydrogen fluoride gas, which has a recommended isolation distance of 330 feet in all directions [DOT 2024]. The hazard control zones established for an EV/LIB incident should account for factors such as battery involvement, thermal runaway conditions, fire behavior, weather, topography, structural exposures, and the potential for toxic gas release, projectiles, or other hazards. The hazard control zones may also evolve throughout the incident and may need to be expanded or contracted based on changes in conditions. OSHA's Hazardous Waste Operations and Emergency Response (HAZWOPER) standard, 29 CFR 1910.120, requires that site control measures be implemented to control exposures and that

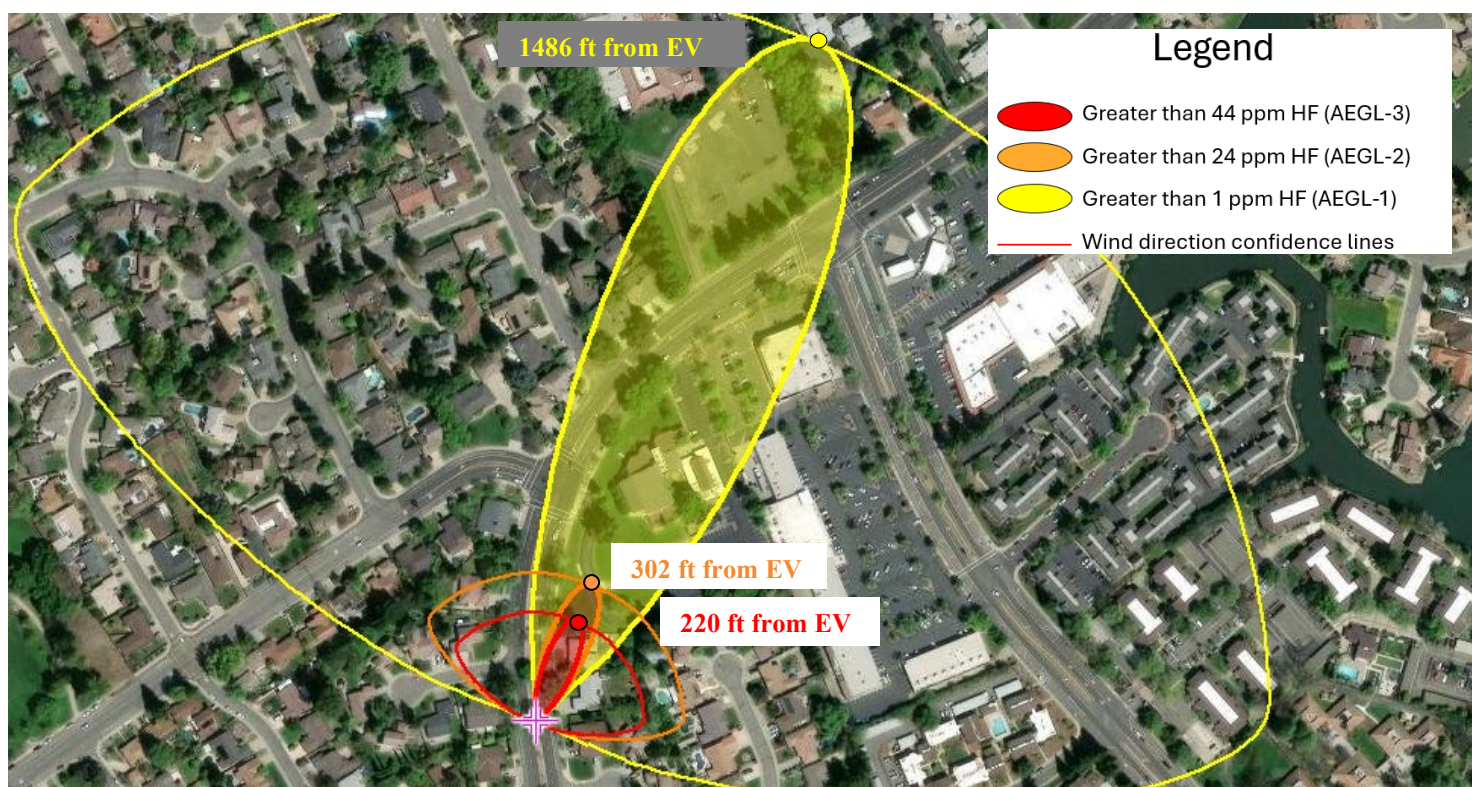
With the assumption of only 50% battery involvement, the threat zones corresponding to each AEGL threshold as modeled by ALOHA were as follows:

- AEGL-3 (>44 ppm [60 min]): 157 ft
- AEGL-2 (>24 ppm [60 min]): 213 ft
- AEGL-1 (>1 ppm [60 min]): 1,053 ft

**Figure 6. MARPLOT Map of AEGL [60 min] Threat Zones (100% Battery Involvement Assumption)**

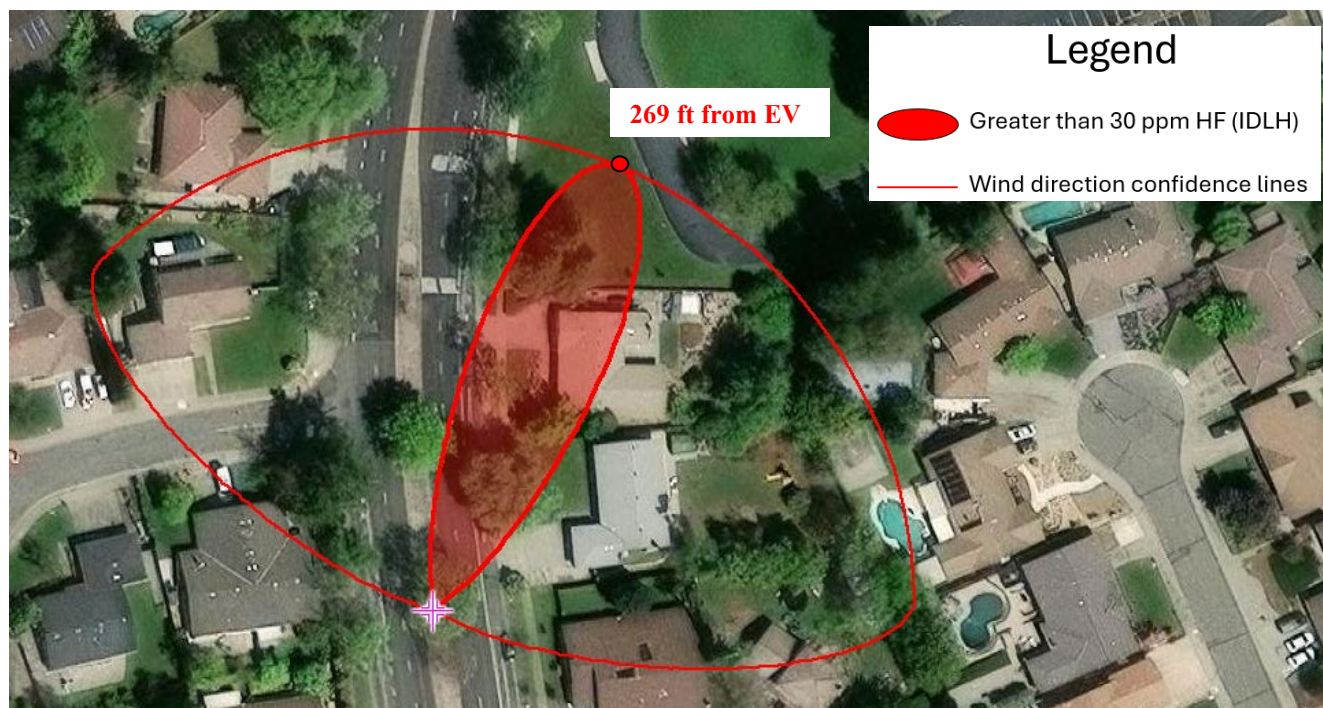
The threat zones corresponding to the IDLH threshold ( $>30$  ppm) as modeled by ALOHA (Figure 7):

- with the assumption of 100% battery involvement: 269 ft
- with the assumption of 50% battery involvement: 190 ft

**Figure 7. MARPLOT Map of IDLH Threat Zone (100% Battery Involvement Assumption)**
