## LINE-OF-DUTY DEATH REPORT

### Lumber mill silo fire and subsequent explosion kills two firefighters and critically injures thirteen more – Maine

F2026-07 ME · August 2026

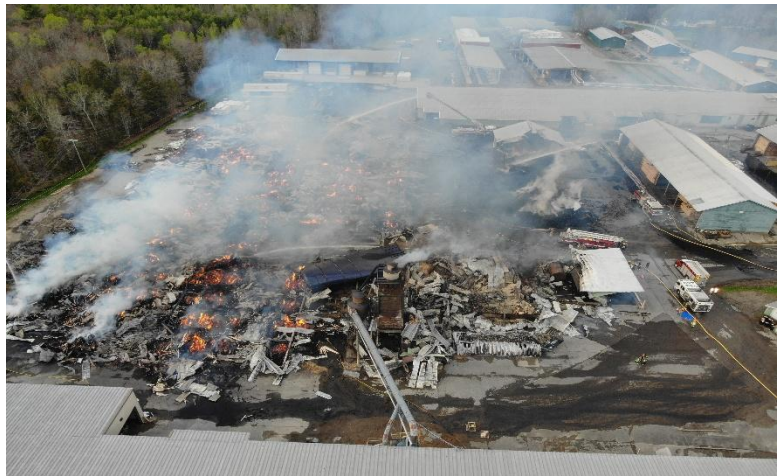
Image 1. Aerial view of incident from Side Bravo of incident silo, post-explosion. (Source: State Fire Marshal's Office)

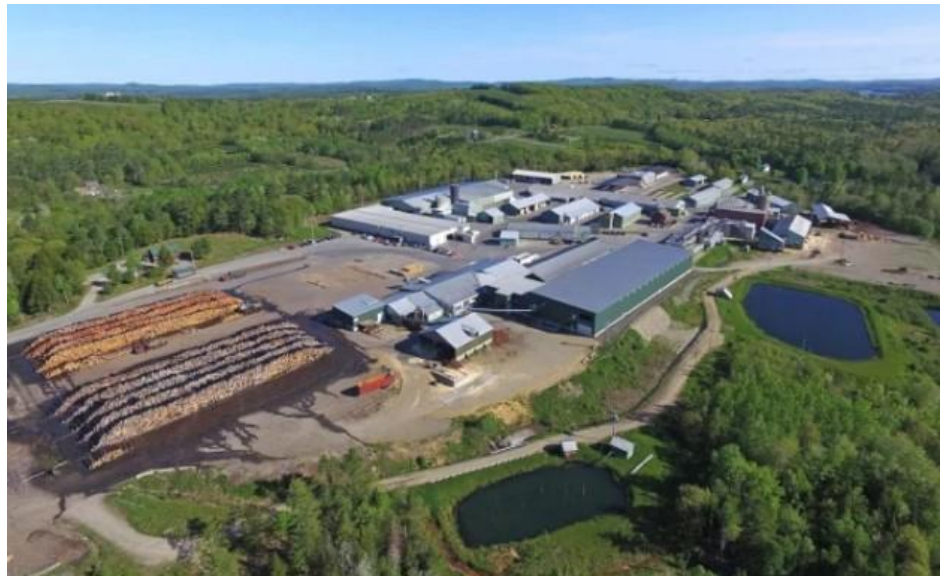
Image 2. Aerial view of lumber mill, pre-incident. (Source: Lumber mill)

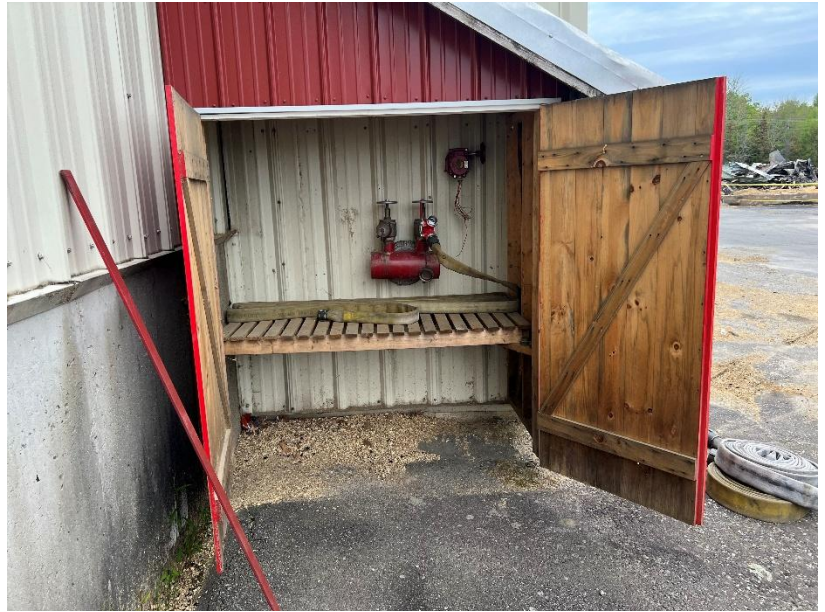
Image 4. Station containing hoseline for facility fire suppression, post-incident. (Source: NIOSH)

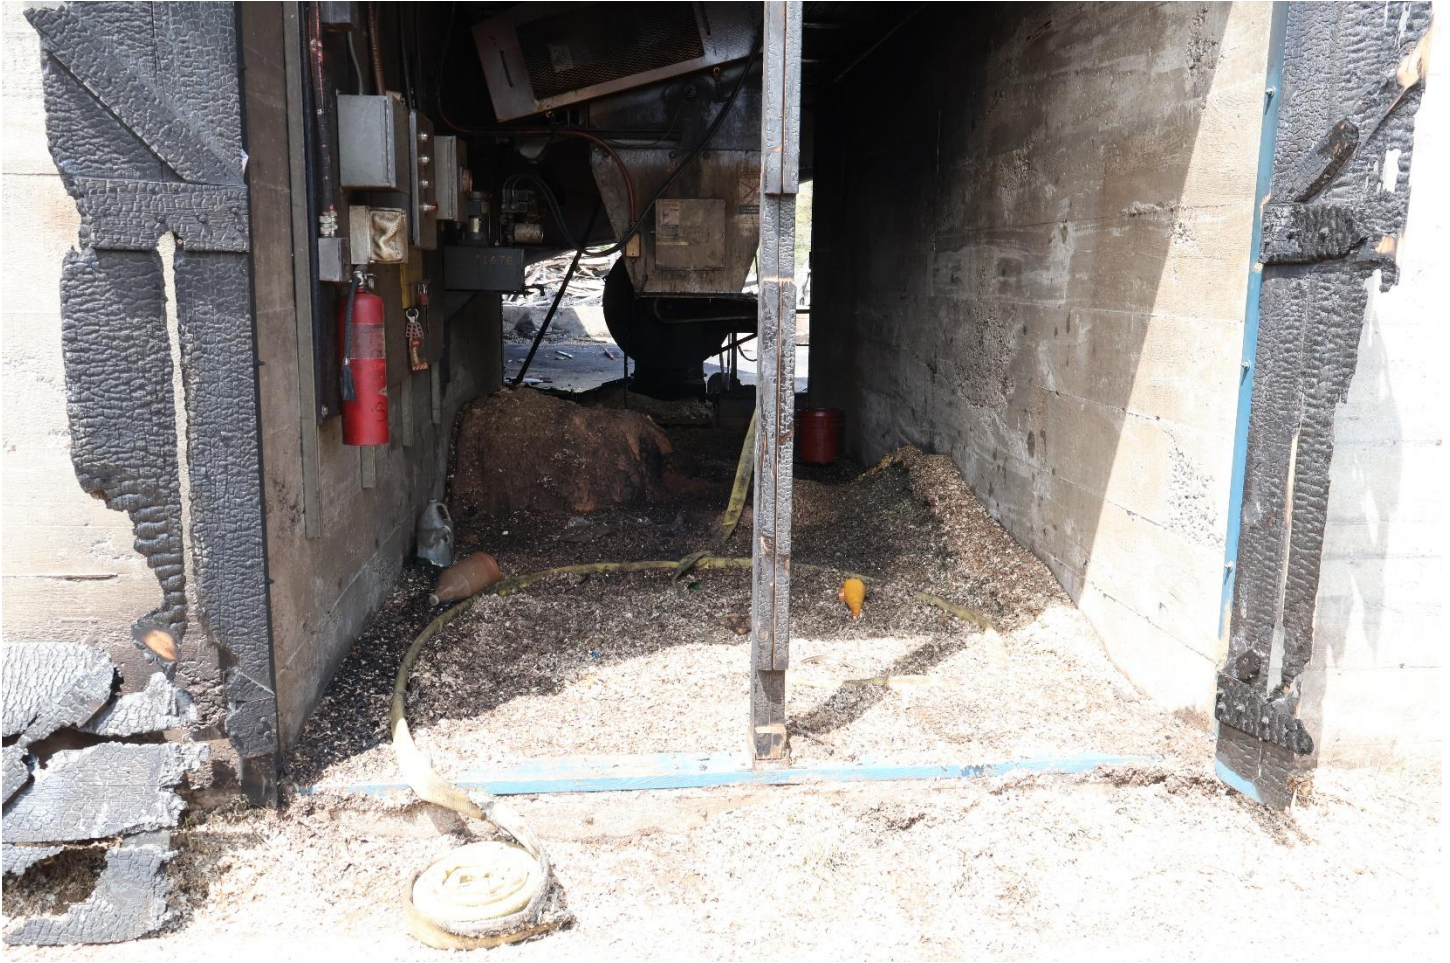
Image 6. View of room under the incident silo, Side Alpha, post-incident. (Source: State Fire Marshal's Office)

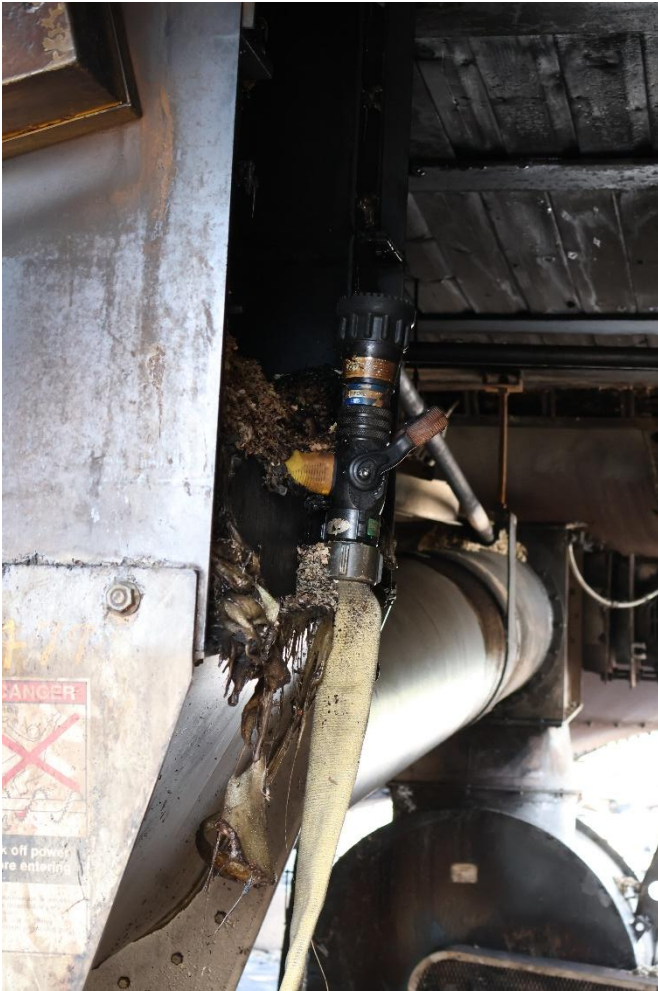
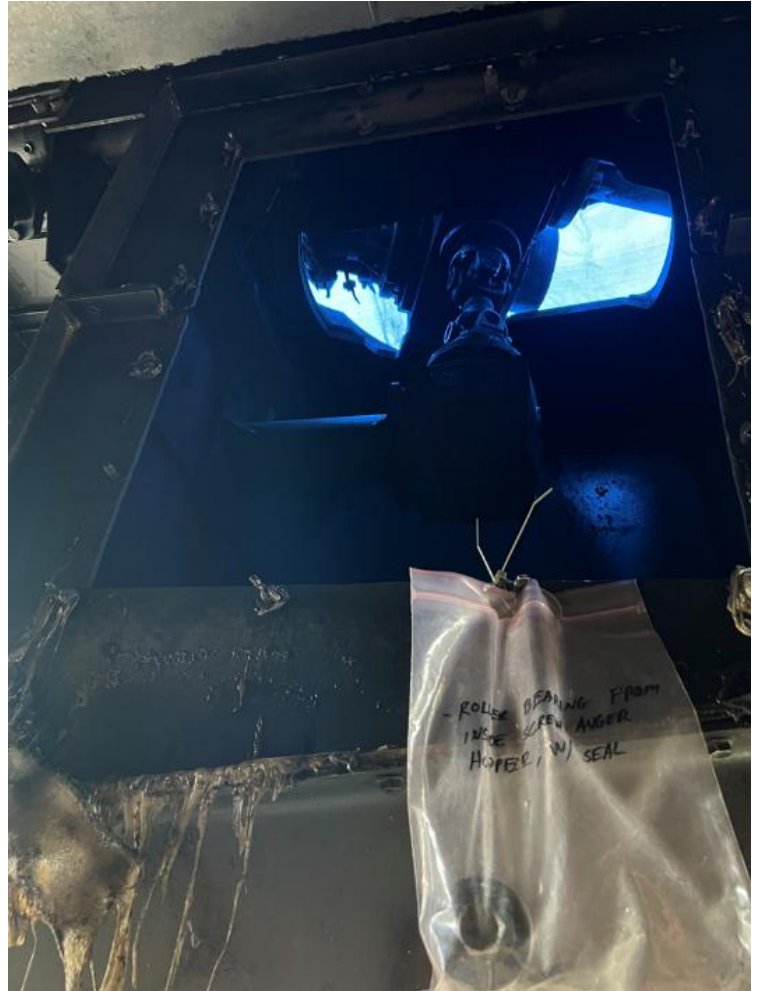
- Chief 70 returned and located the area described but noticed a portion of the panel had melted off. He placed the nozzle of the hoseline from Engine 40-2 in the opening and began to spray water through the 3 ft diameter hole into the base of the silo.

Image 7 and 8. View of nozzle in chute (left) and 3 ft diameter hole into base of silo (right), post-incident.  
(Sources: State Fire Marshal's Office and NIOSH)

| Contributing factor | Prevention action summary |
|---|---|
| 2. Fire suppression tactics for silo fires | Ensure firefighters choose the appropriate firefighting tactics for silo fires and never direct water or foam into an oxygen-limiting silo. |

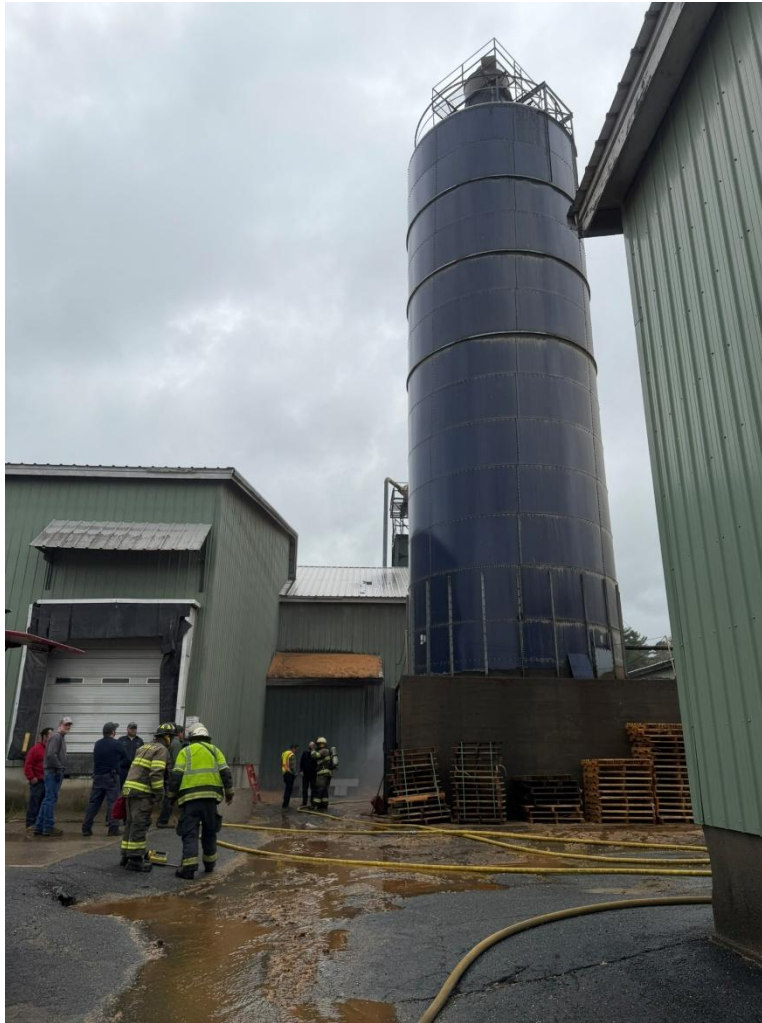
Image 9. View of operations at incident silo, Side Delta. (Source: Fire department)

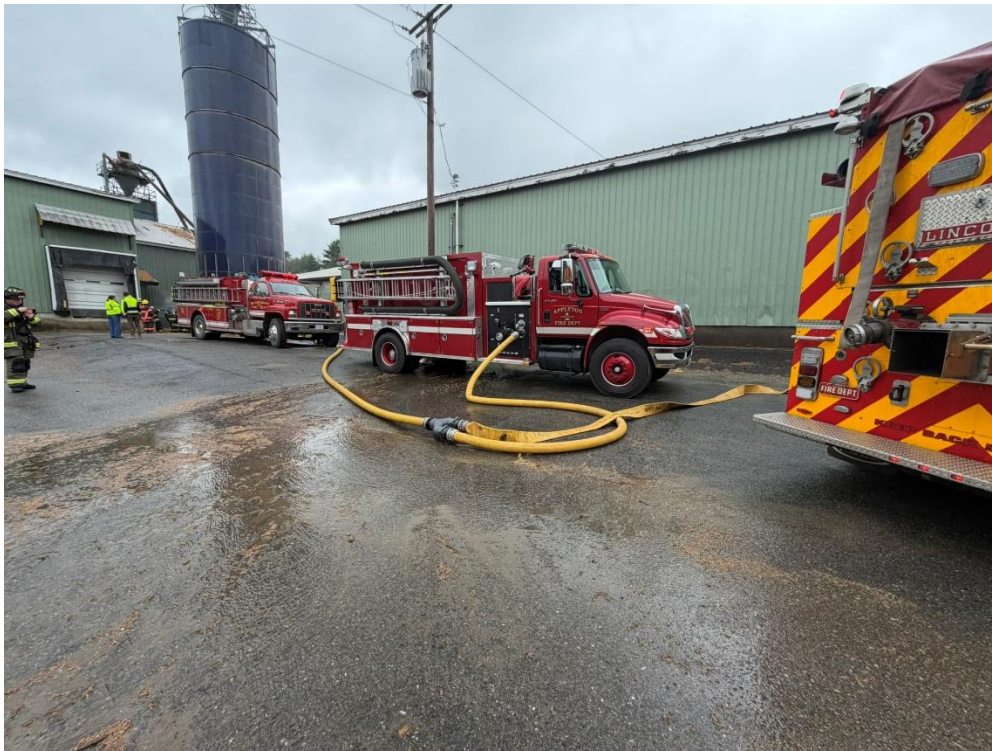
- Chief 40-1 (deceased firefighter) requested Engine 70-1 to connect to Engine 40-2 as a temporary water supply until a connection to a hydrant could be established.

Image 10. View of apparatus placement near incident silo with Engine 70-1 supplying Engine 40-2. (Source: Fire department)

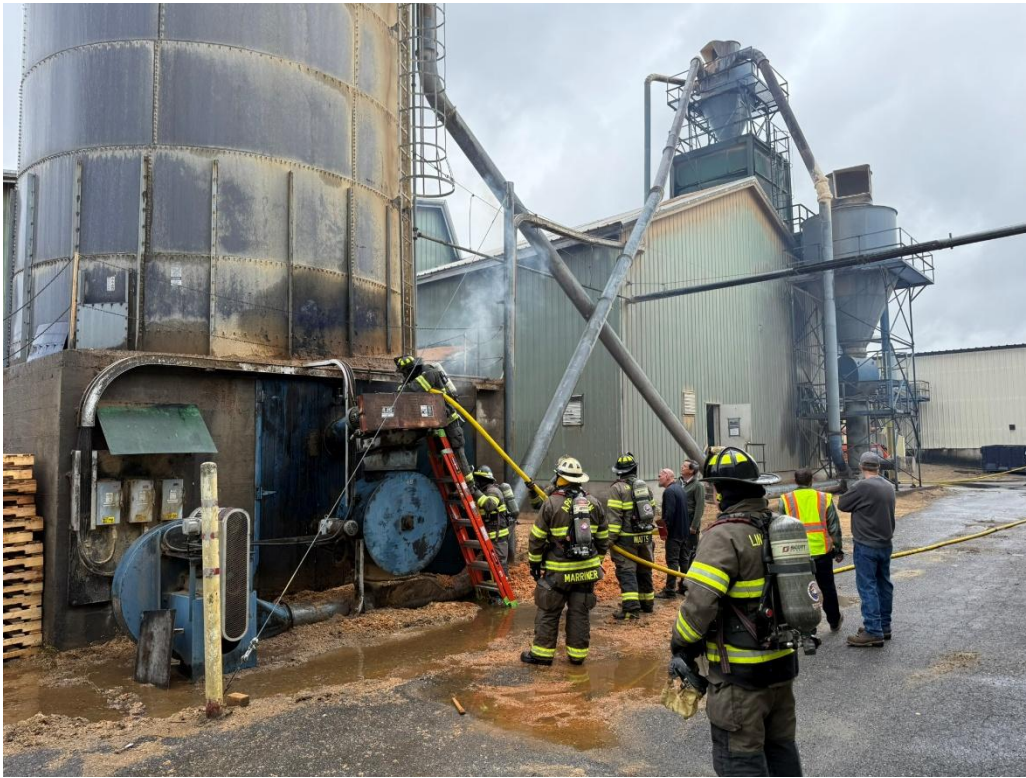
Image 11. Lieutenant 40 flowing water into the blower on Side Charlie. (Source: Fire department)

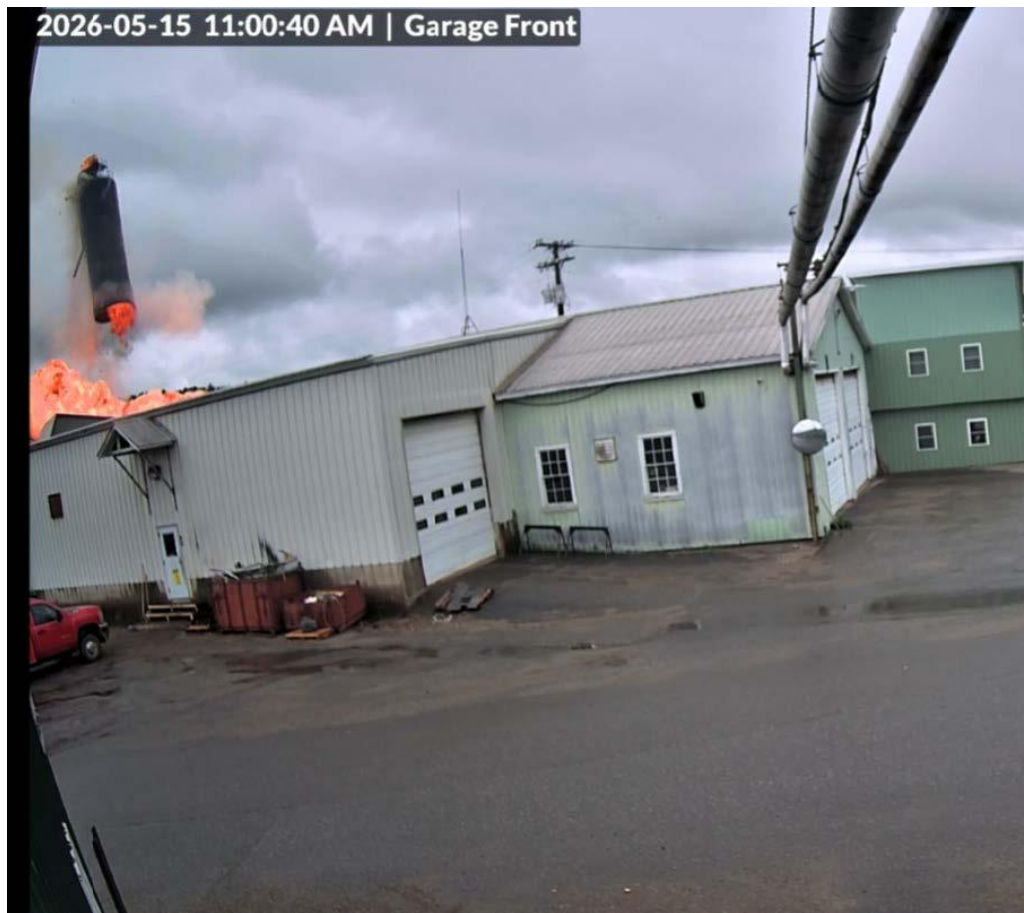
- Firefighters around the silo heard a “whoosh” noise as smoke began to quickly emanate from the air-material separator on the top of the silo.
- The silo launched into the air followed by a large plume of fire at the bottom as it rose.
- The explosion threw surrounding facility employees, firefighters, and EMS providers away in a blast of pressure and fire. The burning contents of the silo covered the area and those thrown by the blast.
- Tower 90-3 arrived on scene.

Image 12. Surveillance footage capturing moment the incident silo exploded. (Source: Lumber mill)

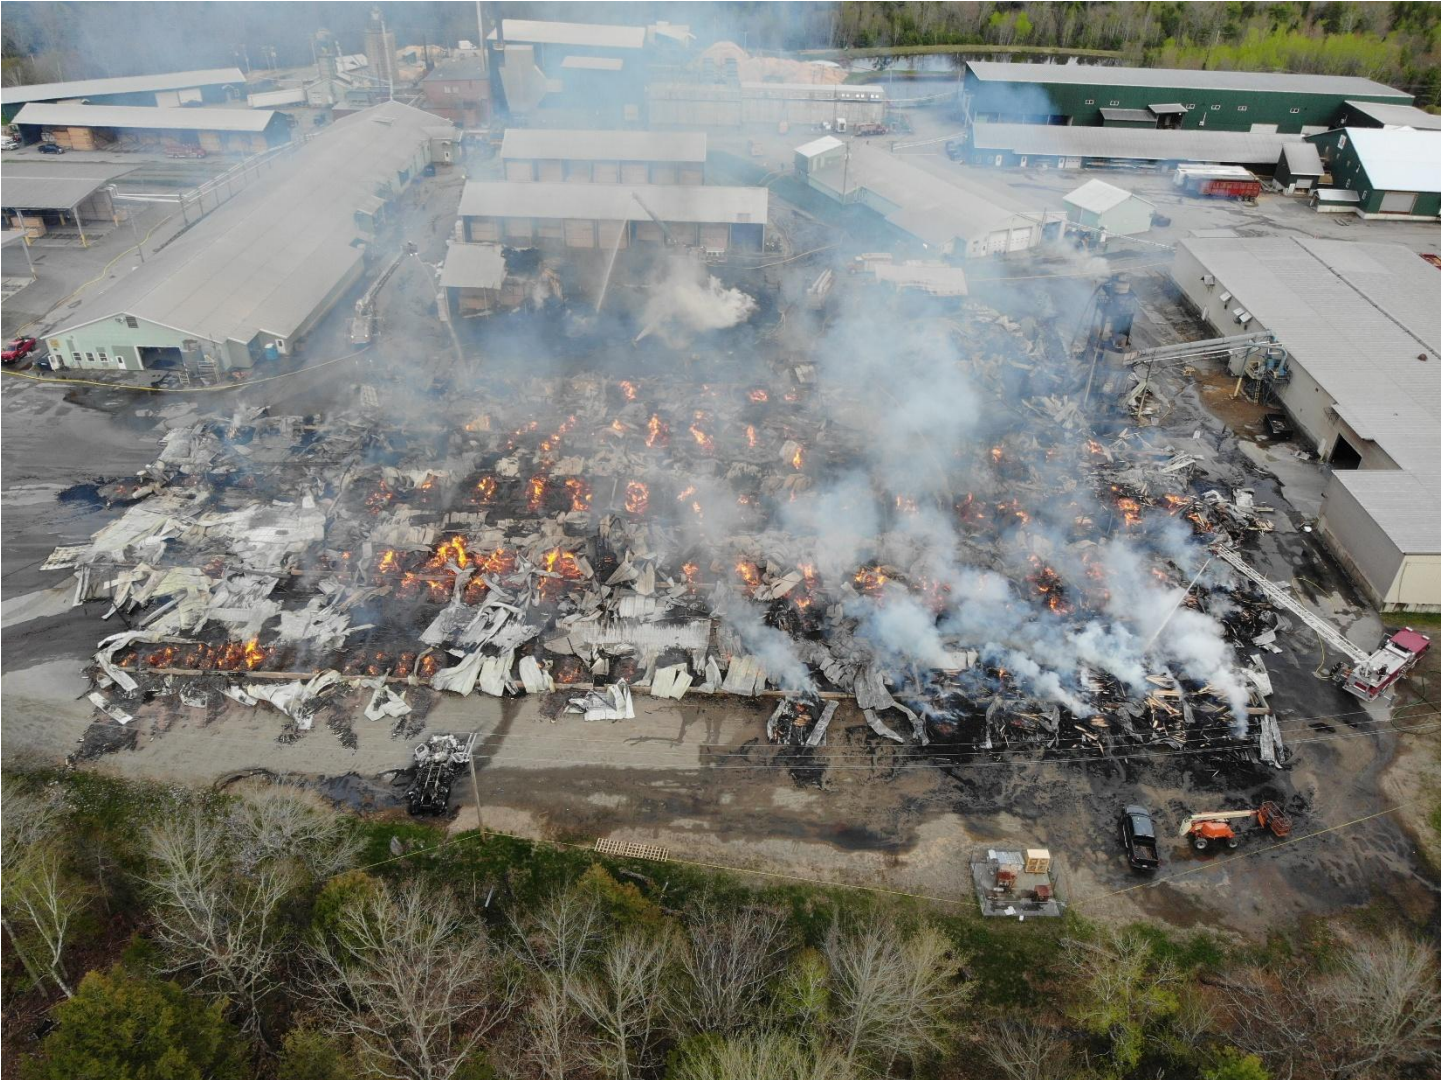
Image 13. View of defensive operations after explosion. (Source: State Fire Marshal's Office)

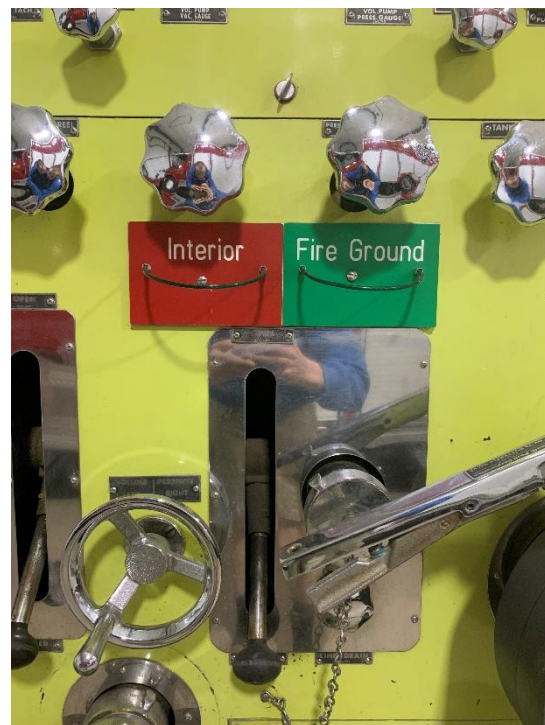
The fire departments in this incident utilize a tag system for accountability. Firefighters are trained to place their accountability tags on rings affixed to the pump panel of the first arriving apparatus. This personnel accountability system was not utilized at this incident. Multiple fire departments conducted station-specific personnel accountability checks following the explosion. Engine 30-2 firefighter was discovered to be missing two hours after the explosion when a full personnel accountability check was conducted by the State Fire Marshal's Office.

Image 14. Accountability rings on pump panel.  
(Source: Fire department)

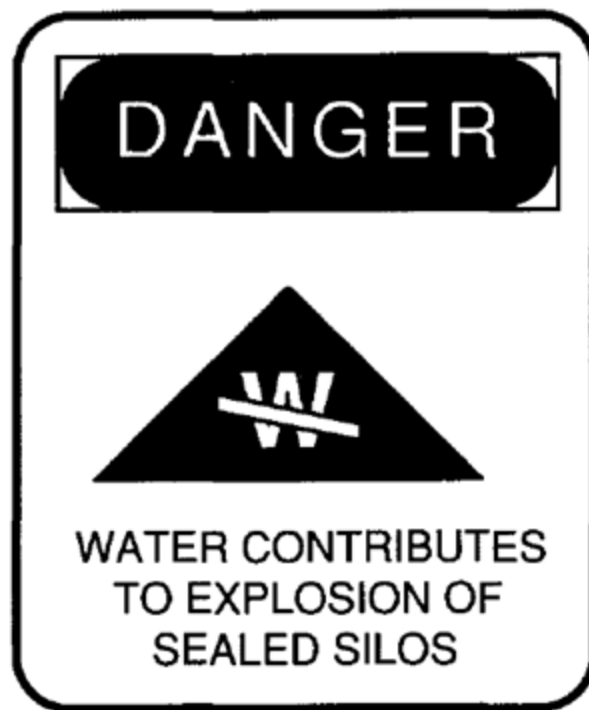
Warning labels have long been used to increase the safety of workplaces. These are used as a method of supplementing design solutions focused on removing or reducing hazards [Lehto and Clark 1991]. For example, OSHA regulations require employers to install signs or labels for confined spaces that can be perceived and understood by all employees [OSHA 1994]. These do not eliminate the hazard but make employees aware that the hazard exists to inform their decision making. Voluntary consensus standard-setting organizations should update relevant codes and standards to require warning labels about combustible dust hazards to support dust hazard analysis practices. As in previous NIOSH recommendations, these can list appropriate fire suppression tactics.

Figure 1. Example oxygen-limiting silo warning label. (Source: NIOSH)

**Prevention action** · Voluntary consensus standard-setting organizations, such as the NFPA and International Code Council, should update relevant codes and standards to require hazard labeling for bulk storage enclosures containing combustible dust.
