Evaluation of Cut-resistant Sleeves and Fiberglass Fiber Shedding at a Steel Mill

Report No. 2011-0113-3179
May 2013

Highlights of this Evaluation

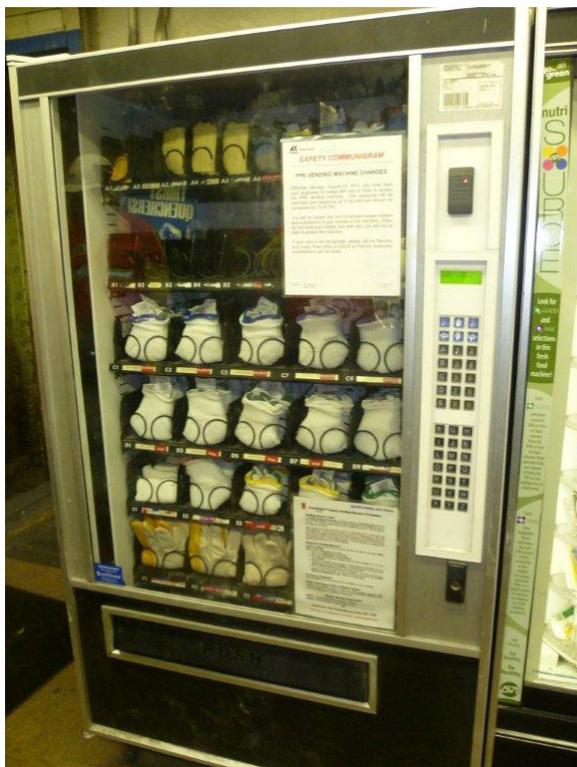
Figure 1. Dispenser for new gloves and cut-resistant sleeves.

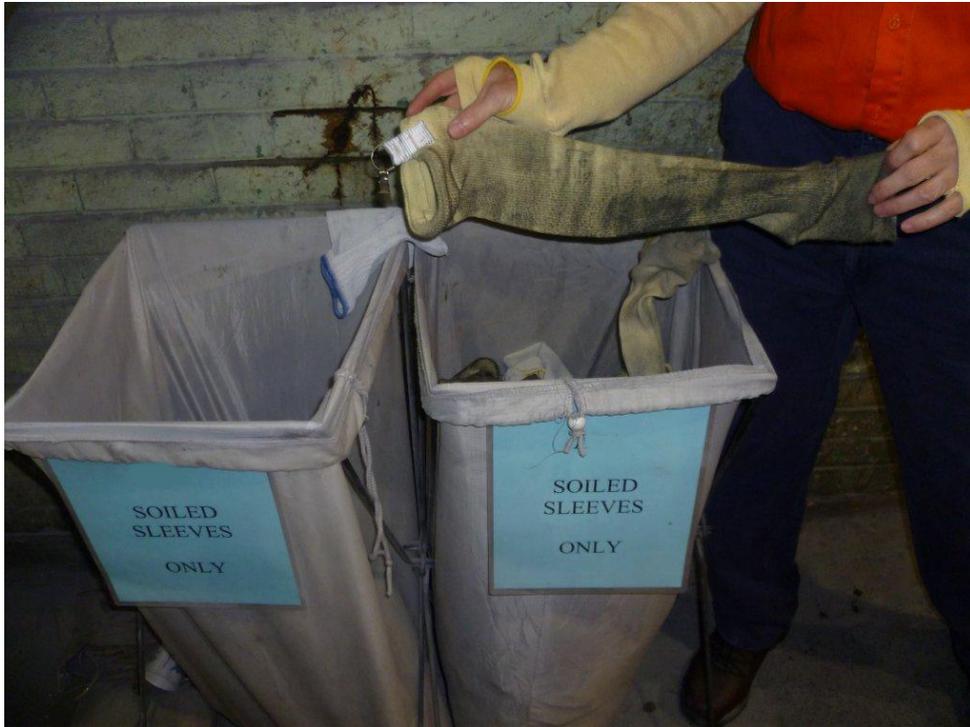
Figure 2. Bins where soiled cut-resistant sleeves were collected near the production area.

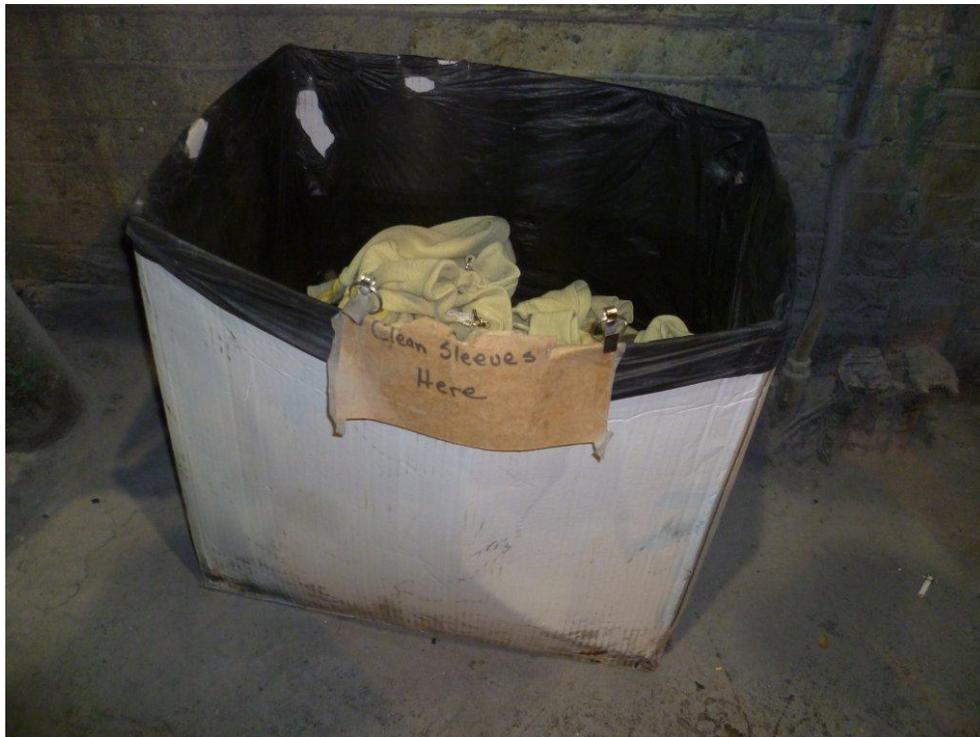
to the manufacturer's recommendations. Laundered sleeves were available in various locations of the steel mill (Figure 3). From our observations and from talking to the employer and to employees, we learned that sleeves were laundered without tracking the number of cleaning cycles and that some employees laundered their sleeves at home. Some of these laundered sleeves had visible holes and stains, suggesting that the sleeves were not adequately inspected and taken out of service. We observed that some employee locker rooms did not provide easy employee access to either new or laundered sleeves. The employer said that they were planning to increase the number of dispensers throughout the steel mill and keep track of the number of sleeves an employee used.

Figure 3. Box where laundered sleeves were stored near the production area.

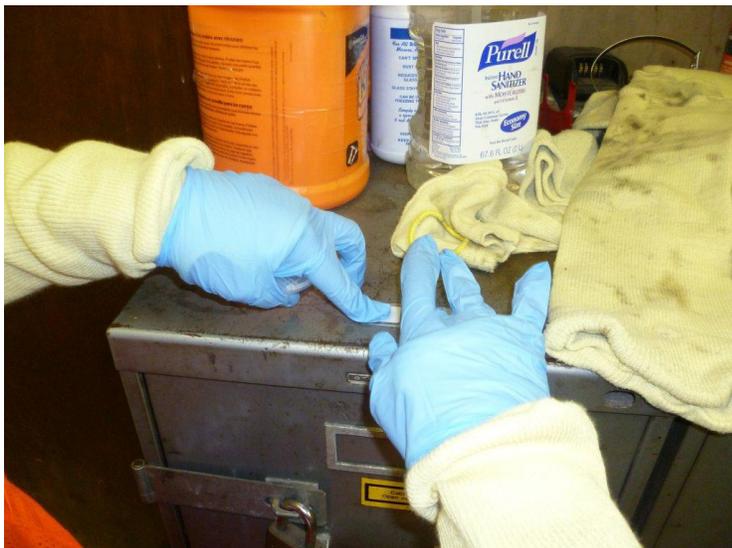
Figure A1. Tape sampling of a surface where cut-resistant sleeves were stored.

following manufacturer instructions [SKC 2011]. The protective liner of the slide was peeled off to expose the adhesive. Then the slide was placed sticky side down on the surface to be sampled while we gently pressed down to ensure contact (Figure A1). The slide was carefully removed, placed back in the slide mailer, and labeled. Figure A2 shows a tape being used to sample on an employee's uniform sleeve after he had removed the cut-resistant sleeves.

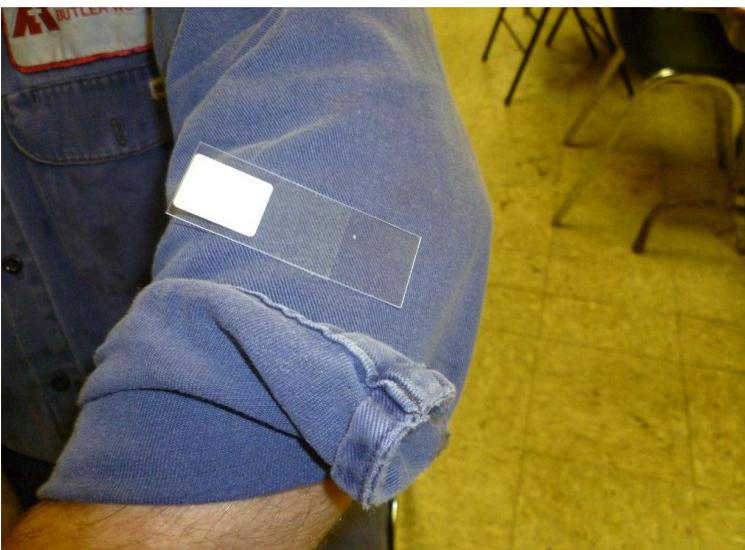
Figure A2. Tape sampling on employee's uniform sleeves after removing the cut-resistant sleeve.

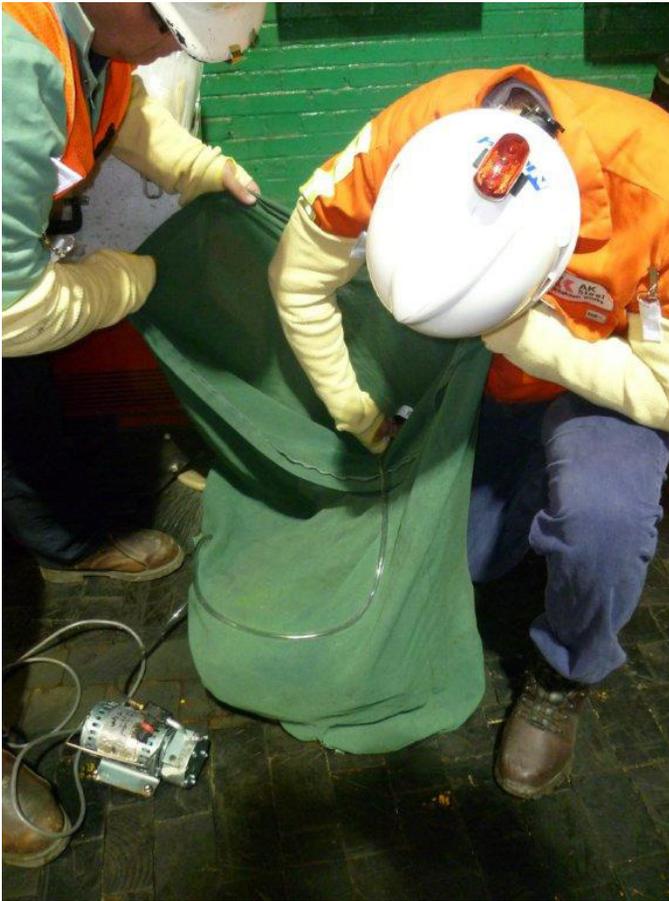
Figure A3. Vacuum sampling of the surface of a bag that stored new cut-resistant sleeves.

A surface was selected, and 100-square-centimeter disposable cardboard templates were used when possible for consistency. When a guide was not possible because of an irregular shape, vacuuming for 1 minute (for an approximate volume of 15 liters of air) was performed. The cassette was placed at an angle with the surface to avoid a pump fault. The cassette was used in an overlapping “S” pattern to vacuum the entire surface with horizontal strokes. The same area was vacuumed again using vertical S-strokes and diagonal S-strokes. Figures A3 and A4 show vacuum sampling of different surfaces.

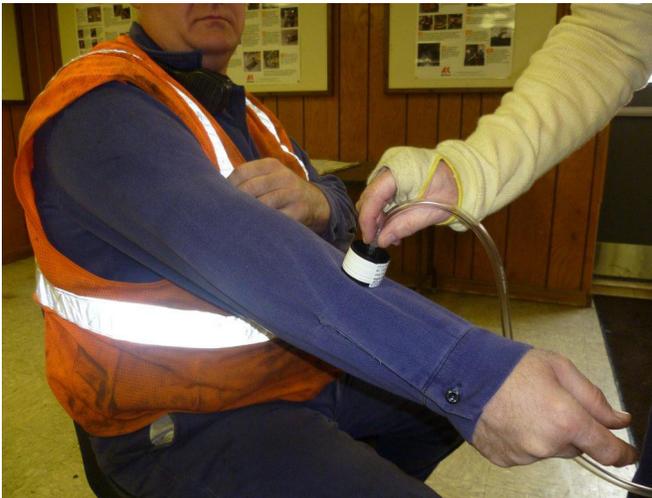
Figure A4. Vacuum sampling on an employee's uniform sleeve after removing the cut-resistant sleeve.

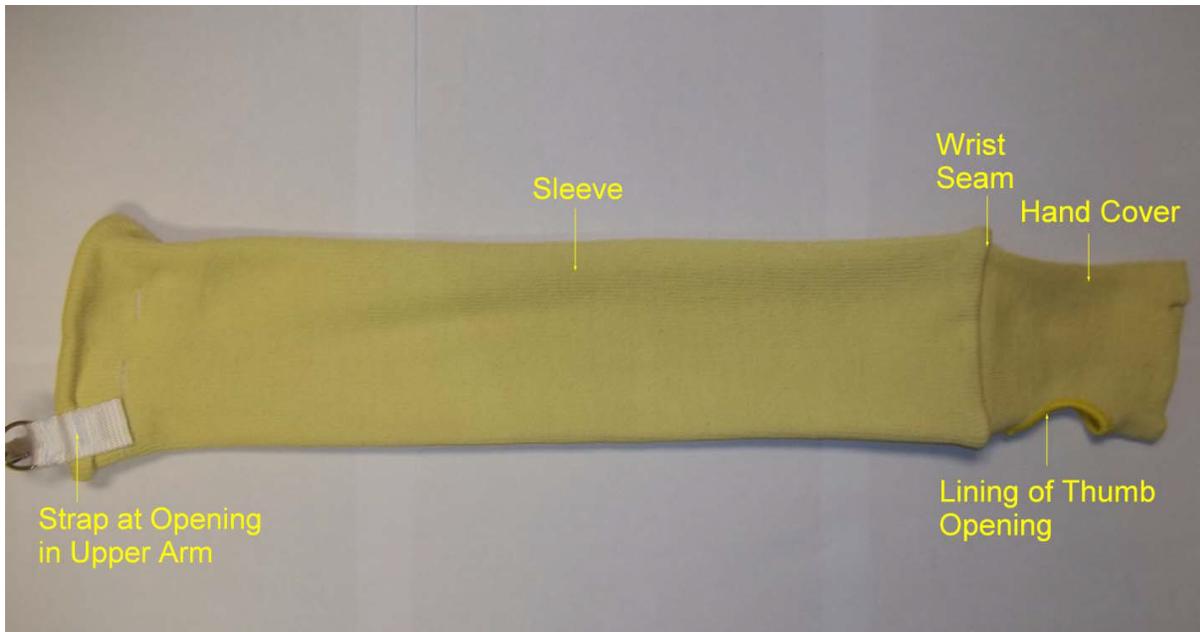
New cut-resistant sleeve

Figure C1. Photomicrograph showing outside of new sleeve.

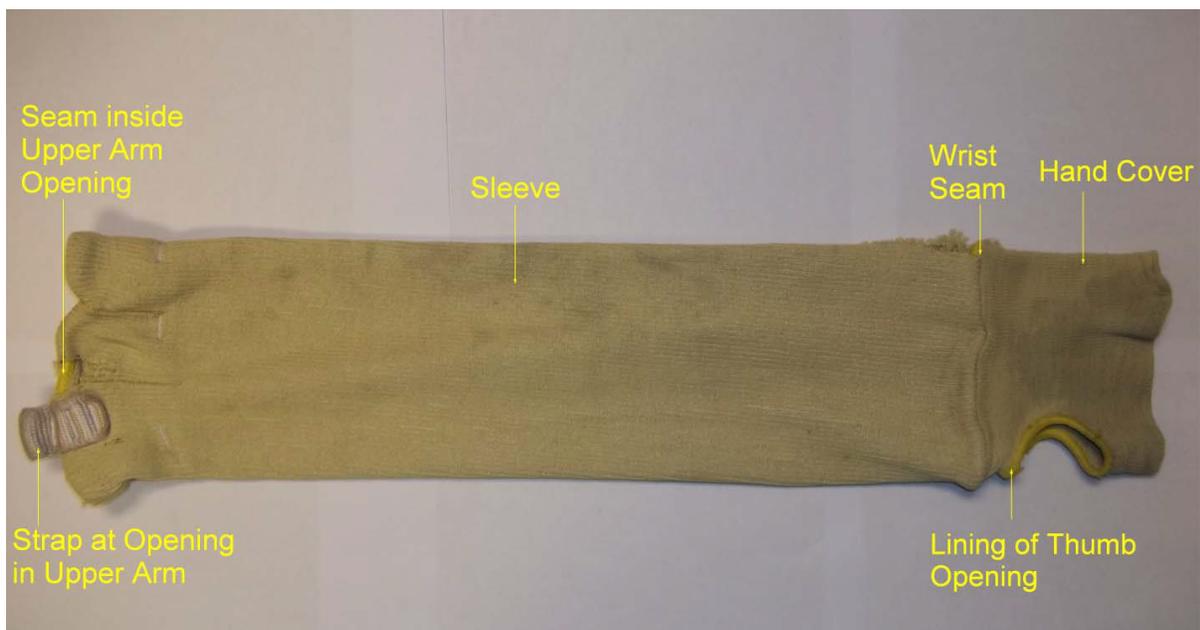
Laundered cut-resistant sleeve

Figure C2. Photomicrograph showing outside of laundered sleeve.

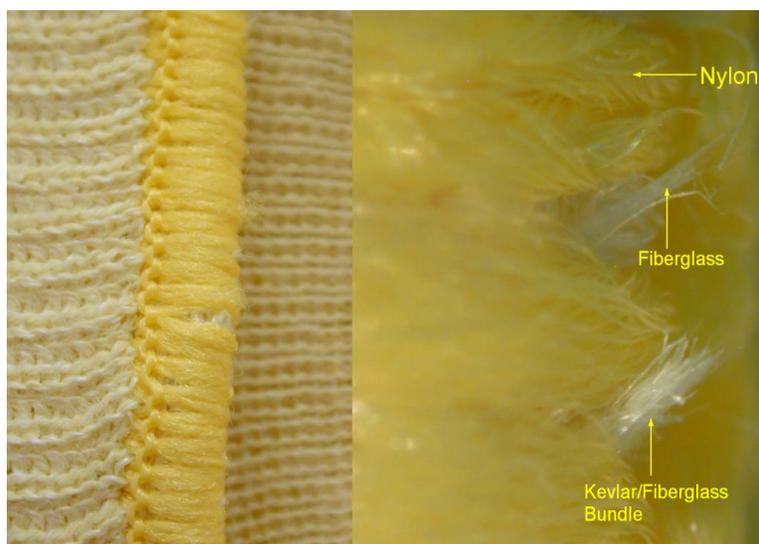
New sleeve wrist seam

Regardless of whether the cut-resistant sleeve was new or laundered, some of the Kevlar and fiberglass bundles in the sleeves were frayed and broken in many areas (Figures C3–C8).

Figure C3. Photomicrographs showing wrist seam. RIGHT: Showing Kevlar and fiberglass coming through nylon at 20X.

The yellow seam at the wrist was composed of nylon and joined the sleeve and hand cover materials from the inside. Even though the seam did not show signs of wear, Kevlar and broken fiberglass bundles were observed coming through the seam (Figure C3).

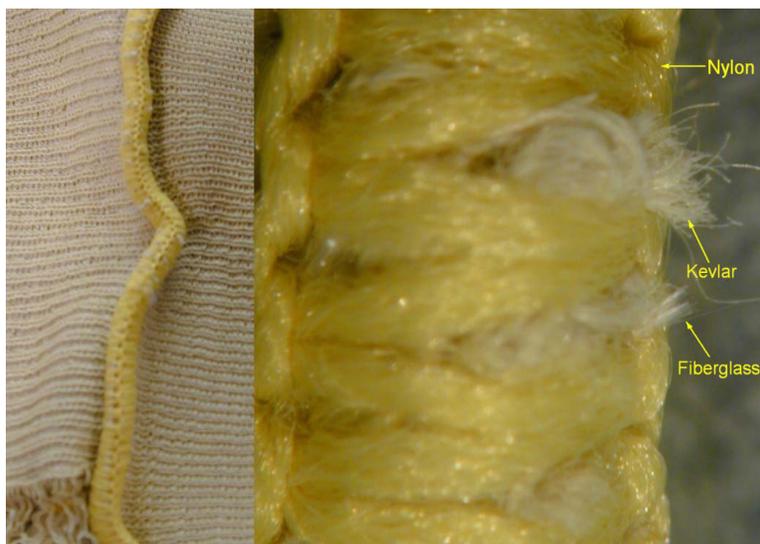
Laundered sleeve wrist seam

Figure C4. Photomicrographs showing a laundered wrist seam. RIGHT: Showing Kevlar and broken fiberglass bundles coming through nylon seam at 20X.

This seam was composed of nylon and joined the sleeve and hand cover materials from the inside. The seam was worn down, and the nylon bundles were frayed. Kevlar and fiberglass from the sleeve and hand cover were coming through the seam where it was worn down (Figure C4). No fiberglass was observed in one of the samples.

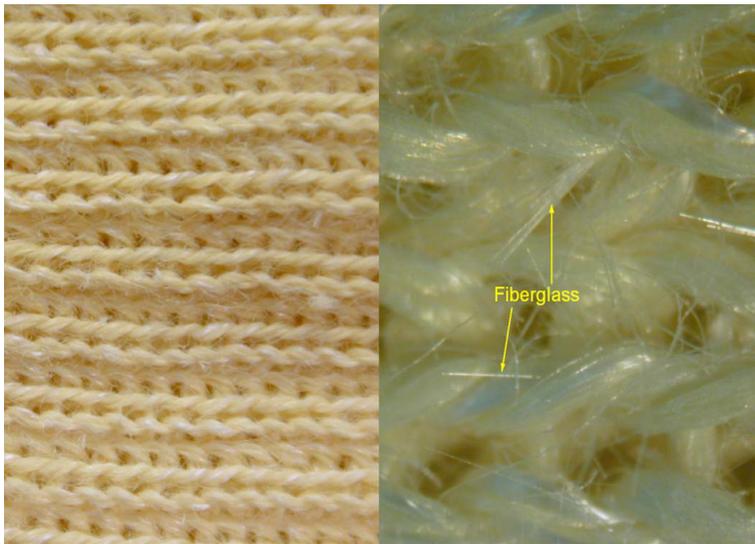
New sleeve

Figure C5. Photomicrographs showing a new sleeve. RIGHT: Showing broken fiberglass bundles at 20X.

The new sleeve was composed of fiberglass and Kevlar bundles woven together. The material did not show signs of wear or tearing. Individual fibers and broken bundles of fiberglass were observed protruding from both the outside and inside of the sleeve (Figure C5). Blue cellulose fibers were stuck to the inside surface of the material of two of the samples.

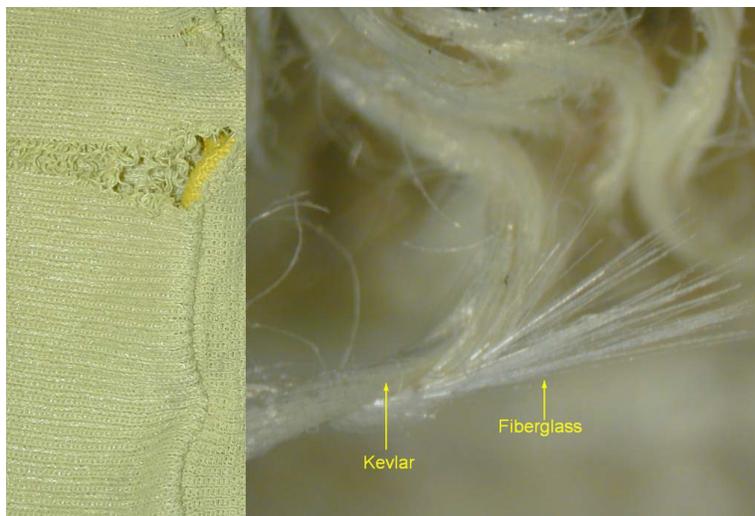
Laundered sleeve

Figure C6. Photomicrographs showing tear in sleeve. RIGHT: Showing broken fiberglass bundles in tear at 15X.

The laundered sleeve was composed of fiberglass and Kevlar bundles woven together. On the inside and outside of the sleeve, where the material did not appear to be torn, individual fibers and broken fiberglass bundles were observed protruding from the sleeve. In the areas where the material was torn (Figure C6), the Kevlar bundles appeared to be frayed. Blue cellulose fibers were stuck to the inside surface of the material in one of the samples. Gray paint was observed on one sleeve sample.

-
5. Keep track of the number of laundry cycles for the sleeves and follow manufacturer's guidelines on replacement.
 6. Train employees in proper care, maintenance, useful life, and disposal of sleeves. Employees should inspect sleeves before wearing to make sure they are not torn or damaged and should notify their supervisor of the need to replace sleeves.

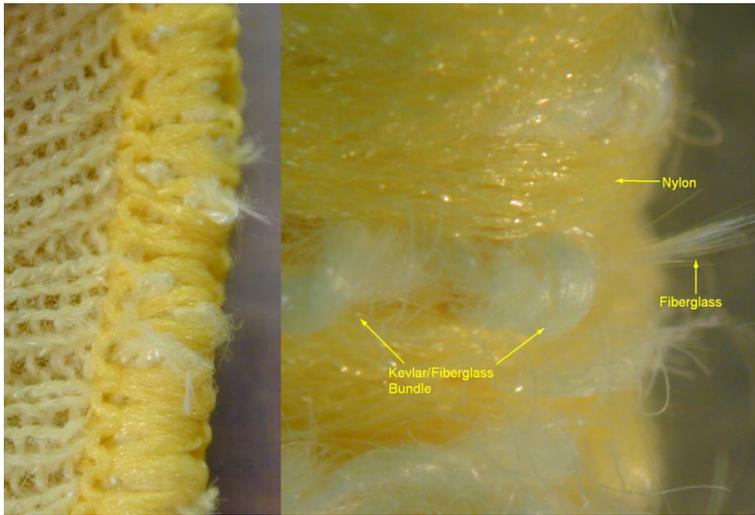
New seam inside upper arm opening

Figure C7. Photomicrographs showing seam inside upper arm opening. RIGHT: Showing Kevlar and fiberglass coming through nylon at 20X.

This seam was composed of nylon, and joined the sleeve and cuff materials. Even though the seam was not exposed and did not show signs of wear, Kevlar and broken fiberglass bundles were coming through the seam from the sleeve (Figure C7). Blue cellulose fibers were also observed in one of the samples.

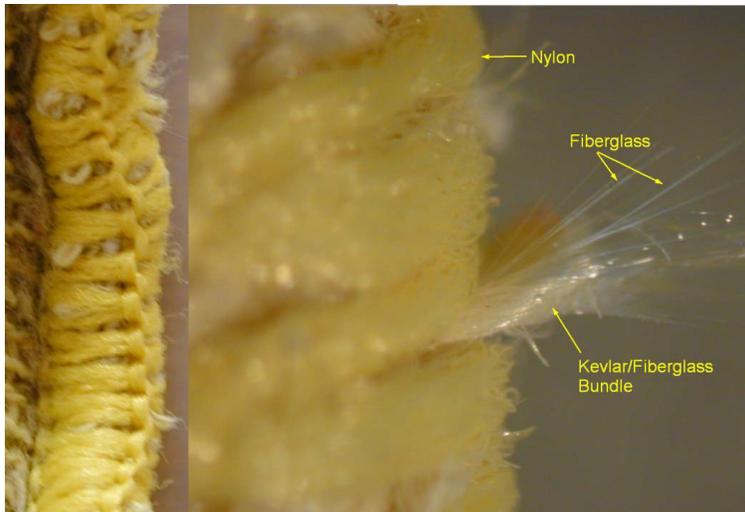
Laundered seam inside upper arm opening

Figure C8. Photomicrographs showing seam inside upper arm opening. RIGHT: Showing Kevlar and fiberglass coming through nylon at 20X.

The yellow seam inside the upper arm opening was composed of nylon and joined the sleeve and cuff materials together. The seam was only exposed in areas where the sleeve had been torn. Kevlar and fiberglass from the sleeve were coming through the seam from the sleeve and cuff materials (Figure C8).

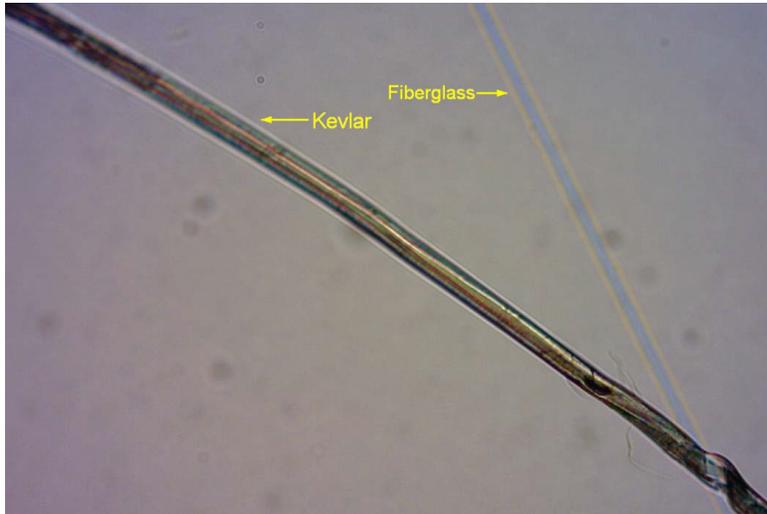
We analyzed the size and other characteristics of these fibers to determine if they posed a health hazard. Fibers found on surfaces, shirt sleeves, and skin were of the same material and width as those from the sleeves. Kevlar fibers had an average width of 20 μm , and fiberglass had an average width of 10 μm . The fibers had variable lengths. We did not find glass wool

Figure C9. Photomicrograph showing Kevlar and fiberglass from sleeve.

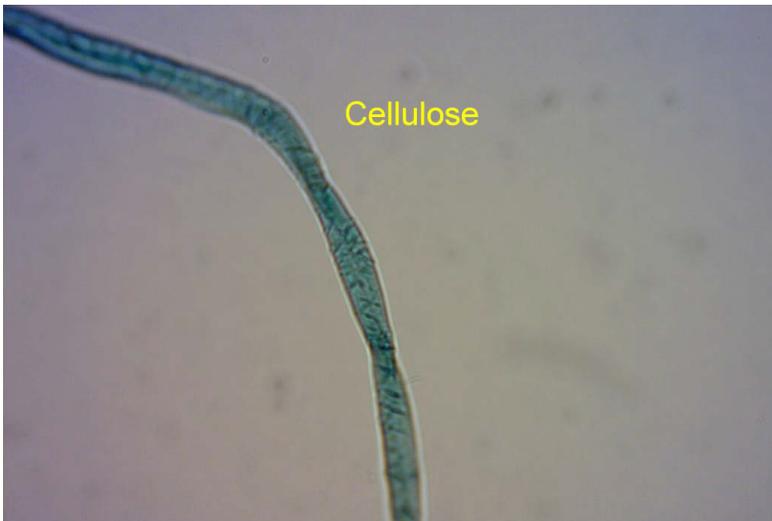
Figure C10. Photomicrograph showing cellulose from sleeve.

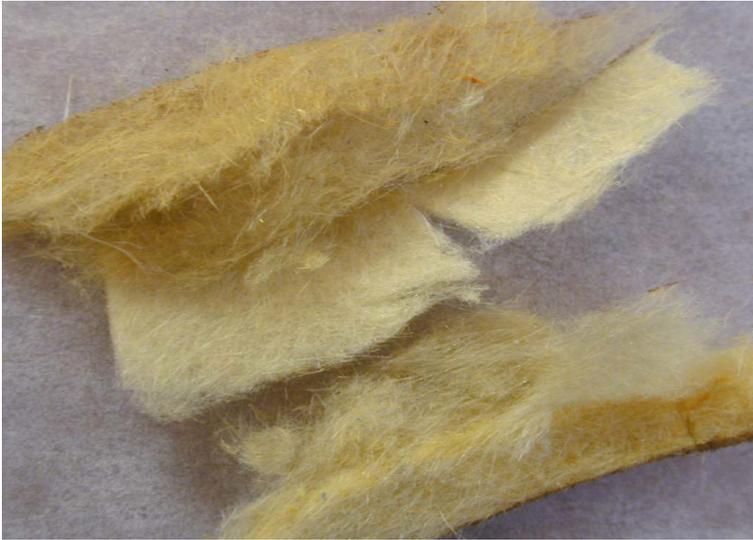
Yellow insulation

Other sources of fiber in the steel mill were yellow insulation composed of 100% glass wool and white fibrous material composed of 99% Kaowool and 1% cellulose fiber. Photomicrographs of the fiber analysis for the yellow and white insulation are included in Figures C11–C14 (Appendix C). Glass wool and Kaowool fibers were not found in any of the sleeve or surface samples.

Figure C11. Photomicrograph of yellow insulation.

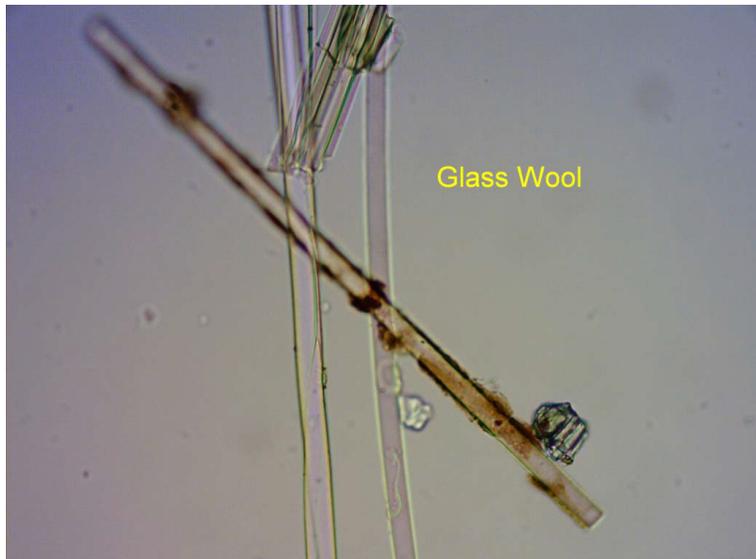
Figure C12. Photomicrograph of glass wool from yellow insulation.

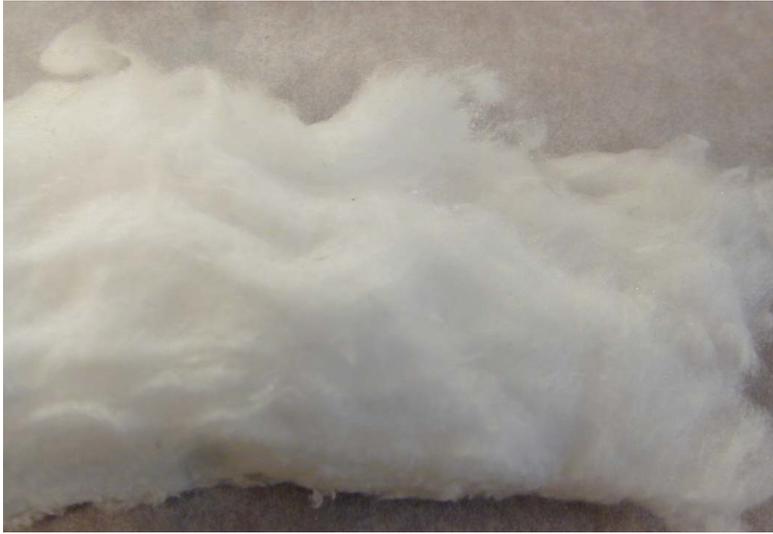
White fibrous material

Figure C13. Photomicrograph of white Kaowool.

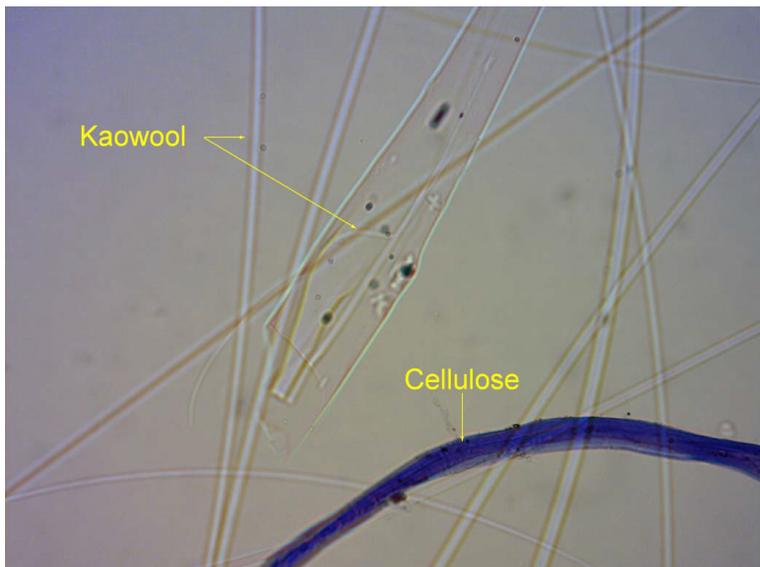
Figure C14. Photomicrograph of Kaowool and cellulose from white fibrous material.
