Evaluation of Environmental Controls at a Homeless Shelter (City Rescue Mission–New Life Inn) Associated with a Tuberculosis Outbreak – Florida

Health Hazard
Evaluation Program

Report No. 2012-0155-3180
July 2013

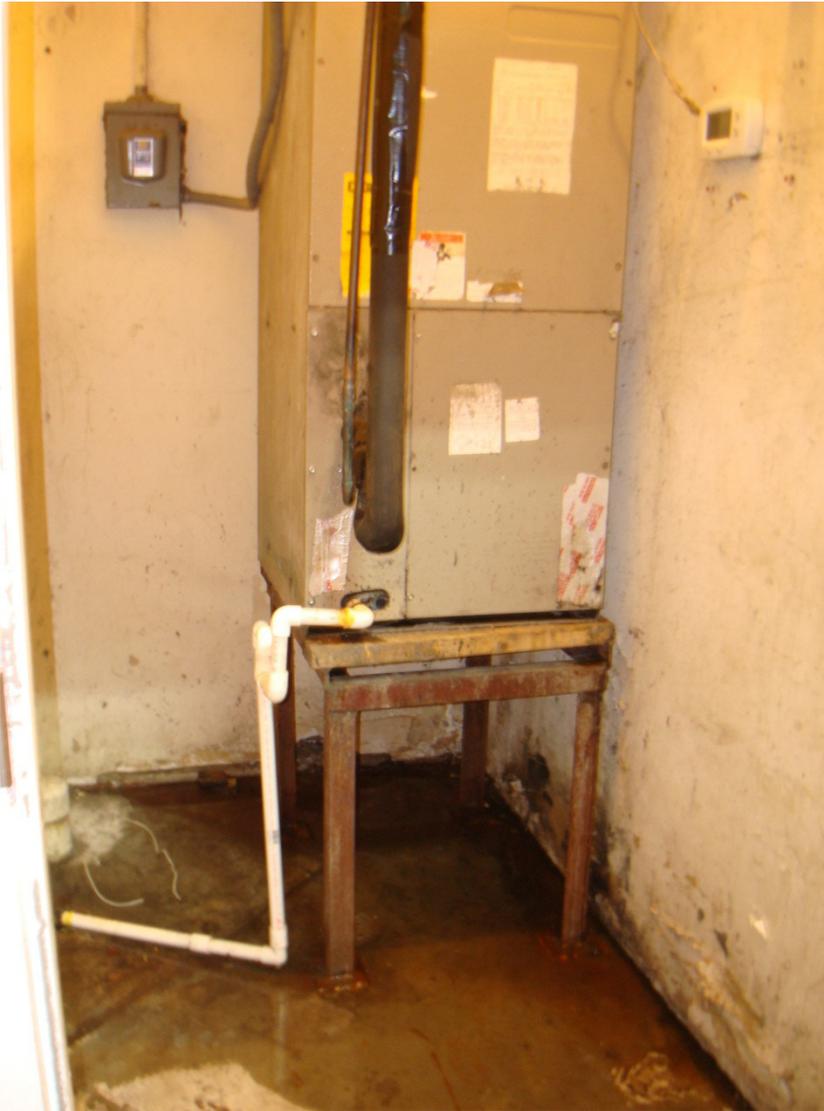
With the exception of the Annex, the mechanical spaces housing the AHUs were clear and free of clutter. All AHU air filters were changed just prior to the NIOSH visit. As shown in Table 1, AHU-1 did not have a filter installed in the unit itself. Four other AHUs had filter sizes/configurations that differed from manufacturers' recommendations. While these filters provided some filtration, the level was uncertain as the deviation from intended design provides ample opportunity for filter failure and bypass. On the day of our visit, all of the AHUs were operational and capable of maintaining temperature set points and air flow. However, there were some issues with controlling condensate from the cooling coils. AHU-1 on the first floor was dripping substantial amounts of condensate onto the floor of the mechanical room (Figure 1). Similarly, AHU-6 on the second floor was dripping condensate inside the mechanical room, including inside the return air ductwork of the AHU (Figure 2). Finally, the drain pan on AHU-8 (third floor) was completely full of water and was overflowing into the mechanical space (Figure 3). The excess moisture resulting from these condensate leaks is a recognized contributor to the development of microbial growth of public health concern [NIOSH 2013]. Proper slope of mechanical room floors, condensate pans, and clean unobstructed drain lines that route condensate into mechanical room floor drains should eliminate these moisture accumulation problems.

Figure 1. AHU-1 in the central mechanical room on the first floor of the shelter. The photograph shows standing water and apparent microbial growth due to condensate from the AHU leaking onto the floor of the mechanical room.

- Determine and fix the cause of condensate leaks with AHU-1, AHU-6, and AHU-8. Develop a monitoring strategy to prevent further occurrence of condensate buildup within the mechanical rooms.

- After the condensate issue in AHU-1 is resolved, install a proper filter in that unit, which serves the registration/lobby area of the first floor. The filter through the door into the mechanical room housing AHU-1 can stay in place to provide additional air filtration if desired, but a filter is needed in the AHU itself to protect against aerosols generated within or leaking into the mechanical space.

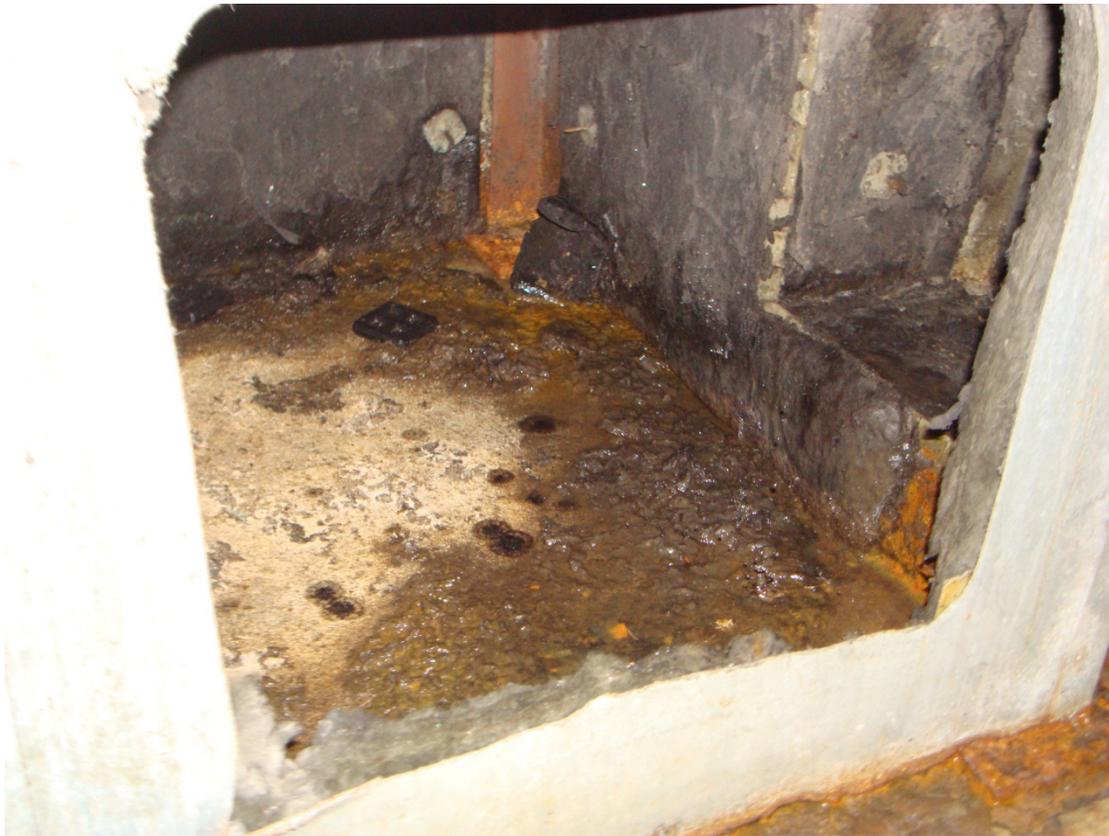
Figure 2. AHU-6 in the southeast corner mechanical room on the second floor of the shelter. The photograph shows condensate and debris in the return air plenum under the AHU.

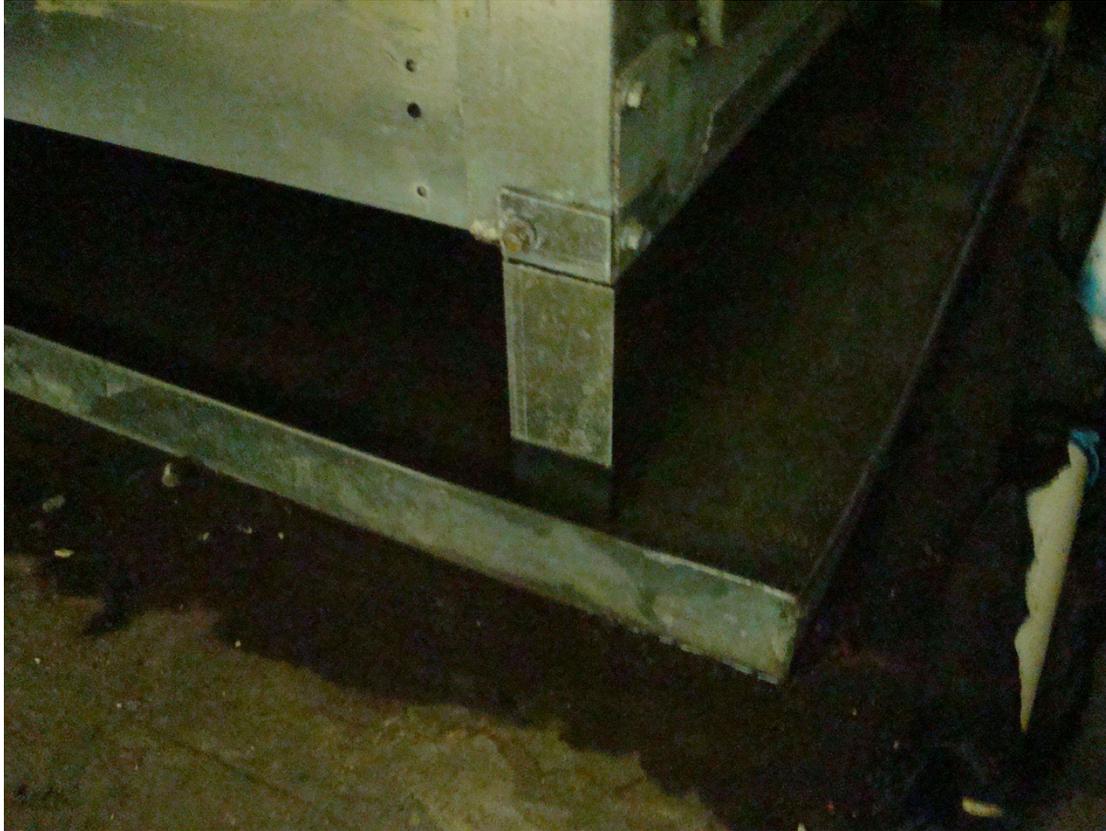
Figure 3. AHU-8 in the southeast corner mechanical room on the third floor of the shelter. The photograph shows a drain pan overflowing with condensate, which is covering the floor of the mechanical room.
