# Evaluation of Crystalline Silica Exposure during Fabrication of Natural and Engineered Stone Countertops

Health Hazard  
Evaluation Program

HHE Report No. 2014-0215-3250  
March 2016

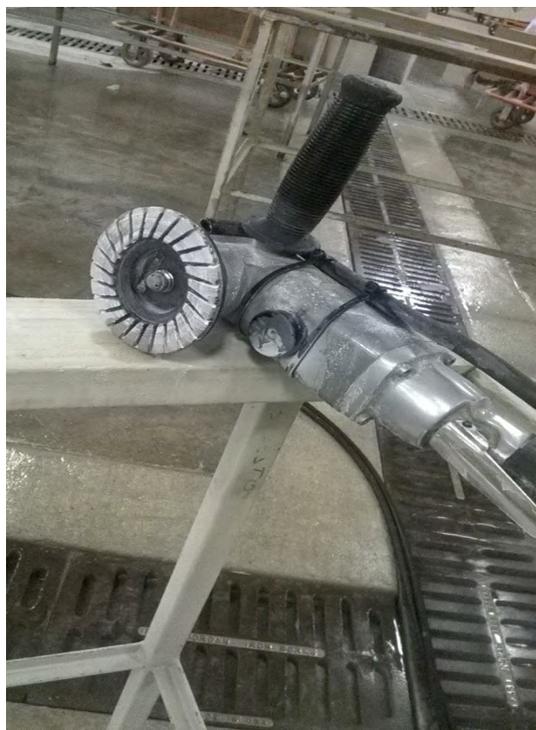
1). The water lines connected to the hand tools were equipped with a control knob that allowed the user to adjust the amount of water flowing to the tool. Some employees used higher water flow rates than others. We saw no dry cutting in the facility.

Figure 1. Photo of a pneumatic wet grinder equipped with a diamond cup wheel and a water spray used in the polishing area. Photo by NIOSH.

- Use local exhaust ventilation for cutting, grinding, and polishing tasks. Do this in addition to the wet methods already in use. Use a dust collector and enclosure that

captures silica when using the pneumatic grinders with diamond cup wheels.

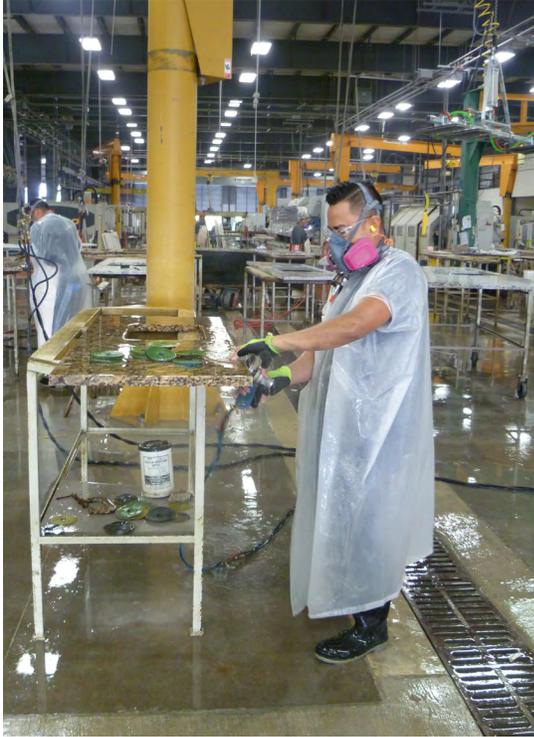
The polishers and grinders used similar-looking hand tools, with the major differences being the type of disc that was used and the speed at which they were run. The polishers used resin bonded discs that ran at about 4,500 RPM, while the grinders used diamond cup wheels that ran at about 7,000 RPM. Figure 2 depicts a worker using one of the hand polishing tools.

Figure 2. Employee using a hand polishing tool outfitted with a water spray. Photo by NIOSH.

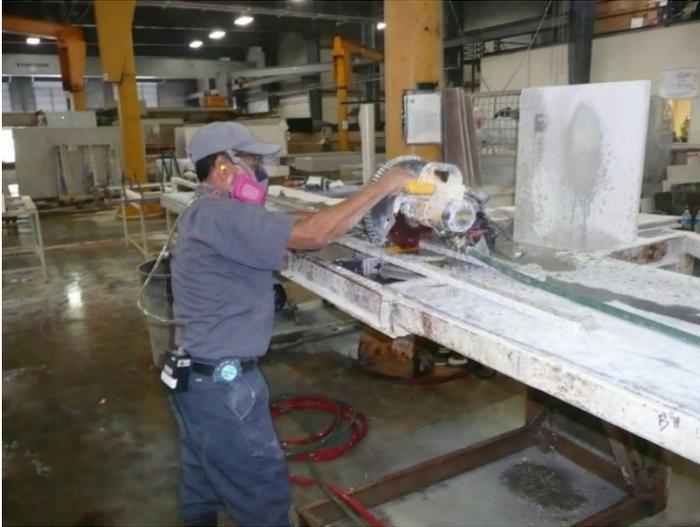
Figure 3. Photo of a lamination employee making a cut with a miter saw. Photo by NIOSH.

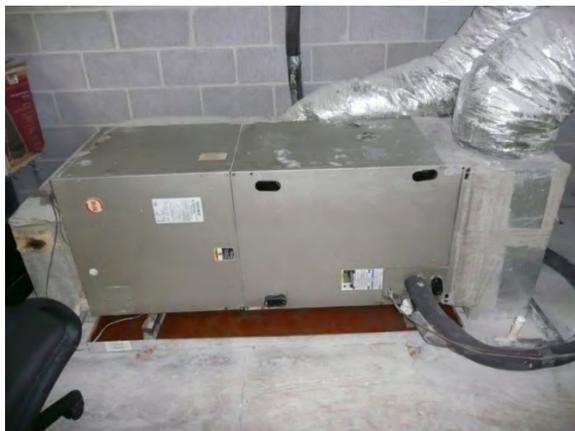
Two rooftop-mounted Trane® air-handling units provided ducted supply air to the office spaces adjacent to the production floor. A Payne® air-handling unit on a mezzanine inside the production floor and outside the conference room also served the office space. We observed standing water and extensive rust and biological growth in the condensate drain pan for the Payne® air-handling unit (Figure 4). We also observed that the unit was missing its air filter

Figure 4. Discolored standing water in the drain pan of the air-handling unit on the mezzanine. Photo by NIOSH.

6. Use wet sweeping methods or a HEPA-filtered vacuum to clean up dust after working with stone. Do not dry sweep dust.
7. Contact the HVAC contractor to determine the frequency of the HVAC filter change-outs and proper system maintenance schedule for the systems throughout the facility. Follow the manufacturers' recommended schedule.

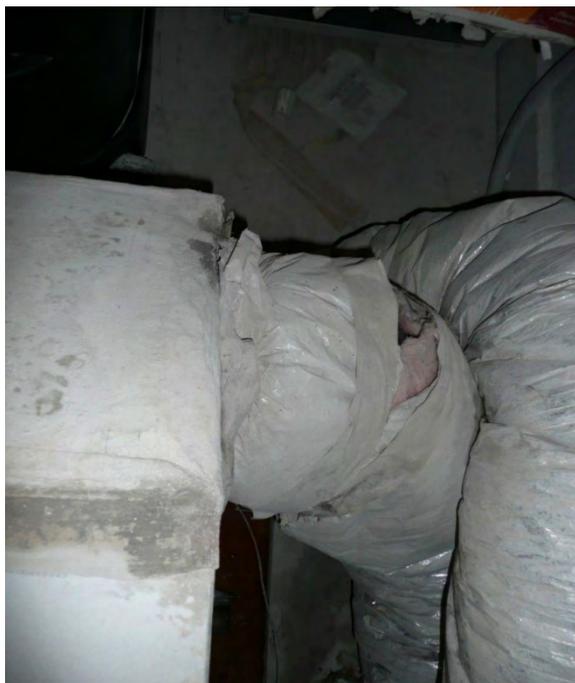
and that some of the flexible duct attached to the unit was torn (Figure 5). This unit was in the production area, so openings in the flexible duct could allow crystalline silica or other dusts from the production area to enter the office space. Employer representatives stated that an HVAC contractor serviced these units, and that they were unsure how often the filters were changed.

Figure 5. Torn flexible duct attached to the air-handling unit on the mezzanine. Photo by NIOSH.

8. Inspect HVAC ductwork regularly and promptly complete repairs, if needed.
9. Inspect electric cords and electrical systems regularly. Promptly replace damaged electrical cords and repair damaged equipment.

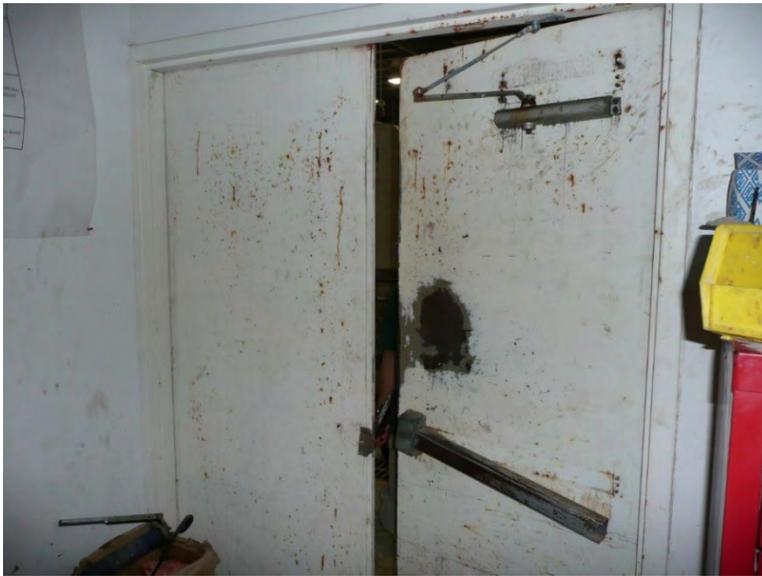
The handle on the maintenance office door was broken, and the door would not close. This office was connected to the production floor, and the open door could allow airborne silica to enter the maintenance office (Figure 6). The maintenance supervisor used the office and did not wear a respirator when inside.

Figure 6. View of broken door from inside of the maintenance room, looking out to the production floor. Photo by NIOSH.

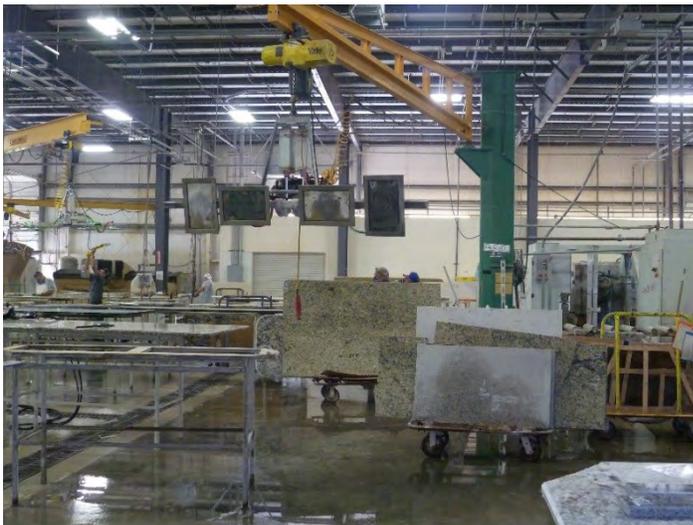
We observed that the pneumatic stone slab lifter attached to a half-ton overhead crane remained in a suspended position about 6 to 8 feet above the floor during times it was not in use. Employees sometimes walked under the suspended slab lifting device (Figure 7).

Figure 7. Slab lifter attached to overhead crane. Photo by NIOSH.

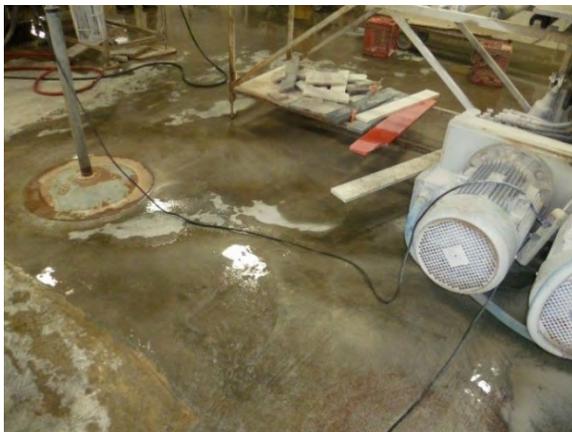
- Electrical cords were lying in water (Figure 8).
- Electrical cords had damaged or torn insulation jackets. Some had been repaired using electrical tape (Figure 9), and others had exposed inner wires (Figure 10).

Figure 8. Electrical cords in water. Photo by NIOSH.

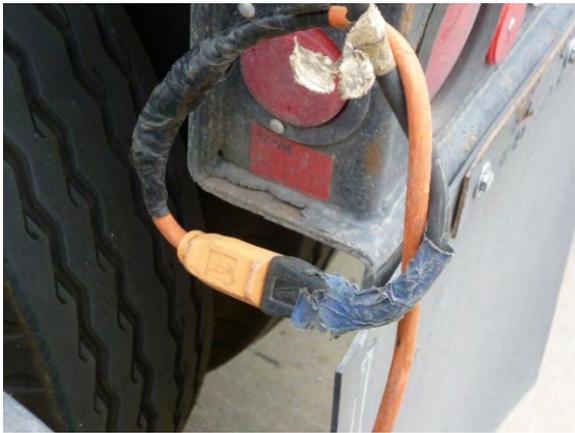
Figure 9. Electrical cords with damaged or torn insulation jackets. Photo by NIOSH.

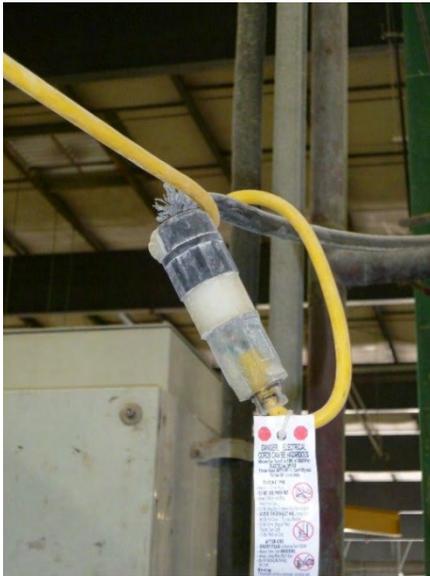
Figure 10. Extension cord with damaged insulation jacket near the plug. Photo by NIOSH.

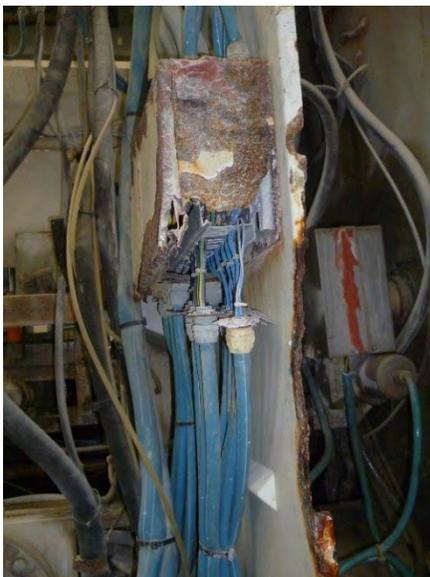
- An electrical junction box attached to a Comandulli machine was severely damaged from oxidation and rust. The electrical power supply fittings were dangling loose from the junction box, exposing internal electrical wiring junction box connection points (Figure 11).

Figure 11. Severely damaged electrical junction box at Comandulli machine. Photo by NIOSH.

4. Replace the damaged electrical junction box at the Comandulli machine and utilize a weather-resistant junction box or install a water-repellant shroud over the top of the box to help protect it from water splashes or drips.
