Evaluation of Silica Exposures During Micro Trenching

HHE Report No. 2019-0020-3353

July 2019

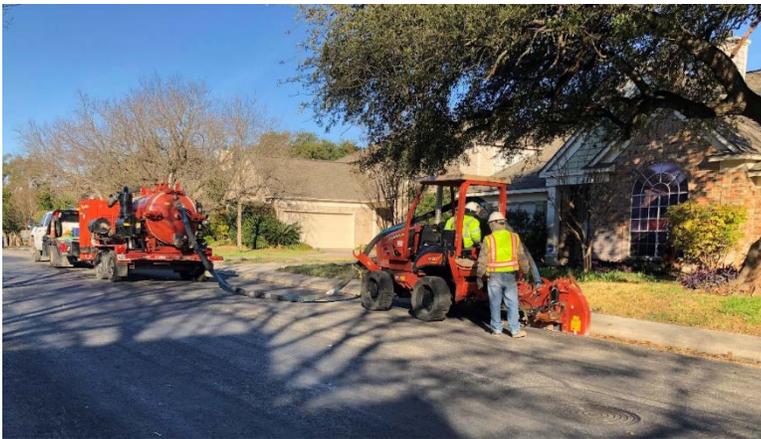
While we were on-site, the job task was to cut micro trenches in the roadway to install communication cable (Figure 1). This process used the vacuum truck to capture dust. Earlier in the week, the company had employees cut what they called “laterals” into the sidewalk. Each lateral was a cut perpendicular to the street and would eventually connect the micro trench in the street to each property along the street. The laterals were cut with a drivable saw that did not utilize the vacuum truck, so small debris piles were at each cut location (Figure 2). We did not observe many laterals being cut during our visit. The crew cut the laterals earlier in the week in preparation for the micro trenching during our visit. We were able to watch one employee from a different crew cut a few laterals that were missed when the majority of laterals were cut earlier in the week.

Figure 1. Vacuum truck and drivable saw cutting the micro trench for the communication cable. There is an employee serving as a spotter behind the drivable saw. Photo by NIOSH.

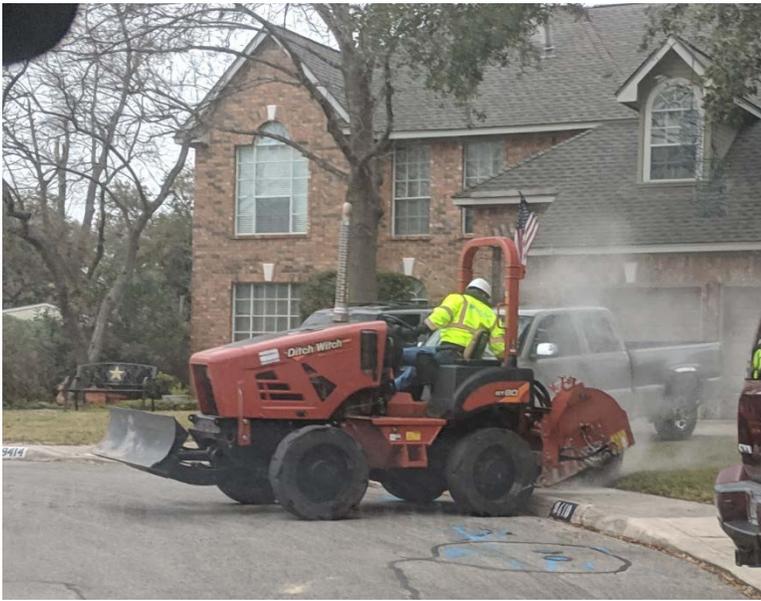
Figure 2. A “lateral” is being cut into the sidewalk to connect the micro trench in the street with the property. The micro trench will be cut into the street after this task. Photo by NIOSH.

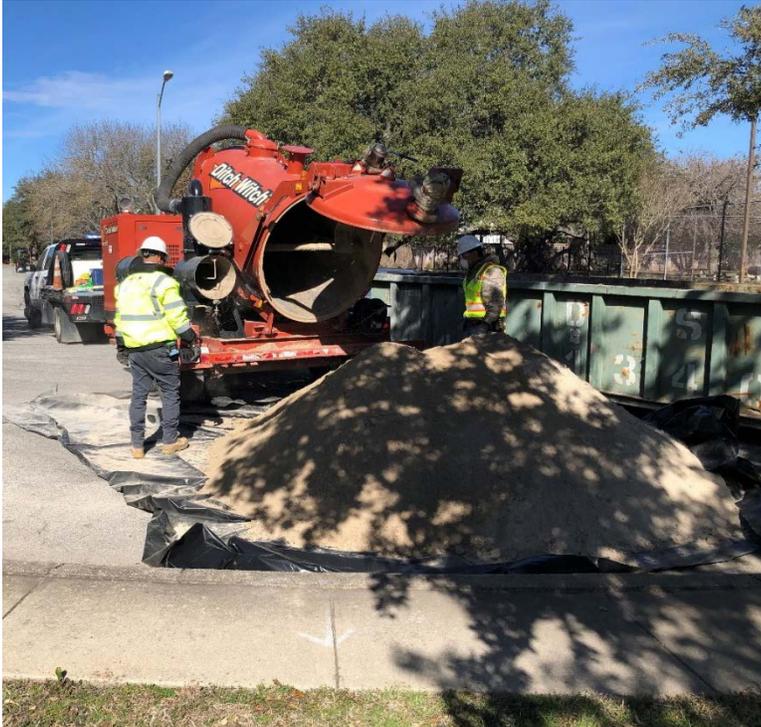
The vacuum truck was emptied several times during the shift after it filled with debris (Figure 3). Employees from multiple job titles/tasks were responsible for emptying the vacuum truck. When the vacuum needed to be emptied, the vacuum truck driver, saw operator, spotter, and one or two other employees would drive the vacuum truck to a predetermined dumping area. The dumping area for the project we observed was at the end of a cul-de-sac and outside the cutting area.

chamber and dumped the spoils onto the tarp. This process took anywhere from 5 to 25 minutes. Each time the vacuum was emptied, different levels of employee interaction were required with the spoils. At times, employees needed to use shovels to empty the filter compartments and or clean the filters. If the filters needed to be cleaned, employees removed the filters and banged them onto the ground from chest height in order to knock off dust that had built up around the filter.

Figure 3. Employees emptying the spoils from the vacuum truck. One of the filter housings (the small, black cylinder to the left of the large, orange cylinder) is open so that employees could empty it using a shovel. Photo by NIOSH.

- Emptying the vacuum more often should prevent the need for excessive cleaning of the filters in the vacuum system. It could also potentially reduce the frequency of hose clogs.

- Dropping the filters on the ground created a cloud of dust around the employee and could potentially damage the filter. Using a vacuum will lessen the size of the dust cloud produced while cleaning the filter and reduce the chance of damage.
- Consider contacting the vacuum manufacturer to explore alternatives, such as a shaker or a reverse air pulse, to reduce the frequency of filter cleaning.

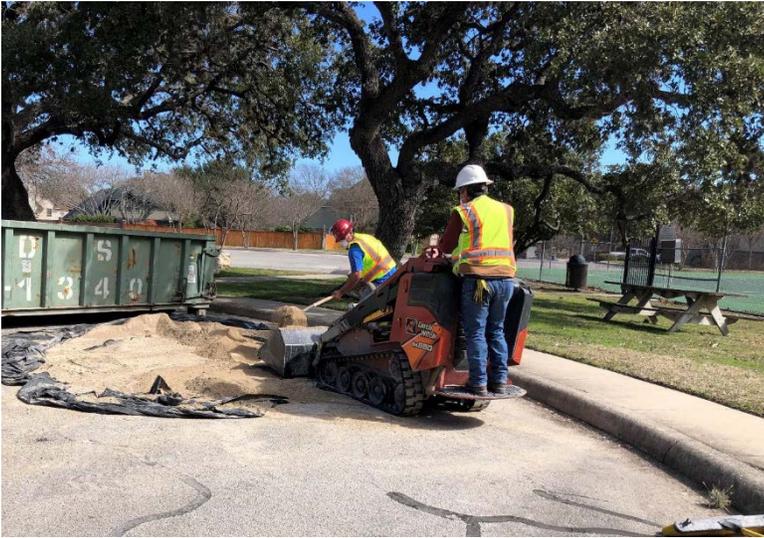
One or two employees loaded the spoils pile on the tarp into the dumpster after cutting was done for the day (Figure 4). Employees used a mini skid steer to move the spoils into the dumpster. Spoils were scooped with the mini skid steer and then dumped into the dumpster from each side of the dumpster to ensure the dumpster was evenly loaded. When the pile was small enough, shovels were used to move the rest into the dumpster, along with the tarp.

Figure 4. Employees loading the pile of spoils into the dumpster using shovels and a mini skid steer. Both employees are wearing N95 respirators.

The dumpster needed to be loaded from both sides to ensure an even load, so it was impossible for employees to stay upwind during this task, as was current policy. The high walls of the dumpster prevented the mini skid steer from loading from a single side and required the spoils to be dropped into the dumpster from a height.

- Loading the dumpster through the open tailgate would reduce the height from which the load was dumped, if the tailgate can be safely secured in the open position.
- Loading the dumpster so that employees are standing upwind of it would reduce the amount of dust exposure.
