Health Hazard Evaluation Report

HETA 83-349-1901
WEYERHAEUSER CORPORATION
LONGVIEW, WASHINGTON

HETA 83-349-1901
MAY 1988
WEYERHAEUSER CORPORATION
LONGVIEW, WASHINGTON

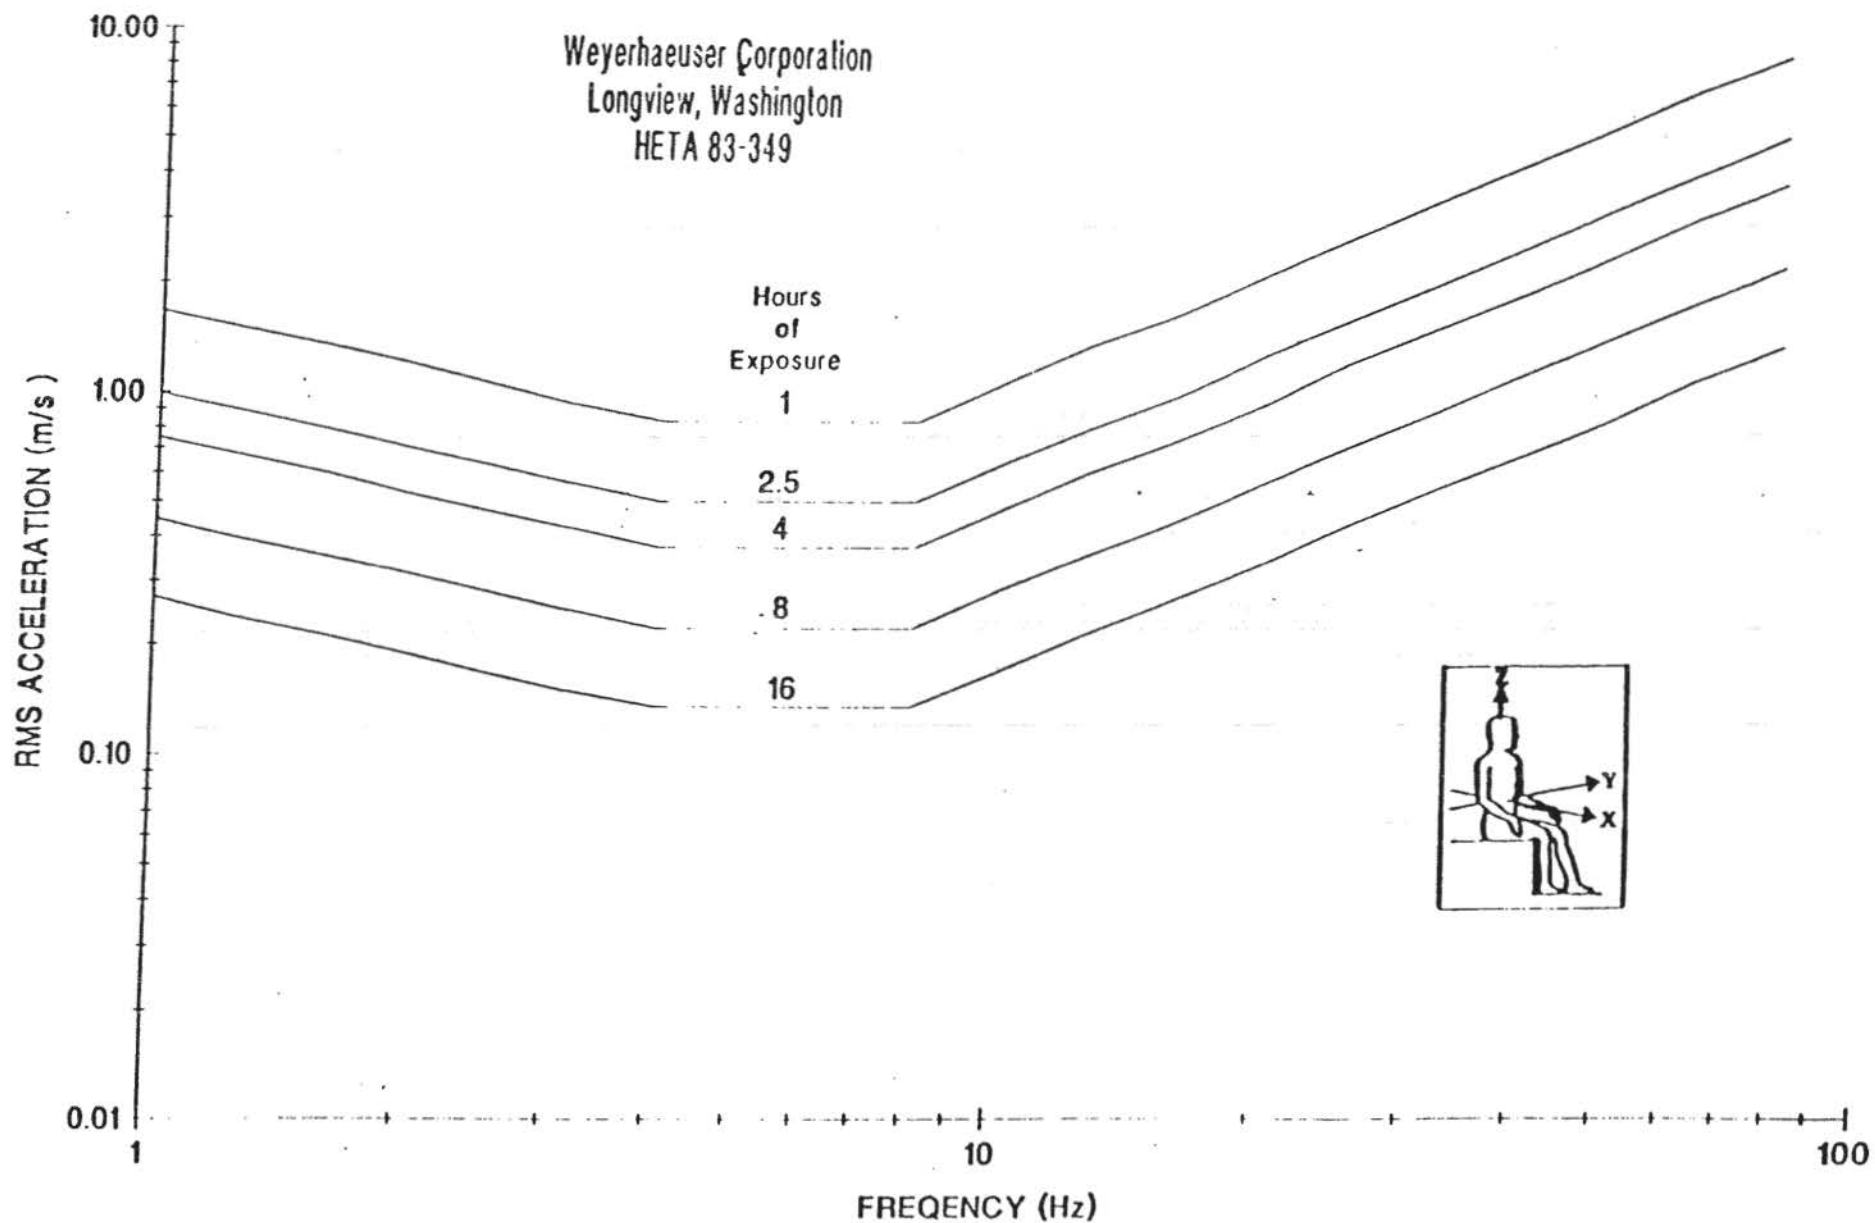
Graph 2

the head, the X-axis represents acceleration in the direction from dorsal to ventral (chest-to-back), and the Y-axis is represented by side-to-side motions in the seated operator (Graphs 1 & 2).

Fatigue Decreased Proficiency
Longitudinal Acceleration (Z)
Limits as a Function of Frequency and Exposure Time

There are three limits recognized in the International Standard 2631 for the evaluation of human exposure to whole-body vibration.¹ These limits are criteria for preserving comfort, preserving working efficiency, and for ensuring safety and health. These are denoted in the international standard as "reduced comfort boundary," "fatigue-decreased proficiency boundary," and the "exposure limit." The 1-hour through 16-hour "fatigue-decreased proficiency" boundary curves for the X, Y and Z axes are shown in Graphs 1 and 2.

The general shape of these two curves is dictated somewhat by a phenomenon known as resonance. Resonance occurs with those vibration frequencies that set the human body into motion most easily. In fact, at these resonance frequencies the human body will actually amplify the acceleration exposure levels by a factor of 1.5 to 3 times the original acceleration value. For example, at resonance, if a worker is seated on a tractor seat which is delivering 1 meter per second per second of vibration, then one might measure acceleration values of up to 3 meters per second per second at the worker's head. This resonance phenomenon appears in the ISO curves as the frequencies with the lowest allowed values of RMS accelerations. These are frequencies between 1 and 2 Hz for the transverse axes (X and Y), and frequencies between 4 and 8 Hz
