Reducing the fire and explosion hazards of flame-cutting and welding in underground coal mines

W. D. MONAGHAN

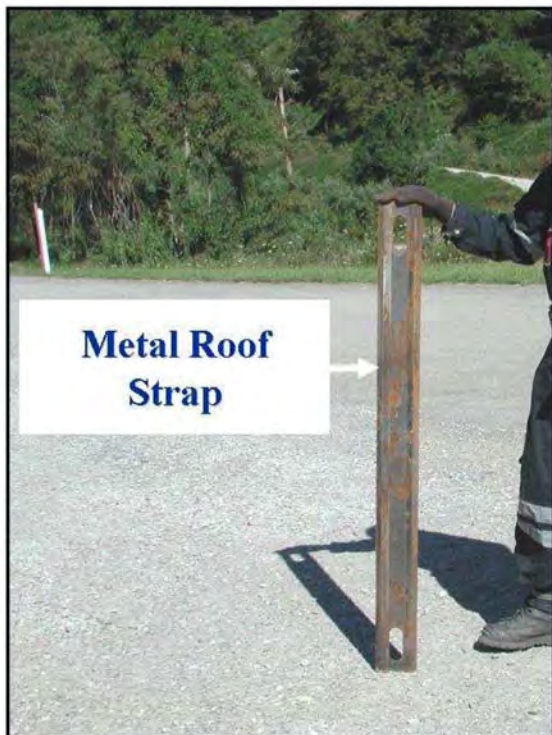
FIGURE 1

On May 20, 2006, an explosion occurred in a sealed section of the Darby Mine No. 1 in Kentucky, resulting in fatal injuries to five miners and injuries to one miner. A methane explosion occurred behind a block seal. MSHA determined that the explosion was caused by sparks that were generated by flame-cutting of a metal roof strap that passed above the seal (MSHA, 2006). Figure 1 shows the type of metal roof strap that was being flame-cut by an oxygen and acetylene torch at the time of the explosion.

Metal roof strap.

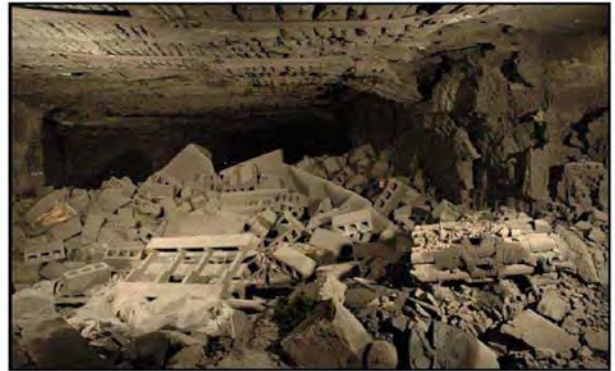
FIGURE 2

Figure 2 shows the actual debris from a stopping, which was destroyed by the explosion. MSHA further determined that the incident occurred because the operator did not observe basic mine safety practices and critical safety standards were violated. Mine management failed to ensure that proper seal construction procedures were utilized in building seals, that safe work procedures were used while employees attempted to make corrections to an improperly constructed seal and that miners were adequately trained (MSHA, 2006).

Debris from a stopping near the explosion in Darby Mine No. 1 (MSHA, 2006).

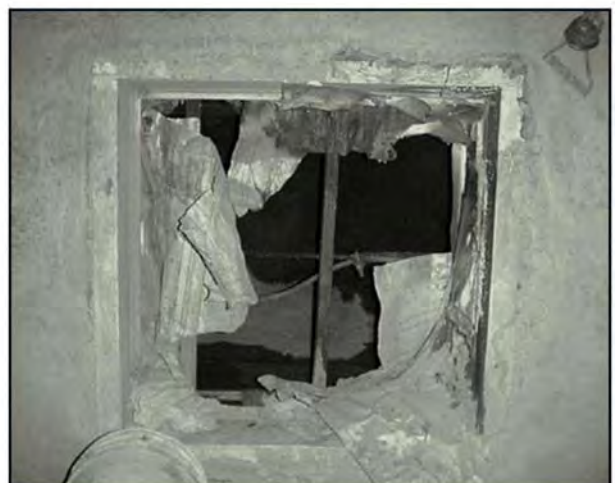
FIGURE 3

On Jan. 22, 2003, an explosion occurred inside an air-shaft under construction for the McElroy Mine in West Virginia. Six miners were inside the shaft at the time of the explosion. The explosion fatally injured three miners and seriously injured three others. The miners were attempting to remove corrugated galvanized steel sheeting that blocked access to the unventilated water ring being constructed. Figure 3 shows the corrugated, galvanized steel sheeting after the explosion had occurred. After obtaining a reading of 0.2% methane on a handheld detector, the foreman directed the mechanic to cut the panning with an oxygen and acetylene torch. The mechanic ignited the torch and started to flame cut the panning. An explosion occurred when the torch cutting process ignited an explosive methane-air mixture contained inside the water ring. MSHA determined that the incident occurred because the examination for methane was not adequate. An adequate examination would have required testing for methane in all areas that could have been affected by the use of the cutting torch (MSHA, 2003).

Corrugated, galvanized steel sheeting after the explosion in McElroy Mine (MSHA 2003).

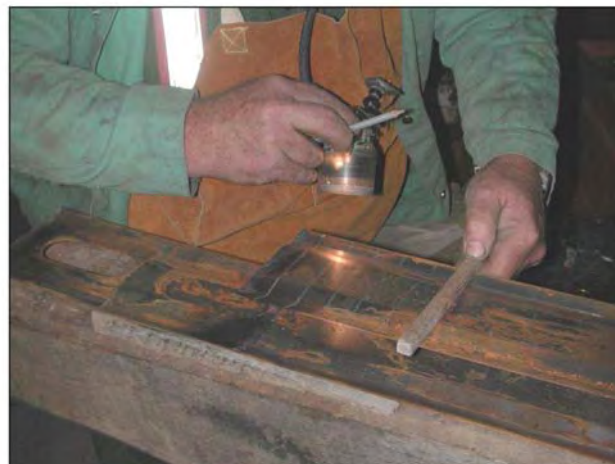
FIGURE 7

In this experiment, metal strips ranging from 1.27 to 3.75 cm (0.5 to 1.5 in.) were flame-cut from the metal roof strap shown in Fig. 7. The temperature histories of the hot metal strips were obtained by recording the temperature every 250 milliseconds using the IR camera. Figure 8 shows an example of the temperature histories of a 1.27-cm (0.5-in.) and a 3.75-cm (1.5-in.) metal strip following the cut. The 3.75-cm (1.5-in.) strip's temperature remained above 593° C (1,099° F) for 19 seconds, and the 1.27-cm (0.5-in.) strip's temperature remained

Metal roof strap prior to flame cutting individual strips.

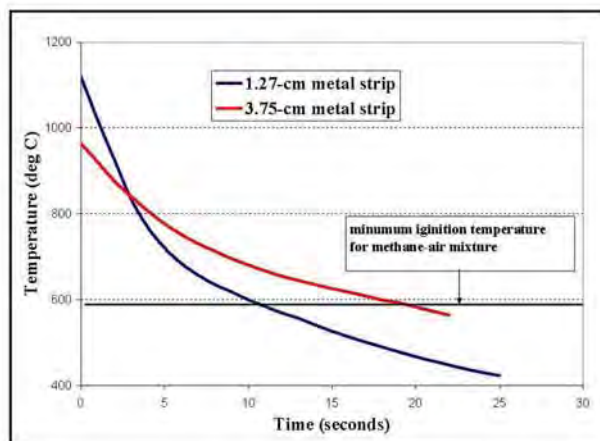
FIGURE 8

Temperature histories of two hot metal strips following cutting.

about 593° C (1,099° F) for 10.5 seconds. The results from this experiment showed that these hot metal strips were capable of igniting a methane-air mixture.

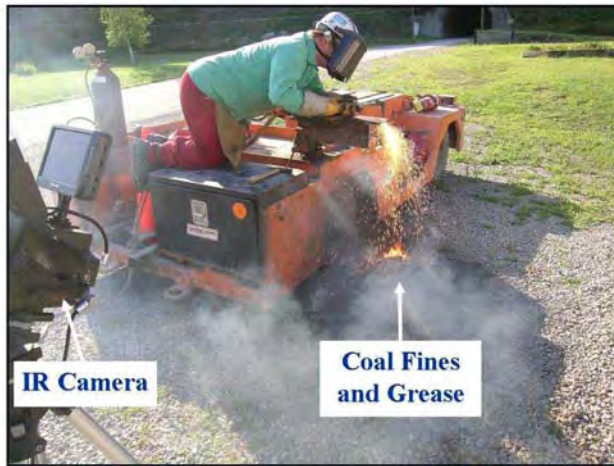
FIGURE 9

Setup for hot molten metal experiment.

In this experiment, the effect of hot molten metal on float coal dust and grease was observed. Flame-cutting was performed approximately 1 m (3.3 ft) above the float coal dust and grease. The hot molten metal was allowed to fall directly on the float coal dust and grease. The temperatures of the metal, float coal dust and grease were recorded using the IR camera, shown in Fig. 9. The hot molten metal immediately ignited the grease. After several minutes, flames from the grease appeared to have self-extinguished. However, hot spots in the float coal dust were observed with a temperature range between 93-145° C (199-293° F).
