INFORMATION CIRCULAR 9453

Proceedings: New Technology For Coal Mine Roof Support

U.S. DEPARTMENT OF HEALTH AND HUMAN SERVICES
Public Health Service
Centers for Disease Control and Prevention
National Institute for Occupational Safety and Health
Pittsburgh Research Laboratory
Pittsburgh, PA

October 2000

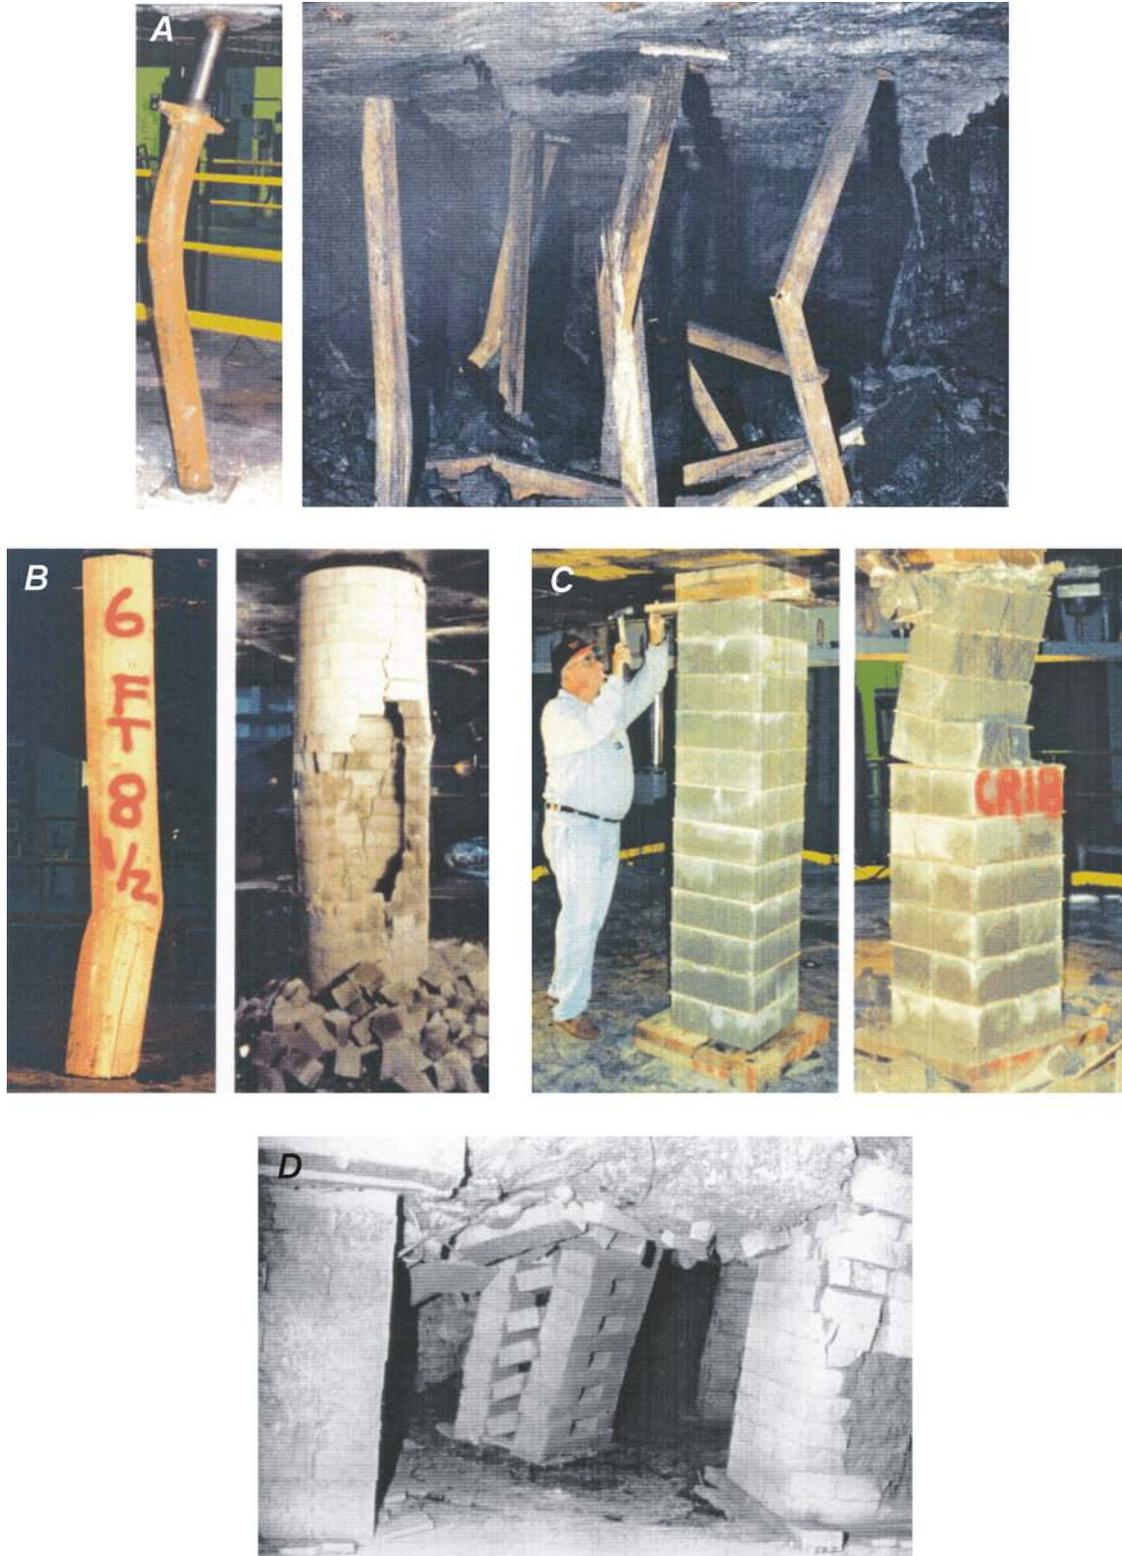
Figure 24.—Examples of support instability. A, buckling; B, material failure; C, eccentric loading; D, lateral roof-to-floor movement.

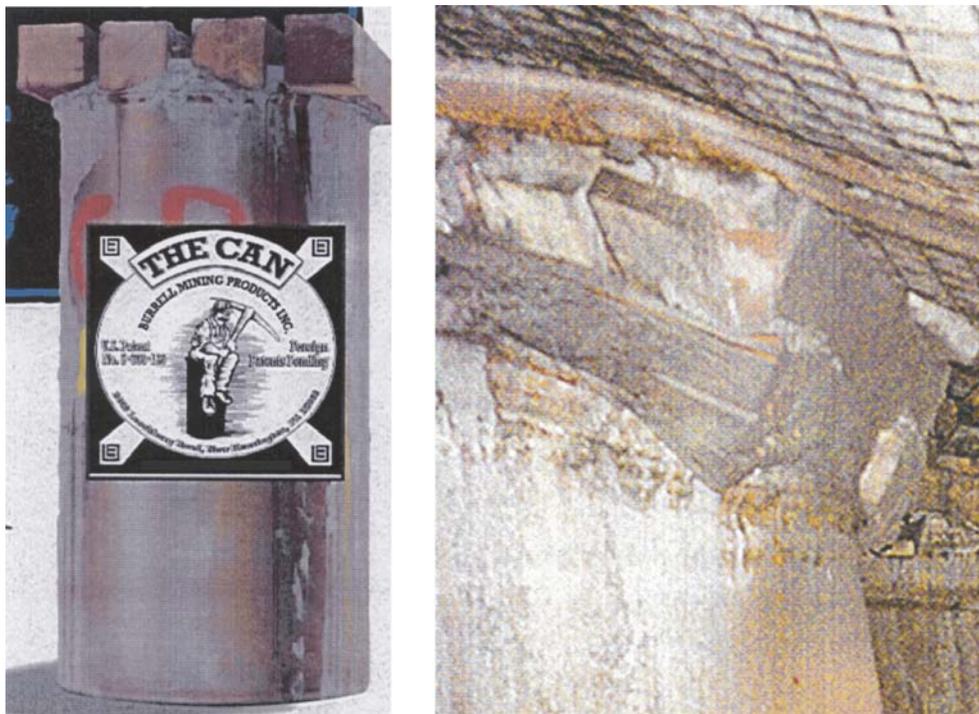
Figure 26.—Poor-quality timber on top of Can degrades support.

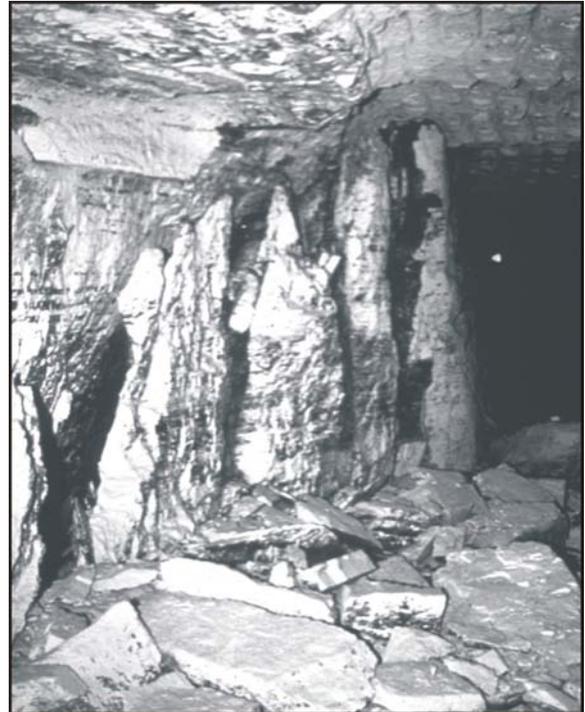
Figure 3.—Skin failure of unsupported rib.

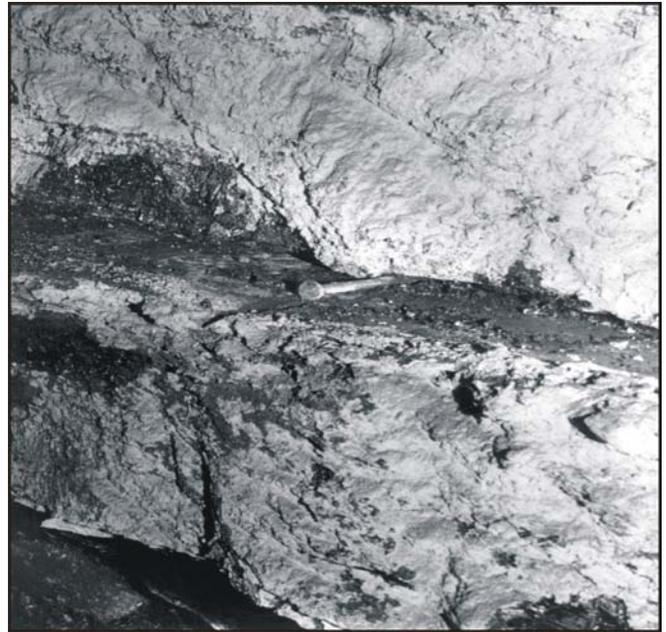
Figure 6.—Example of differential movement along a parting in a coal rib.

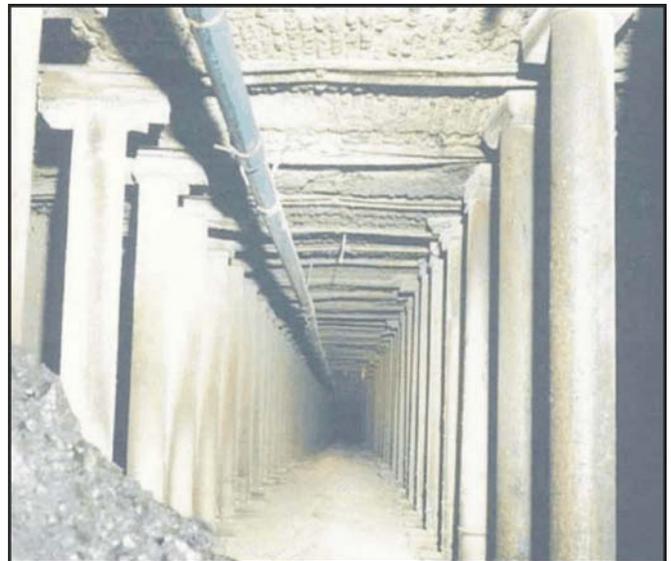
Figure 12a.—Outby area supported by Propsetter support.

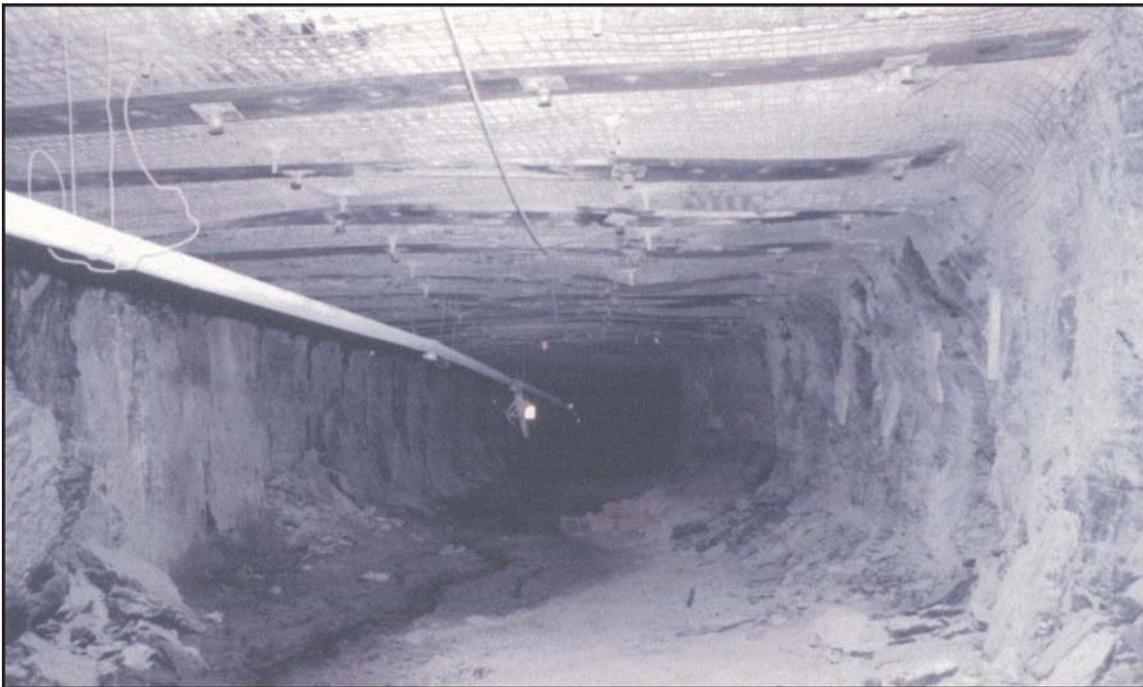
Figure 8.—Surface control in the form of a "Monster Mat" installed with cable bolts.

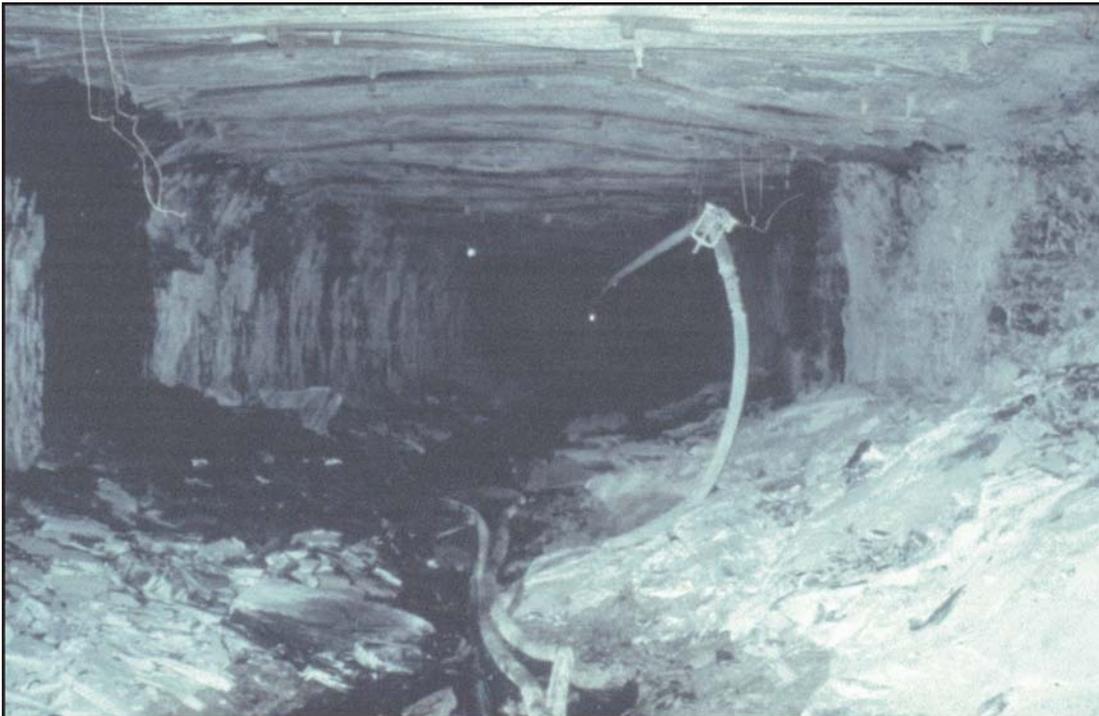
Figure 14.—Tailgate abutment zone outby the face supported with cable bolts.

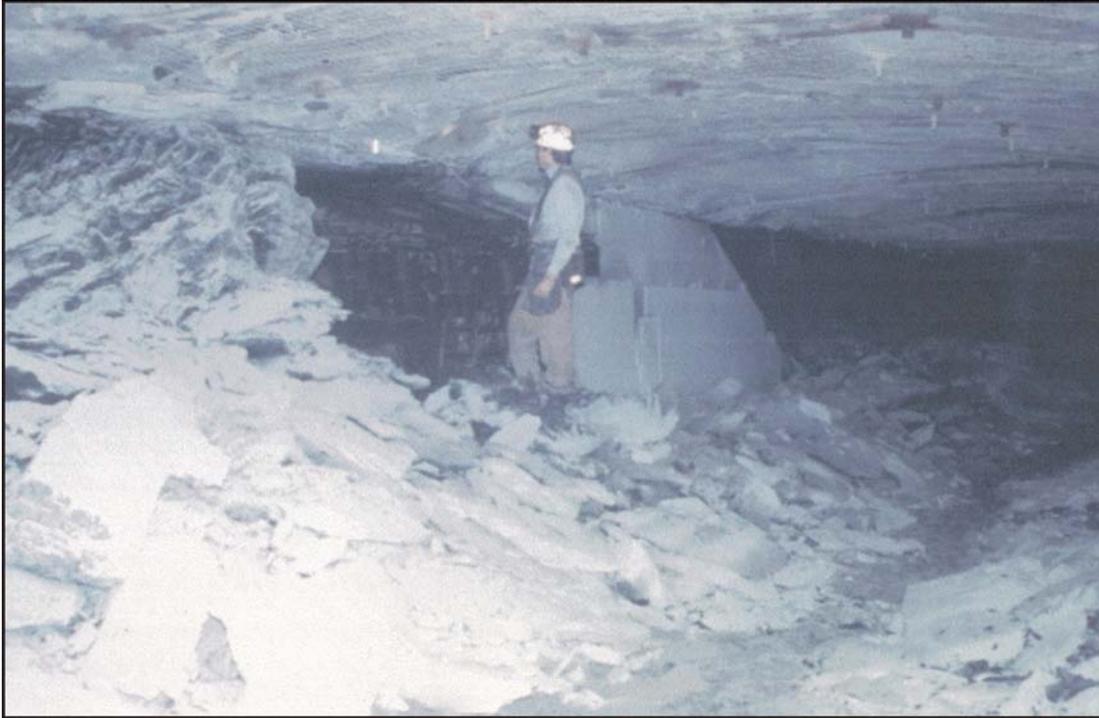
Figure 15.—Tailgate shield zone supported by cable bolts.

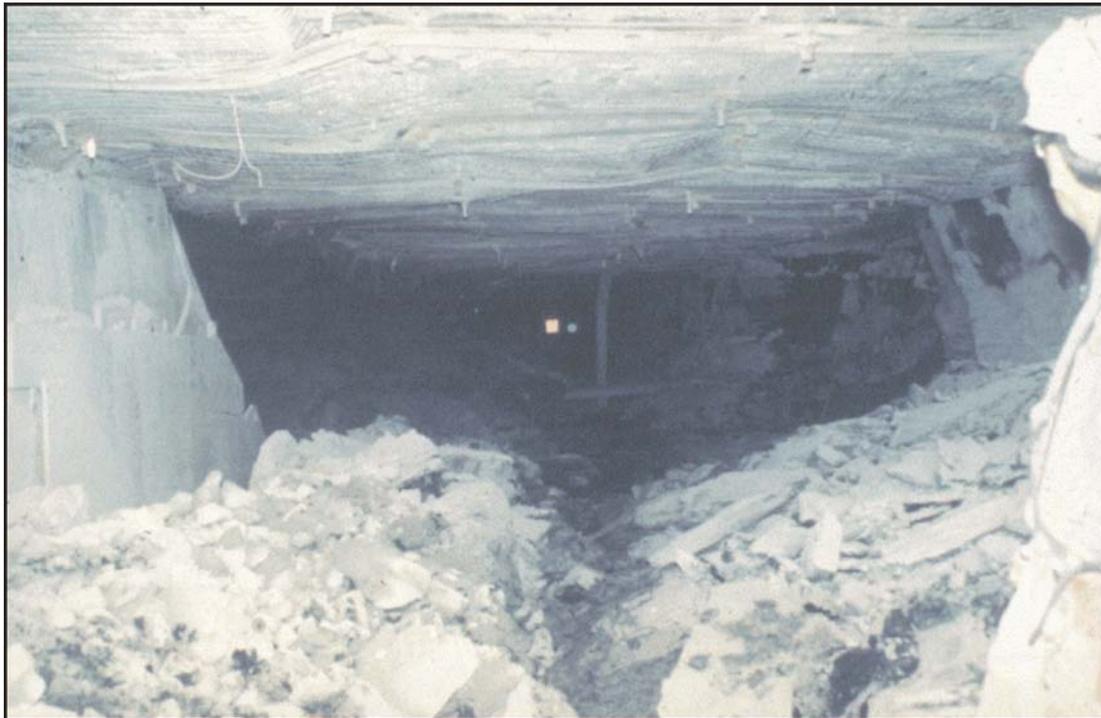
Figure 17.—Tailgate behind the shields kept open with cable bolts.

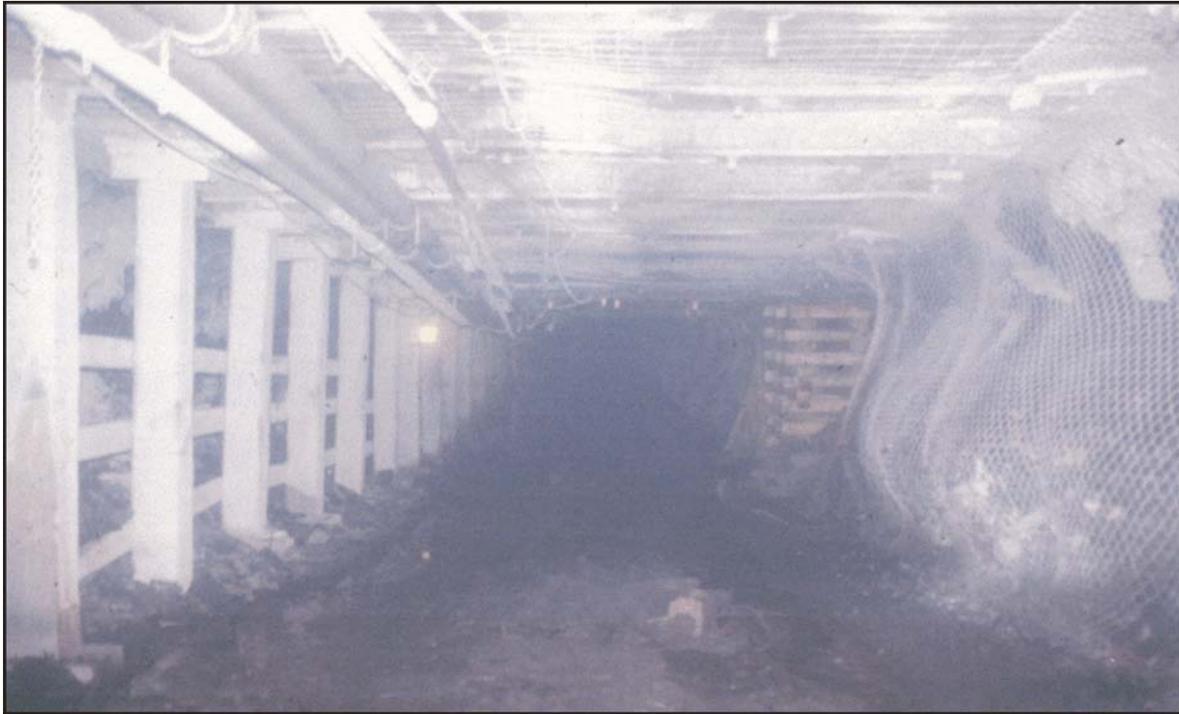
Figure 20.—Two entry yield pillar tailgate showing the abutment zone outby the face, supported with cable bolts

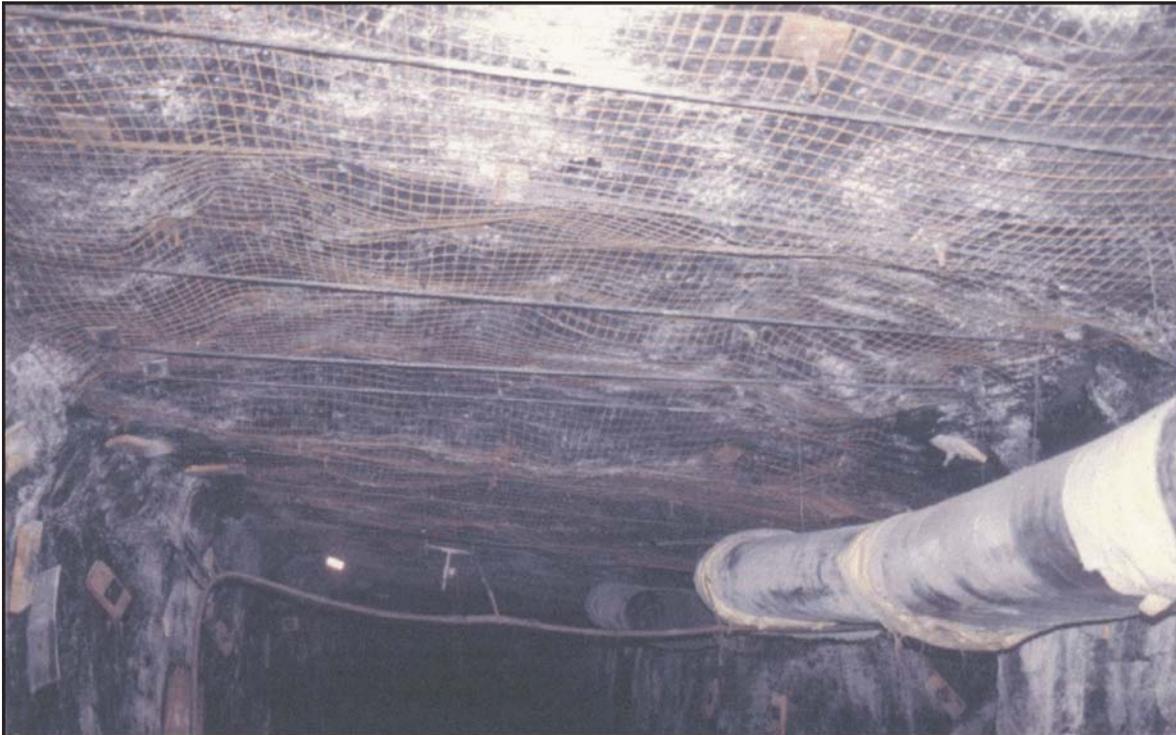
Figure 26.—Cable trusses installed in the headgate entry.

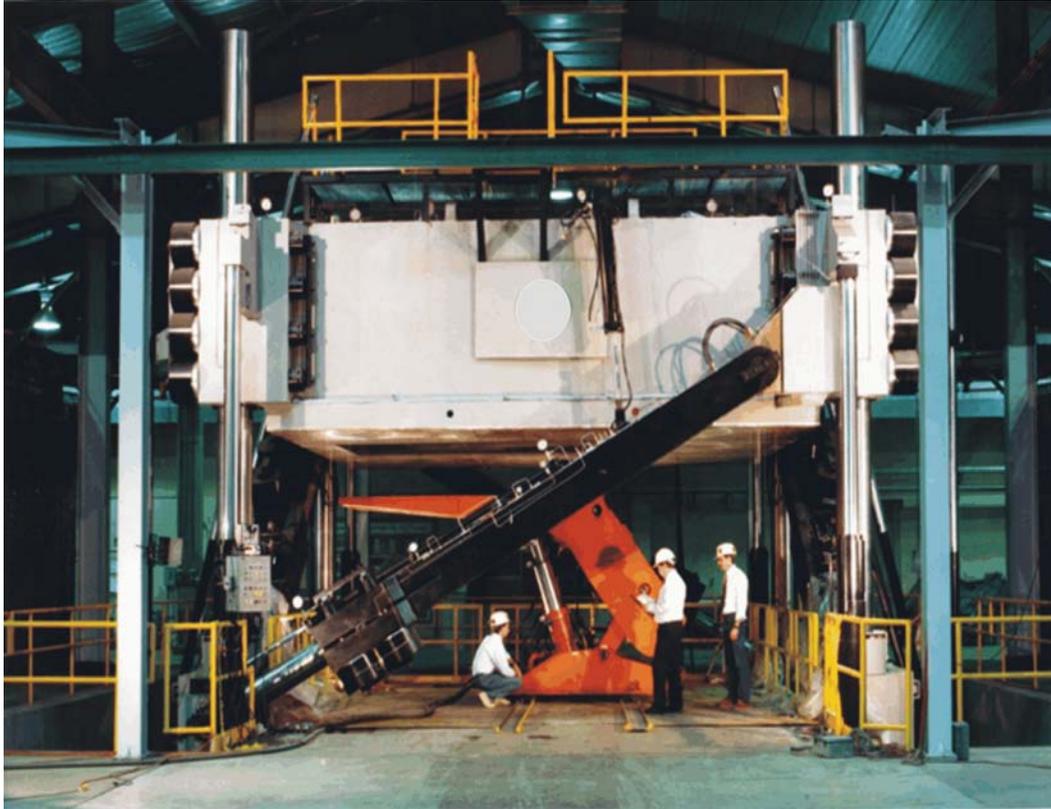
Figure 7.—NIOSH Mine Roof Simulator.

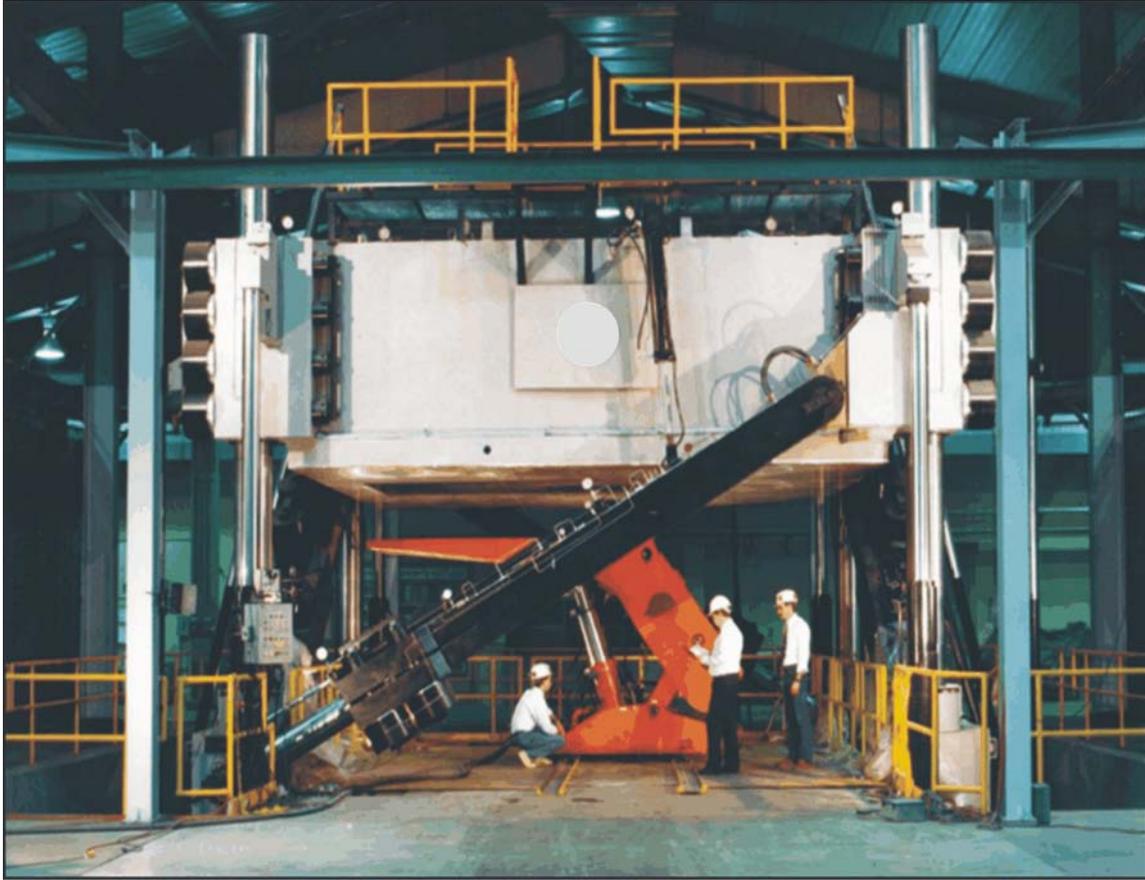
Figure 1.—The Mine Roof Simulator at NIOSH's Pittsburgh Research Laboratory.
