RI 9674

Performance of a Polyurethane Core Seal
Tested in a Hydrostatic Chamber

By Dennis R. Dolinar, Michael J. Sapko, and Samuel P. Harteis

May 2008

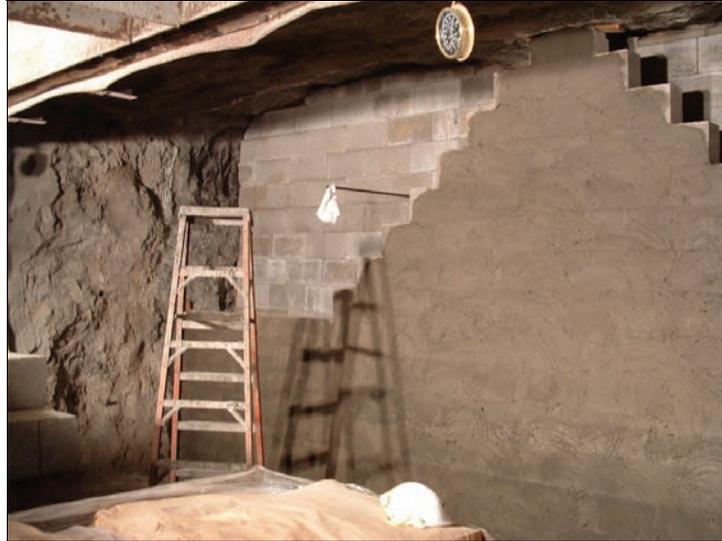
Figure 1.—The dry-stacked concrete block walls comprising the forms for the composite polyurethane seal.

The standard construction practices were followed, and the recommended materials were used for installing this type of polyurethane-aggregate seal. The composite seal tested consisted of two dry-stacked concrete block walls spaced 18 in apart with a polyurethane and limestone aggregate core (Figures 1–2). The concrete blocks used to construct the walls were nominally 16 in by 8 in by 6 in. The back wall was constructed first. After the last block in each row was placed, a wedge was driven between the block and rib to tighten the blocks in place. Wedges were also used between the top row of blocks and the roof. A manhole was left open in the upper right⁷ corner of the back wall to allow the back side to be plastered with an MSHA-approved sealant. Once plastering was complete, concrete blocks with MSHA-approved sealant applied to the back side were placed in the manhole until the opening was filled. To complete the back wall at the manhole, boards were used between the top of the blocks and the roof. An MSHA-approved sealant was then used to fill the gap at the roof and ribs. The front wall was constructed similar to the back wall for the first six courses of block. From this point, the blocks were pyramided to the roof so that two blocks were in contact with the roof and wedged in place. An MSHA-approved sealant was then applied to the front side of the outside wall.

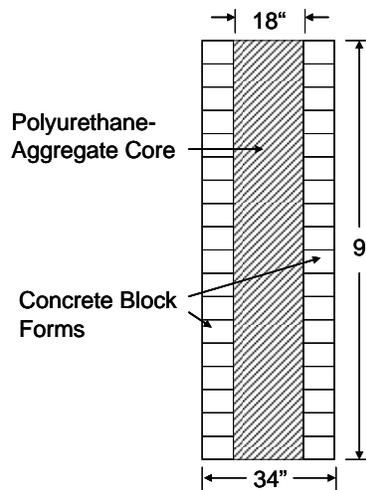
Figure 2.—Vertical cross-section across thickness of the polyurethane-aggregate seal.

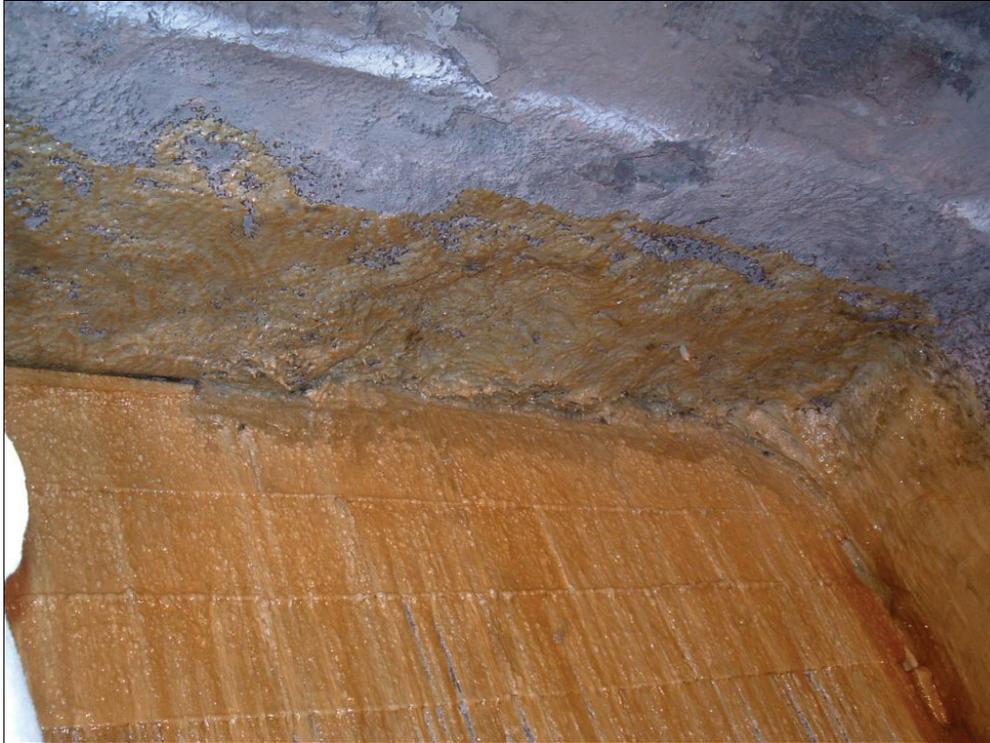
Figure 3.—High-density (70 lb/ft³) polyurethane sprayed on roof, ribs, and back form wall.

Before constructing the inner core, high-density polyurethane was sprayed on the ribs, floor, and around the perimeter of the block walls inside the core area. This was, in part, to provide better adhesion of the seal to the surrounding rock mass and block walls (Figure 3). The improved adhesion, however, only occurs when the polyurethane is still tacky and is limited to the first three lifts. The high-density polyurethane also provided a barrier to protect the low-density foam from moisture or water. For this application, higher-strength polyurethane foam with a density of 70 lb/ft^3 was used. This material was also sprayed along the upper edge of the back wall to improve the seal along the roof line. The high-density polyurethane also fixed the bottom layer of blocks to the floor and was used to saturate the first layer of aggregate to create a good bond with the floor.

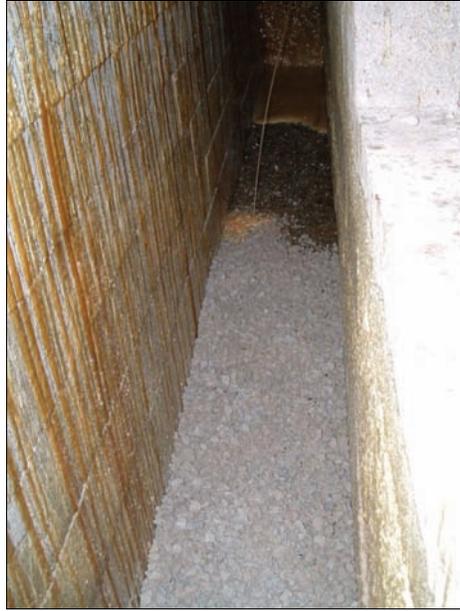
Figure 4.—Polyurethane foam applied on the aggregate at the start of a lift.

The process of developing a lift began by placing a 4-in layer of aggregate at the bottom of each lift, then a polyurethane mixture was poured on top of the aggregate (Figure 4). After the aggregate was placed in a layer, the layer was saturated with polyurethane. The foam would then rise or expand as a result of the blowing agent in the vertical direction. As the polyurethane expanded, the aggregate was carried with and dispersed within the foam. However, depending on the degree of saturation, the polyurethane would expand beyond the aggregate, and a zone of only polyurethane would form a cap at the top of the lift. Once the polyurethane set, a typical lift would be 12–14 in high and consist of an 8- to 12-in thickness of the polyurethane-aggregate mixture and a cap of polyurethane with a thickness of 1–4 in. The cap would generally be 1–2 in thick in the middle of the lift and 2–4 in at the edges. Steps were taken to minimize the thickness of the pure polyurethane cap. Figure 5 shows a typical lift. Eight lifts were used in the seal construction.

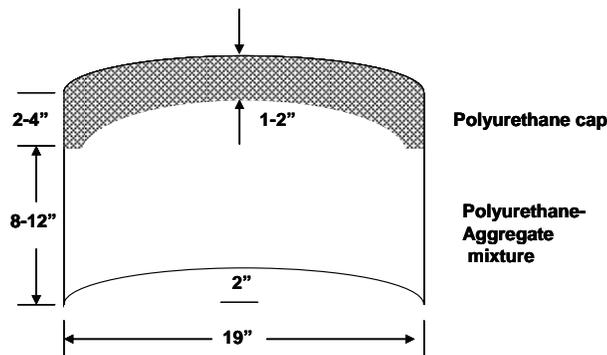
Figure 5.—Cross-section of a typical lift used to form the seal.

Because of the addition of the aggregate in the seal, there are two zones that develop in a lift: a zone consisting of a mixture of polyurethane and aggregate, and a polyurethane cap (Figure 5). By volume, about 80% of the lift is composed of the polyurethane and aggregate mixture where the polyurethane cap is 1–4 in thick. However, the reported results from previous tests on the polyurethane and aggregate mixture prepared under laboratory conditions indicated there was no apparent reduction in the elastic modulus when the aggregate was added [Sawyer 1999]. In the present testing program, samples from a seal constructed under field conditions would be tested. Therefore, the testing program was designed to evaluate the materials to determine physical properties developed under field conditions.

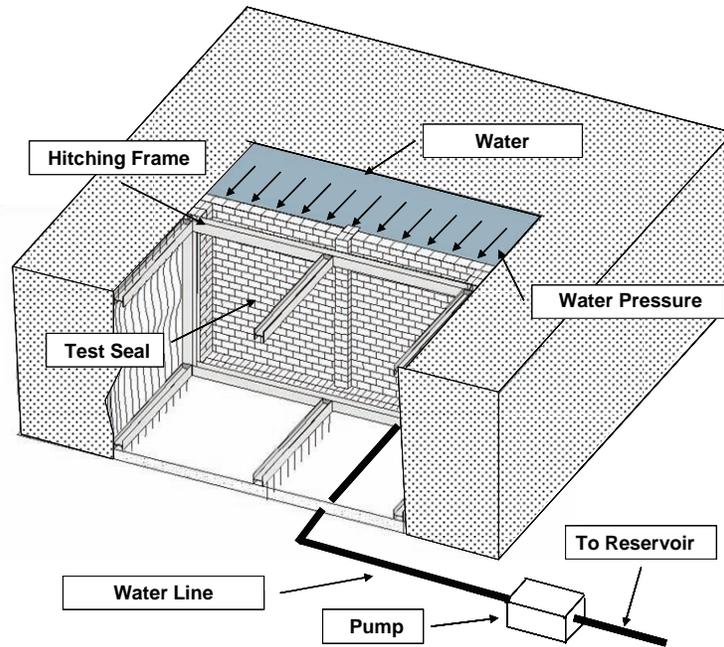
Figure 6.—Schematic of the hydrostatic chamber.

Figure 6 shows a diagram of the hydrostatic chamber. The chamber used in this test averages 20 ft wide by 8.0–9.5 ft high by 10 ft deep [Sapko et al. 1999a,b; Sapko and Weiss 2001; Sapko et al. 2003]. The seal was constructed at the front portion of the chamber. A steel frame structure built inside the chamber allows for simulated hitching of the seals. However, for this test the polyurethane seal was not in contact with the steel frame and therefore was not considered hitched. The typical design and installation of these polyurethane-aggregate seals does not require hitching into the surrounding rock.

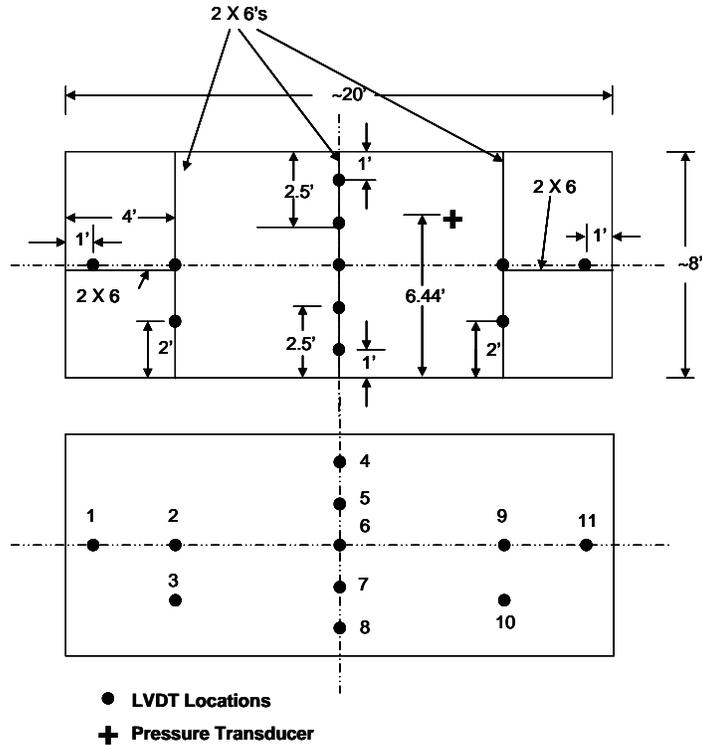
Figure 7.—Locations of the LVDTs and pressure transducer used to monitor displacement of the seal and pressure behind the seal during the test. Nominal dimensions are given for the seal and LVDT locations.

Eleven linear variable displacement transducers (LVDTs) were used to monitor the displacement of the seal. Figure 7 shows the locations the LVDTs. These spring-loaded LVDTs capable of measuring up to 6 in of displacement were installed on the outside of the seal by attaching them to 2 by 6's that were set between the roof and floor (Figure 8). The LVDTs measured this displacement by generating an output signal of approximately 1.68 V/in. A strain gauge pressure transducer (1,000 Hz) with an internal pressure range of 0–100 psi measured the water pressure behind the seal. This transducer was connected to a pipe placed through the seal and located 6.44 ft above the floor (Figures 7–8). Data from the pressure transducer and LVDTs were recorded at 2,000 samples per second per channel with a WinDaq PC-based data acquisition system.

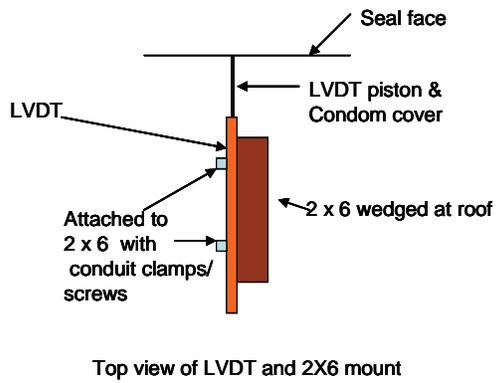
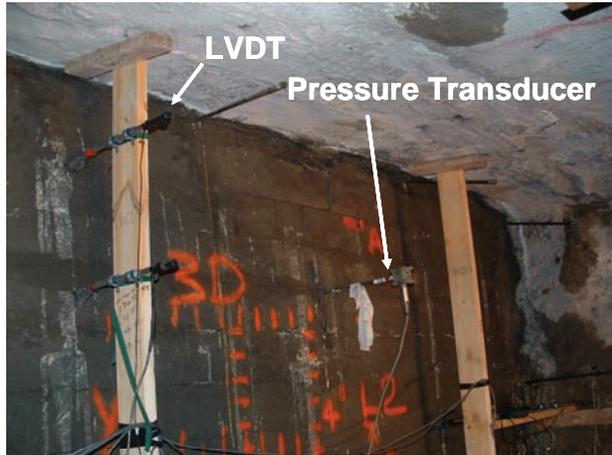
Figure 8.—Pressure transducer and LVDTs used to monitor pressure and deflection during seal test. Schematic of LVDT is shown on the left.

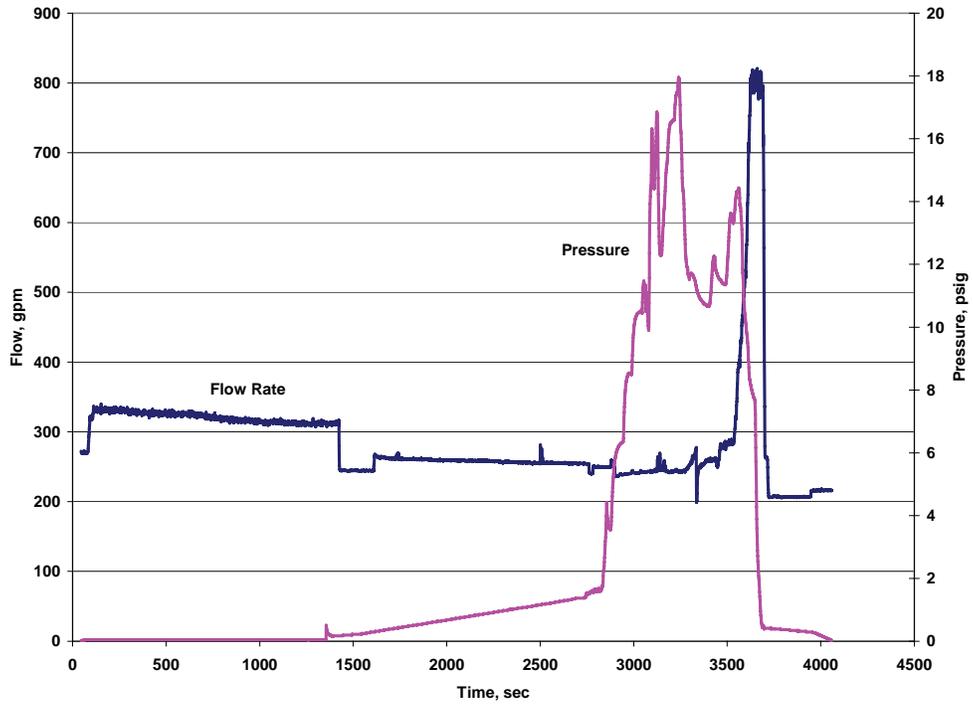
Figure 9.—Water pressure and flow rate versus time during seal test.

Figure 9 shows the flow rates and water pressures generated during the test. In the initial phase, the pumping rate was 250–350 gpm. Once the chamber behind the seal was filled, the remaining portion of the test then took 13–14 min to complete.

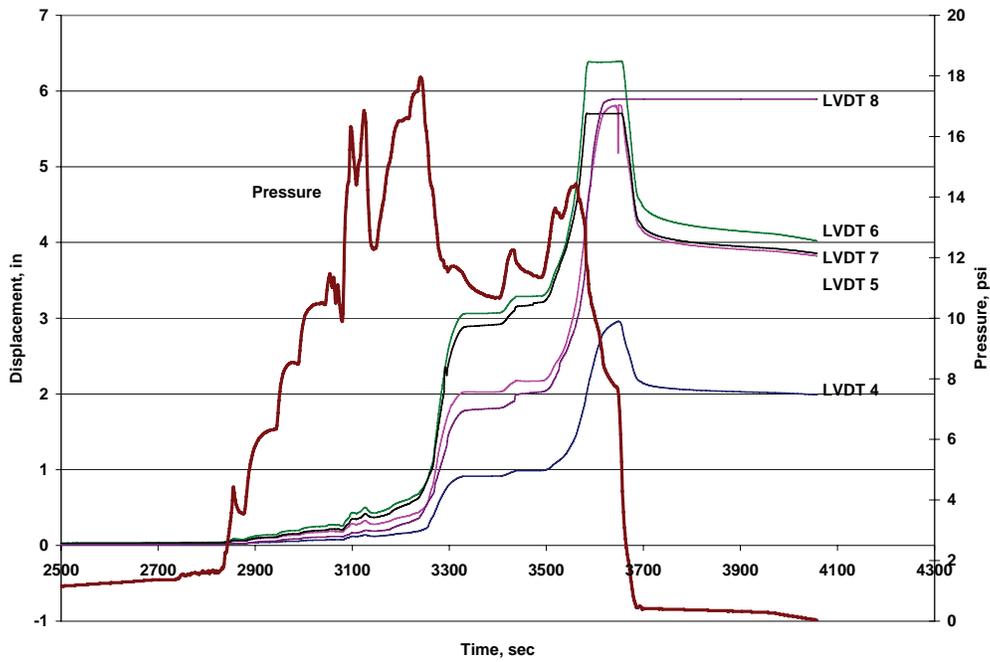
Figure 10.—Displacement for LVDTs along the vertical center line of the seal and pressure recorded versus time.

Figure 10 shows the pressure and the displacements with respect to time for the five LVDTs placed along the vertical center line of the seal. The responses of the LVDTs along the horizontal center line are shown in Figure 11, and the responses of the two LVDTs just off the horizontal center line are shown in Figure 12. During the initial pressurization to about 11 psi, the pressure-time curve showed a stairstep behavior. This behavior resulted from adjustments to the rate of pressurization using a pressure relief valve at the pump. At just over 16 psi at about 3,100 sec into the test, significant leakage began to occur through the seal. This resulted in several sudden pressure drops just before reaching the maximum pressure. A maximum pressure of 18 psi at about 3,250 sec into the test was achieved at the transducer. Just past the peak pressure, a large amount of displacement occurred at all LVDT locations over a short period of time (Figures 10–12). After the maximum pressure was reached and the pressure dropped to about 11 psi because of leakage, the flow rate was increased to 800 gpm to determine if a higher pressure could be achieved. Although the pressure did increase to 14 psi with the higher pumping rate, there was an accompanying rapid increase in the seal deflection. This resulted in severe leakage from the seal and a rapid pressure drop to about 8 psi. The maximum seal deflection of at least 6 in at the center of the seal was recorded at this time. However, several of the LVDTs had reached their maximum stroke limit of 6 in. The pumping was then halted and the water was allowed to drain from behind the seal at 3,650 sec into the test. As the pressure dropped, there was some rebound of the seal with up to 2 in of displacement recovered near the center. However, there was still nearly 4 in of displacement that was not recovered by the end of monitoring.

The maximum pressure that the seal withstood at the pressure transducer was 18 psi. As shown in Figures 10–12, at that point there was a large increase in displacement with a sudden drop in pressure. This occurred as the seal failed and the pumping could not keep up with the leakage. Further loading at an increased pumping rate did not achieve a higher maximum pressure, but did significantly increase the deflection and water leakage. Essentially, the 18-psi static pressure can be considered the pressure where the seal structurally failed. When this occurred, the stress was 16.9 psi at the top of the seal and 20.8 psi at the bottom. This calculates to an average stress across the seal of 18.9 psi. This is below the 20-psi criterion mandated by the Code of Federal Regulations at the time of the test [30 CFR 75 (2005)].

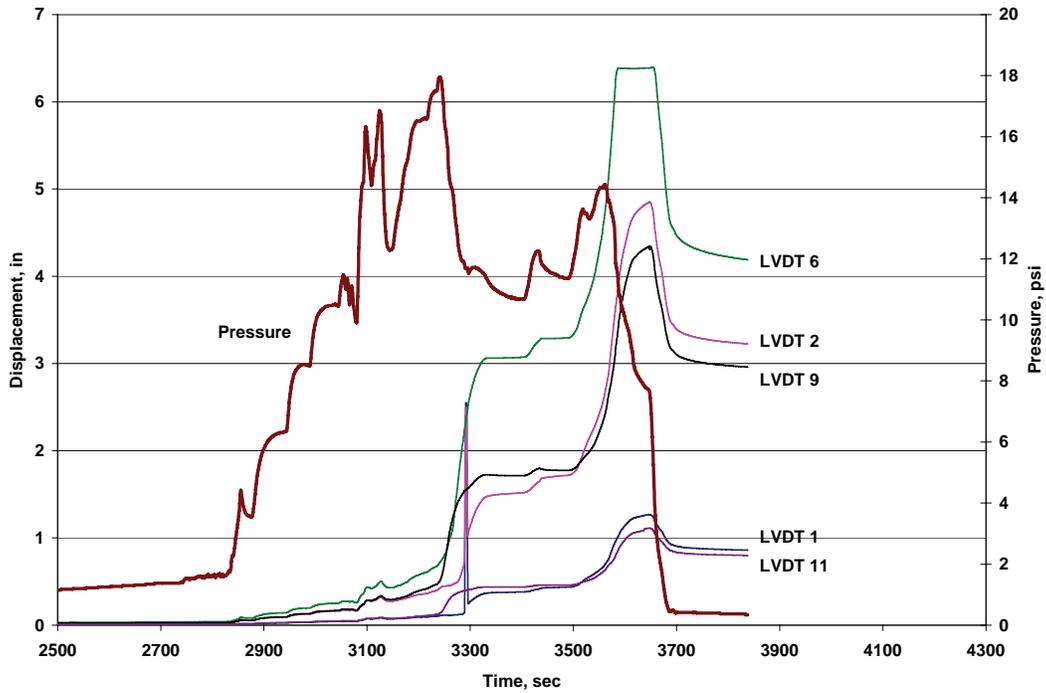
Figure 11.—Displacement for LVDTs along the horizontal center line of the seal and pressure recorded versus time.

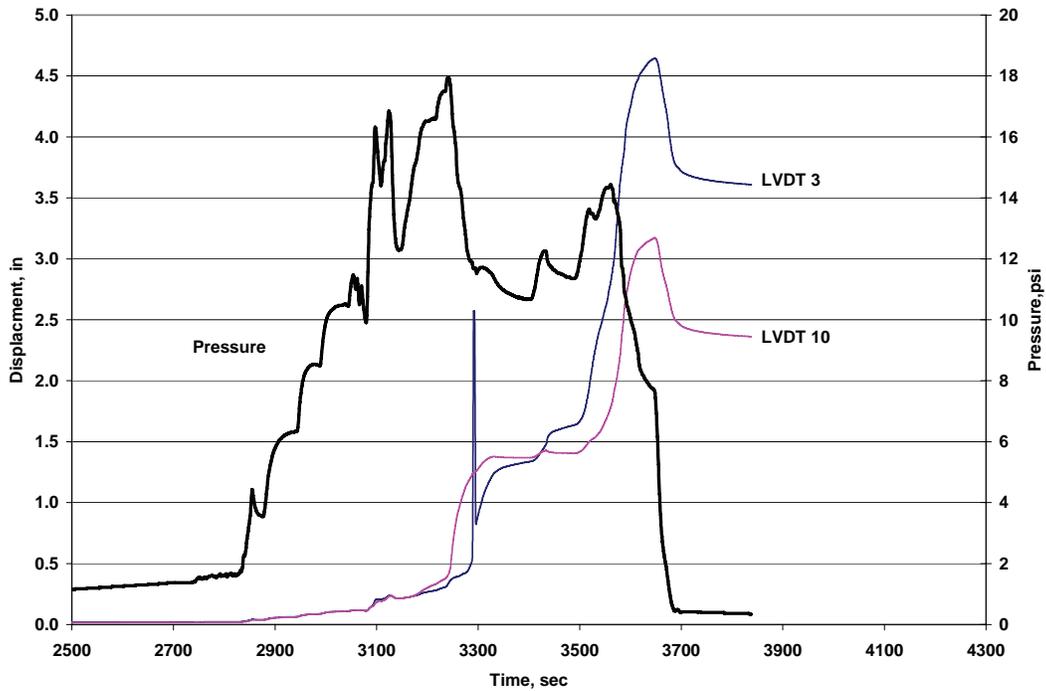
Figure 12.—Displacement for LVDTs just off the horizontal center line near the ends of the seal and pressure recorded versus time.

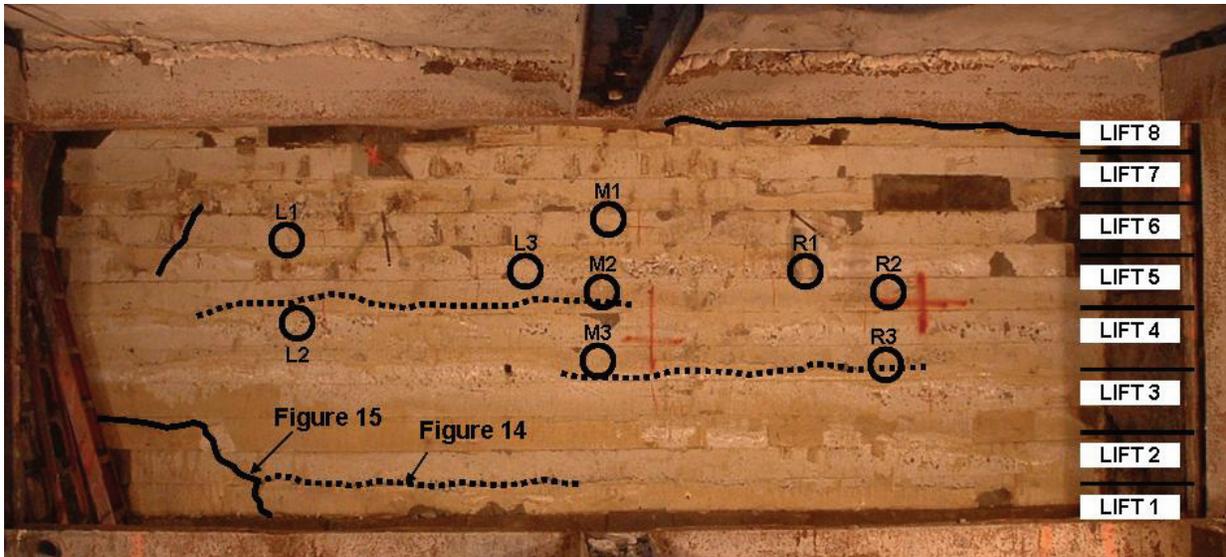
To evaluate the damage done to the polyurethane seal core, the front stack wall was removed. Figure 13 shows the seal after removing the block wall, with the fractures and open joints indicated. Fractures developed at or near the lift joints at the lower left and upper right side of the seal. There is also a fracture cutting across the lifts along the lower left side of the seal. The joints along the lifts near the center portion of the seal also opened. Figure 14 shows the major fracture or open joint that formed parallel to the lifts just above the bottom row of blocks along the interface of lifts 1 and 2. Further, the area at and below the fracture parallel to the lift line was displaced a few inches horizontally over the top of the lowest row of block. Figure 15 shows the major fracture that developed across lifts 1 and 2 on the lower left side of the seal. This fracture was open along the front side of the seal core. A portion of the polyurethane was excavated so that internal damage to the seal and the back block wall could be examined. Internal damage to the seal near the floor is shown in Figure 16. The damage includes major near-vertical fractures in the lowest lift. This area is just to the right of the external fracture shown in Figure 15. Essentially, the external damage is directly related to the development and movement along these internal fractures. Even though there were several inches of horizontal displacement of the polyurethane core over the top of the first row of blocks in this area, no horizontal shear surface or fracture was observed at this location. A small diagonal fracture was also noted in the upper left quadrant of the seal (Figure 13).

Another zone of damage and deformation occurred near the roof and extends across most of the right side of the seal (Figure 13). In exposed portions of this damaged zone, there is high concentration of aggregate with very little polyurethane to lift the aggregate and to act as a binder (Figure 17). The seal below the fractured zone was displaced outward.

Other fractures opened along the joined surfaces between the top and bottom of the lifts (Figure 13). This occurred in the lifts from the upper middle portion of the seal and below and involved the interfaces between lifts 1 to 5. Cores taken along some of these joint surfaces reveal that the joint is open only to the middle of the seal, thus being restricted to the tension side of the seal (Figure 18).

Figure 13.—Damage observed in polyurethane core after removing block form. Fractures in seal are indicated with solid lines; open joints along lifts are indicated with dashed lines. Circles denote where core was obtained for compressive tests.

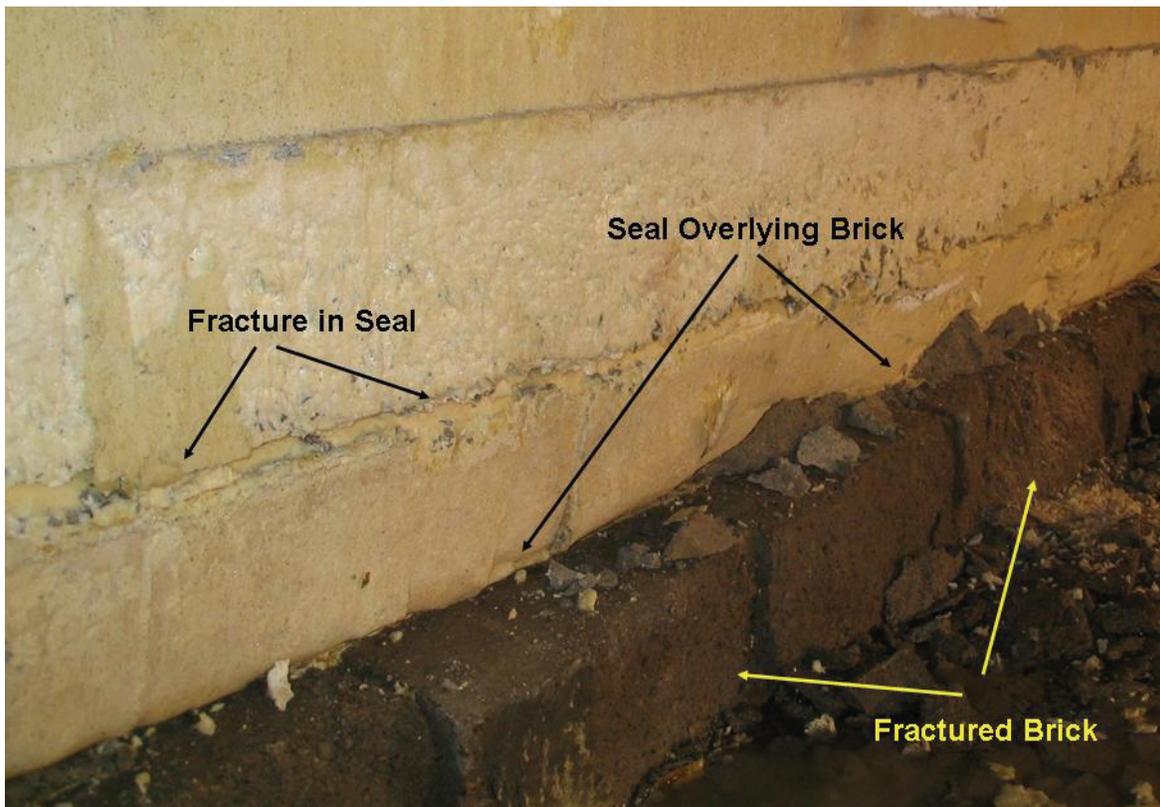
Figure 14.—Closer view of damage observed along lower left side of polyurethane seal along top of bottom row of blocks. Seal has displaced about 2 in over the top of the blocks. The fracture or open joint is along the interface of lifts 1 and 2.

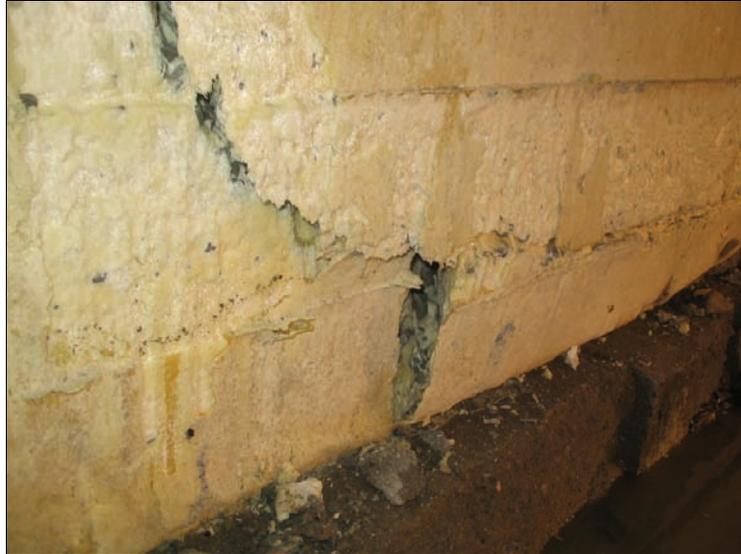
Figure 15.—Fracture and damage observed along lower left side of polyurethane seal along top of bottom row of blocks.

After the seal had failed structurally, the water flow rate was increased to 750 gpm and there was a subsequent increase in pressure to 14.5 psi. However, the seal could not sustain this added pressure, resulting in a large increase in deformation and a sharp drop in pressure to less than 8 psi. At this point, the fracture through the seal on the lower left side would probably have been fully developed (Figure 15).

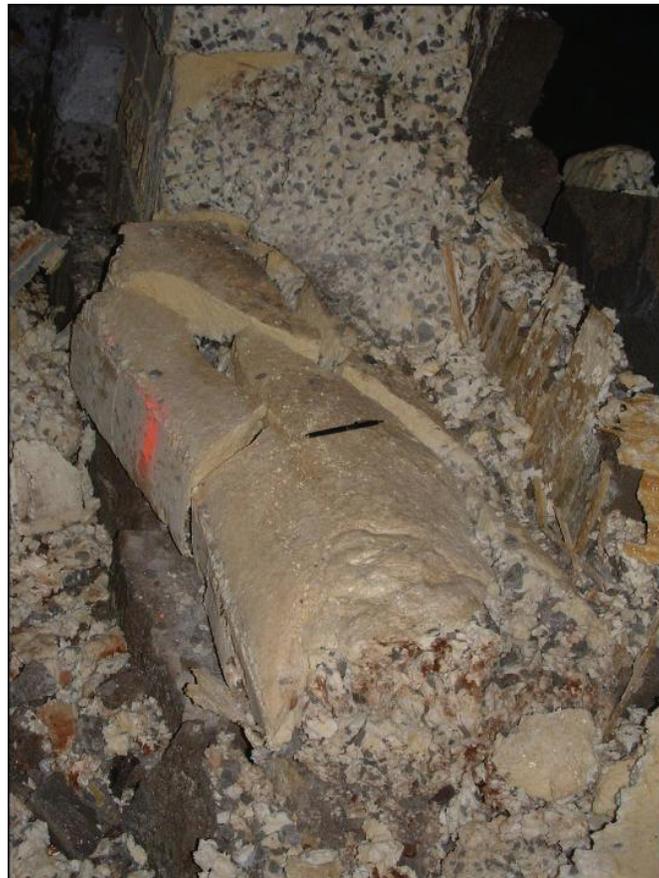
Figure 16.—Internal damage along lower left side of polyurethane seal just above of the bottom row of blocks.

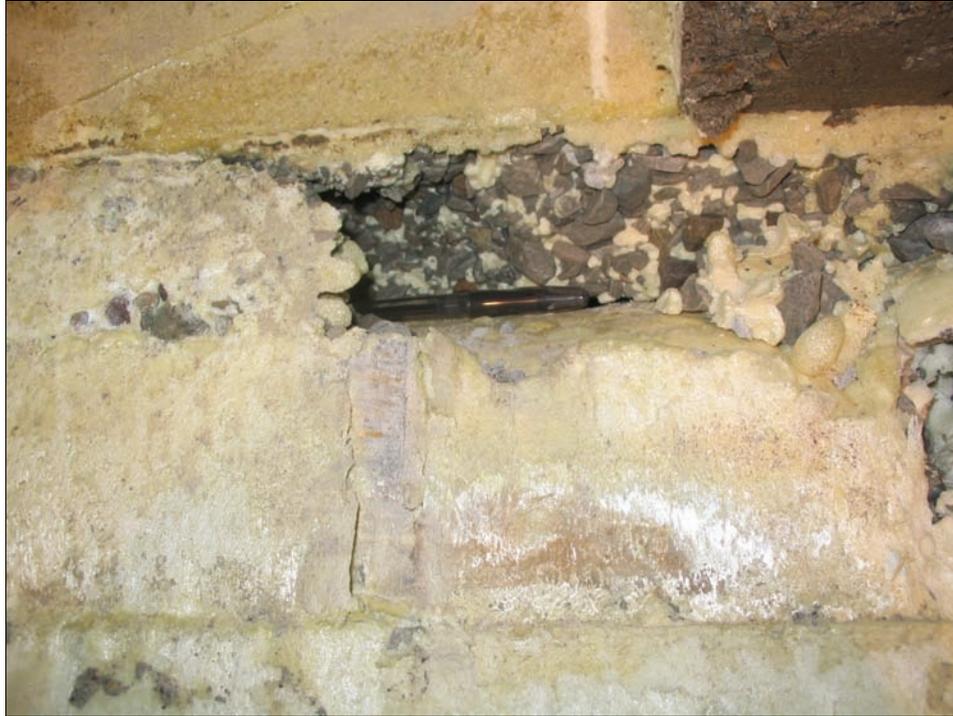
Figure 17.—High concentration of aggregate that is poorly bonded with polyurethane observed along upper right side of seal.

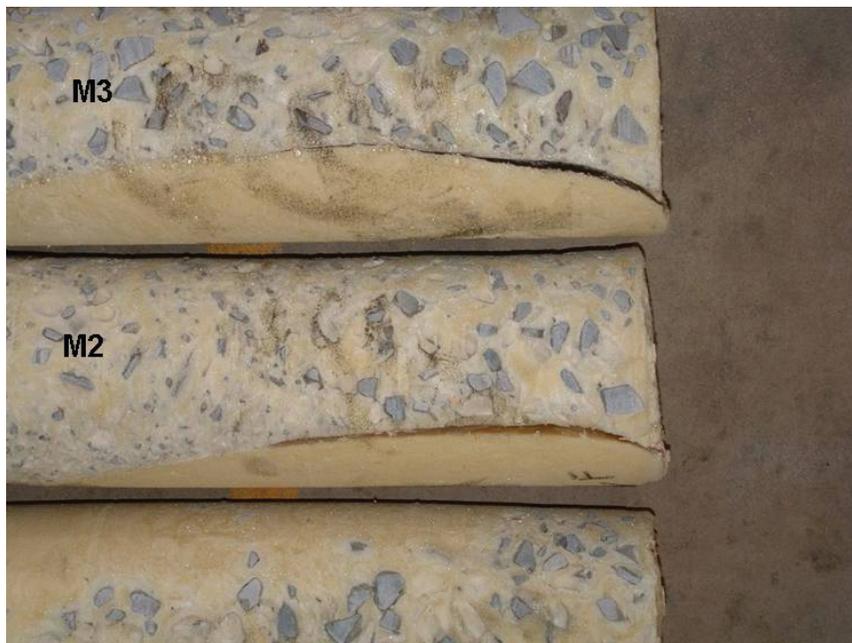
Figure 18.—Separation along the interface between lifts observed in 6-in-diam core drilled horizontally. The right side of the cores is the front side of the seal.

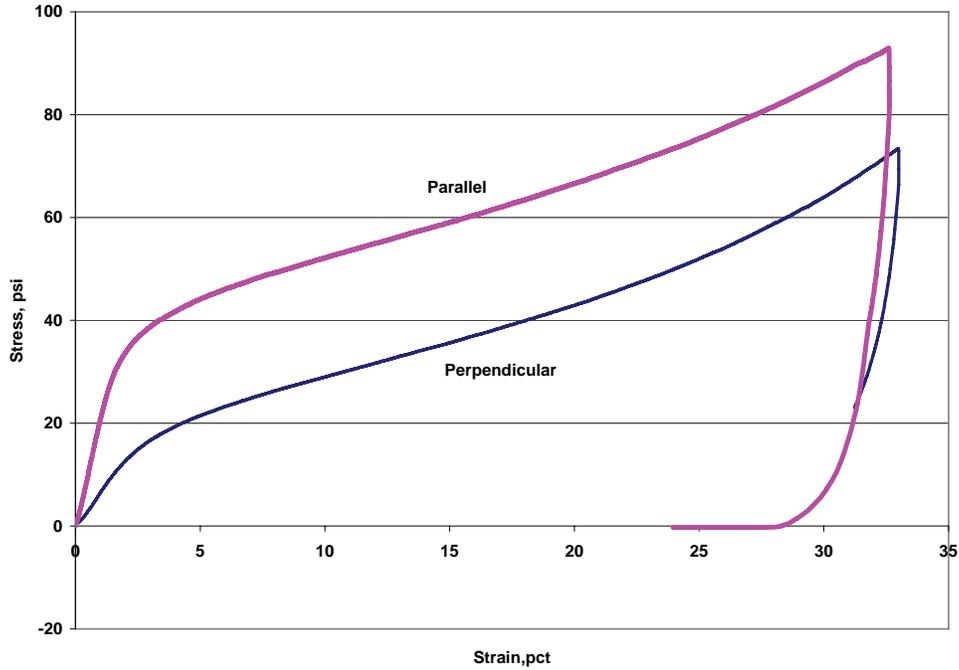
Figure 19.—Typical stress-strain curves developed from uniaxial compressive tests on polyurethane-aggregate mixture tested both perpendicular and parallel to the direction of foam rise.

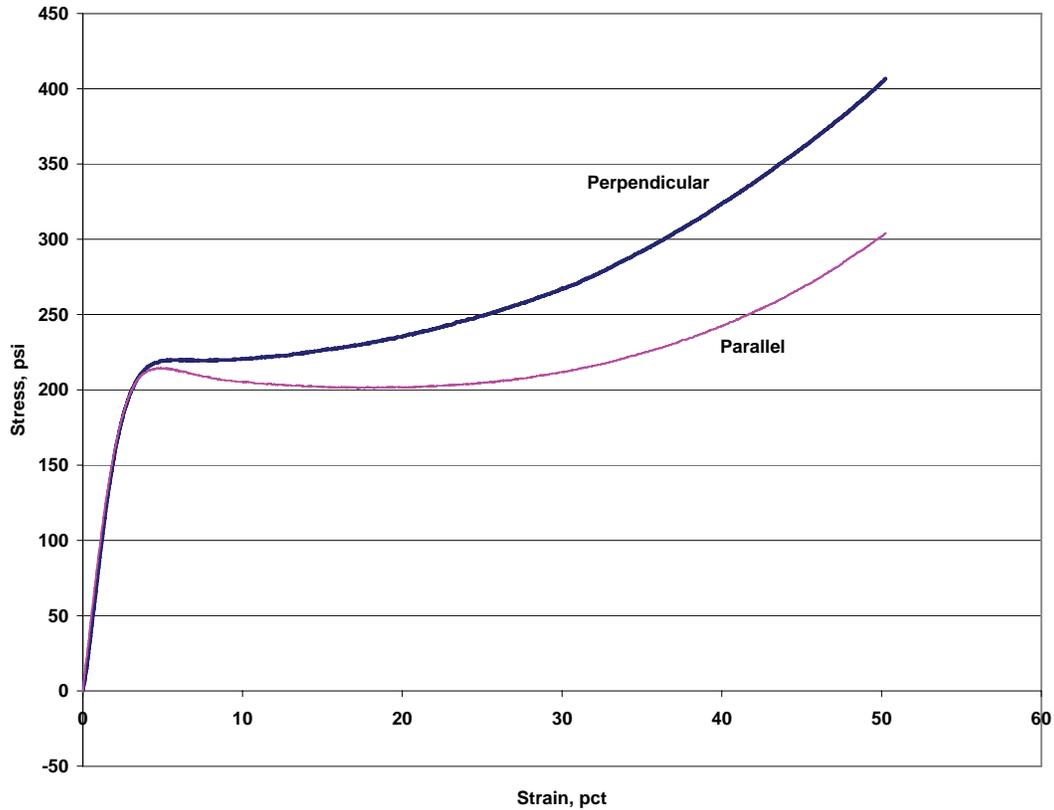
Figure 20.—Typical stress-strain curves developed from uniaxial compressive tests on polyurethane-only cap of lift.

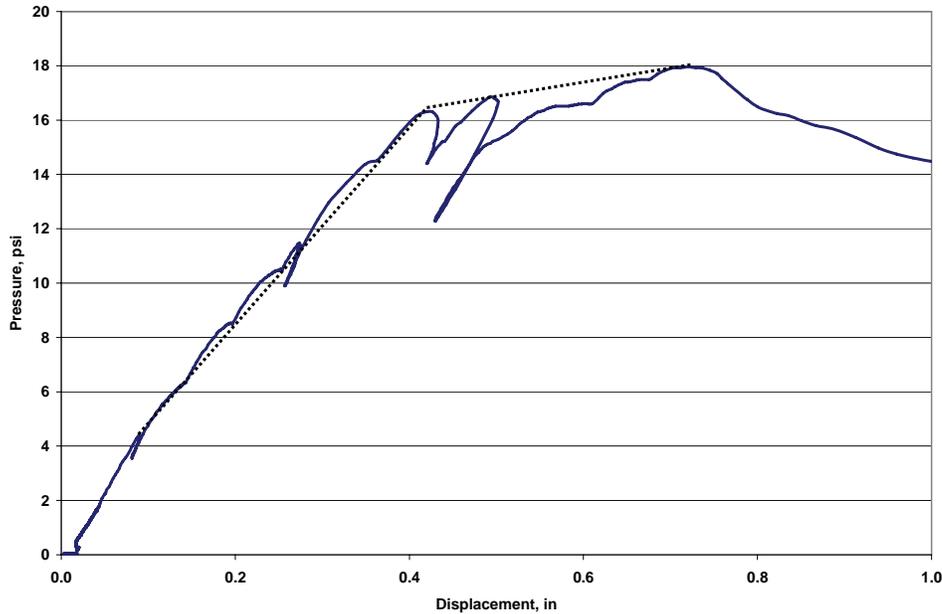
Figure 21 shows the pressure-displacement curve for LVDT 6 located at the center of the seal. The pressure used is that at the pressure transducer. From 0 to 4 psi, the curve is linear, indicating a linear elastic behavior for the seal. From 4 to 16 psi, the curve shows some nonlinear characteristics, possibly associated with inelastic behavior that is time-dependent. Fitting a line from 4 to 16 psi, the decrease in slope indicates some softening of the seal. However, from 16 to 18 psi a significant change in behavior occurs. This was accompanied by a larger increase in visible leakage from the seal. Again, fitting a line between the pressure peak at 16 psi and the maximum pressure at 18 psi shows a further and significant softening of the seal. This suggests that structural damage to the seal was taking place after the pressure reached 16 psi at the pressure transducer. Therefore, 16 psi can be considered the yield strength for the seal. This calculates to an average pressure across the seal of about 17 psi based on the stress distribution of the hydraulic load.

Figure 21.—Pressure-displacement curve for LVDT 6 at the center of seal shows the behavior of the seal. General slopes of curves are indicated by dashed lines.

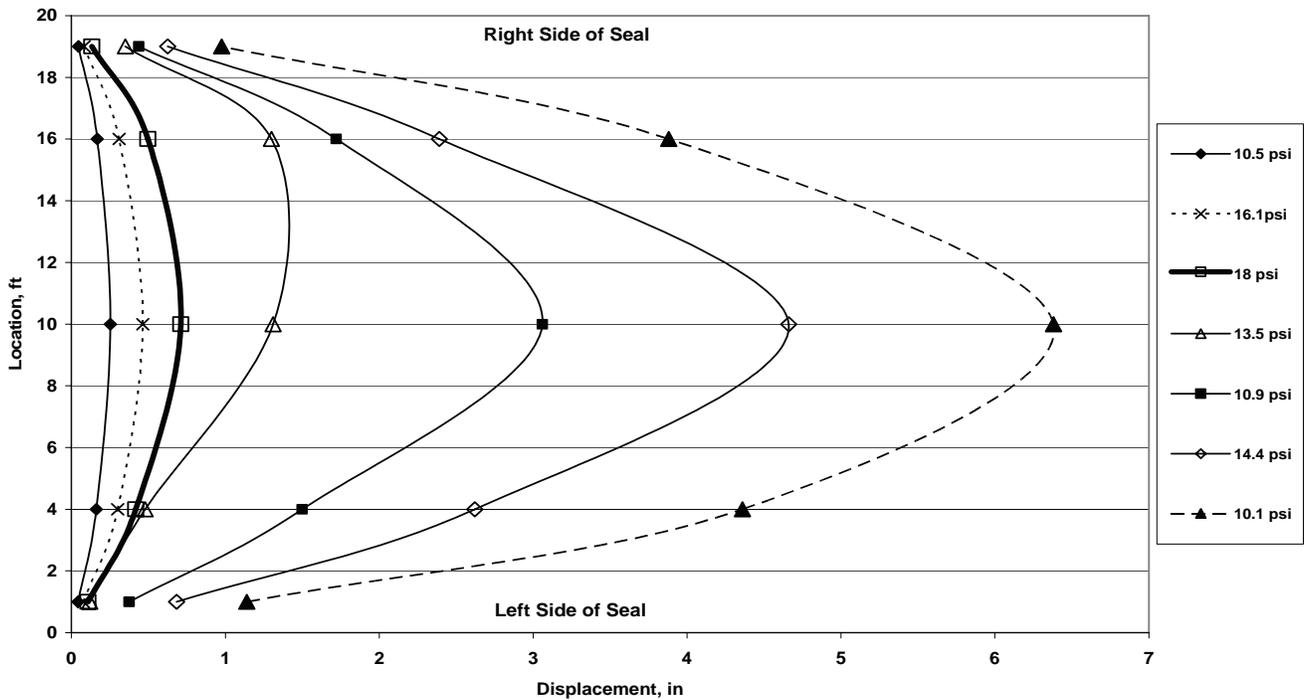
From the observed damage and the pressure and displacement measurements, an understanding of how the seal may have failed can be developed. Figure 22 shows the displacement versus the location of the LVDTs along the horizontal center line of the seal for various pressures. The lines on the graph indicate the change in shape of the seal for a given pressure. The heavy line (third from left) is the deflection at the maximum transducer pressure of 18 psi. All curves past this point are for a failed seal. At the initiation of failure, there is a change in the geometry of the seal. Failure is also indicated by the continued displacement even with a pressure drop. However, the change in shape and movement initially occurs on the right side of the seal. After the failure on the upper right side, at a pressure of 13.5 psi, the displacement at the location 6 ft to the right of the center was initially larger than the displacement at the center. Little or no additional movement is seen on the left side of the seal until the pressure has dropped to 10.9 psi. Figure 23 shows the displacement versus time for LVDTs 2 (left side), 6 (center), and 9 (right side). There is about a 40-sec delay before the increase in displacement is seen on the left side as opposed to that on the right side and center. The main damage observed along the right side of the seal is near the top where the aggregate was not well bonded with the polyurethane (Figures 13 and 17). A major leak also developed at this location (Figure 24). This high concentration of poorly bonded aggregate can be considered a construction flaw.

Figure 22.—Displacements along horizontal center line of the seal show the change in shape of the seal during the test for a given transducer pressure. Curves to the right of the 18-psi line represent the behavior after the peak pressure was achieved.

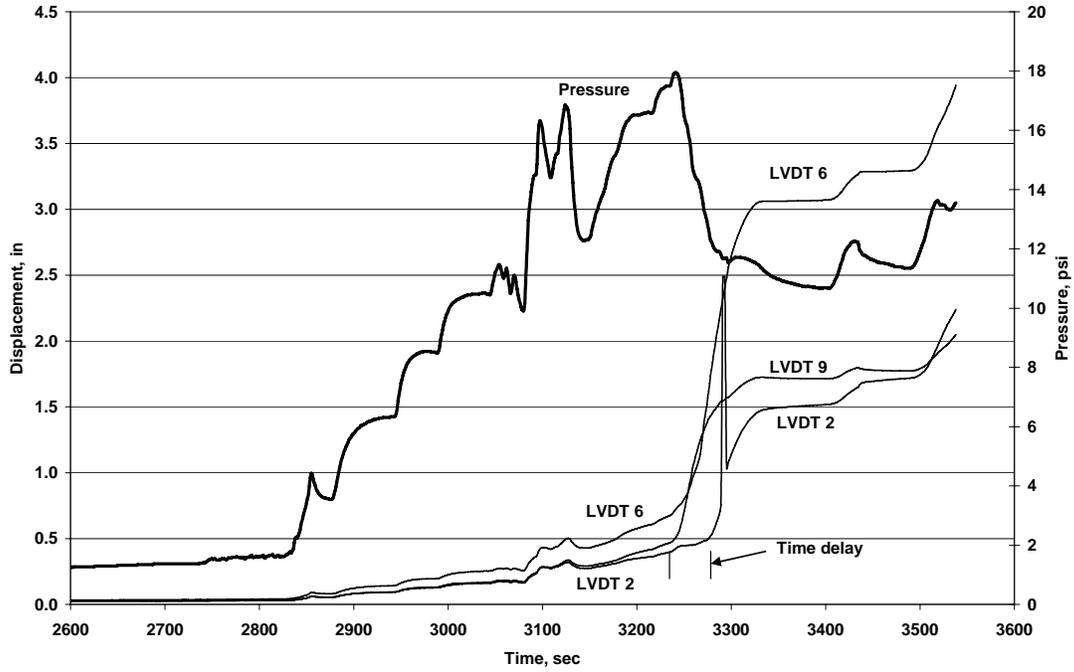
Figure 23.—Displacements measured on the left side (LVDT 2), center (LVDT 6), and right side (LVDT 9) of seal showing the 40-sec delay in the reaction of the left side when the seal failed.

About 40 sec after the failure on the right side, there was a significant change in the geometry on the left side of the seal. This change in geometry probably developed as a result of increased shear stresses and displacements along the top of the bottom row of blocks due to the failure on the upper right side of the seal. This increased shearing and displacement resulted in the development of the near vertical fracture near the lower left corner of the seal (Figures 13 and 15). This was the external manifestation of the internal fractures that extended across the thickness of the seal at this location (Figure 16). This fracture system developed because the lower left corner was more constrained by the rib and blocks than the seal to the right of the fractures. When sufficient shearing and displacement had taken place, the right portion of the seal was torn or sheared away from the lower left corner of the seal, thus creating the fractures. Mostly likely these fractures developed at or just past the peak pressure.

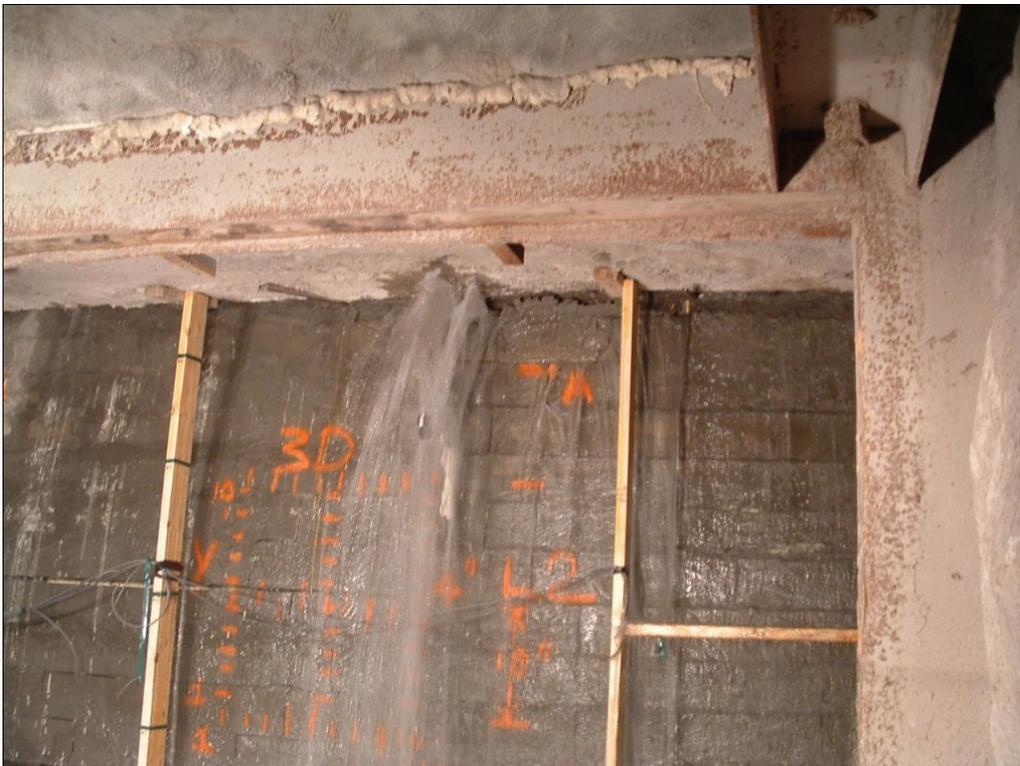
Figure 24.—Water leakage observed from failure zone along upper right side of the seal.

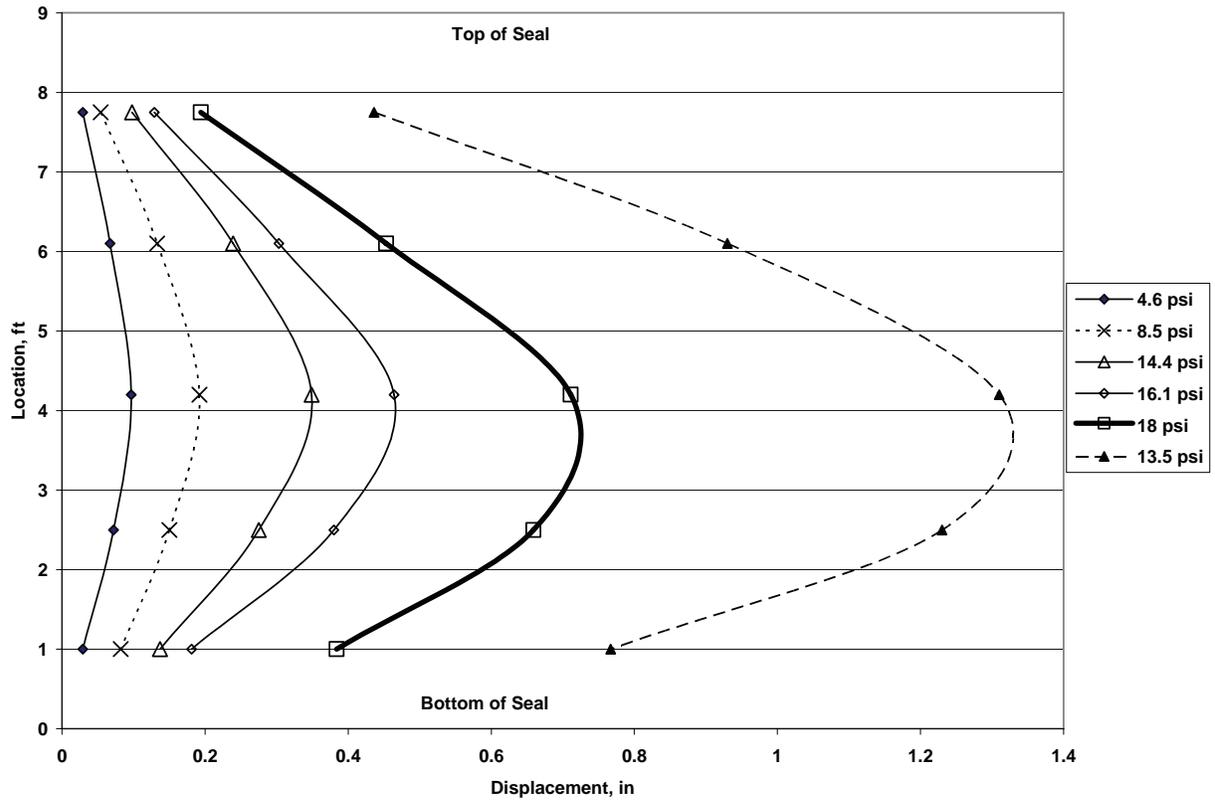
Figure 25.—Displacements along vertical center line of the seal show the change in shape of the seal during the test for a given transducer pressure. Curves to the right of the 18-psi line represent the behavior after the peak pressure was achieved.

One can ask whether the dry-stacked concrete block wall forms increased the strength or stiffness of the seal and thus could be an important element in maintaining the structural integrity of the seal. The possible effects of the forms on the stiffness can be evaluated from the pressure and deflection data prior to failure. Figure 25 shows the deflection of the seal along the vertical center line for different water pressures before and after failure.

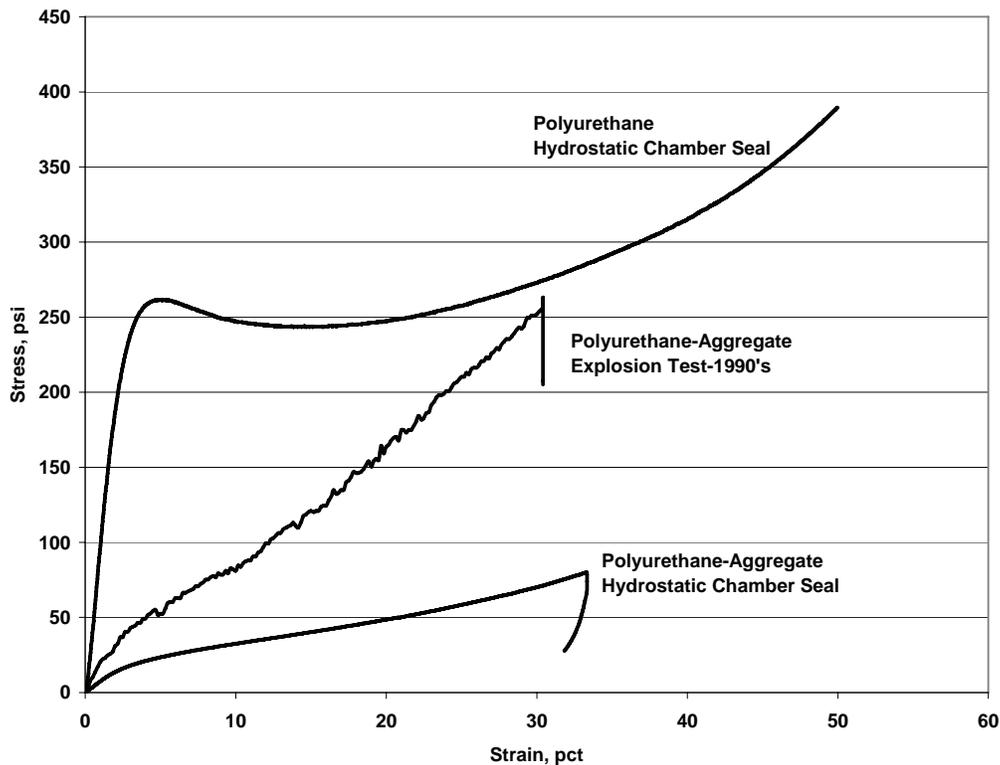
Figure 26 shows some stress-strain curves for samples tested in compression for the polyurethane cap and polyurethane-aggregate mixture from the explosion-tested seal and the seal tested in the hydrostatic chamber. All three samples were tested in the direction perpendicular to foam rise. The densities of the samples were 11 lb/ft³ for the polyurethane cap, 46 lb/ft³ for the polyurethane-aggregate mixture from the explosion-tested seal, and 31 lb/ft³ for the polyurethane-aggregate mixture from the hydrostatically tested seal.

Figure 26.—Stress-strain curves from uniaxial compressive tests on samples from explosion-tested seal from the 1990s and the seal tested in the hydrostatic chamber. Direction of testing was perpendicular to foam rise. The samples were either pure polyurethane or a polyurethane-aggregate mixture.

The compressive test results indicate that the strength and stiffness of the polyurethane-aggregate mixture from both sets of seals were degraded significantly from those of the polyurethane only. However, the polyurethane-aggregate mixture from the explosion-tested seal from the 1990s showed much less decrease in strength and stiffness. The polyurethane aggregate from the 1990s seal has about twice the strength at 10% and 30% strain compared to the polyurethane-aggregate mixture from the more recent hydrostatically tested seal. The degradation of the strength of the polyurethane-aggregate mixture of the explosion-tested seal resulted from the formation of a small amount of soft foam around each aggregate similar to that occurring in the polyurethane-aggregate mixture from the seal tested in the hydrostatic chamber.
