RI 9675

Self-Contained Self-Rescuer Long Term Field Evaluation Tenth Phase Results

Self-Contained Self-Rescuer Long Term Field Evaluation: Tenth Phase Results

DEPARTMENT OF HEALTH AND HUMAN SERVICES
Centers for Disease Control and Prevention
National Institute for Occupational Safety and Health

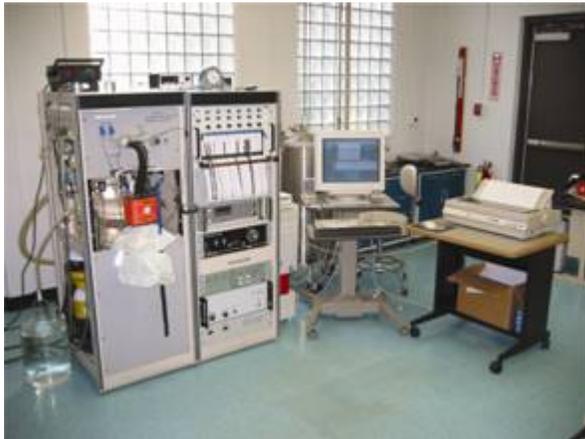
Figure 1. Breathing and Metabolic Simulator

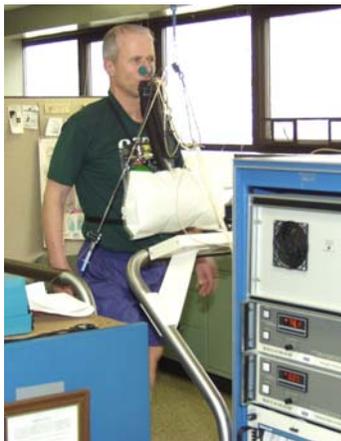
Figure 2. Treadmill Testing

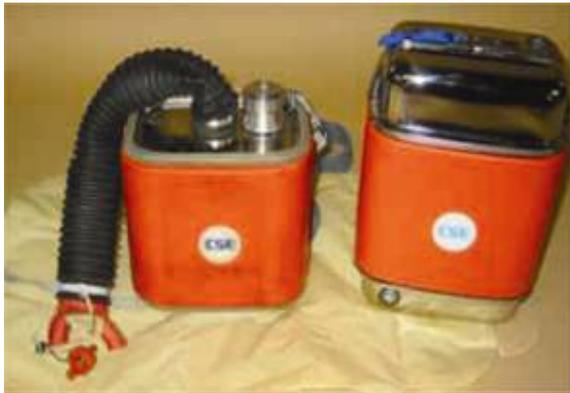
Figure 3. Uncased and Cased CSE SR-100 Self-rescuer

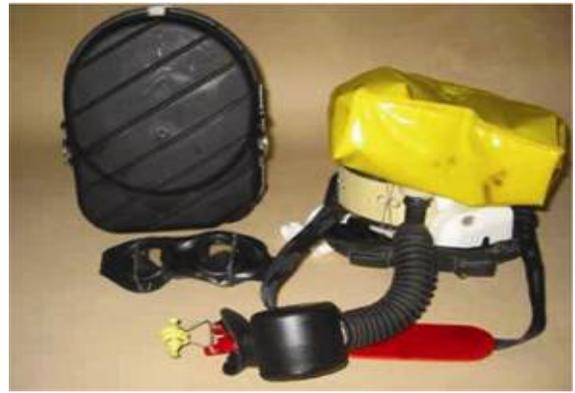
Figure 4. Cased and Uncased Draeger OXY K-Plus Self-rescuer

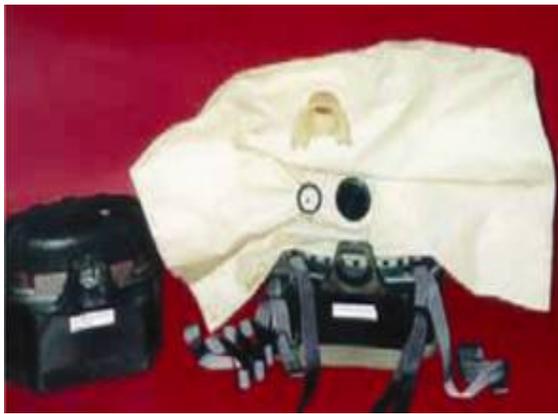
Figure 5. Cased and Uncased MSA Life-Saver 60 Self-rescuer

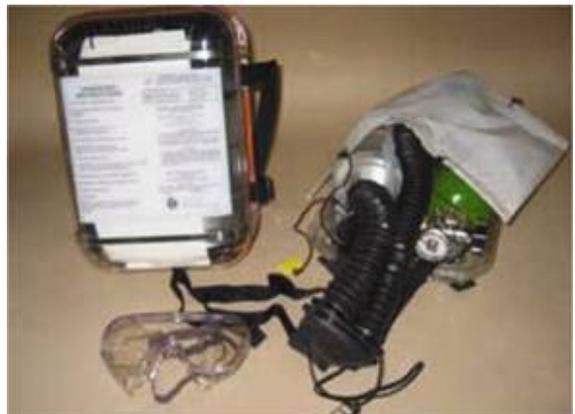
Figure 6. Cased and Uncased Ocenco EBA 6.5 Self-rescuer

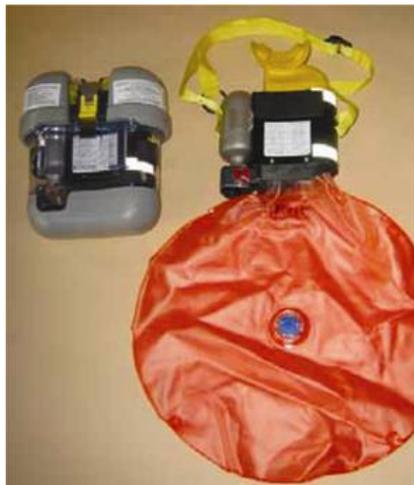
Figure 7. Partially Uncased and Uncased Ocenco M-20 Self-rescuer

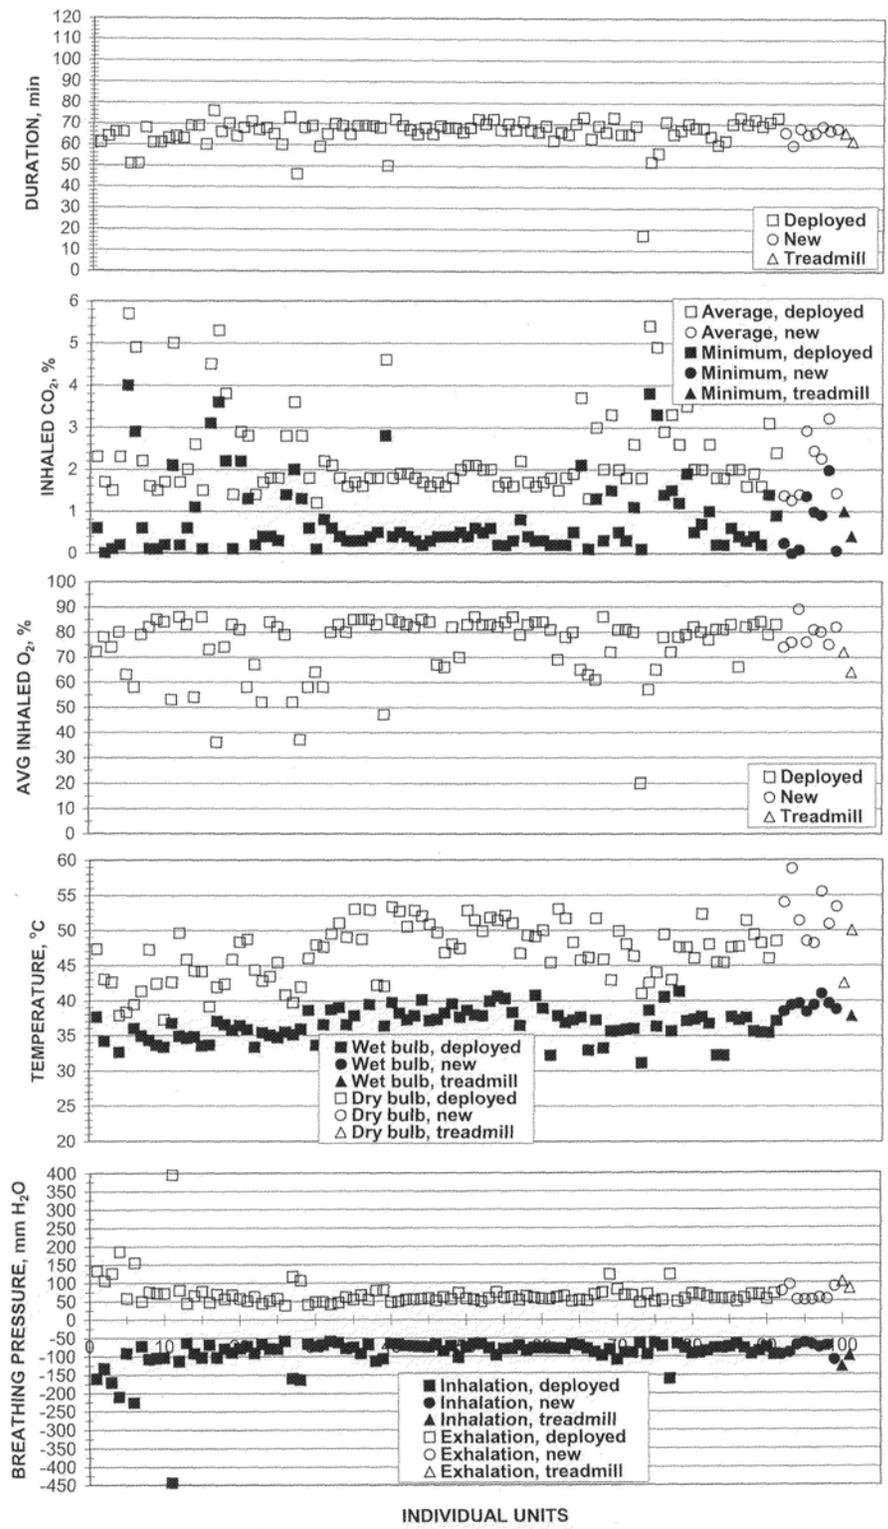
Figure 8. CSE SR-100 test results

Experience with each model of apparatus is discussed separately. The minute-average values of the monitored stressors were averaged over the entire test duration and are presented graphically (Figures 8-12) for each apparatus by stressor. The values for new units tested on the BMS can be compared with those for deployed units also tested on the BMS. To some extent, they may also be compared with those for deployed units tested on the human subject on a treadmill. Because the human subject differs from the BMS in respiratory frequency, treadmill tests cannot be considered equivalent to the BMS tests even though the O₂ consumption rate is the same. Missing data points indicate test equipment malfunction or inability to instrument apparatus.

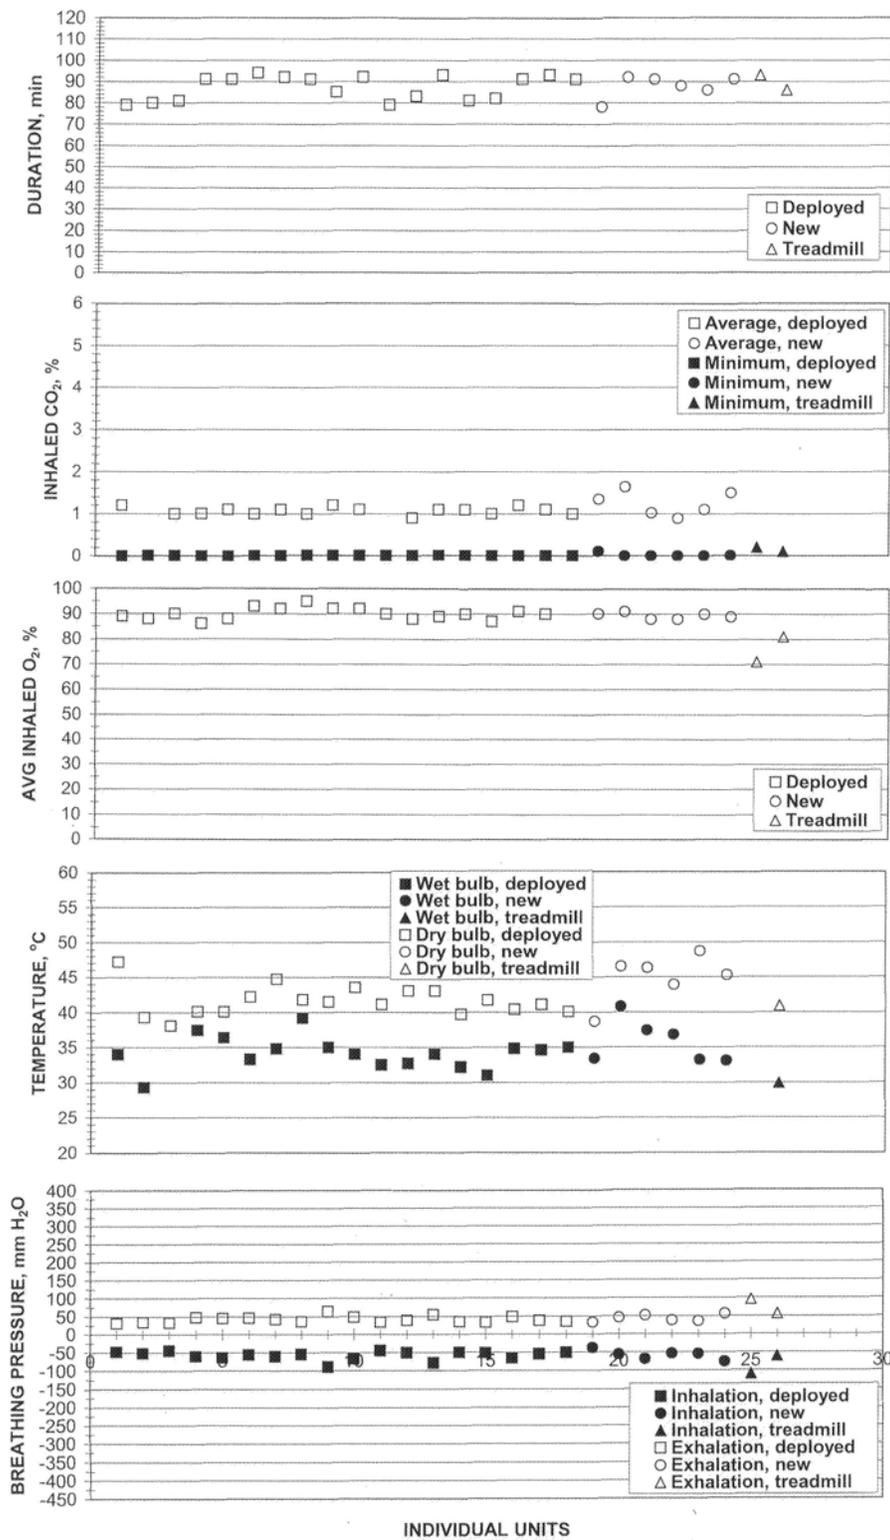
Figure 9. Draeger OXY K-Plus test results

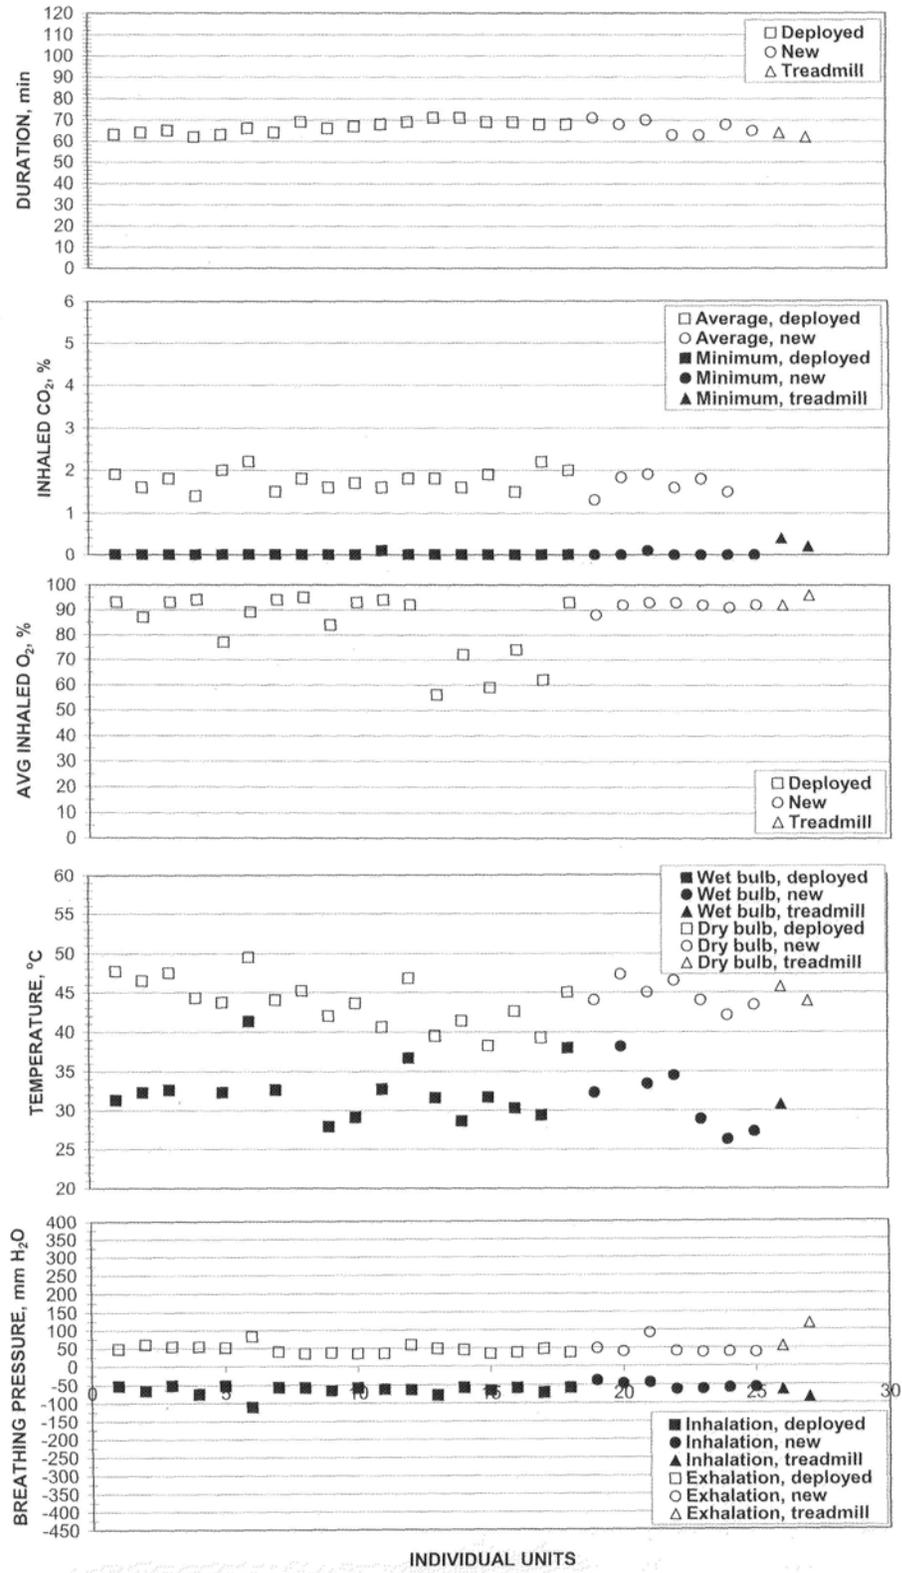
Figure 10. MSA Life Saver 60 test results

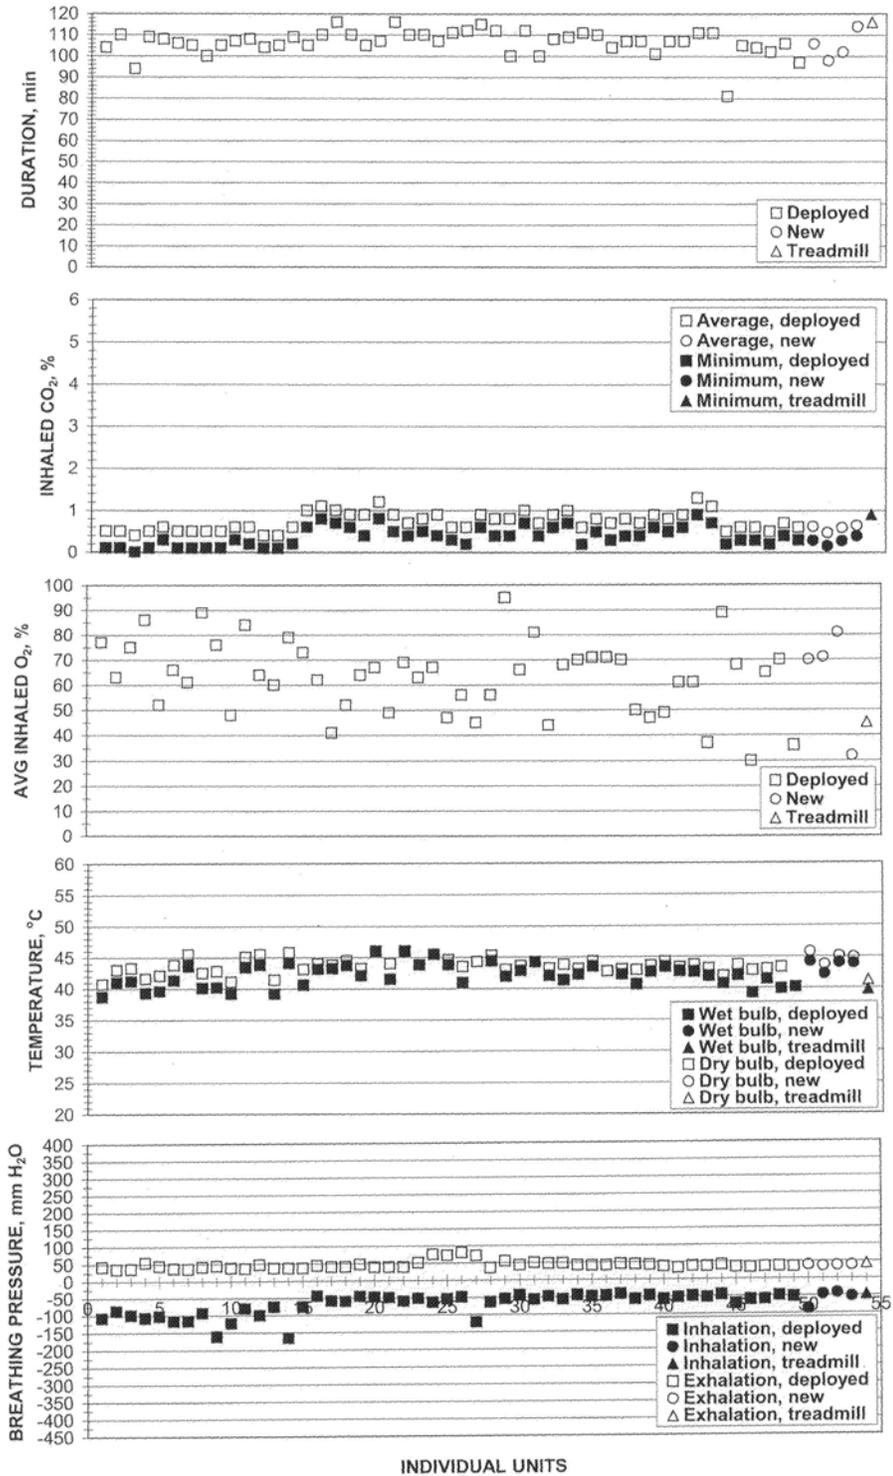
Figure 11. Ocenco EBA 6.5 test results

The wide range of average inhaled O₂ test averages is due to the difference in the apparatus O₂ regulator flow rates, which ranged in this phase from 1.02 to 1.90 L/min ATPD. The O₂ concentration in a breathing circuit will rise if the O₂ supply rate is higher than the O₂ consumption rate.

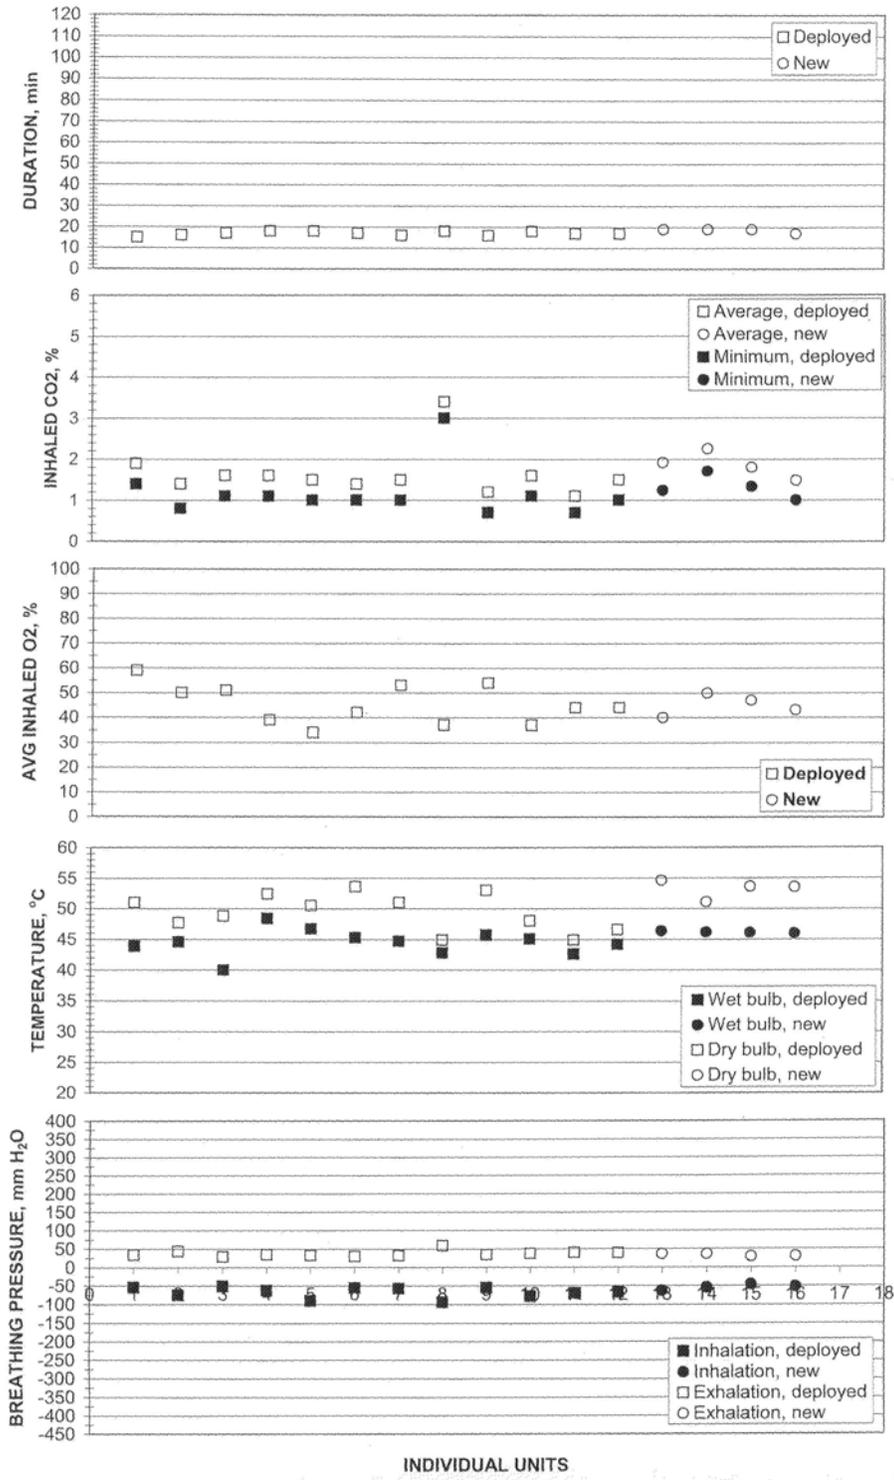
Figure 12. Ocenco M-20 test results

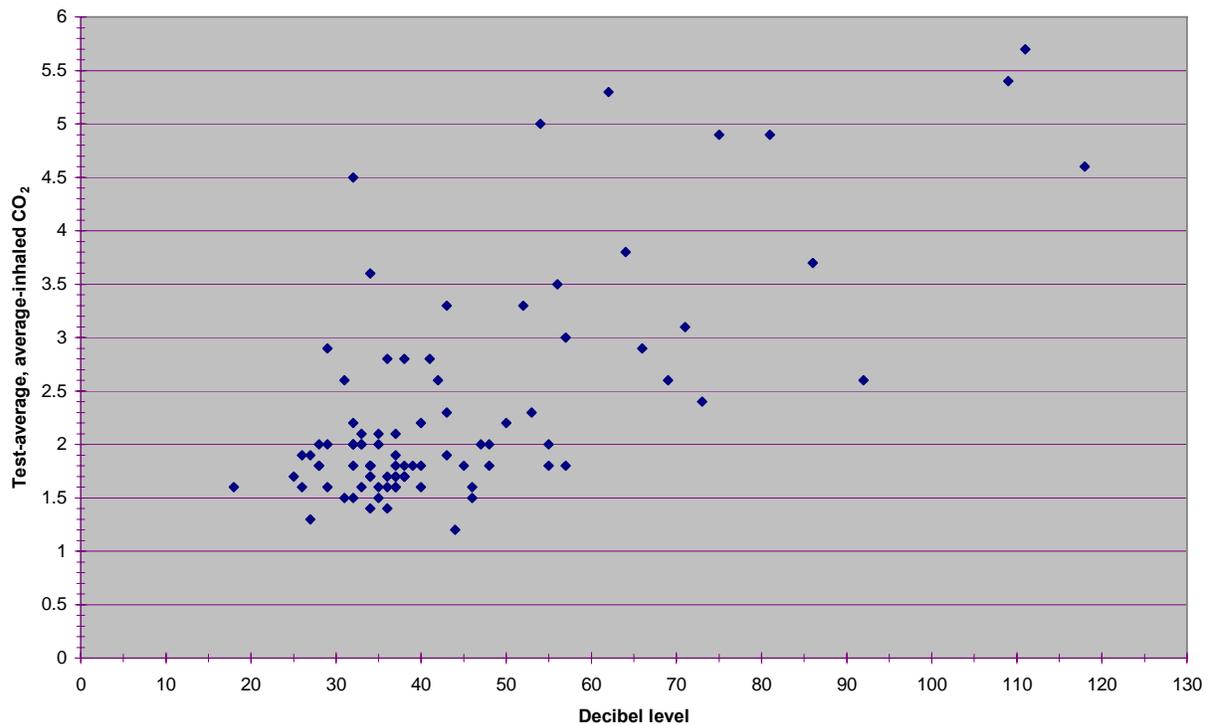
Decibel level vs Test-average, average-inhaled CO₂

Figure 13. CSE SR-100 decibel level versus CO₂ level

The correlation coefficient between the dB levels obtained in the ASMD induced-noise test and the test-average, average inhaled CO₂ levels (Figure 13) was 0.71 for the apparatus tested in this phase.
