A New Visual Warning System to Reduce Struck-by and Pinning Accidents

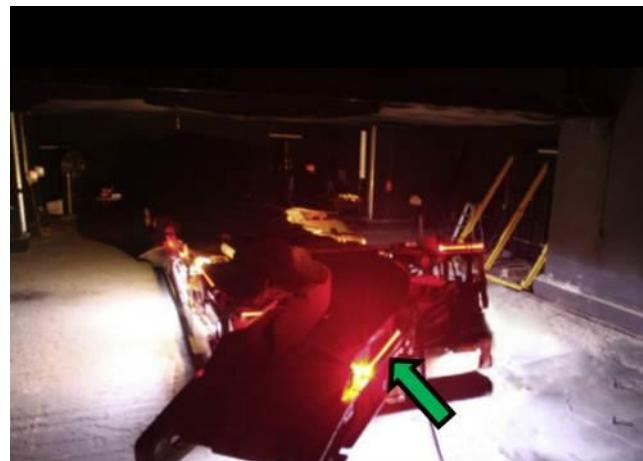
Figure 1. The new Visual Warning System (VWS) installed on a continuous mining machine (CMM). The LED warning light (see arrow) indicates that the conveyor is going to swing to the right.

To verify the practicality (viability) of the new VWS, NIOSH researchers conducted human subject testing in a controlled, laboratory environment [Sammarco et al. 2012] with a CMM as the test machine. The VWS mounts to the CMM and electrically interfaces to the CMM’s control subsystem. The VWS has its own control subsystem and eight luminaires with each using a red, 1-W light-emitting diode (LED) to illuminate a 0.6-m-long, 14-mm-diameter side-emitting optical fiber (Figure 1). Due to safety concerns during testing, researchers used a
