Report of Investigations 9702

## **Ground Stress in Mining (Part 1): Measurements and Observations at Two Western U.S. Longwall Mines**

Mark K. Larson, Heather E. Lawson, Eric G. Zahl, and Tristan H. Jones

January 2020

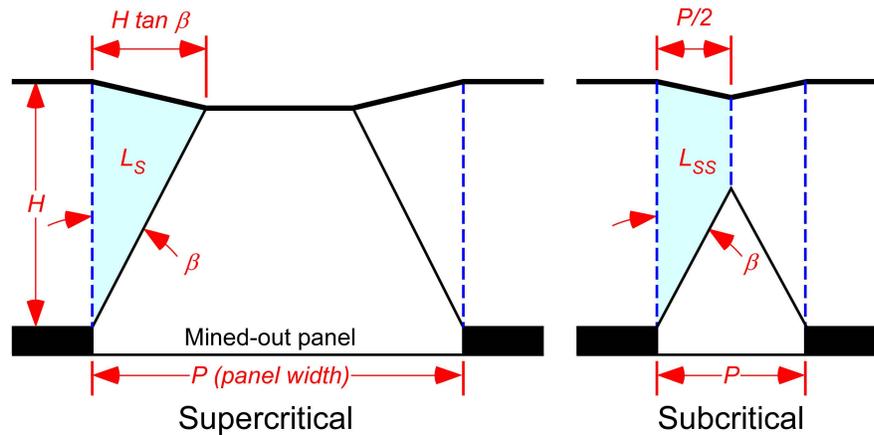
**Figure 1. Distribution of overpanel weight for supercritical and subcritical panels. The weight of the shaded region is transferred to the adjacent abutment. Figure after ideas of King and Whittaker [1970].**

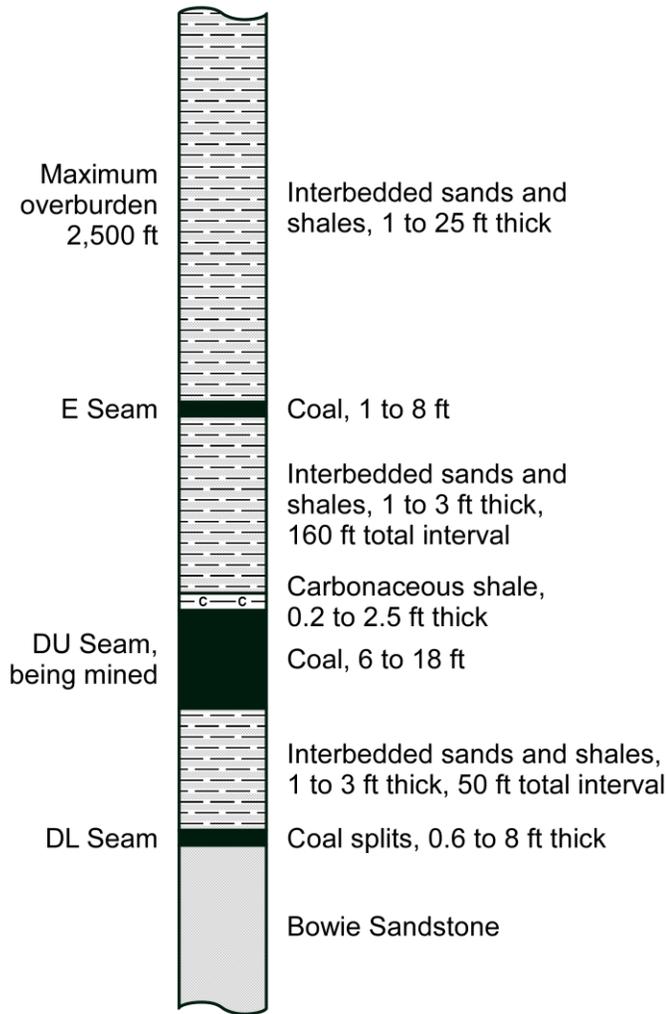
**Figure 2. Generalized stratigraphic column provided by Mine A.**

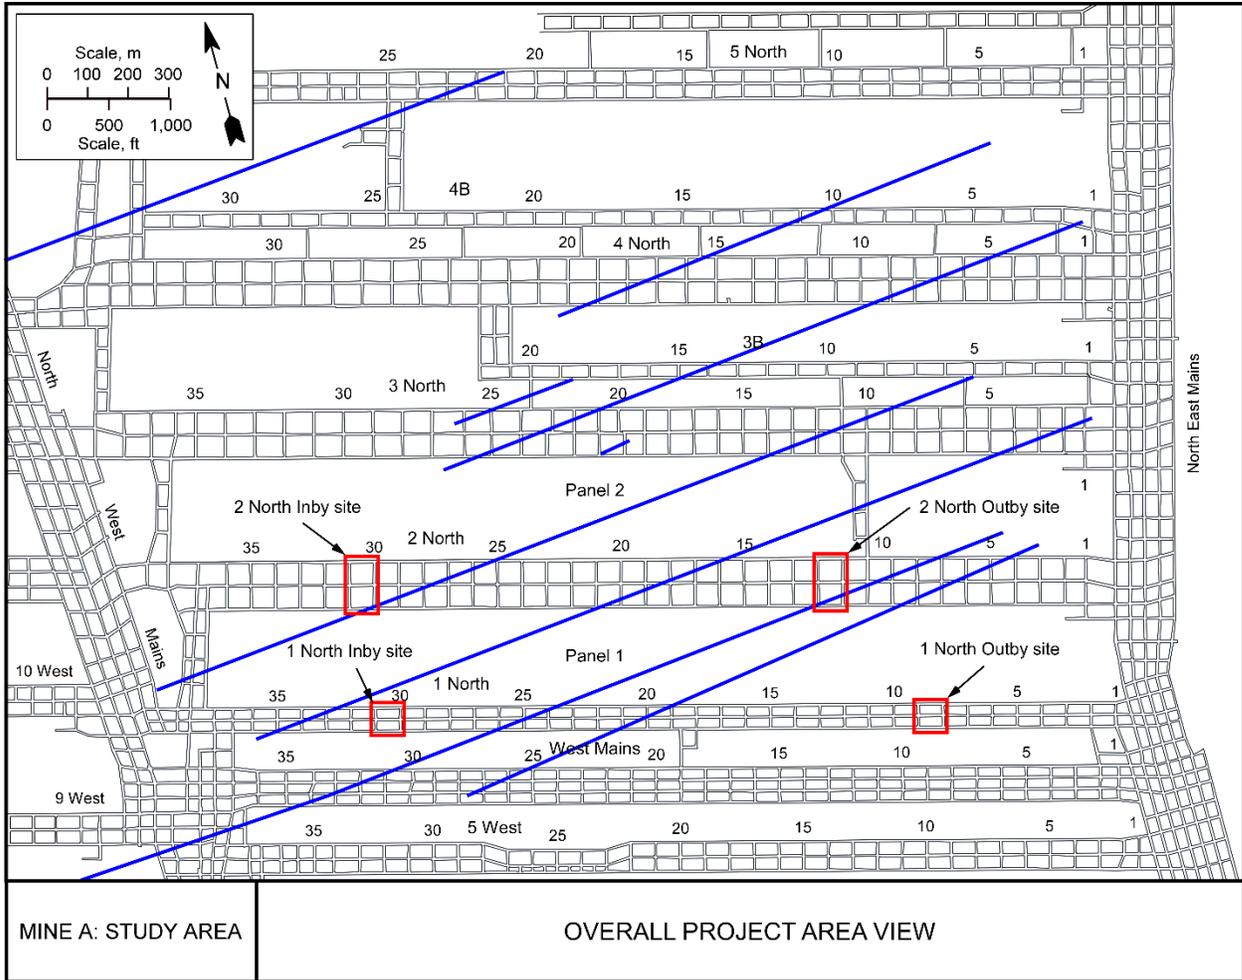
**Figure 3. Mine map of Mine A with overlain mapped and projected faulting. Blue lines indicate both mapped and projected faults. Red boxes indicate location of main instrument sites in this study.**

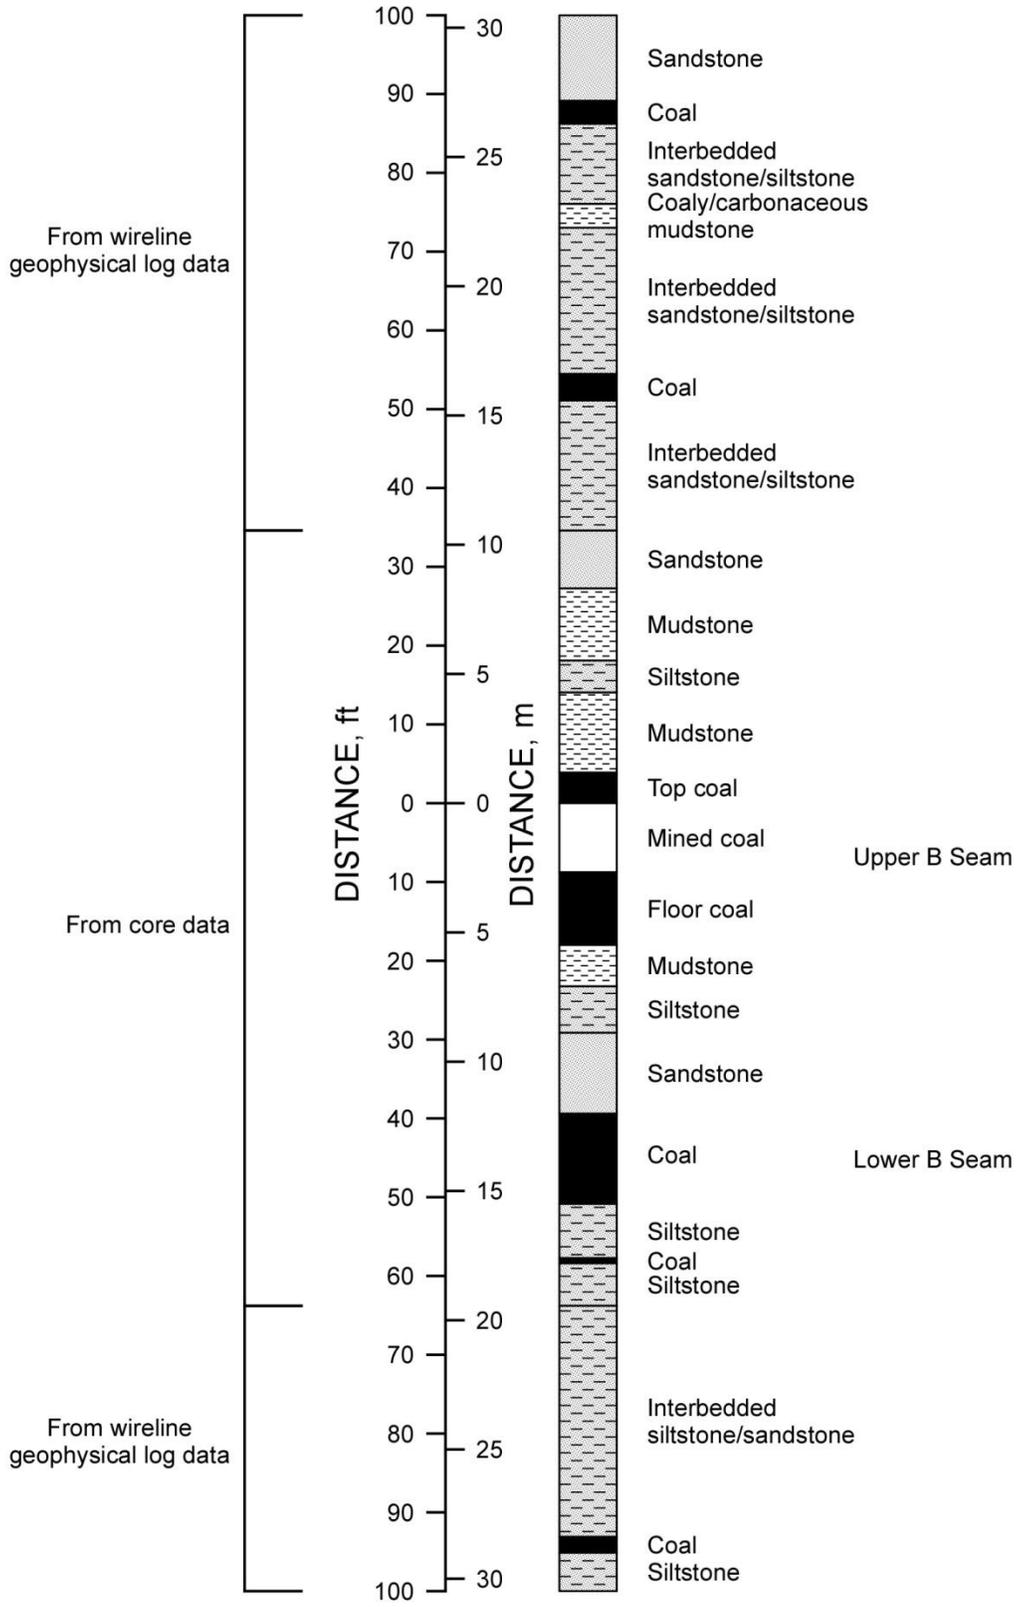
**Figure 4. A stratigraphic column constructed from core taken in the B-12 headgate at crosscut 23 in Mine B.**

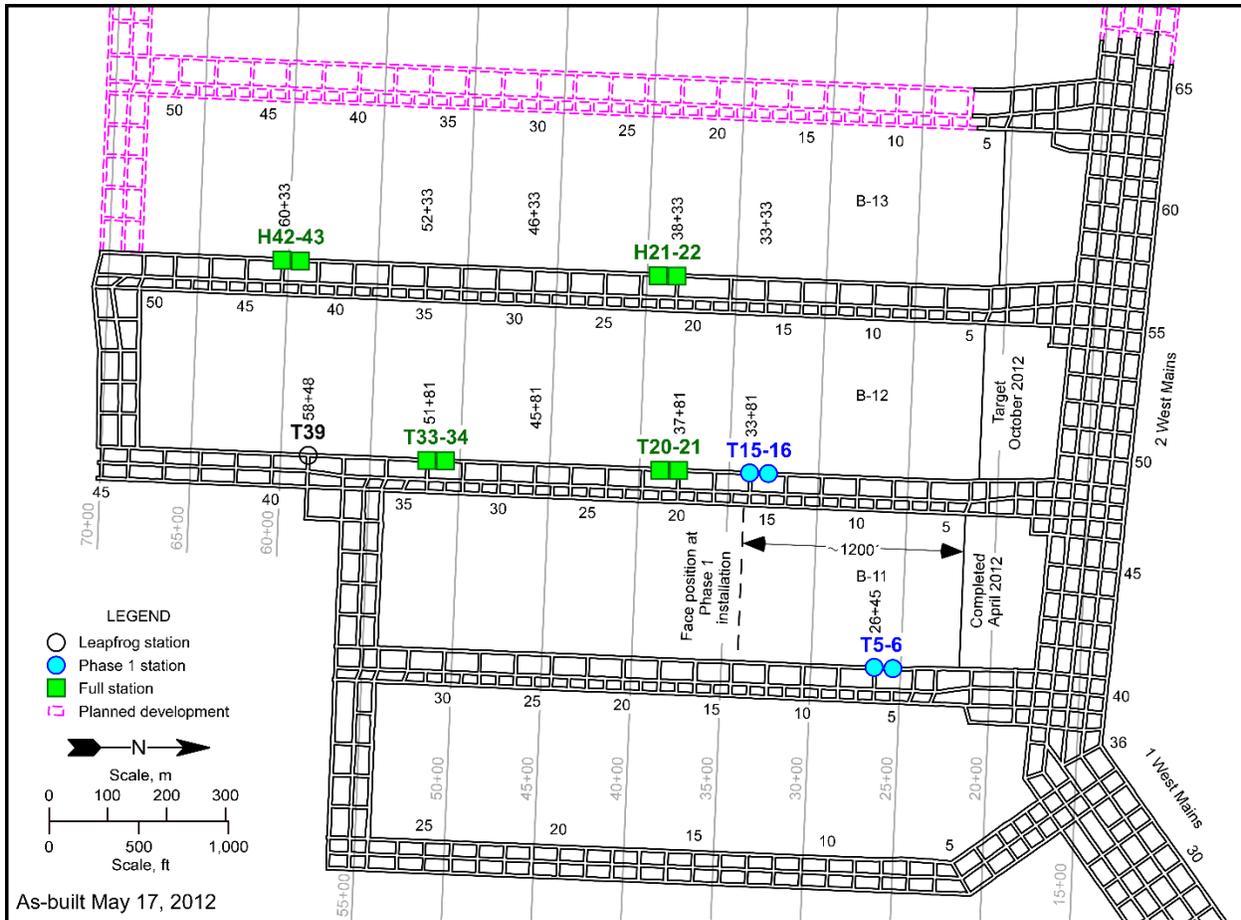
**Figure 5. The locations of instrument sites in the B-11 and B-12 panel gate roads at Mine B.**

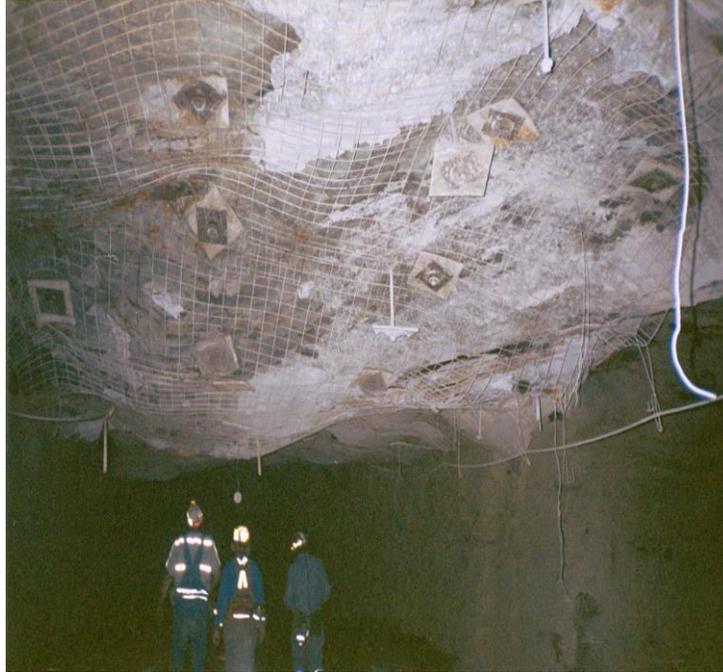
**Figure 7. Sample photograph of rating 3 roof deterioration. The roof is sagging greatly in places and appears loose—only held up by mesh and roof bolts.**

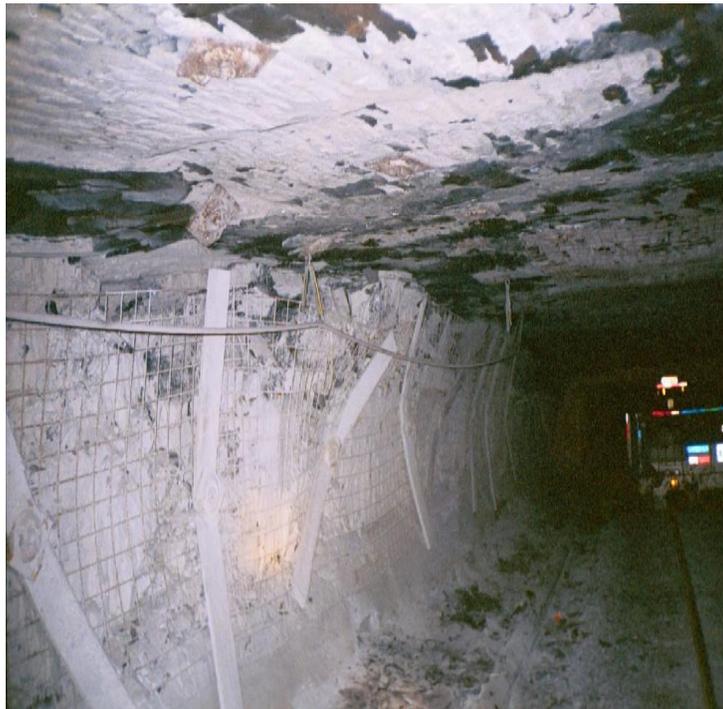
**Figure 8. Sample photograph of rating 1.5 rib deterioration.**

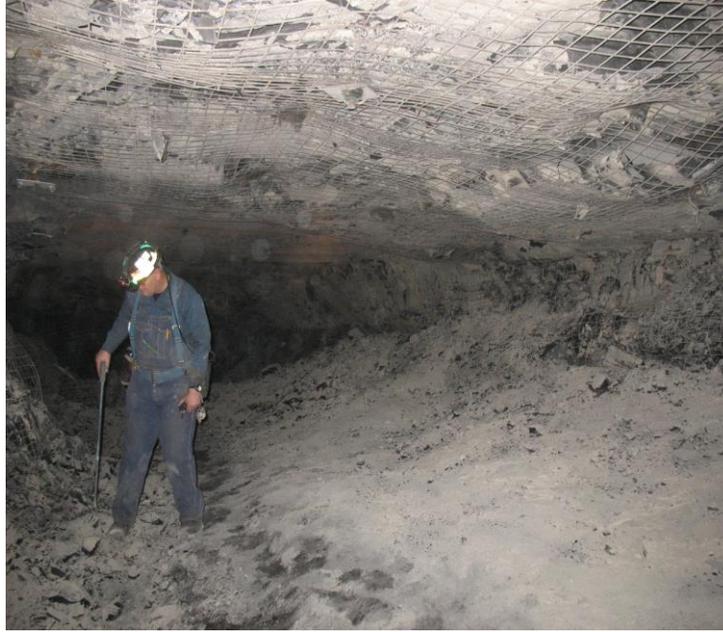
**Figure 9. Sample photograph of rating 4 floor heave.**

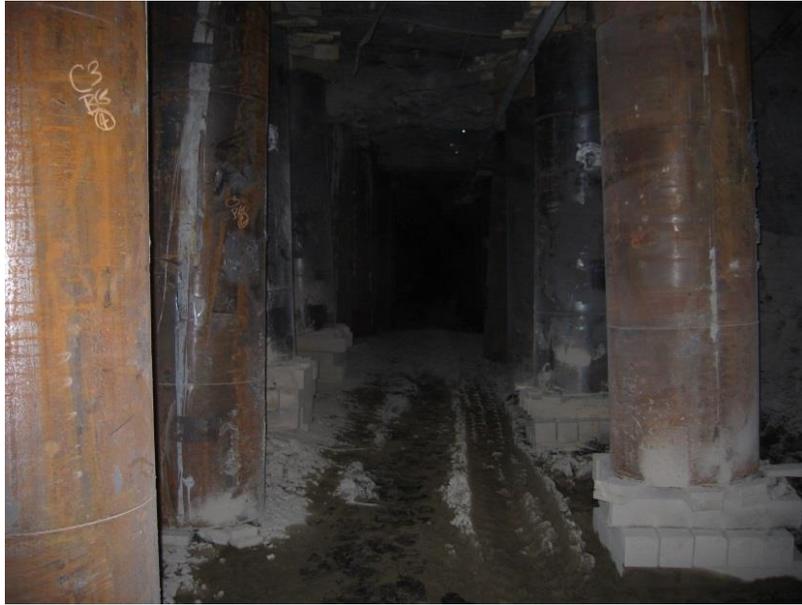
**Figure 10. View of entry 3 at crosscut 10 in 1 North, showing a typical 1 North condition of no significant floor heave.**

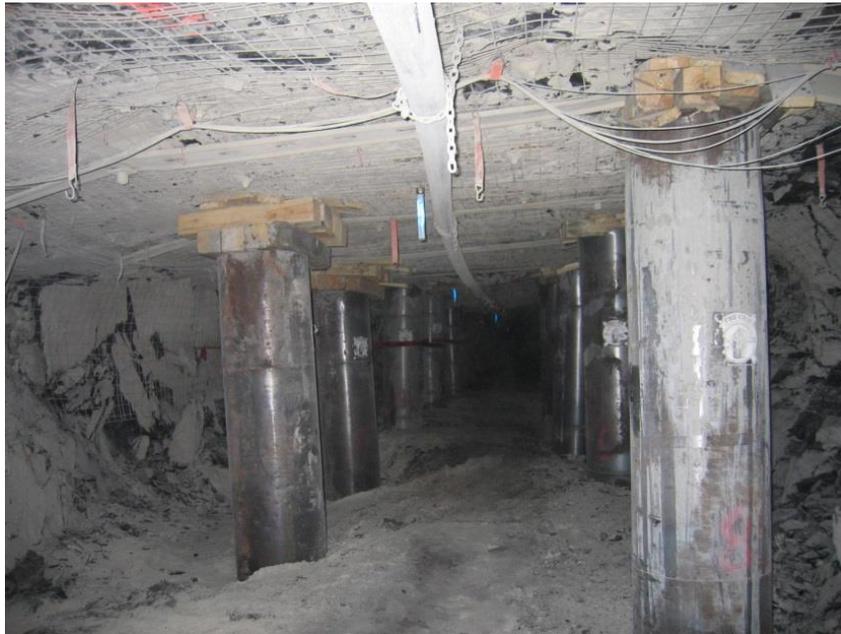
**Figure 11. View of entry 2 at crosscut 30 in 2 North, showing typical floor heave as the face approached.**

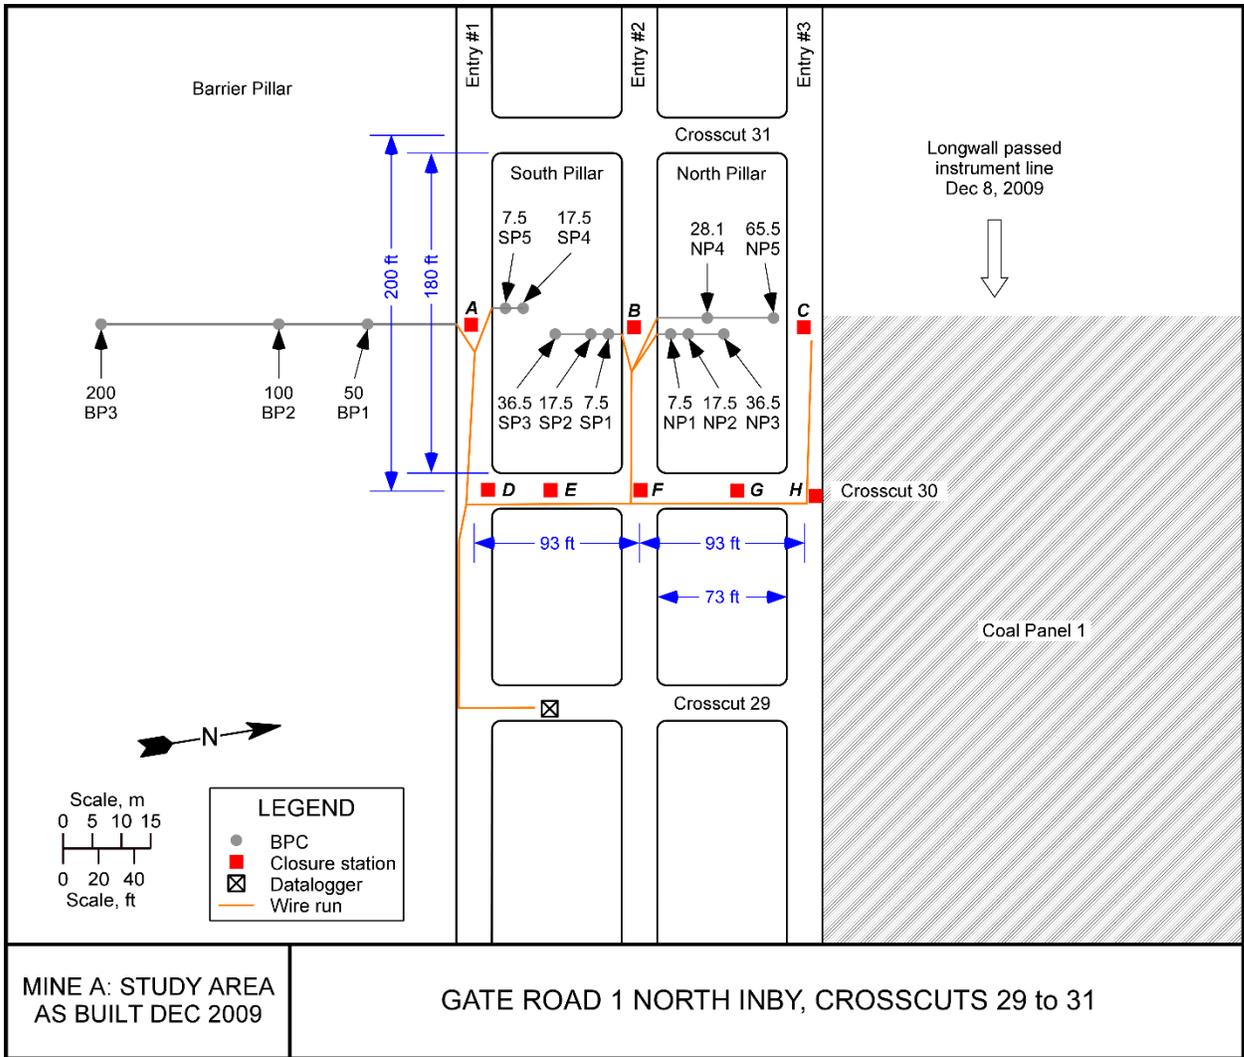
Figure 12. Instrumentation as installed at the 1 North inby site. Pillars between crosscuts 29 and 30 have incorrect lengths by scale. They have the same lengths as the other pillars.

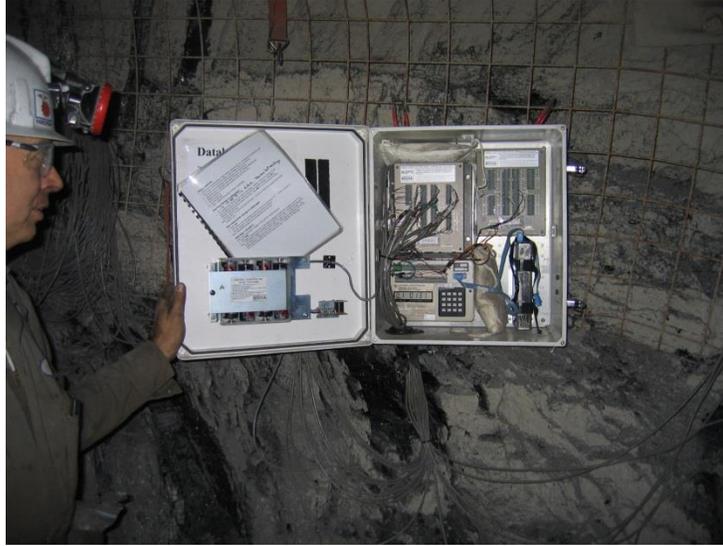
**Figure 13. Enclosure with Campbell Scientific 21XQM datalogger and components for reading BPC pressure transducers and the string potentiometers of roof extensometers.**

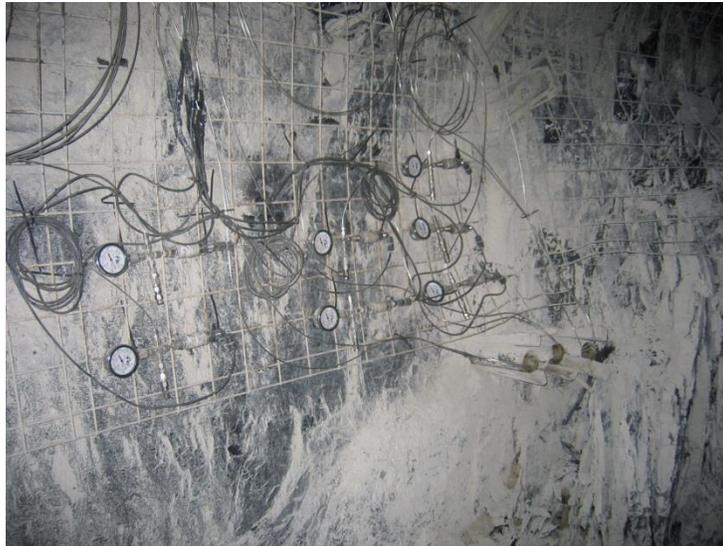
**Figure 14. Hydraulic lines, manifolds, hydraulic gauges, pressure transducers, and cabling installed on the rib near the collars of BPC boreholes at the 2 North inby site.**

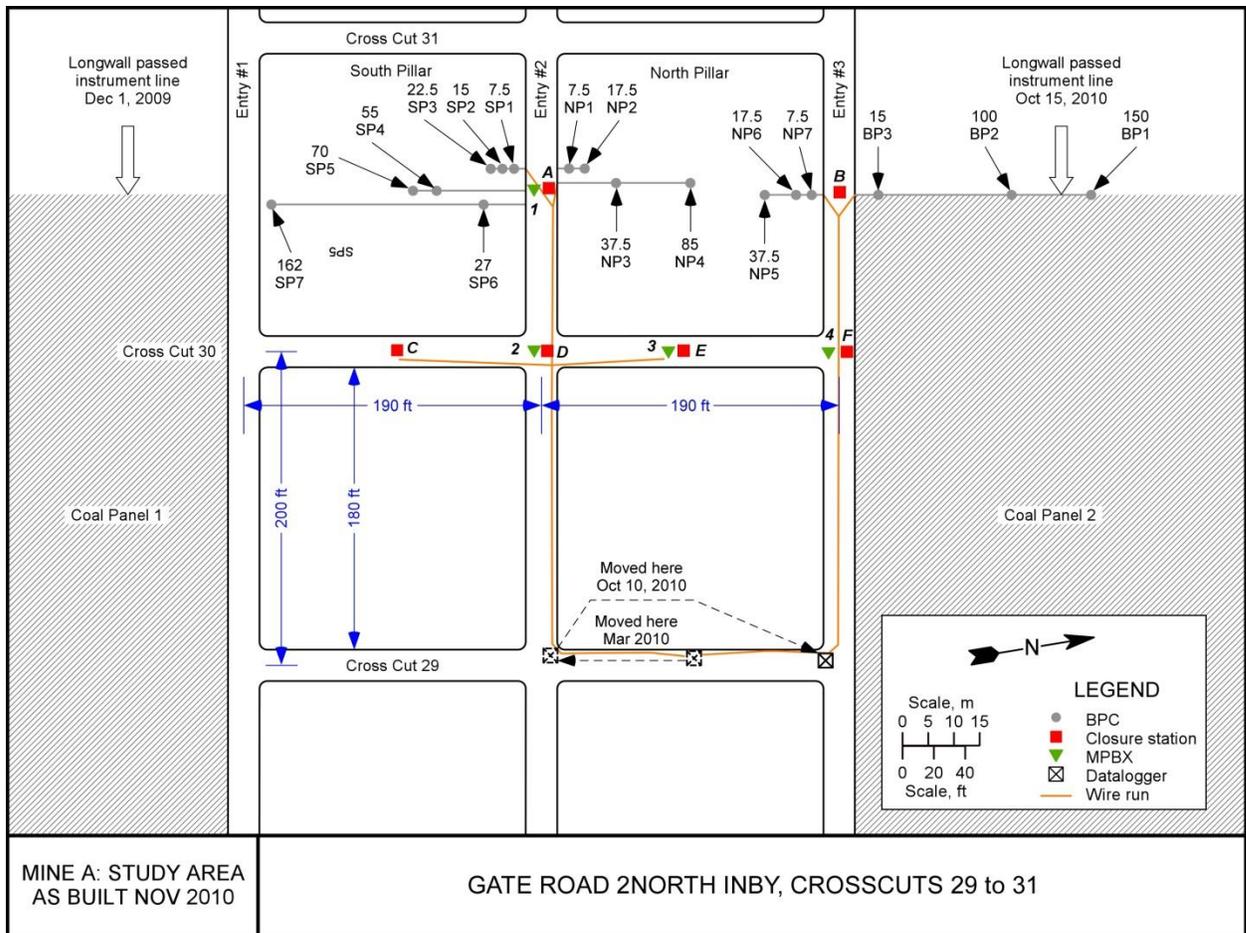
**Figure 15. Instrumentation as installed at the 2 North inby site.**

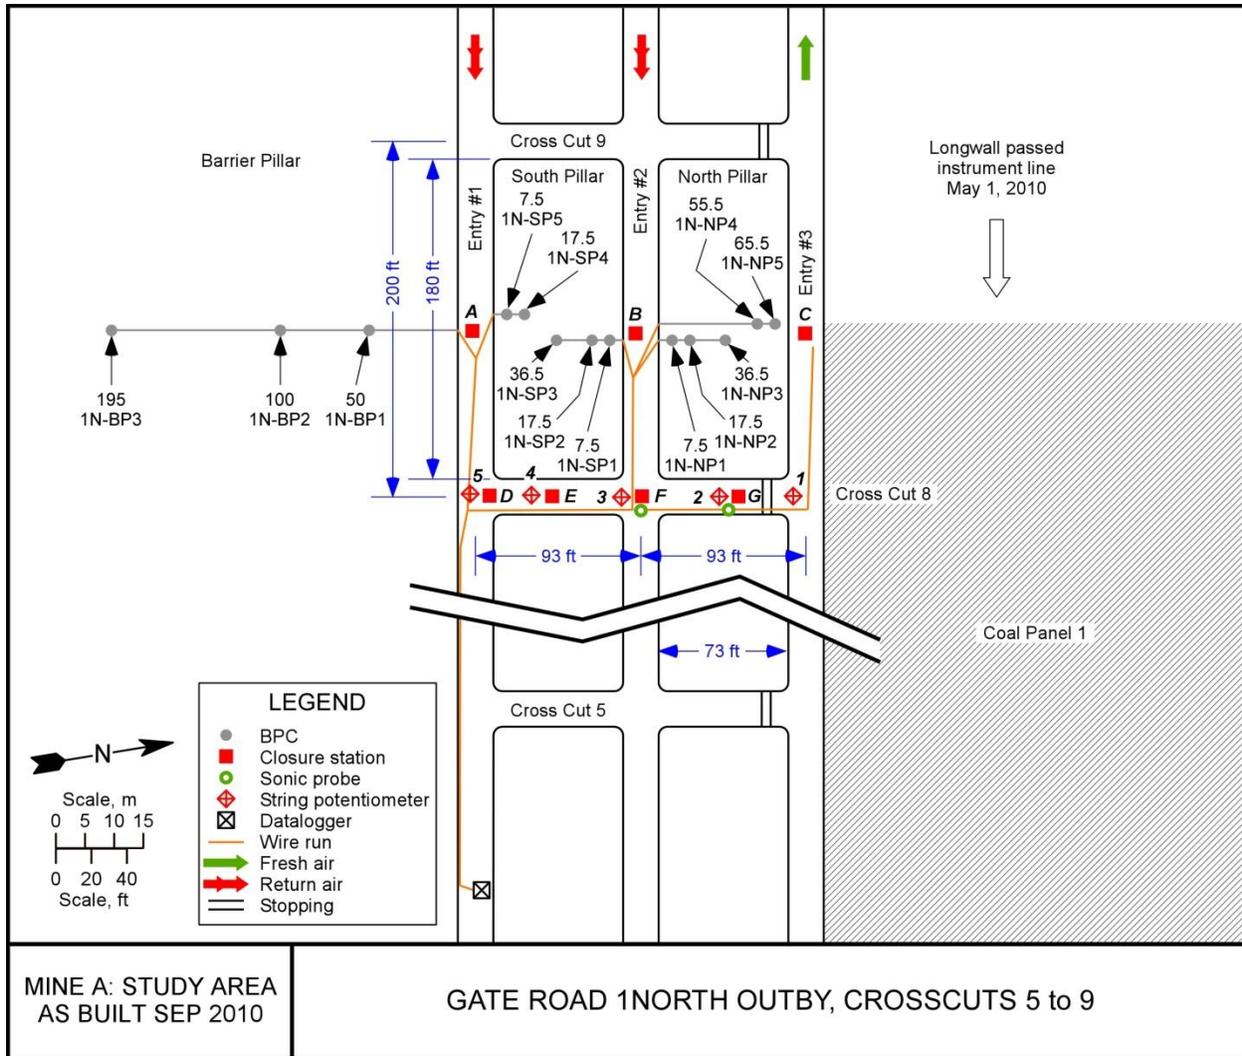
Figure 16. Instrumentation as installed at the 1 North outby site.

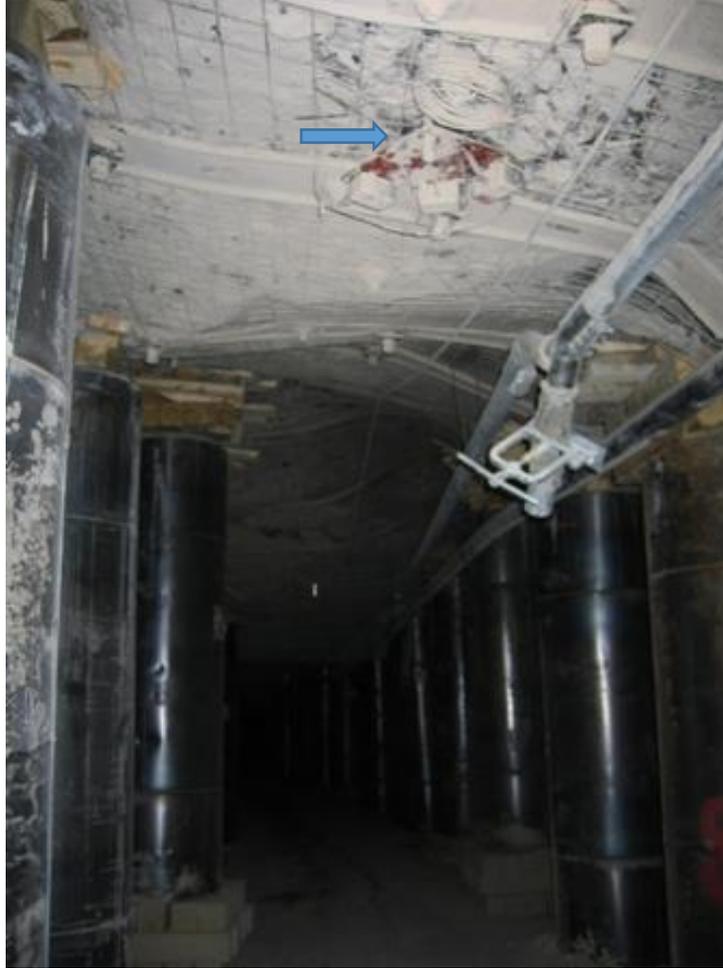
**Figure 17. Installed three-point roof extensometer (indicated with blue arrow) with string potentiometers mounted on red collar brackets that are partially covered with rock dust.**

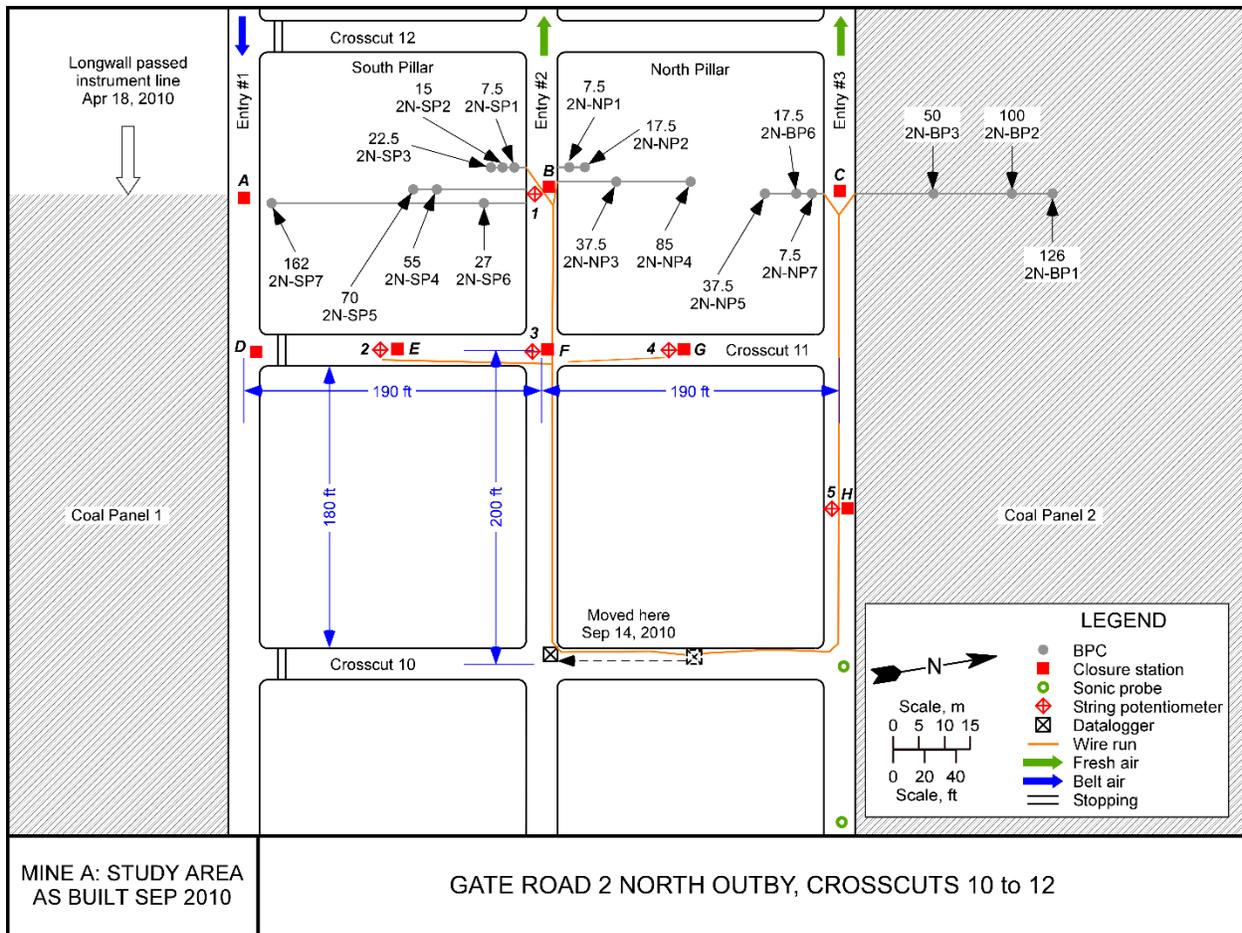
**Figure 18. Instrumentation as installed at the 2 North outby site.**

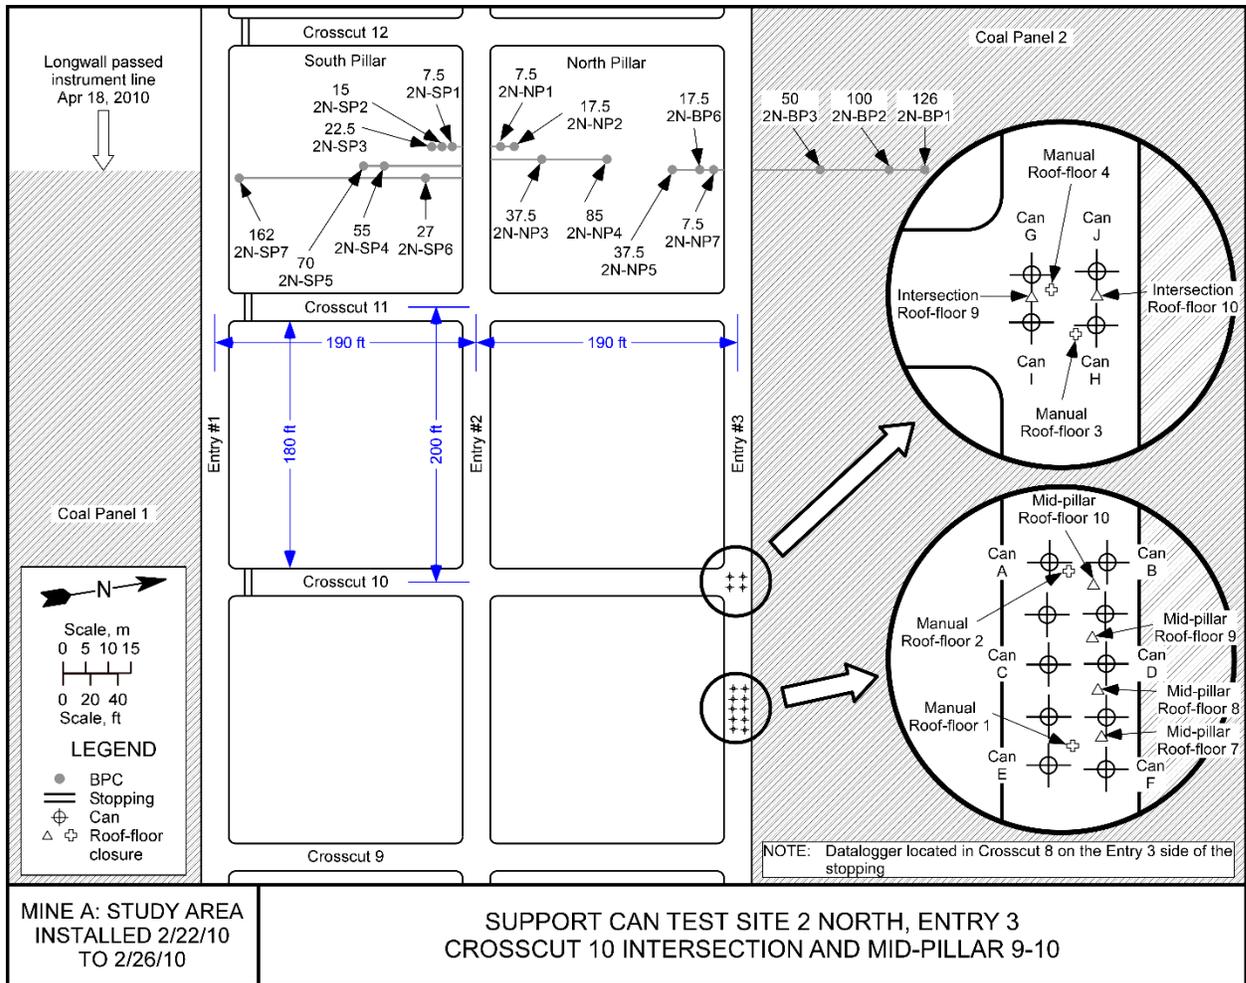
**Figure 19. The 2 North outby instrumentation site at Mine A showing locations of instrumented support Cans and their labels identified in zoomed-in sketches. Also shown are locations of roof-to-floor closure stations.**

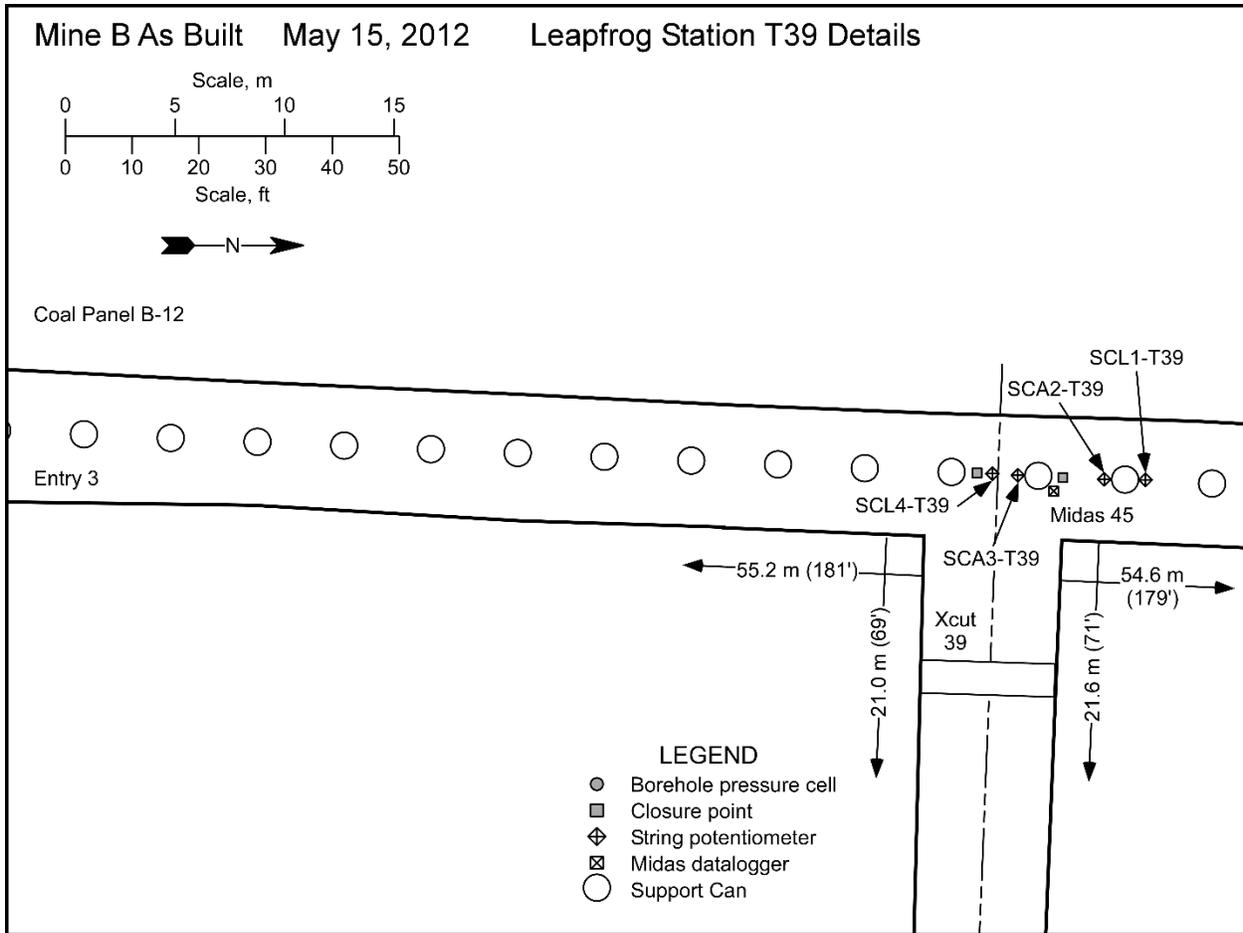
**Figure 20. Map showing detail of instruments installed at the T39 station in the tailgate of the B-12 panel at Mine B.**

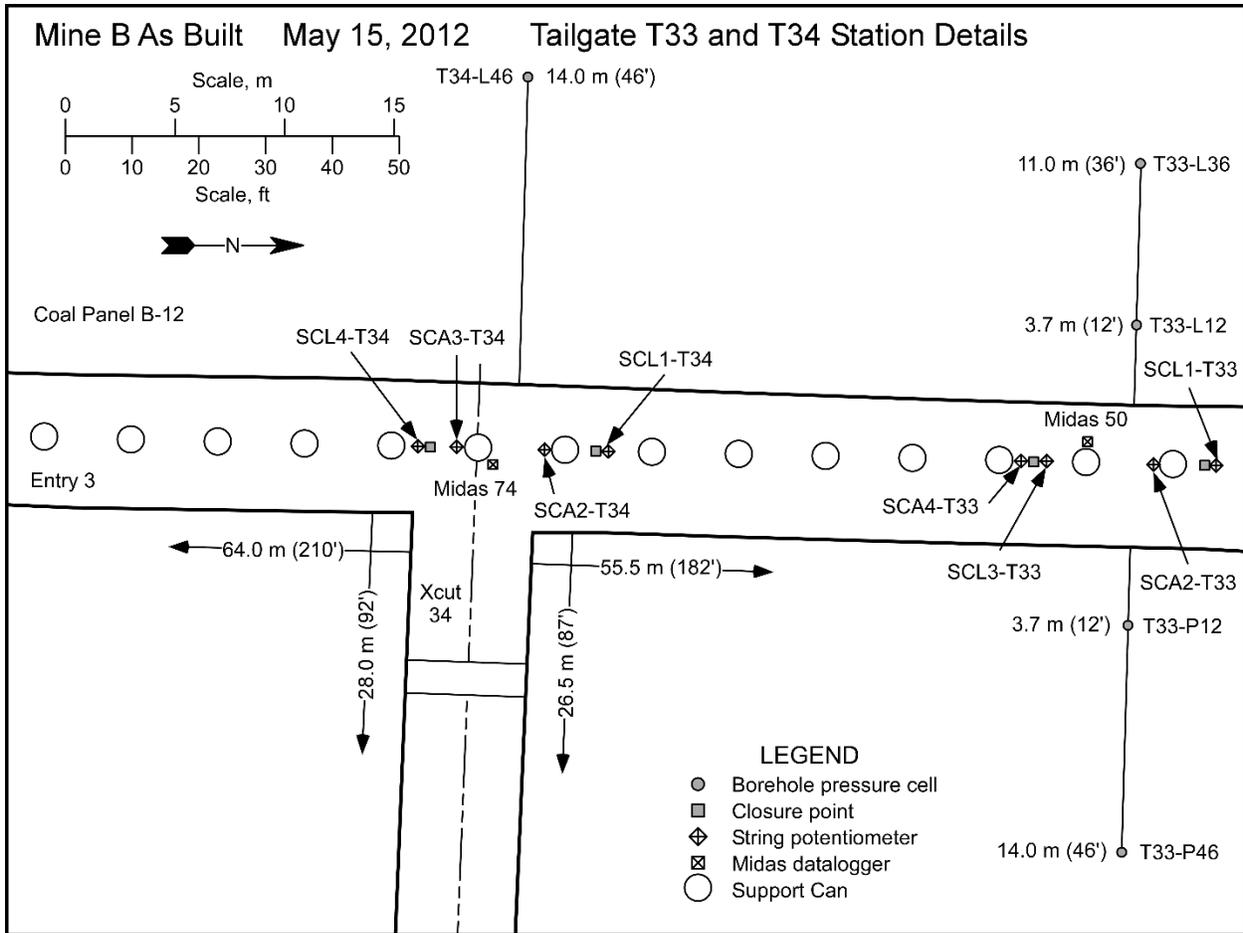
Figure 21. Map showing detail of instruments installed at the T33 and T34 stations in the tailgate of the B-12 panel.

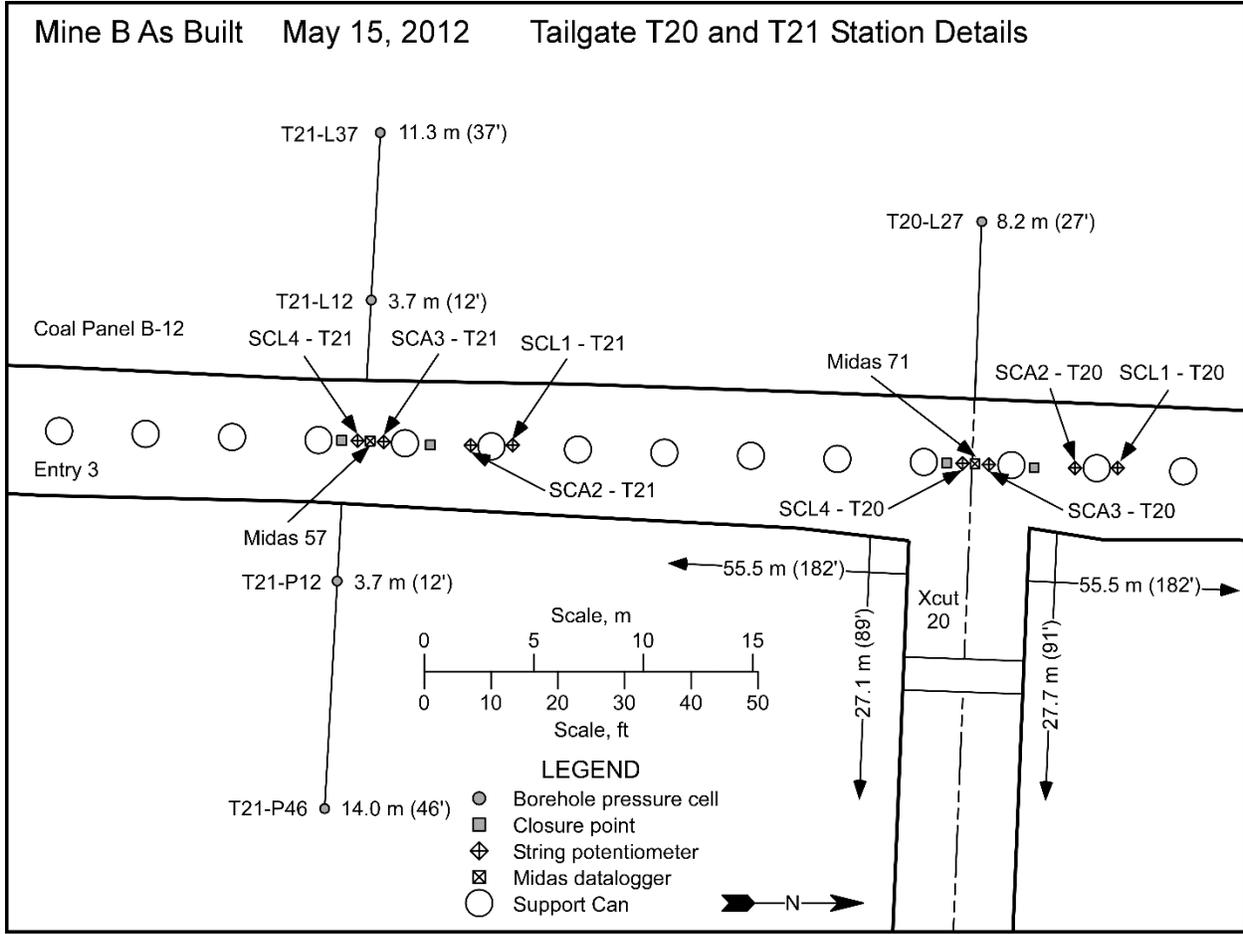
**Figure 22. Map showing detail of instruments installed at the T20 and T21 stations in the tailgate of the B-12 panel.**

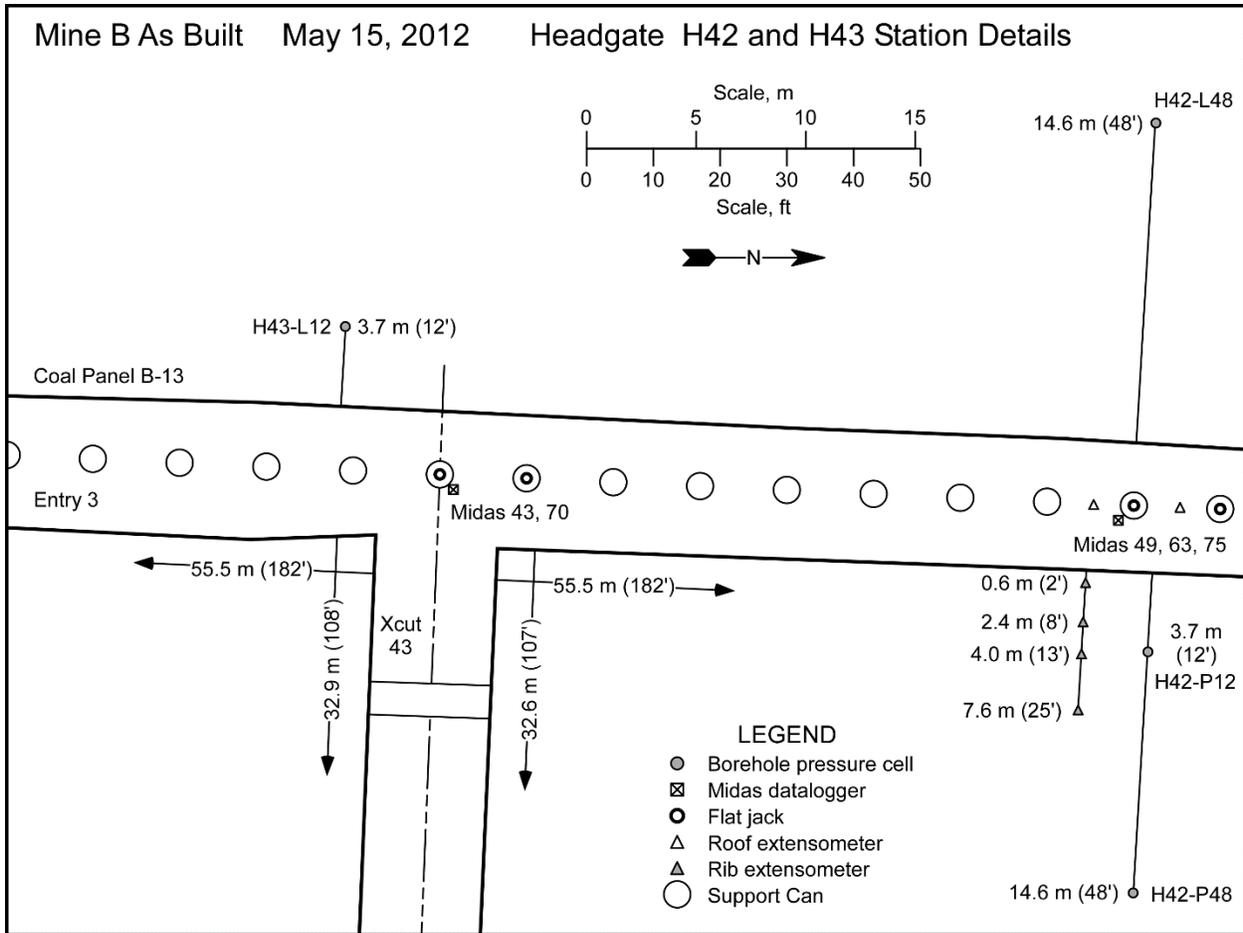
**Figure 23. Map showing detail of instruments installed at the H42 and H43 stations in the headgate of the B-12 panel.**

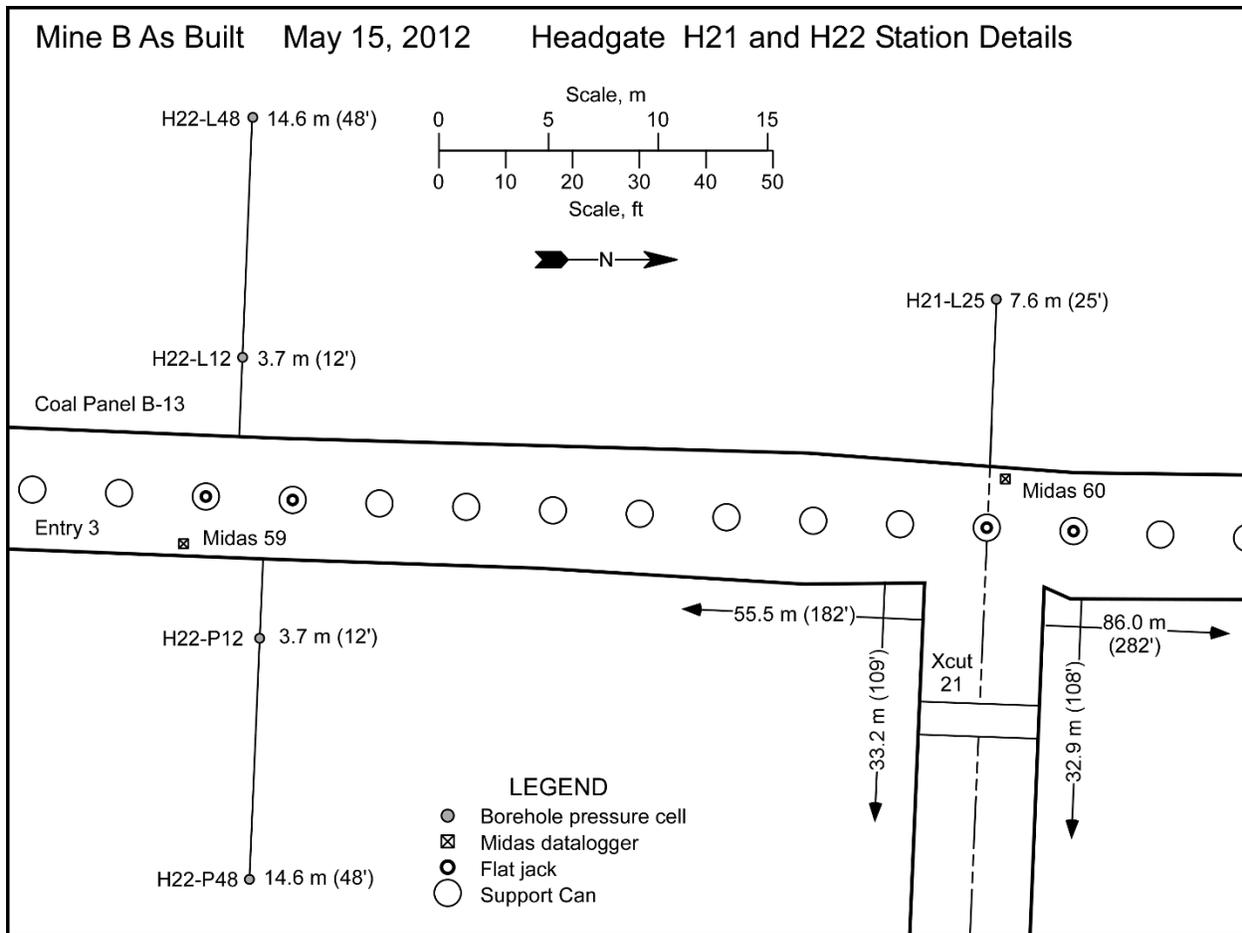
**Figure 24. Map showing detail of instruments installed at the H21 and H22 stations in the headgate of the B-12 panel.**

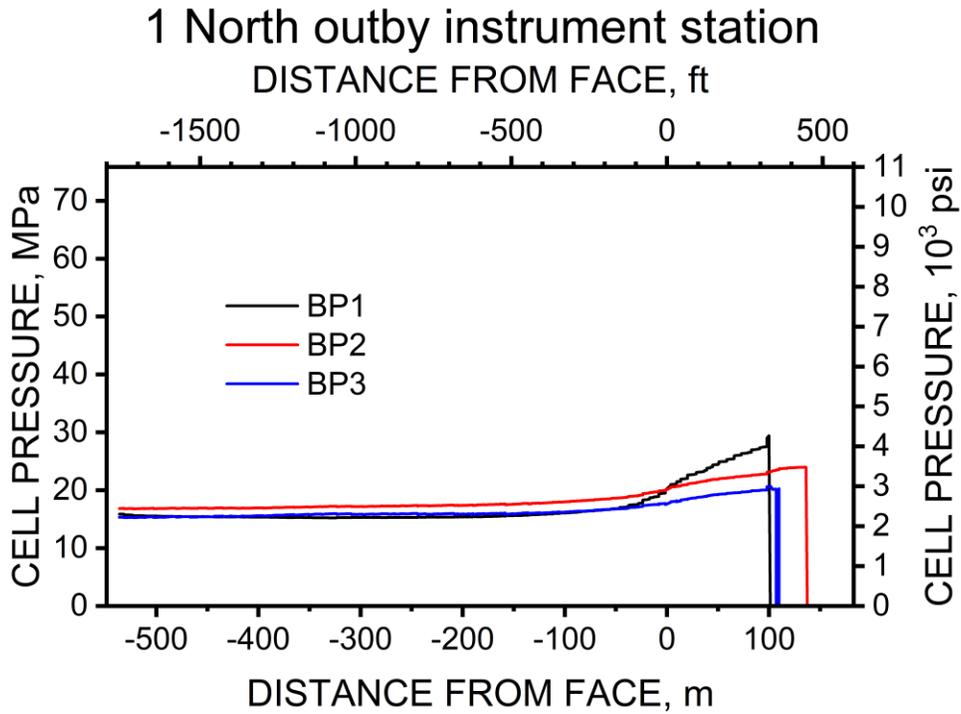
Figure 25. Cell pressure of BPCs in barrier pillar with distance from face at the 1 North outby instrument station.

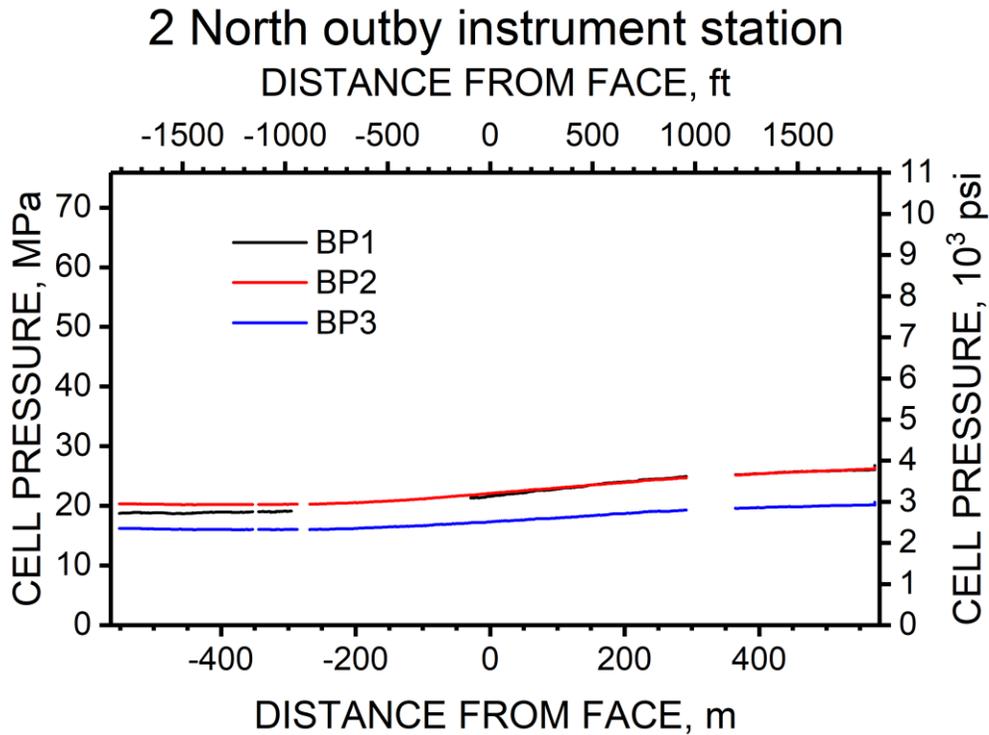
Figure 30. Cell pressure of BPCs in barrier pillar with distance from face at the 2 North outby instrument station.
