Report of Investigations 9702

## **Ground Stress in Mining (Part 1): Measurements and Observations at Two Western U.S. Longwall Mines**

Mark K. Larson, Heather E. Lawson, Eric G. Zahl, and Tristan H. Jones

January 2020

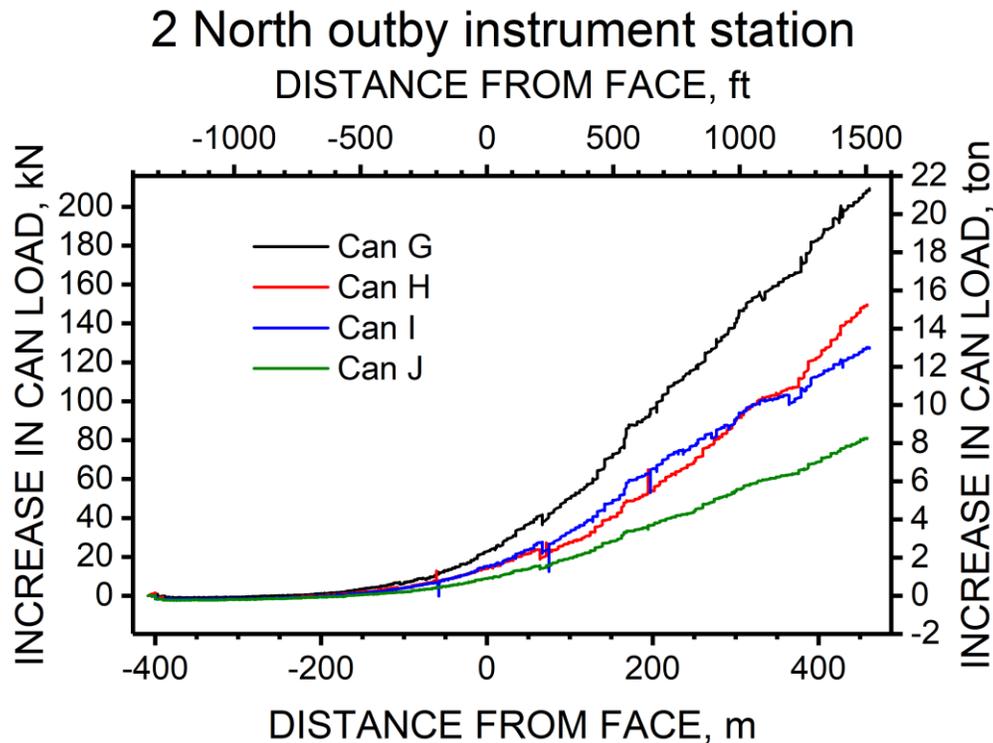
Figure 31. Load increase versus distance from face on support Cans in entry 3 at crosscut 10 in 2 North during mining of Panel 1.

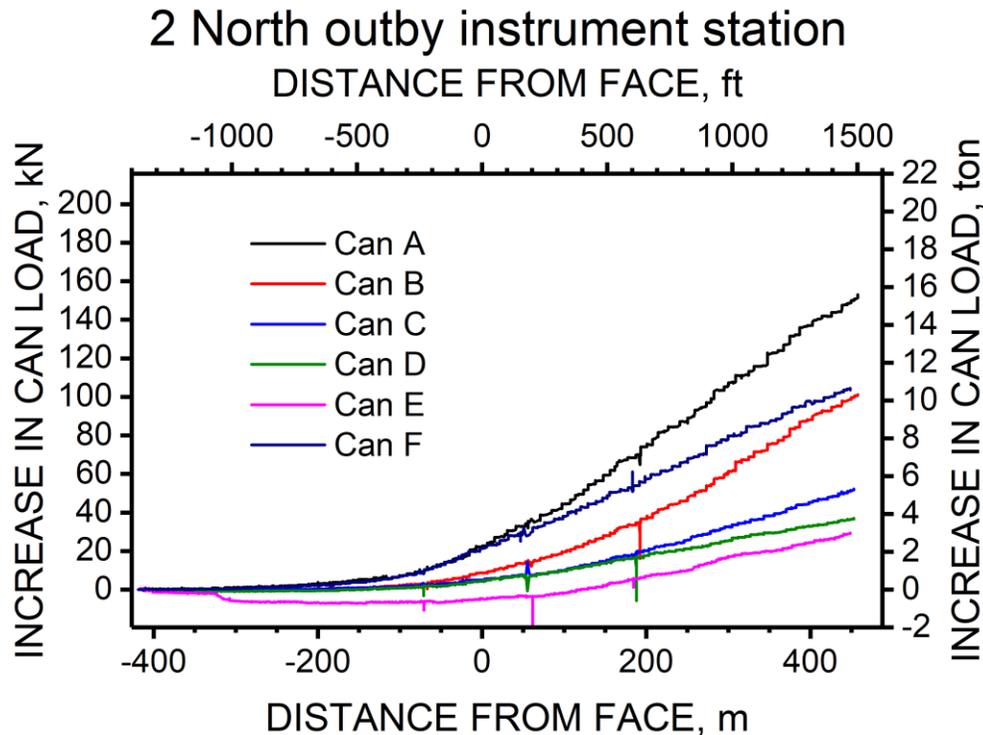
**Figure 32. Load increase versus distance from face on support Cans in entry 3 between crosscuts 9 and 10 in 2 North during mining of Panel 1.**

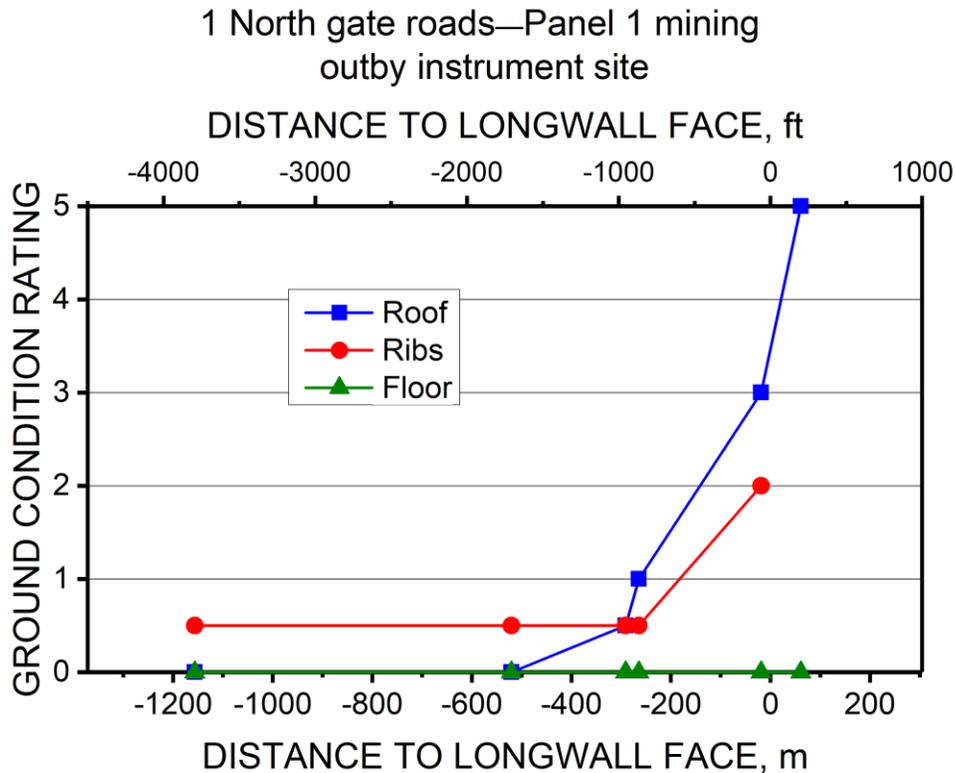
**Figure 33. Deterioration ratings between crosscuts 8 and 9, entry 2, in 1 North, an instrumented location relative to the longwall face.**

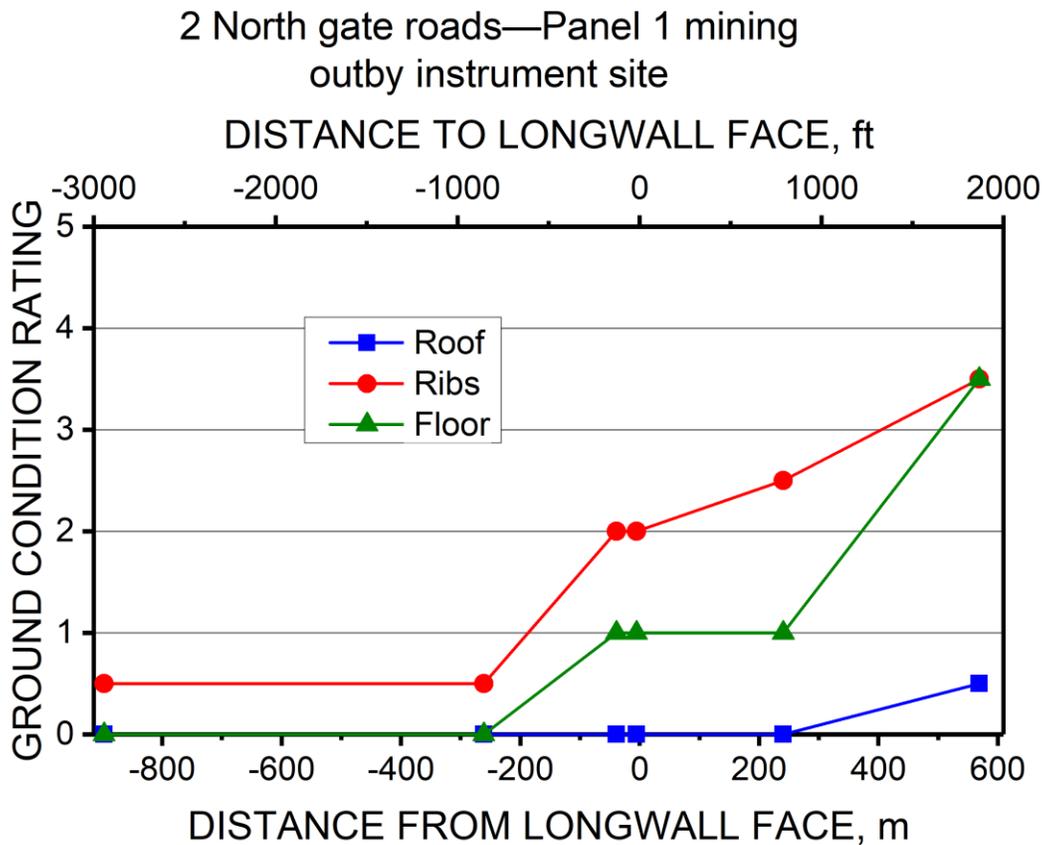
Figure 34. Changing index ratings in the roof, ribs, and floor in the 2 North gate roads during Panel 1 mining in entry 2 between crosscuts 11 and 12.

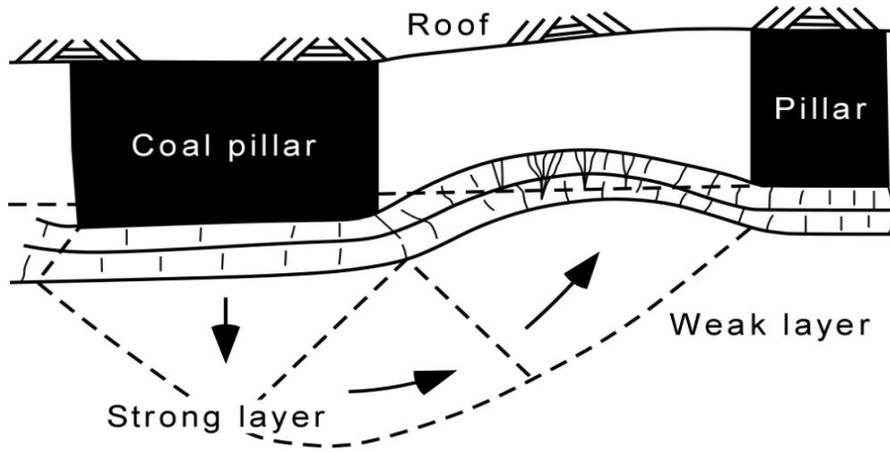
**Figure 35. Buckling failure of the type observed in the 2 North gate road (after Rockaway and Stephenson [1979]).**

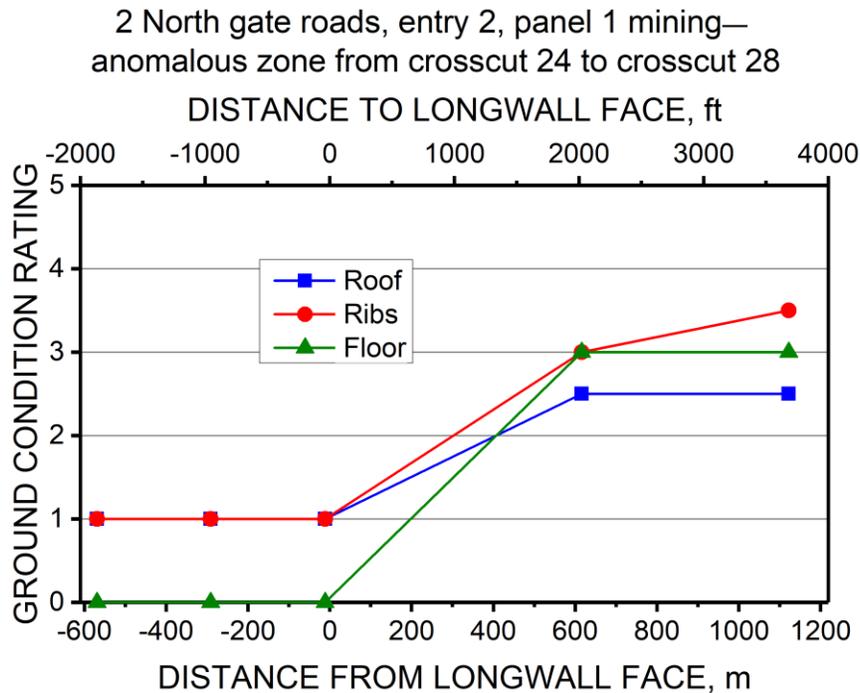
**Figure 36. The varying index ratings in the roof, ribs, and floor in an anomalous zone near crosscut 24 in entry 2 of the 2 North gate roads during Panel 1 mining.**

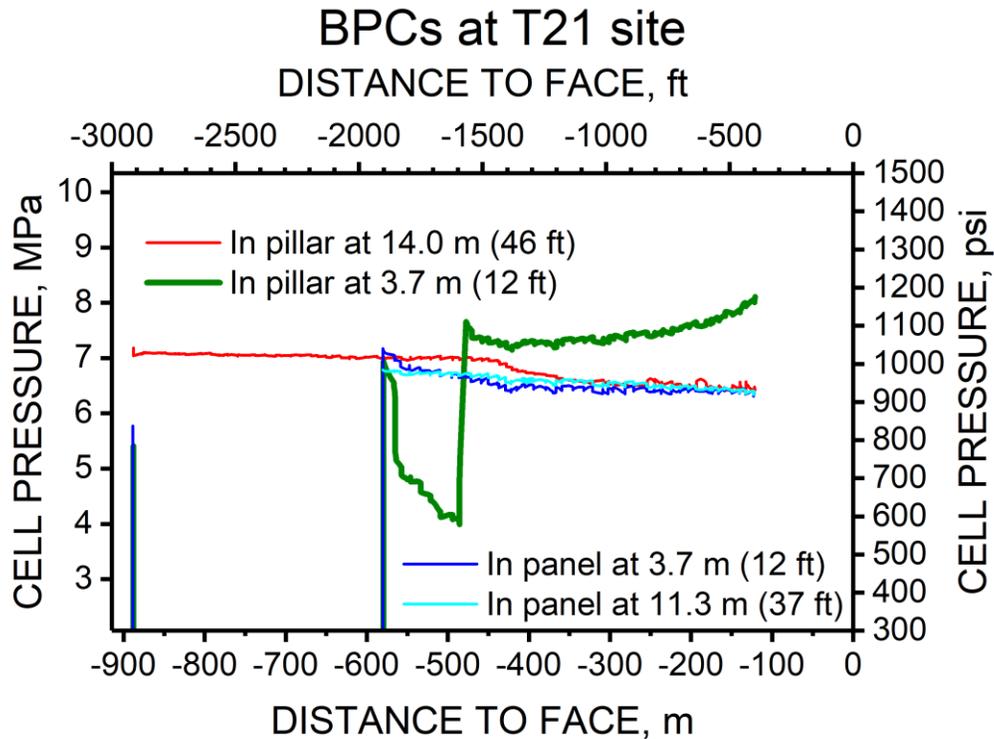
**Figure 37. BPC pressure versus distance to the face of instruments at the T21 site in entry 3 of the B-12 panel tailgate at Mine B.**

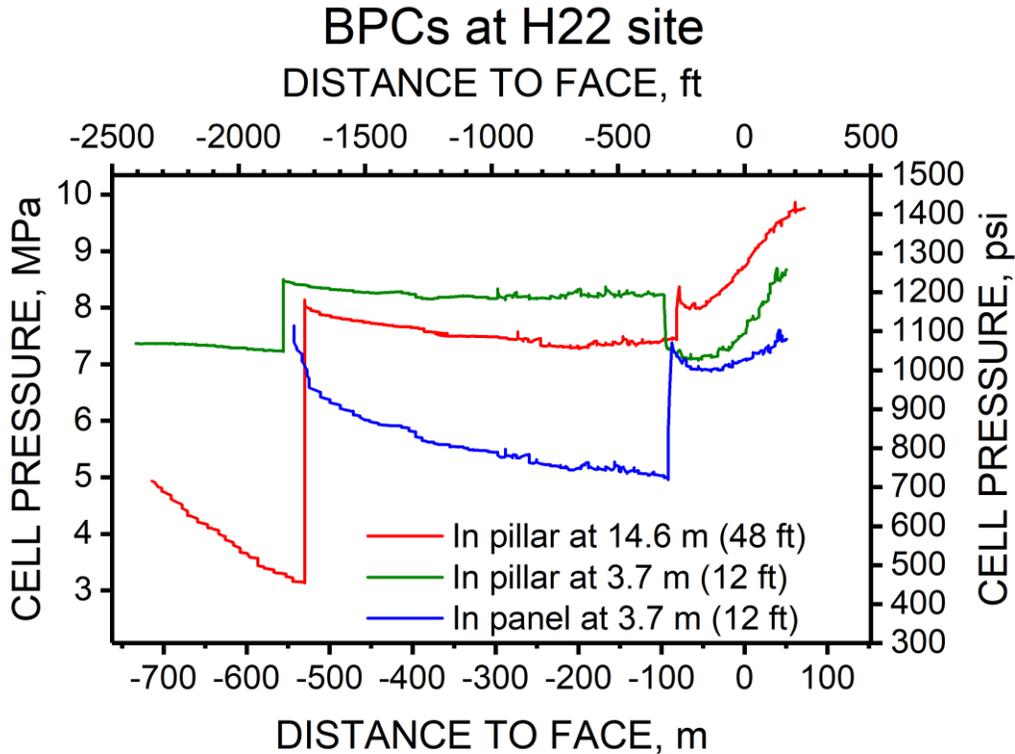
**Figure 38. BPC pressure versus distance to the face of instruments at the H22 site in entry 3 of the B-12 panel headgate at Mine B.**

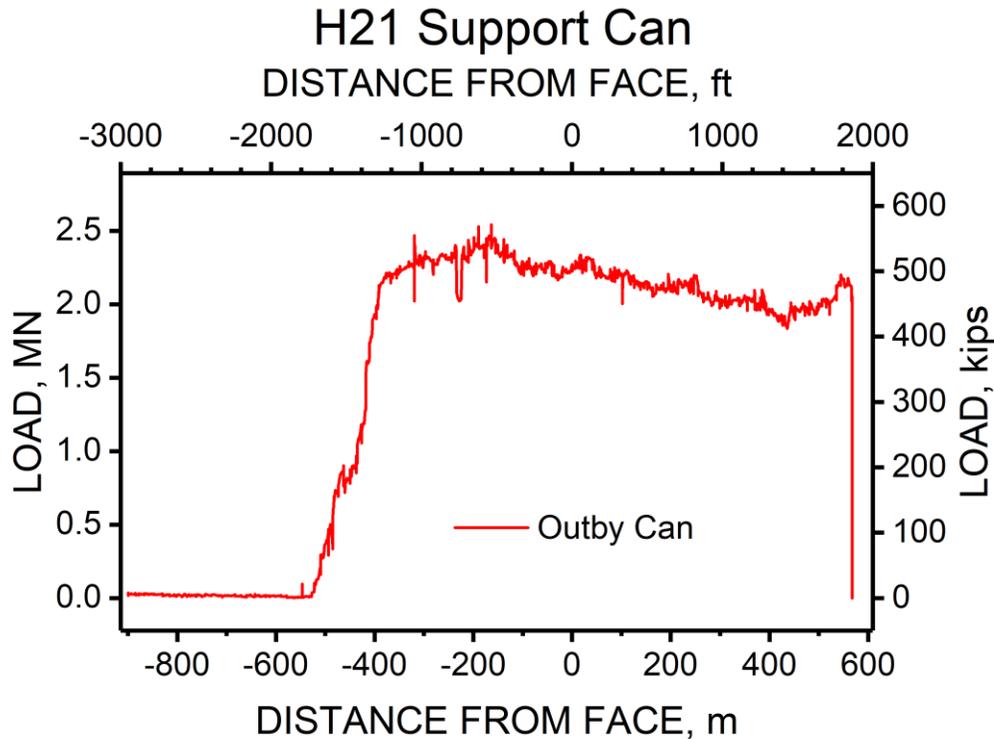
**Figure 39. Outby support Can load with distance to the face in entry 3 at the H21 site in the B-12 panel headgate at Mine B.**

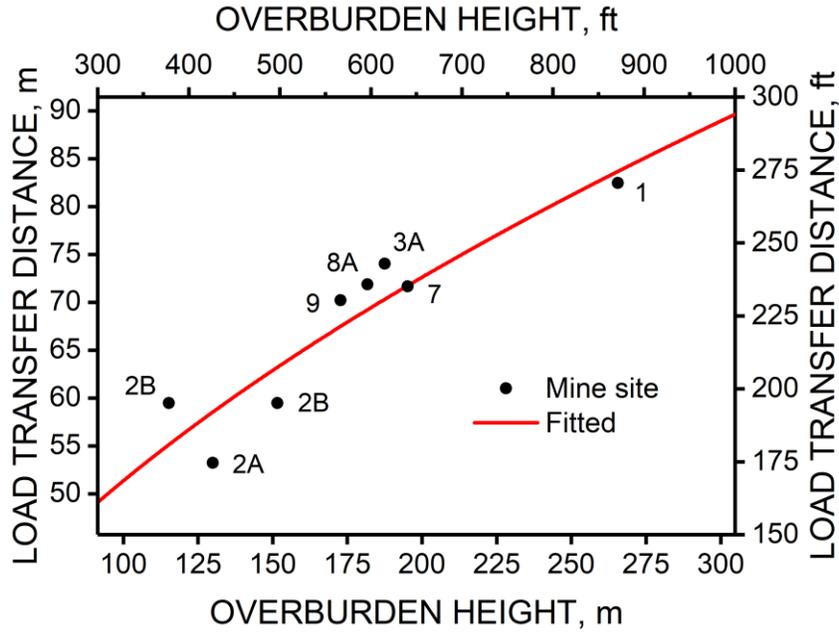
Figure 41. Measured load transfer distance versus seam depth for several cases in the eastern United States. A fitted line resulted in the empirical equation for load transfer distance. After Peng and Chiang [1984].

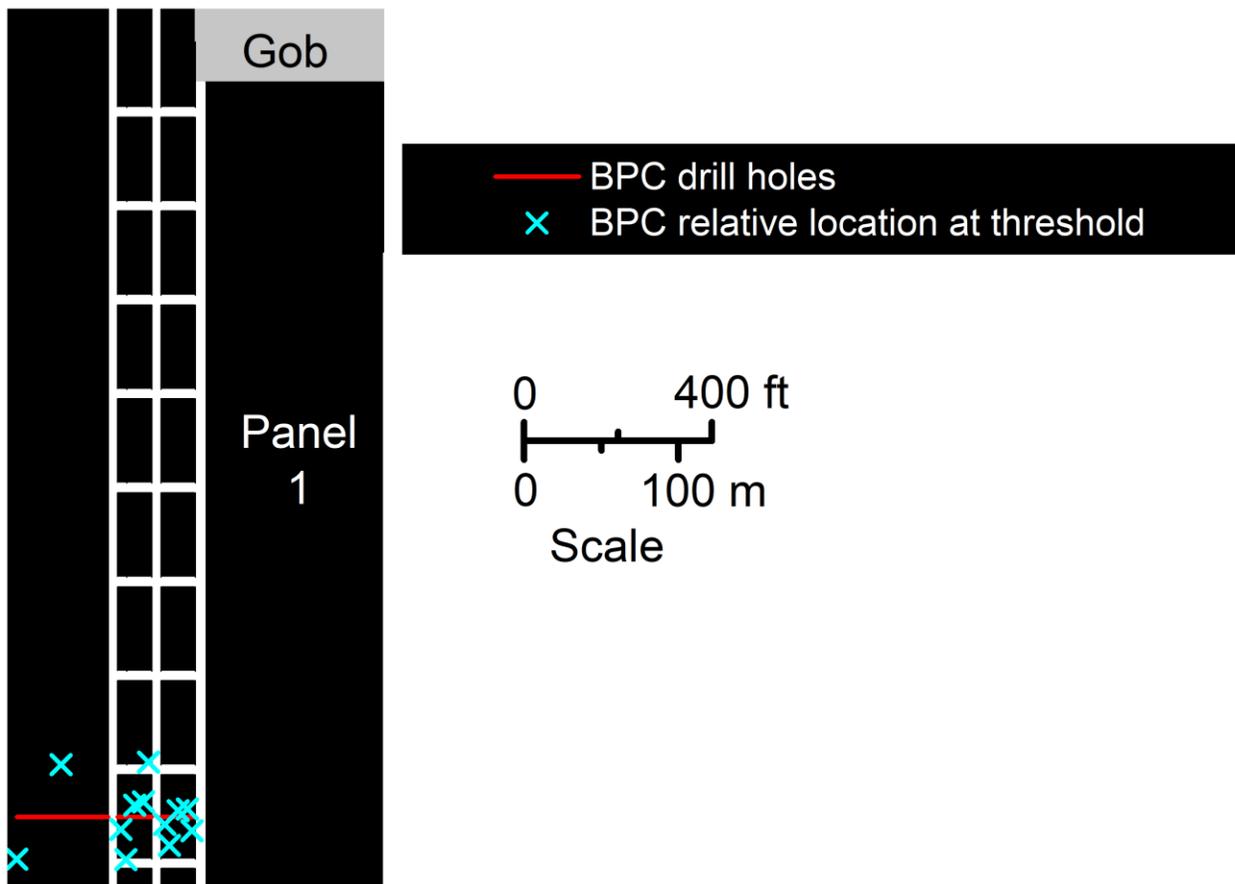
**Figure 43. Relative position of BPCs in 1 North when the stress-increase threshold was reached. These relative positions are superimposed in the gate road geometry with respect to the face, where the face is shown at the average distance along the entries from the BPC drill holes when the stress-increase threshold was met at each BPC.**

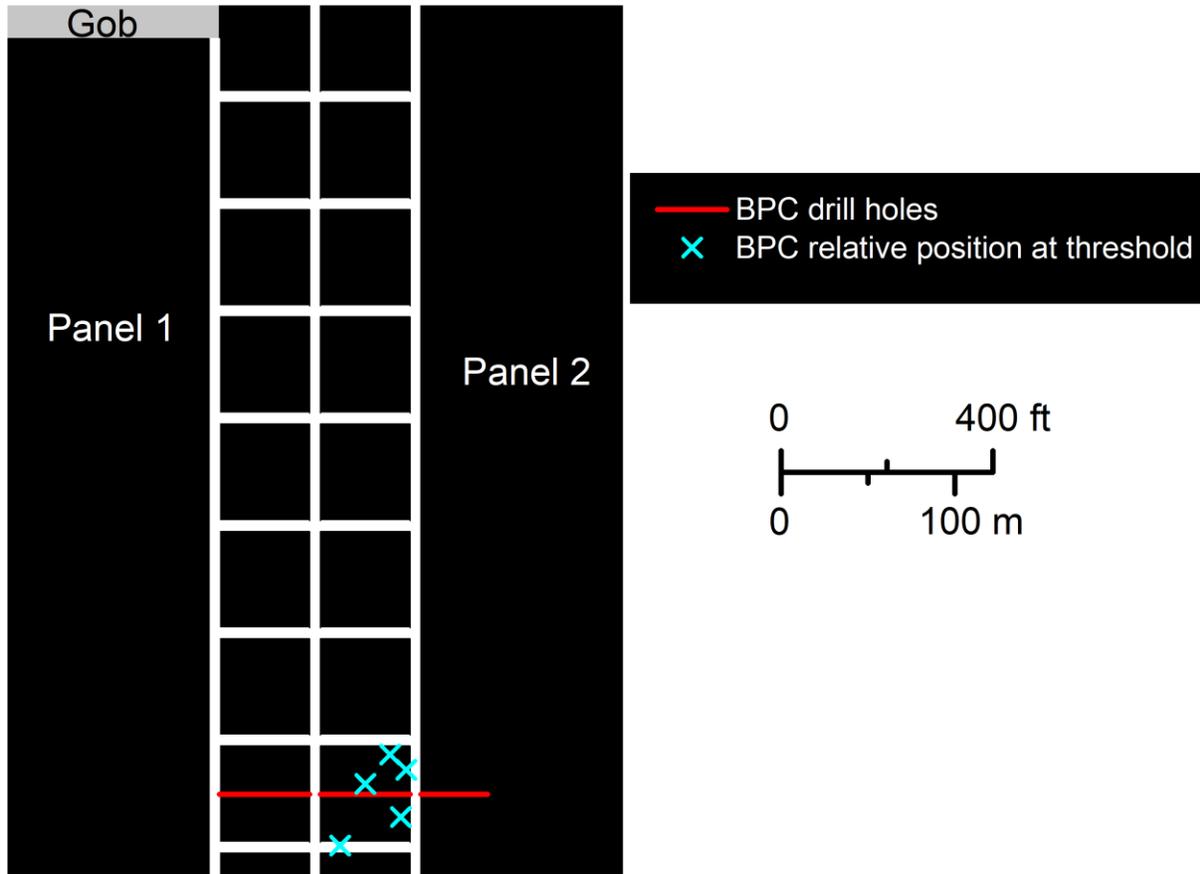
**Figure 44. Relative position of BPCs in 2 North when stress-increase threshold was reached. These relative positions are superimposed in the gate road geometry with respect to the face, where the face is shown at the average distance along the entries from the BPC drill holes when the stress-increase threshold was met at each BPC.**

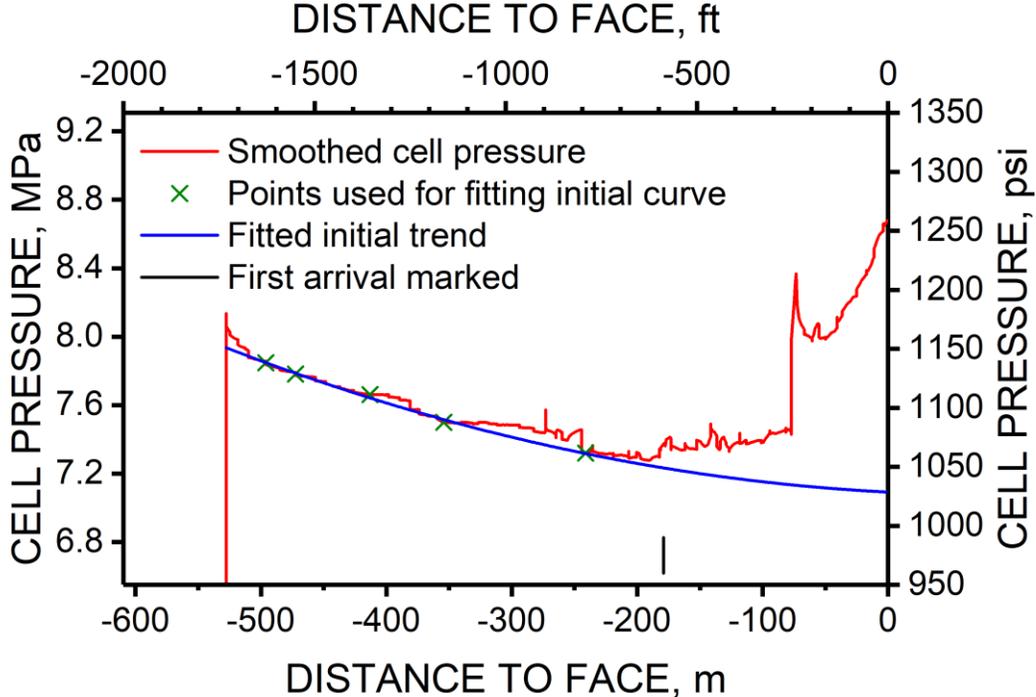
## H22 site—BPC in pillar at 14.6 m (48 ft)

**Figure 48. BPC in the pillar at 14.6 m (48 ft) with distance from face at H22 site at Mine B. Initial trend line is shown and points are marked from which the curve was fitted. First arrival is marked where departure from fitted curve meets detection threshold.**

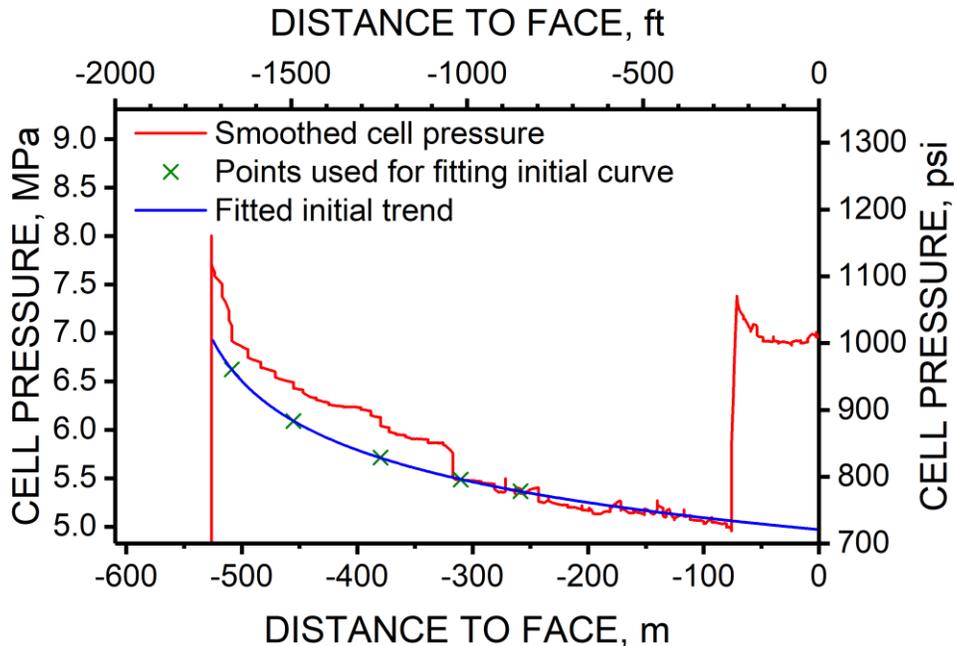
Figure 50. BPC in the panel at 3.7 m (12 ft) with distance from face at H22 site at Mine B. Initial trend line is shown and points are marked from which the curve was fitted. Some points for fitting were offset to compensate for a jump in measurement curve at a distance to face of about -320 m (-1,050 ft). Detection of first arrival of abutment stress appears to be impossible in this case.

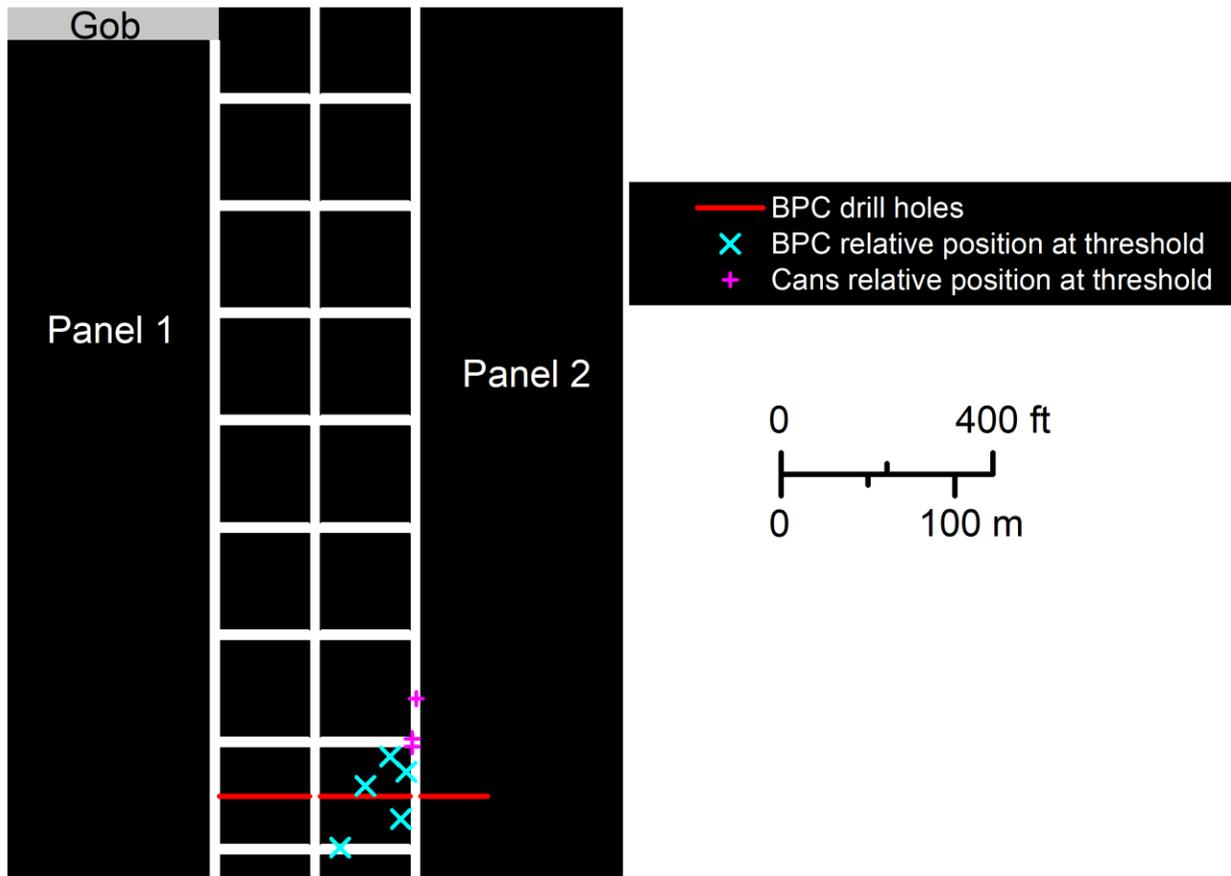
**Figure 51. Relative position of support Cans along with BPCs in 2 North when the load-increase threshold was reached. These relative positions are superimposed in the gate road geometry with respect to the face, where the face is shown at the average distance along the entries from the BPC drill holes when the stress-increase threshold was met at each BPC. The proximity of the Cans to the BPCs indicates that the two sensing methods are nearly equal in sensitivity.**

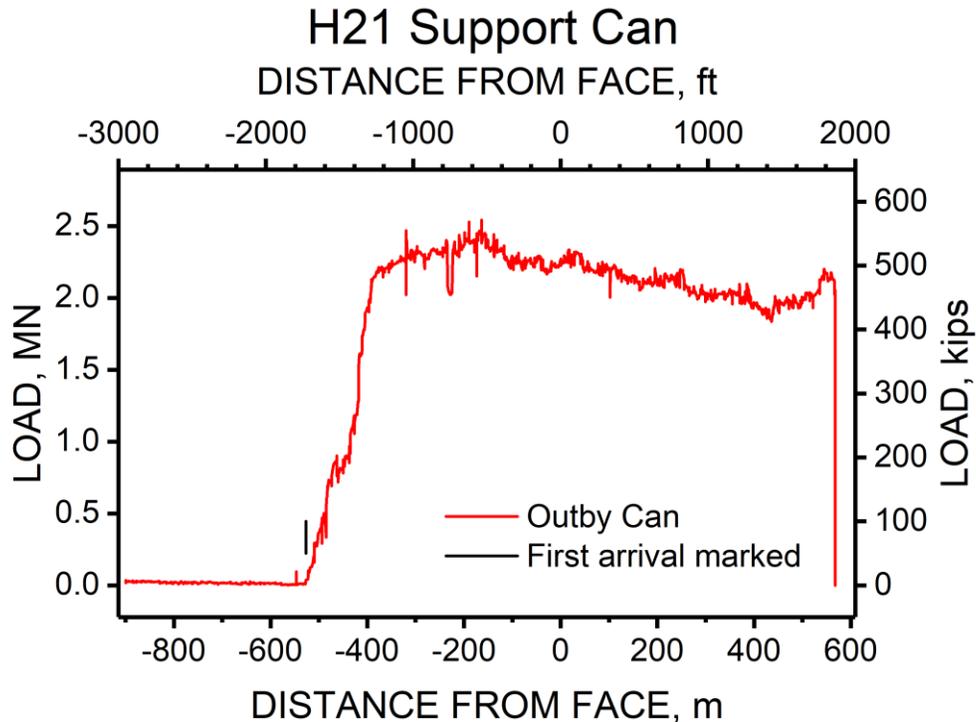
Figure 52. Load on outby support Can at H21 at Mine B, indicating the distance from face at which first arrival of mining-induced abutment stress was detected.

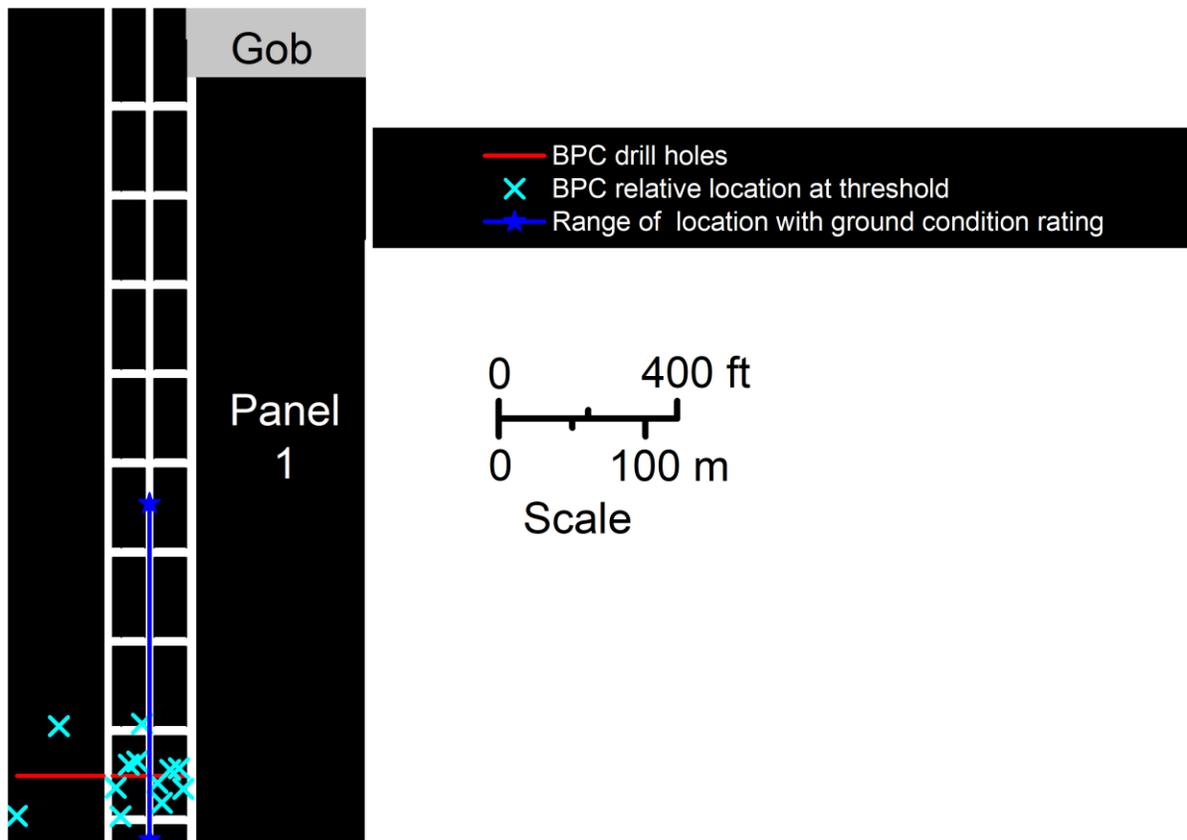
**Figure 53. Relative range, with respect to the face within which a ground condition rating increased, indicating the arrival of abutment load in 1 North. These relative positions are superimposed on the gate road geometry with respect to the face, where the face is shown at the average distance along the entries from the outby BPC drill holes when the stress-increase threshold was met at each BPC.**

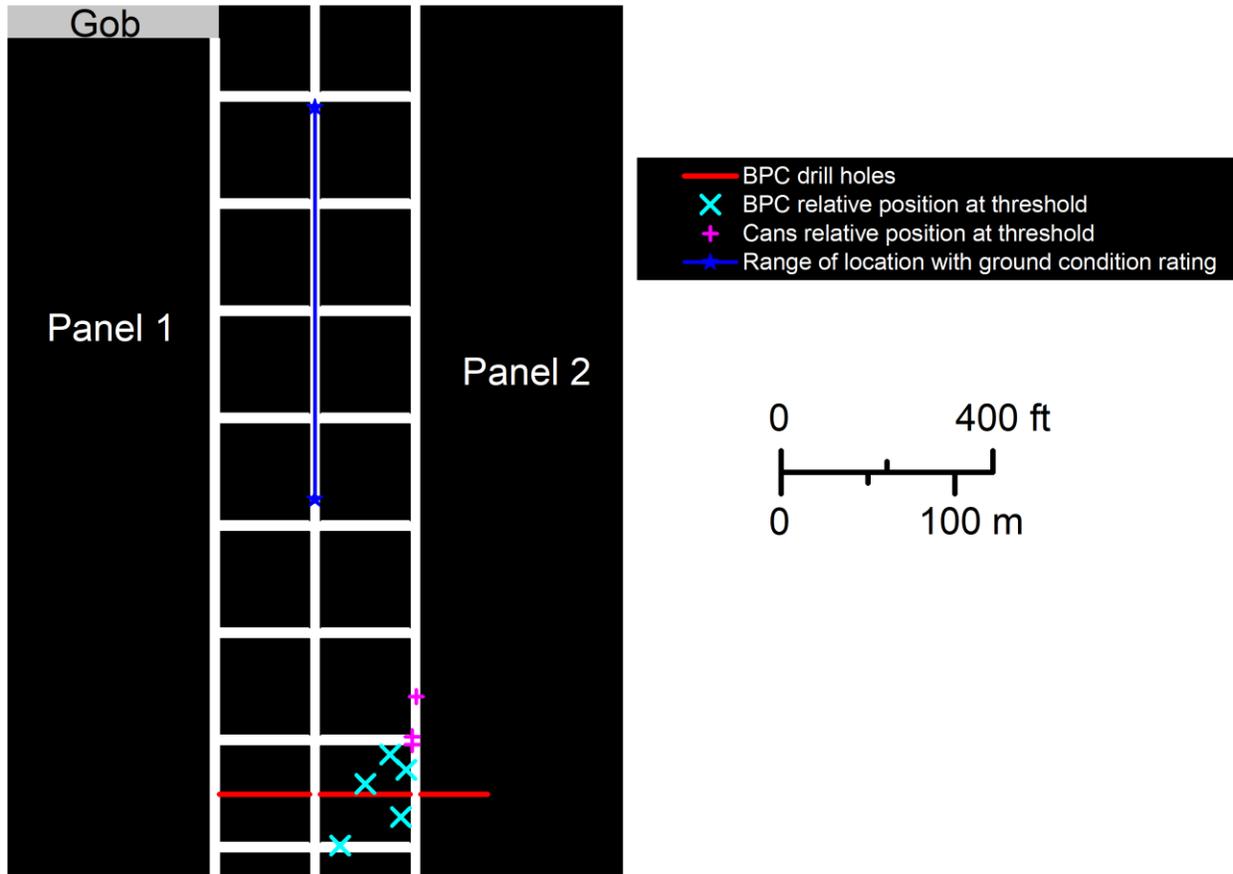
**Figure 54. Relative range, with respect to the face within which a ground condition rating increased, indicating the arrival of abutment load in 2 North. These relative positions are superimposed on the gate road geometry with respect to the face, where the face is shown at the average distance along the entries from the outby BPC drill holes when the stress-increase threshold was met at each BPC.**

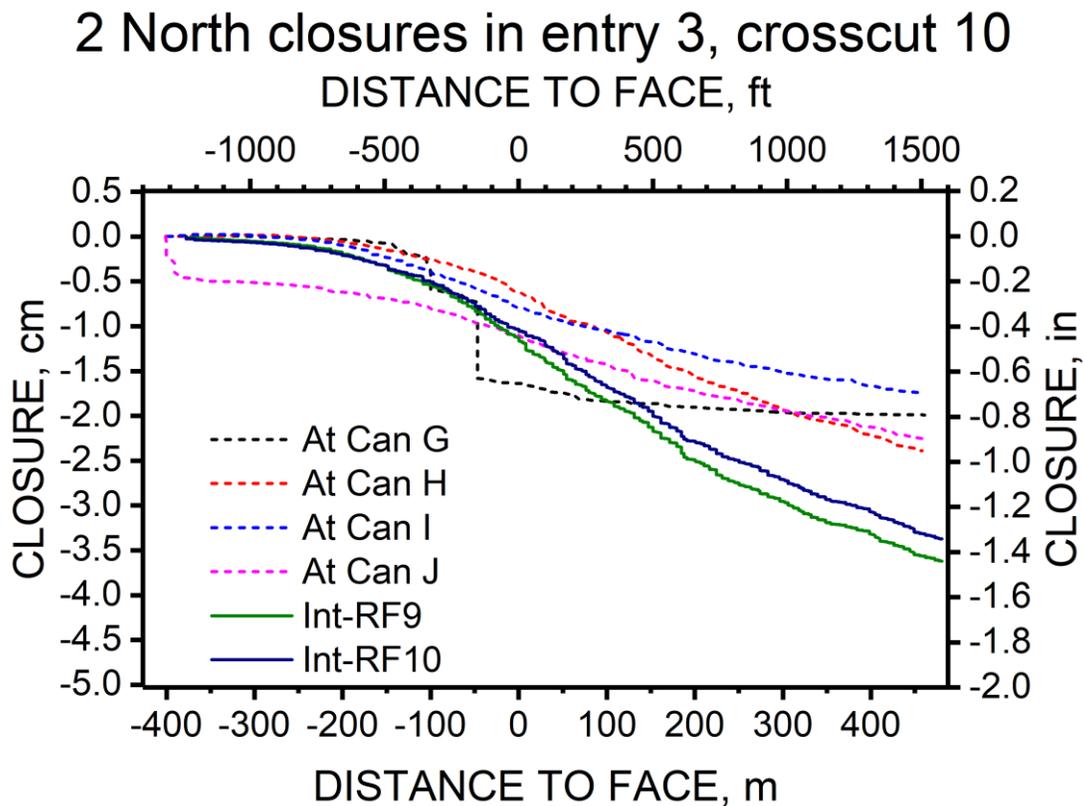
Figure 55. Closure at support Cans and at roof-to-floor measurement points in 2 North, entry 3, at crosscut 10 at Mine A.

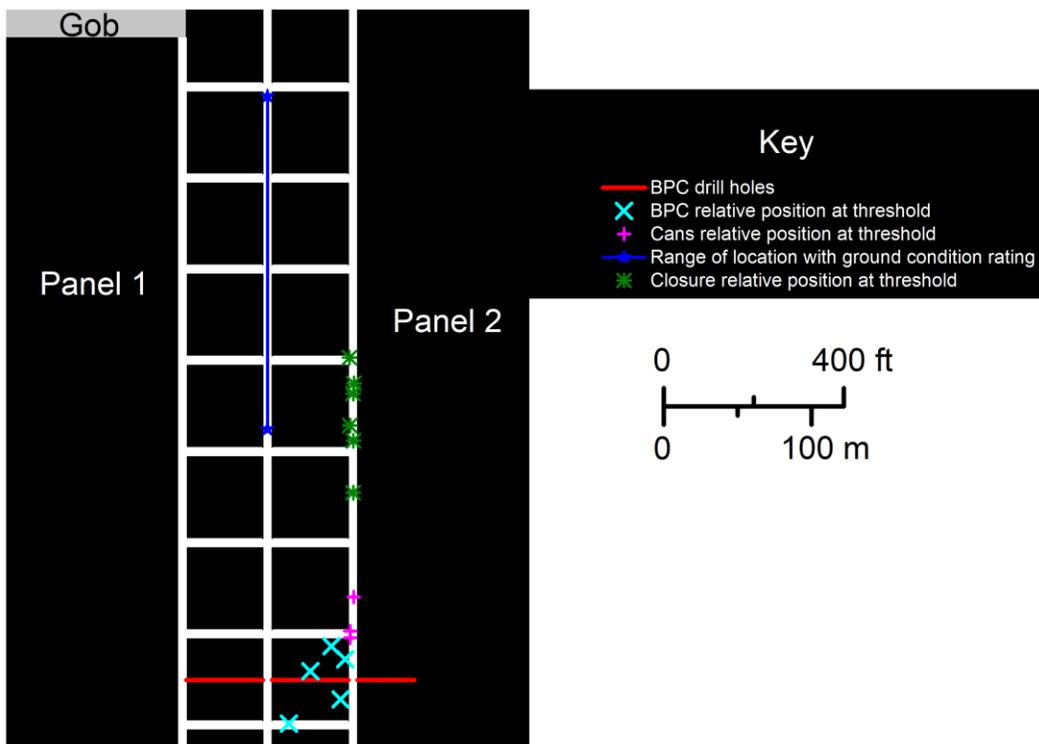
**Figure 62. Relative position of BPCs, support Cans, range of ground condition, and closure meters in 2 North at Mine A when the threshold for first arrival of abutment stress was reached. These relative positions are superimposed in the gate road geometry with respect to the face, where the face is shown at the average distance along the entries from the BPC drill holes when the stress-increase threshold was met at each BPC.**

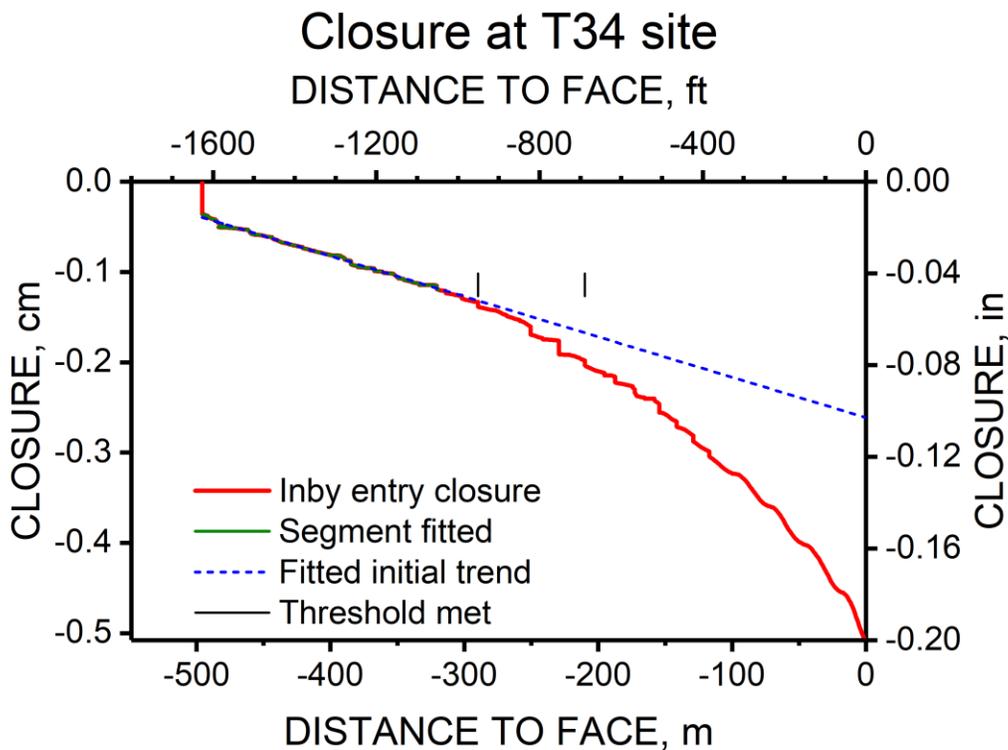
**Figure 63. Closure of entry with distance to face at inby T34 site at Mine B. Measurements used for fitting a line to represent the initial closure rate are indicated. Fitted line used to represent the initial closure trend is shown. Black lines indicate where thresholds of departure from the fitted initial trend were met. Thresholds used are  $-0.003973$  cm ( $-0.001564$  in) on the left and  $-0.03556$  cm ( $-0.01400$  in) on the right.**

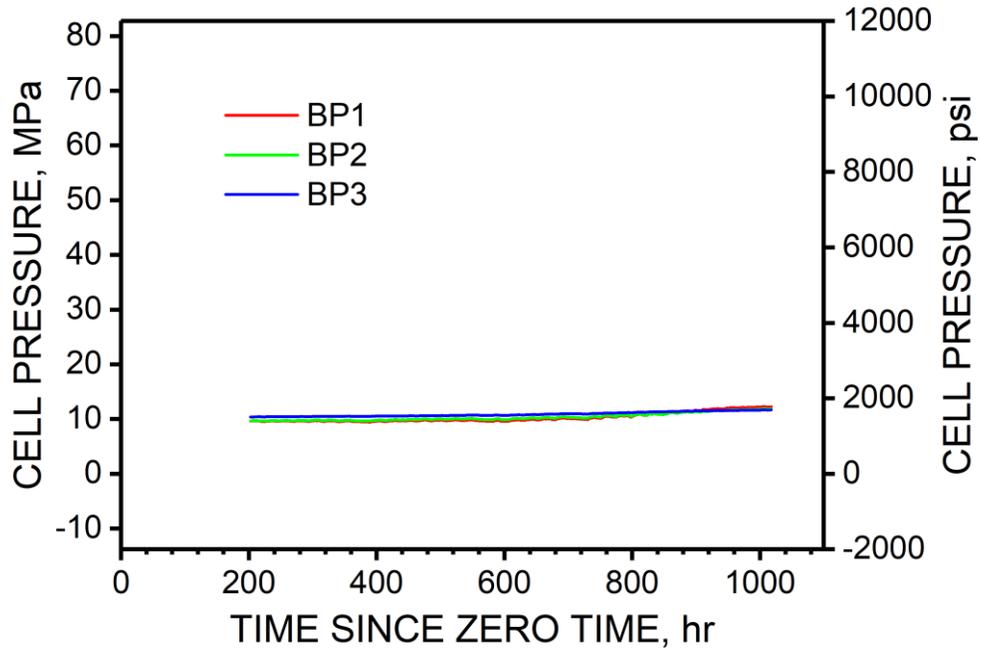
Figure A1. BPC pressures with time for cells in barrier pillar of 1 North inby site during Panel 1 retreat at Mine A.

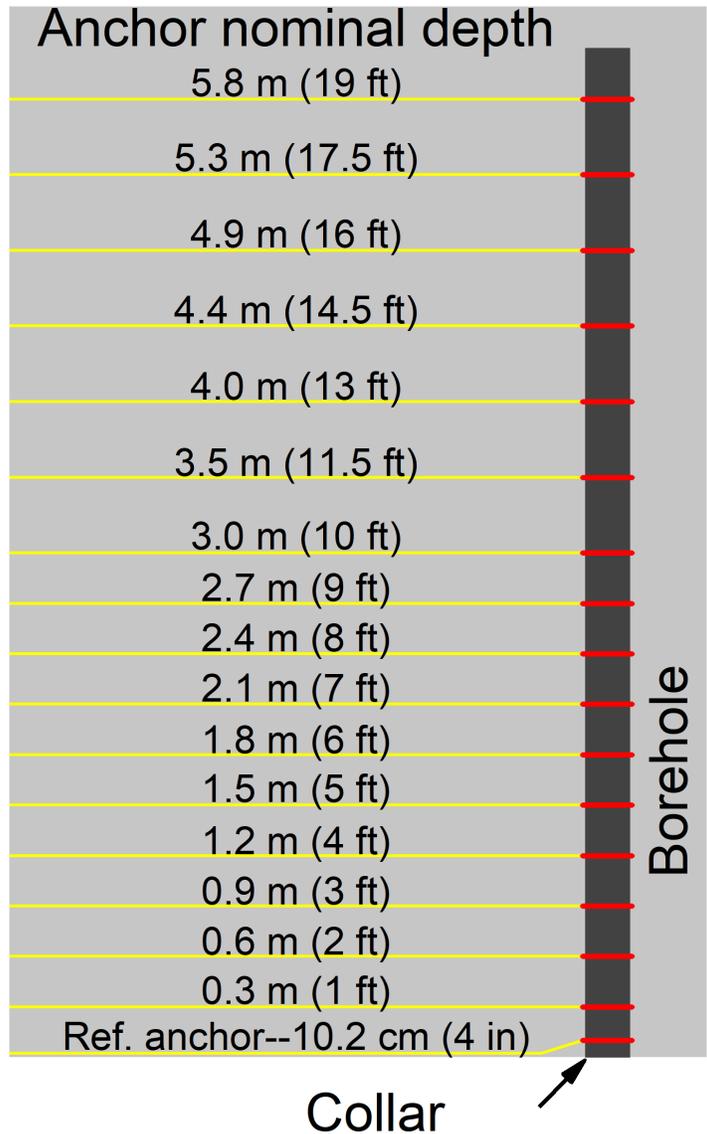
**Figure C21. Nominal depths of anchors installed for sonic probe instruments used in this study at 1 North outby and 2 North outby instrumentation sites at Mine A.**

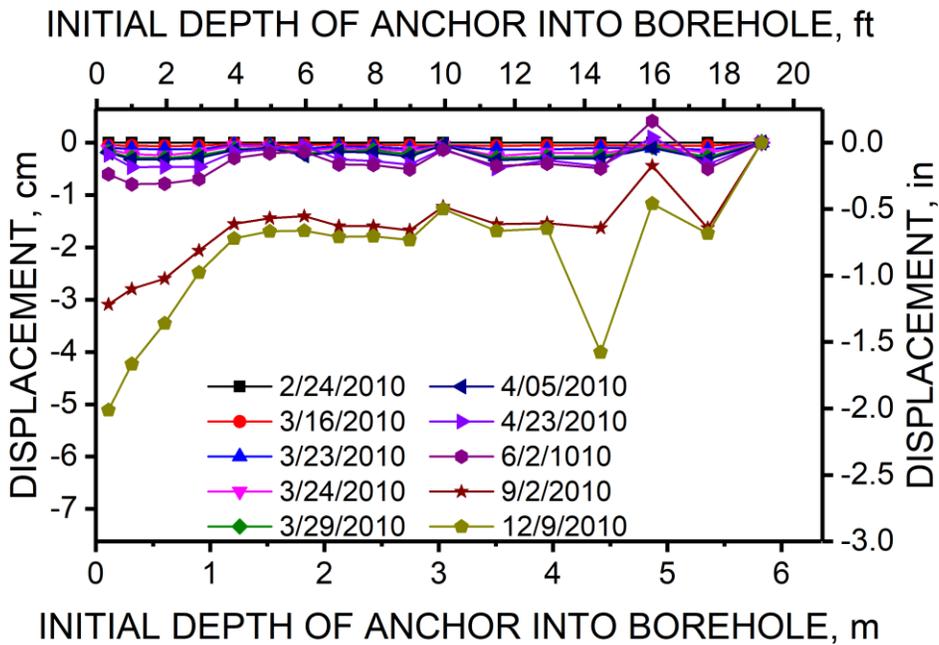
Figure C25. Displacements versus initial depth of anchor into borehole, relative to deepest anchor. Measured with sonic probe on various dates in 2 North gate roads in entry 3 between crosscuts 9 and 10 at Mine A.

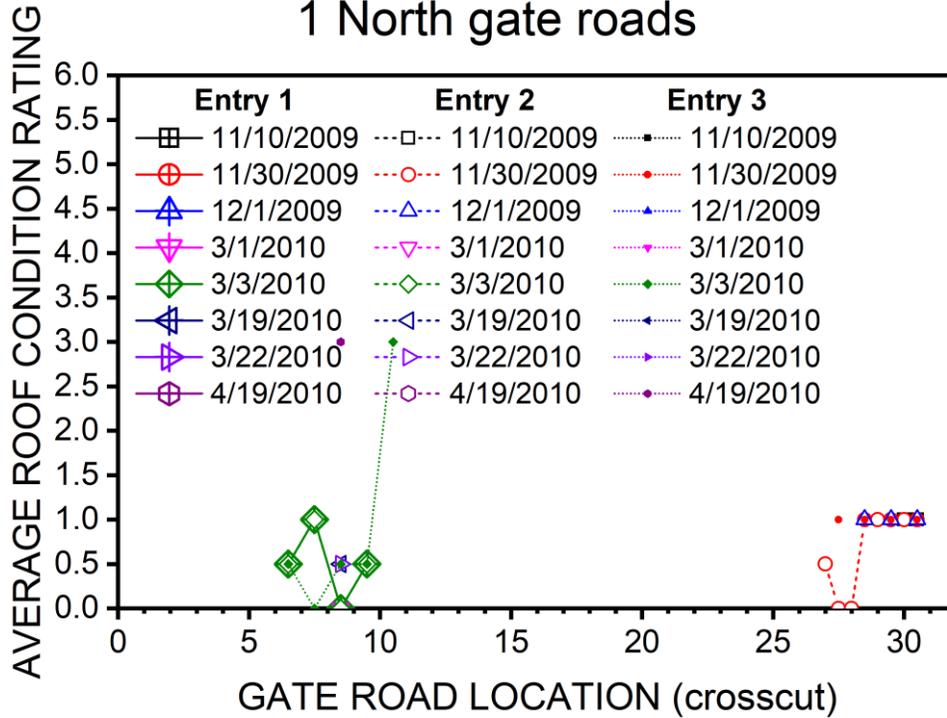
Figure D1. Results of walking survey of average roof condition ratings by location in the 1 North gate roads at Mine A.

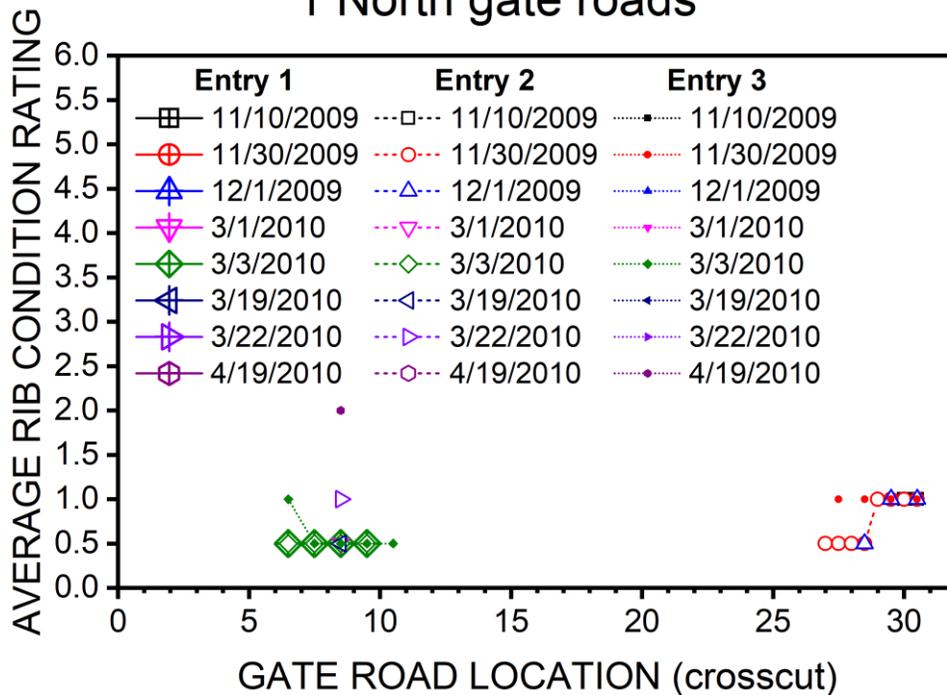
Figure D2. Results of walking survey of average rib condition ratings by location in the 1 North gate roads at Mine A.

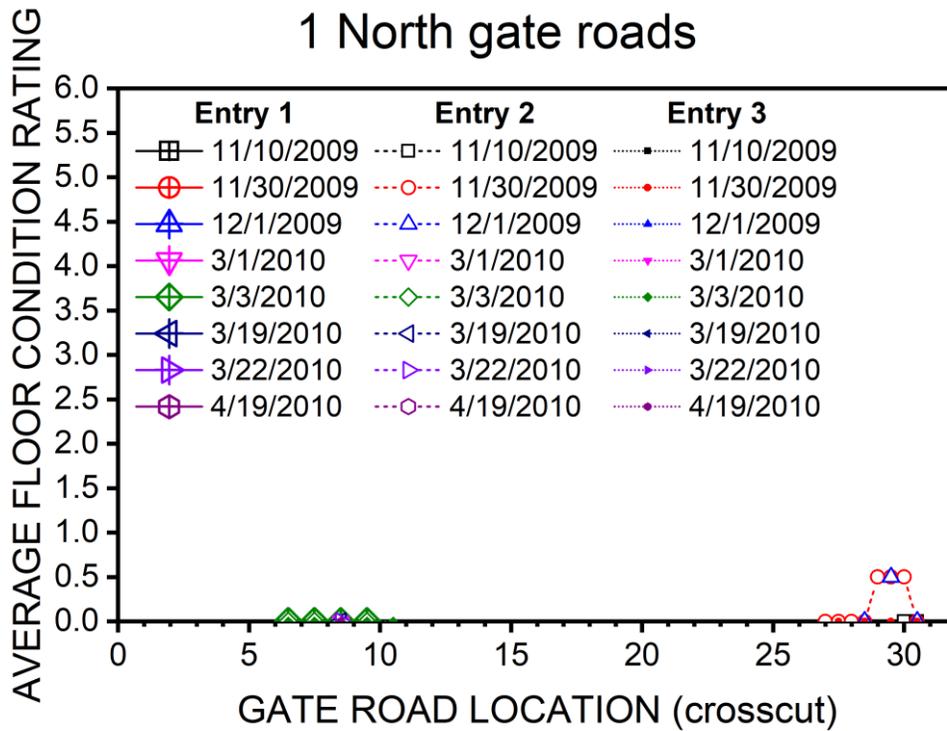
Figure D3. Results of walking survey of average floor condition ratings by location in the 1 North gate roads at Mine A.

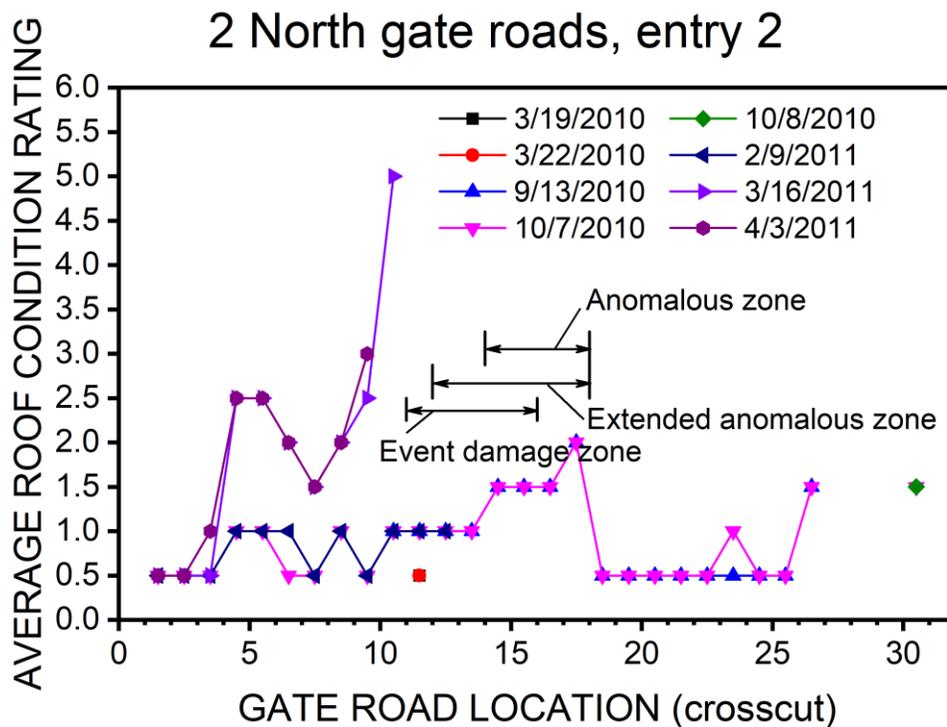
Figure D4. Results of walking survey of average roof condition ratings by location in entry 2 of the 2 North gate roads at Mine A.
