Report of Investigations 9702

## **Ground Stress in Mining (Part 1): Measurements and Observations at Two Western U.S. Longwall Mines**

Mark K. Larson, Heather E. Lawson, Eric G. Zahl, and Tristan H. Jones

January 2020

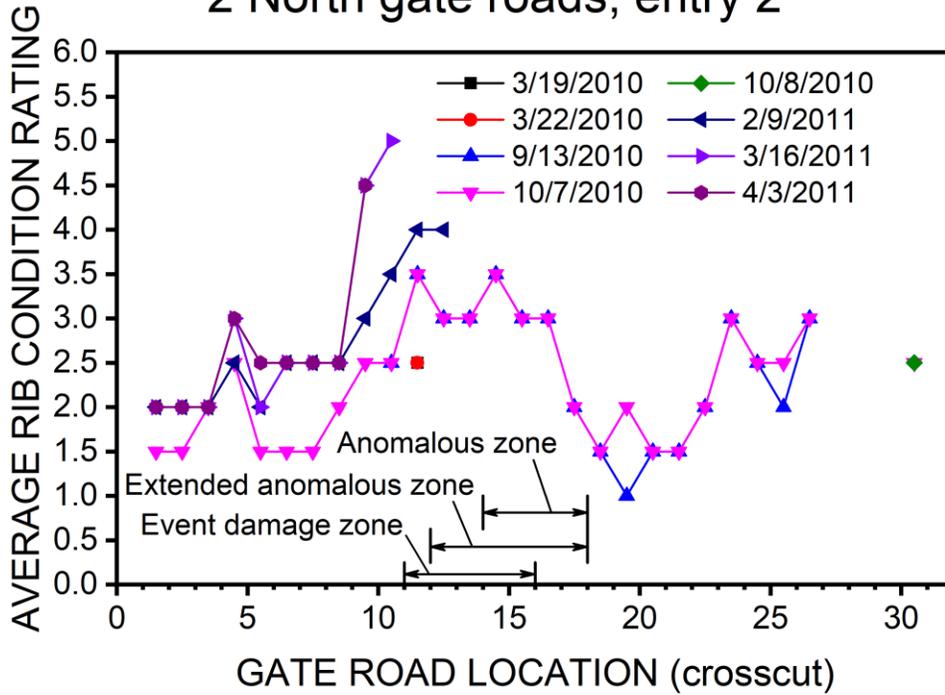
Figure D5. Results of walking survey of average rib condition ratings by location in entry 2 of the 2 North gate roads at Mine A.

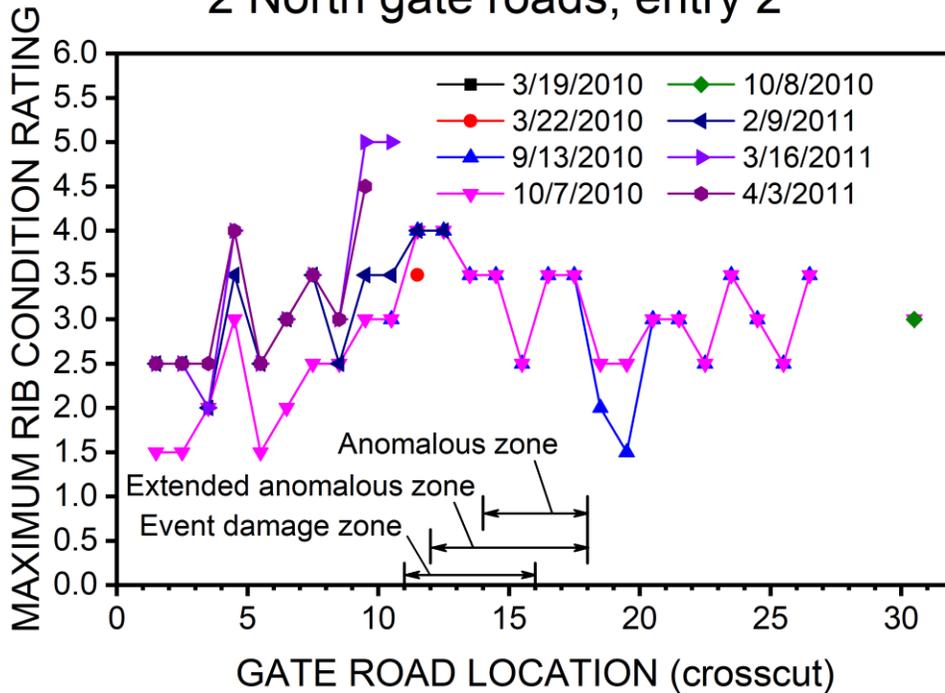
Figure D6. Results of walking survey of maximum rib condition ratings by location in entry 2 of the 2 North gate roads at Mine A.

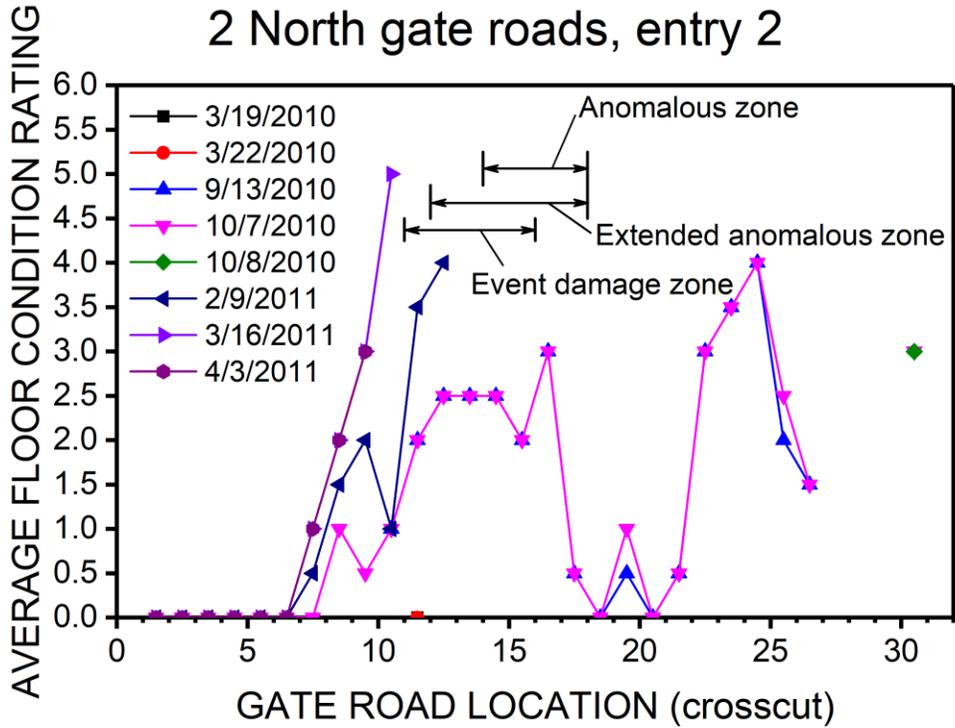
Figure D7. Results of walking survey of average floor condition ratings by location in entry 2 of the 2 North gate roads at Mine A.

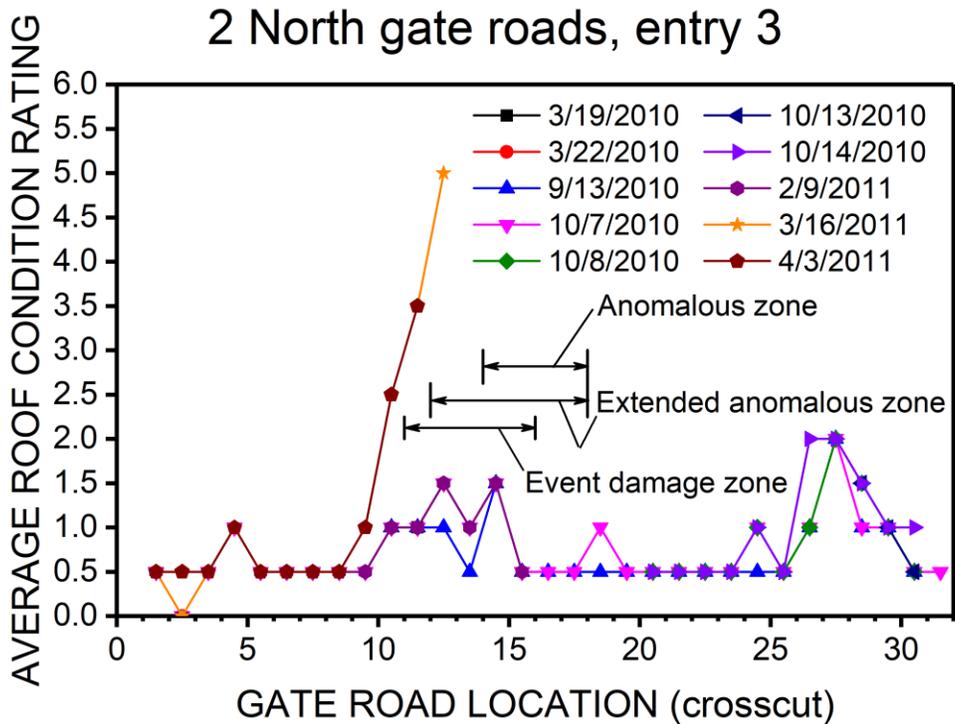
Figure D8. Results of walking survey of average roof condition ratings by location in entry 3 of the 2 North gate roads at Mine A.

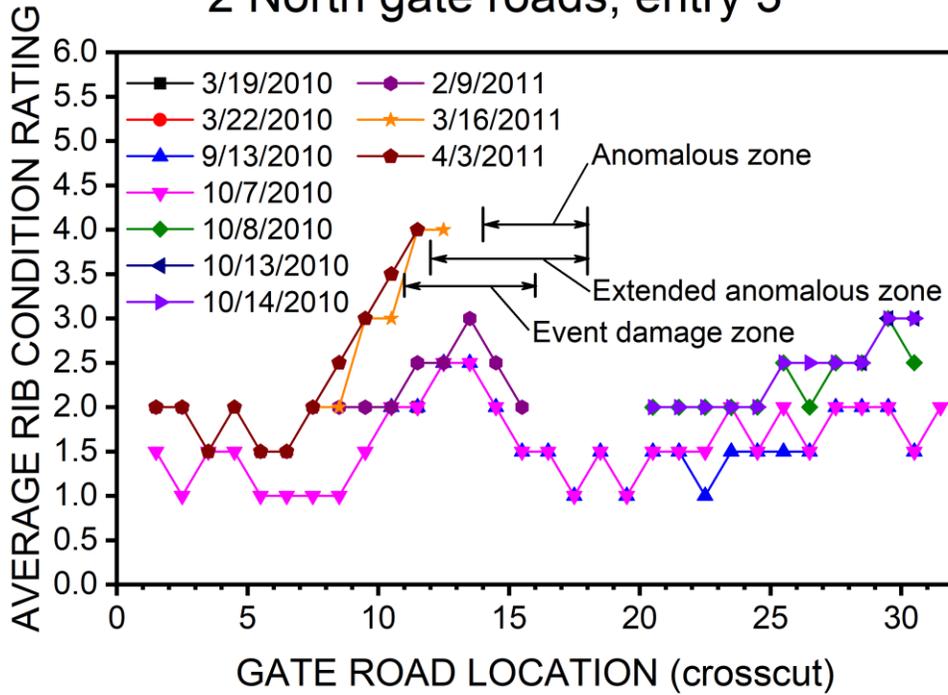
Figure D9. Results of walking survey of average rib condition ratings by location in entry 3 of the 2 North gate roads at Mine A.

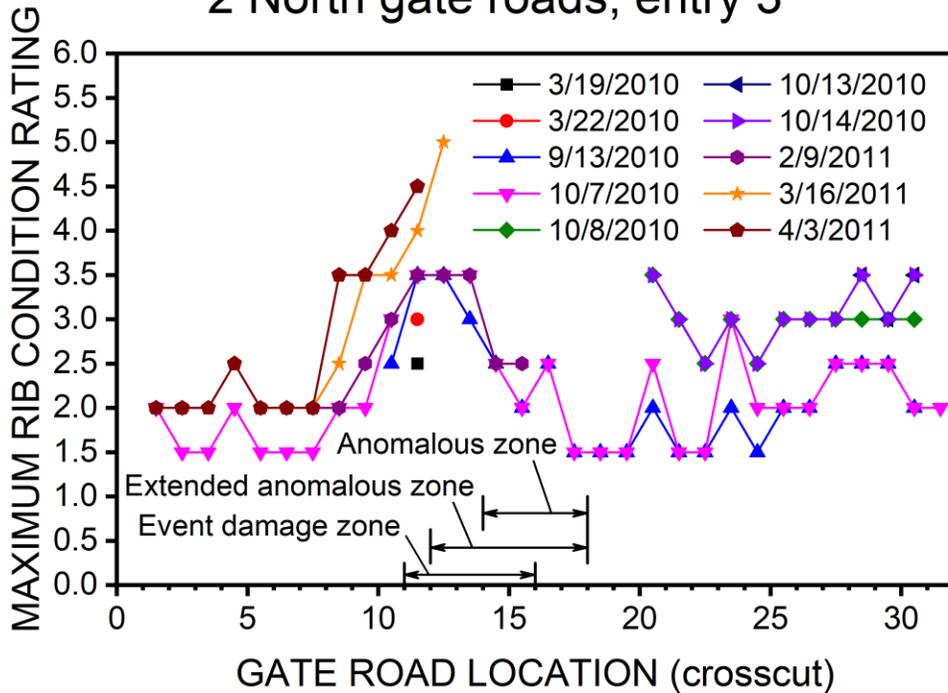
Figure D10. Results of walking survey of maximum rib condition ratings by location in entry 3 of the 2 North gate roads at Mine A.

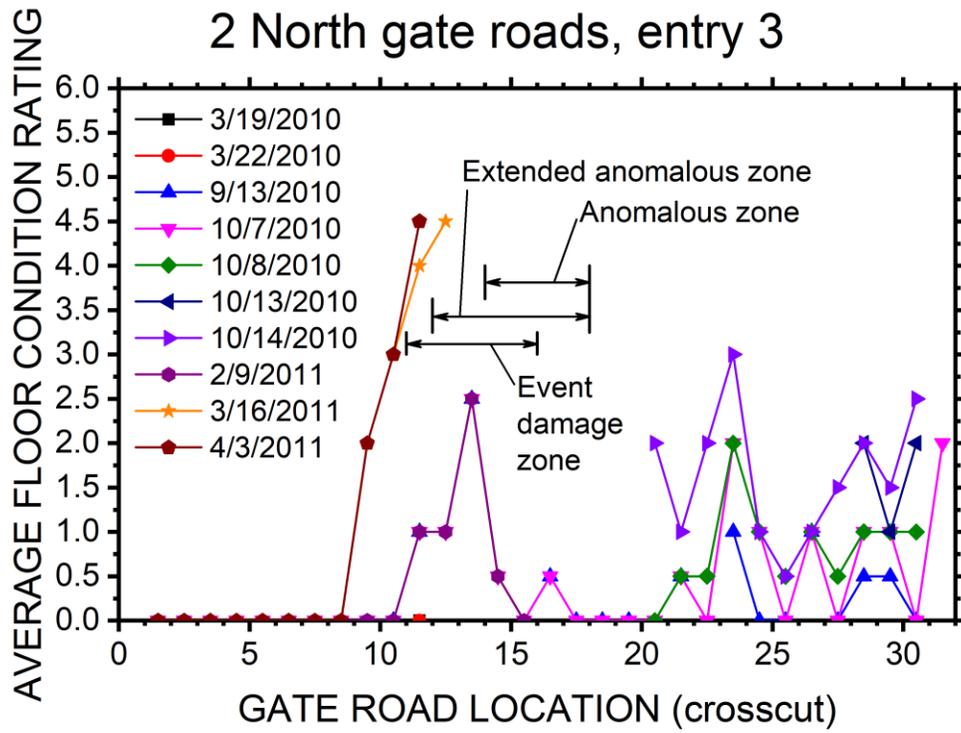
Figure D11. Results of walking survey of average floor condition ratings by location in entry 3 of the 2 North gate roads at Mine A.

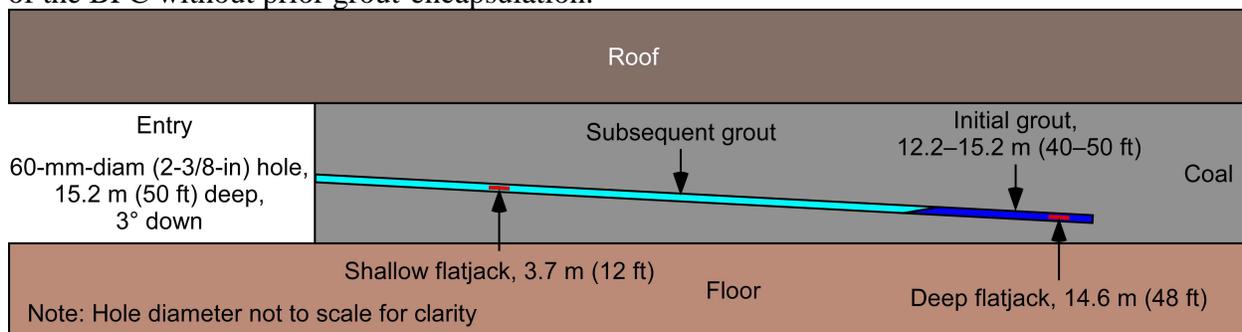
**Figure E1. Vertical section of idealized BPC target installation at Mine B.**

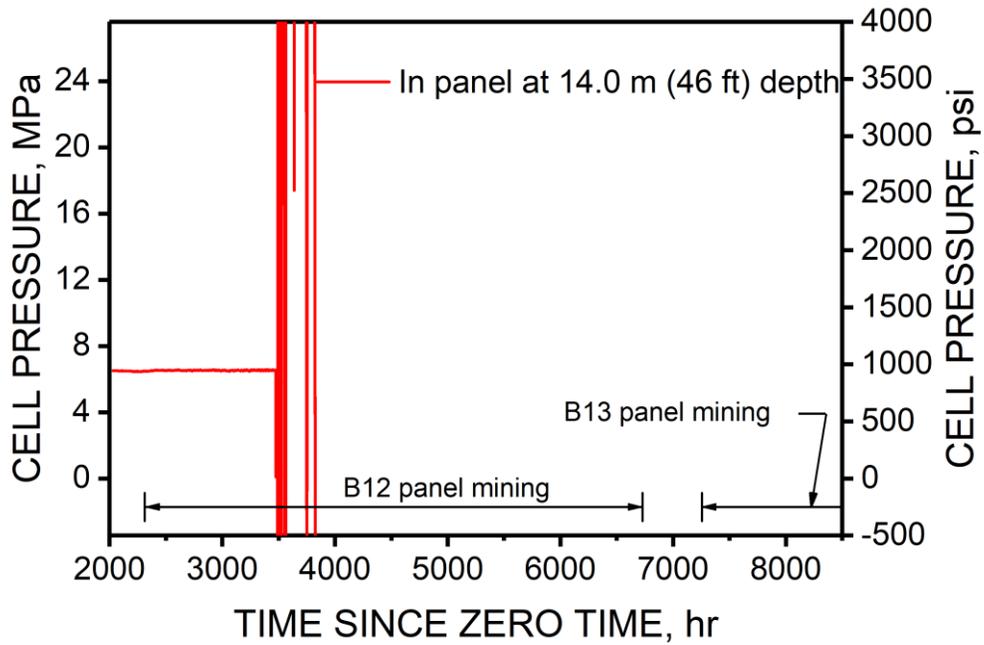
Figure E2. BPC pressure with time at T34 site at Mine B.

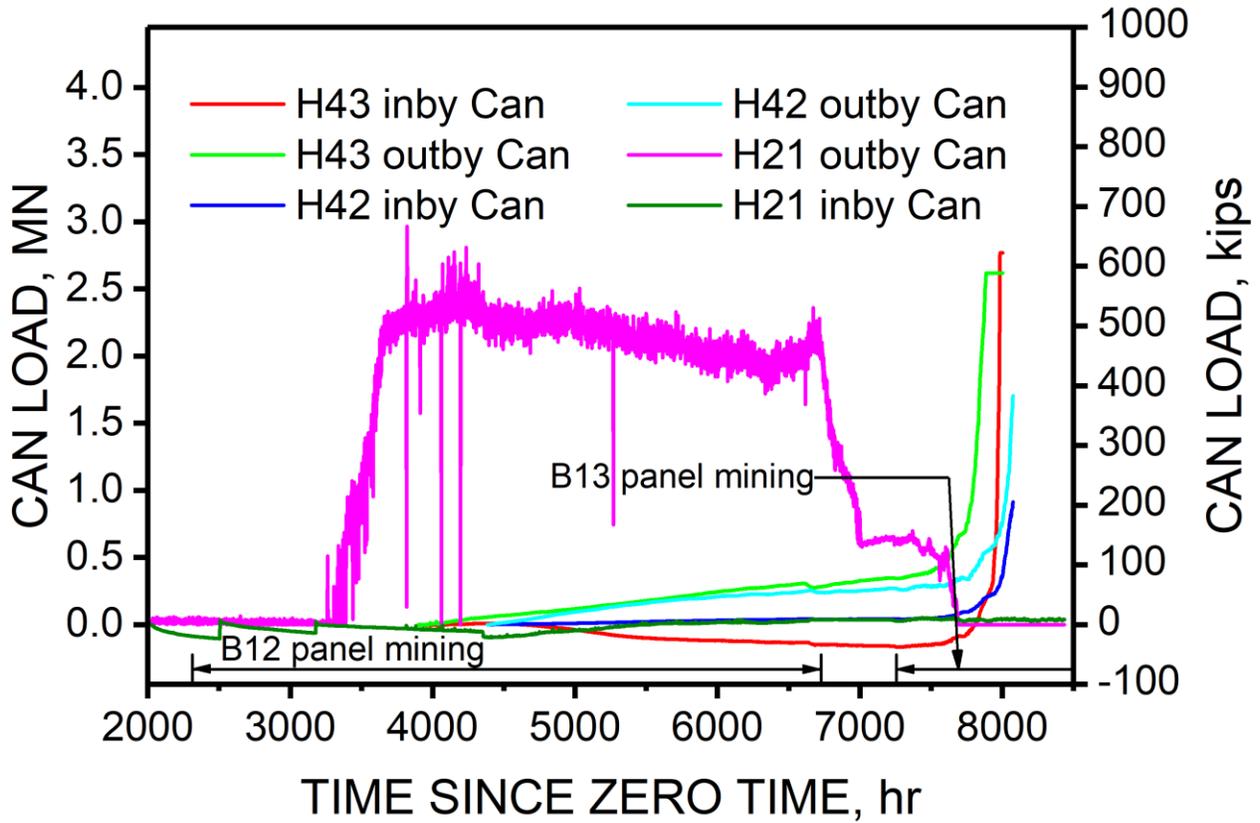
Figure F1. Loads on support Cans at Mine B sites.

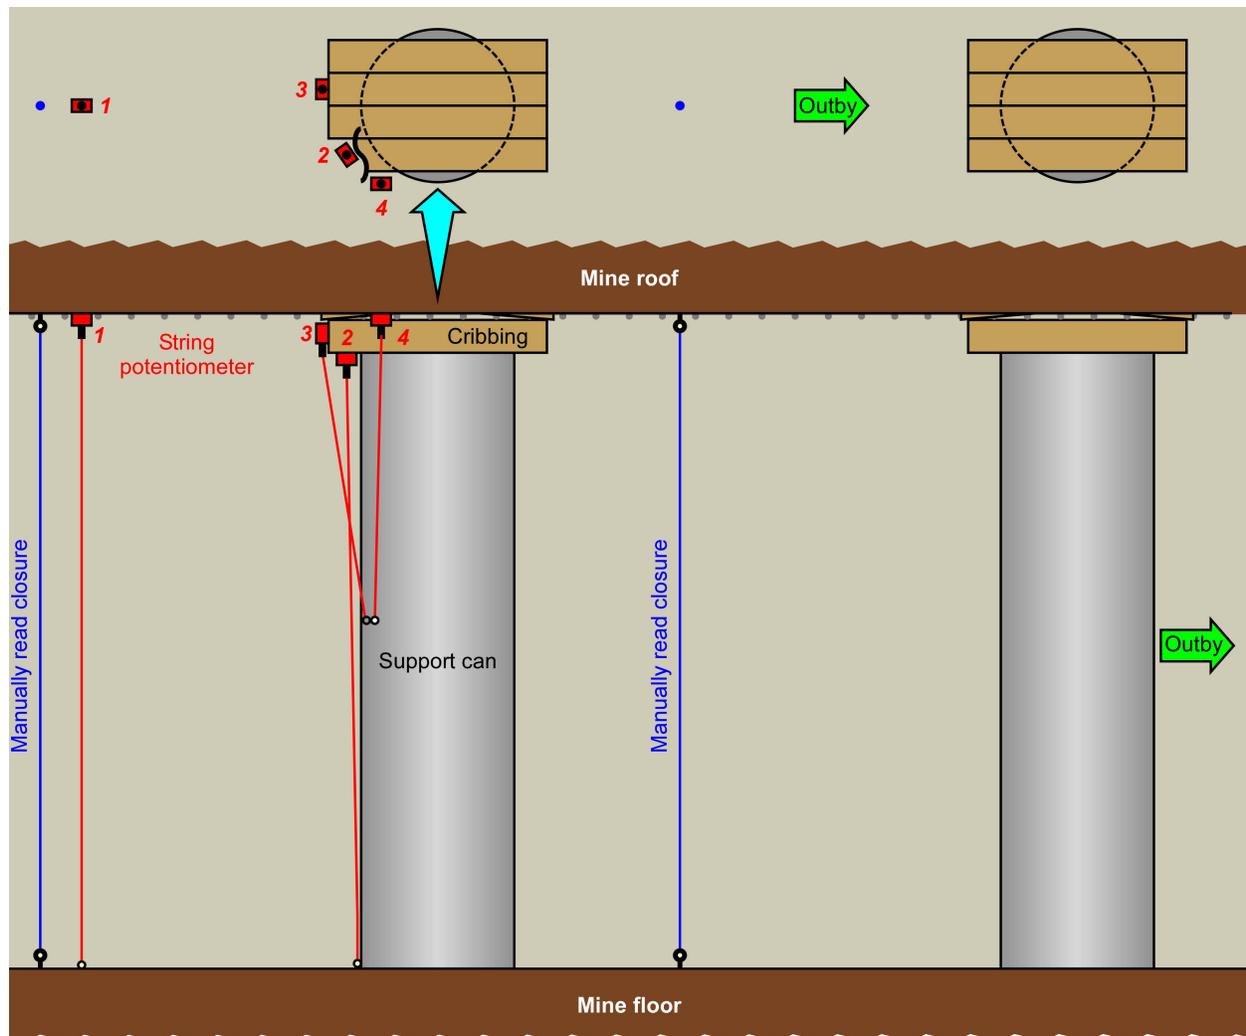
**Figure G1. Target closure measurements with string potentiometers, shown along centerline of entry, in phase 1 of the field study at Mine B, for (1) entry closure, (2) Can closure, (3) closure from top crib to mid-height of Can, and (4) closure from roof to mid-height of Can.**

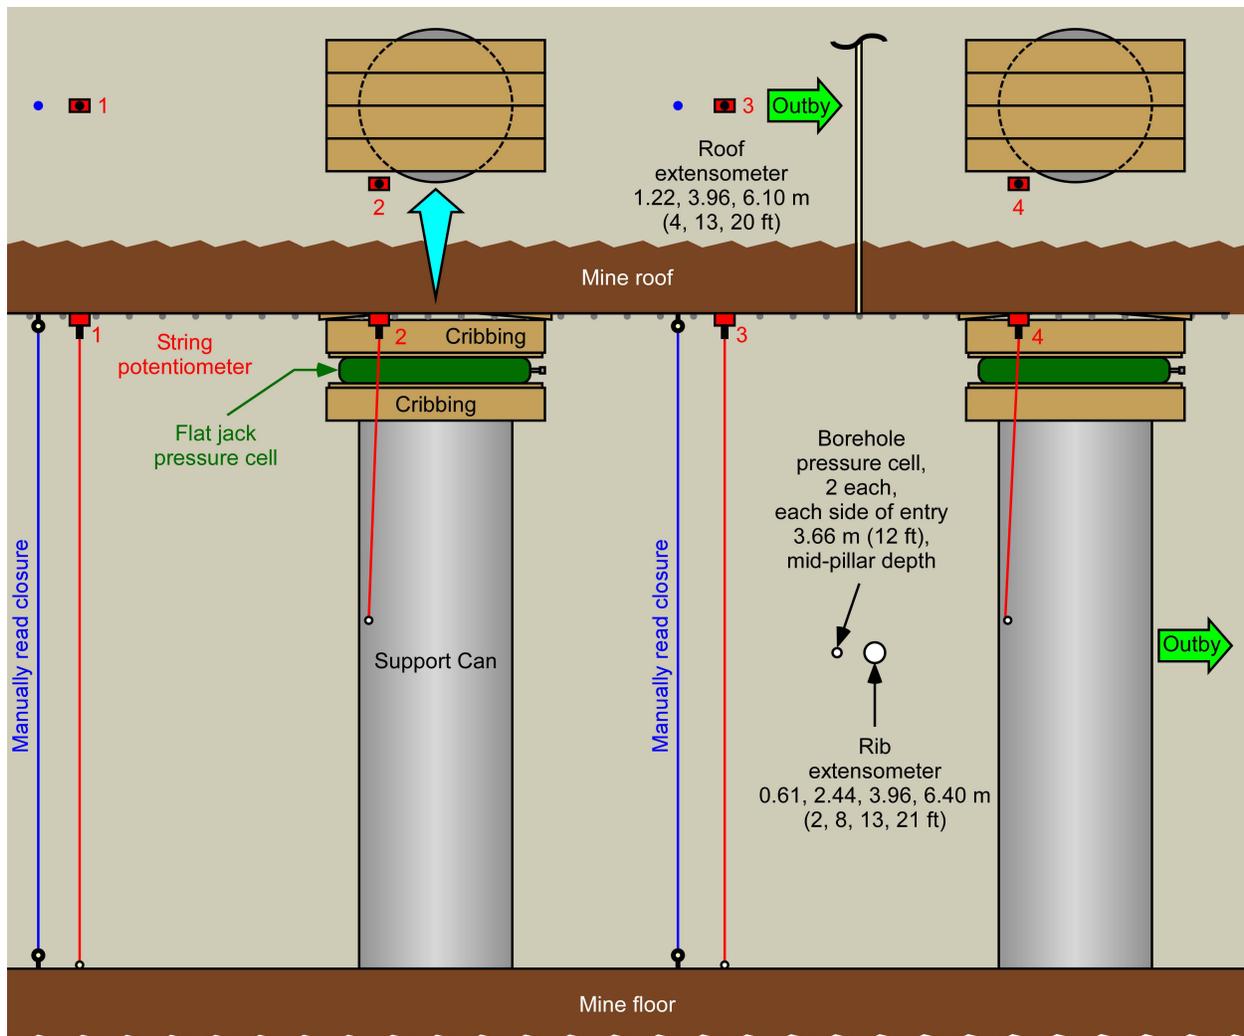
**Figure G6. Target closure measurements with string potentiometers, shown along centerline of entry, in phase 2 of the field study at Mine B, for (1) entry closure, inby set; (2) Can closure from near roof to mid-height of Can, inby set; (3) entry closure, outby set; and (4) Can closure from near roof to mid-height of Can, outby set. Roof and rib extensometers were installed only at H42 site. Can bladders were installed only in the B-12 headgate. String potentiometer closures were not installed in the B-12 headgate, but this configuration was used only at Phase 2 sites in the B-12 tailgate.**

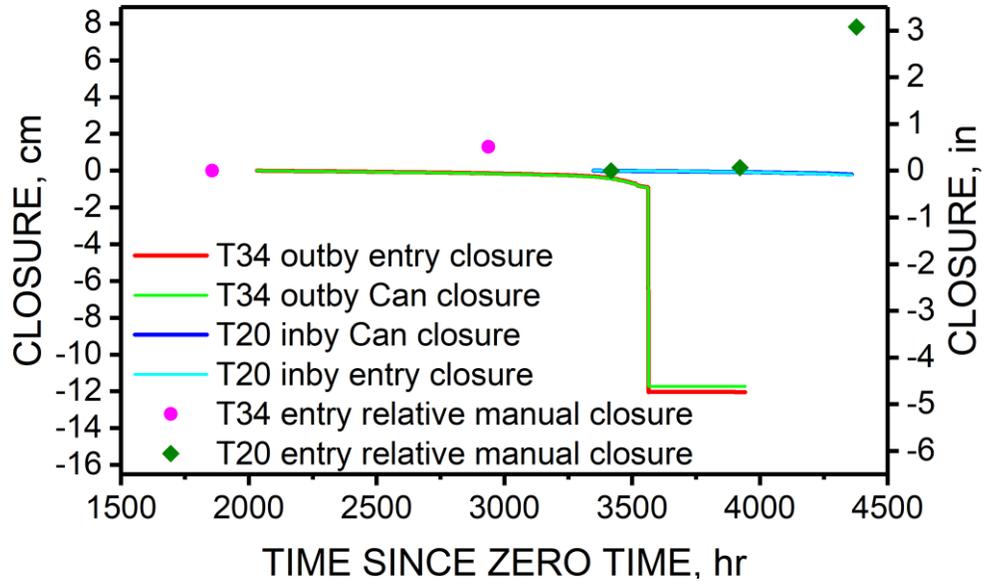
Figure G13. String potentiometer closures versus manually measured entry closures at Mine B.

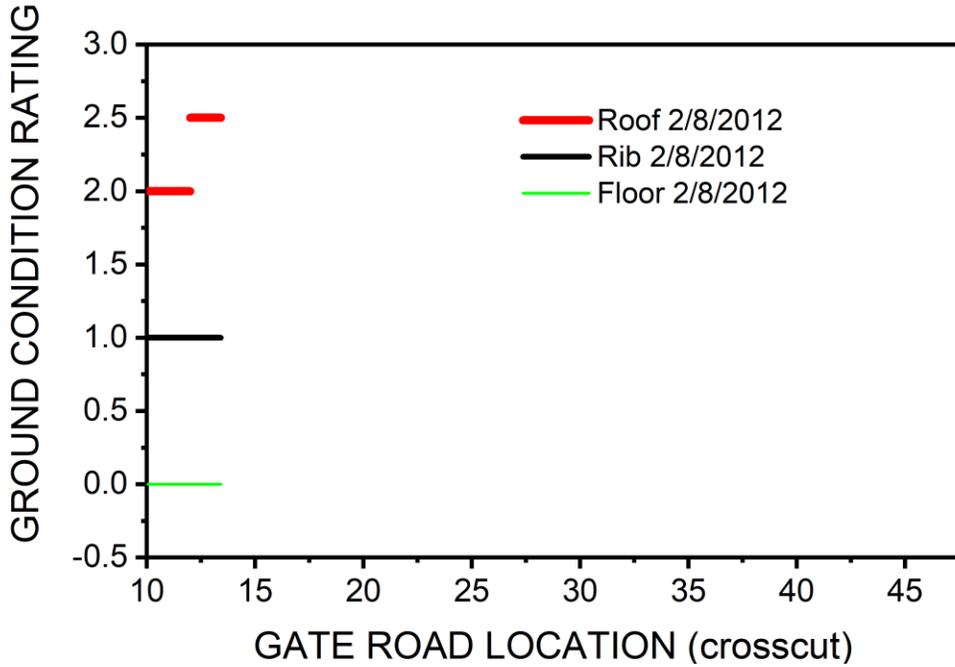
Figure H1. Ground condition ratings plotted with location in the B-11 tailgate at Mine B. The B-11 panel face was between crosscuts 13 and 14 at the time of this survey.

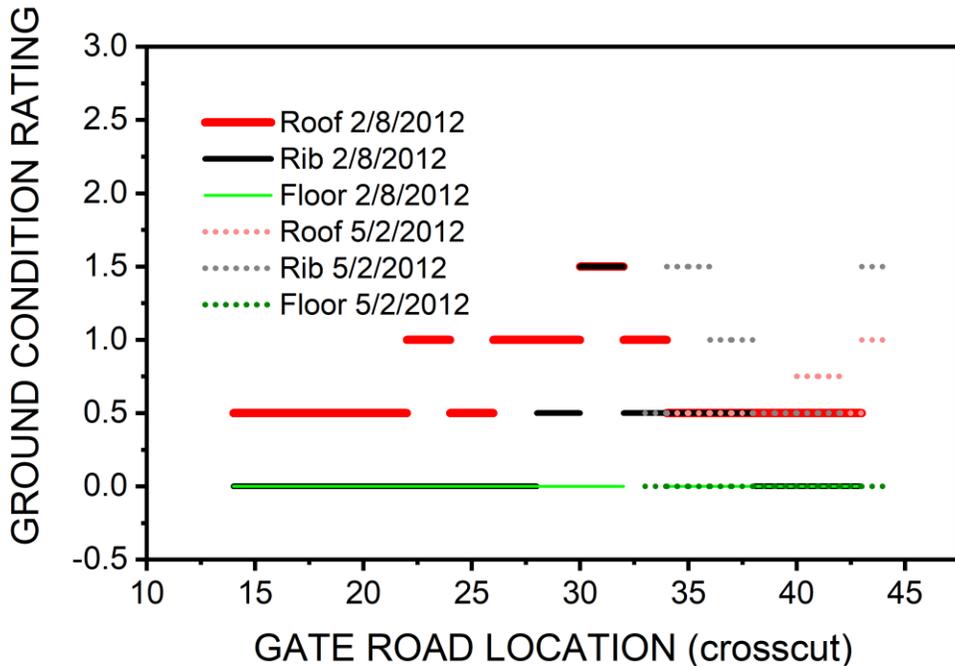
Figure H2. Ground condition ratings plotted with location in the B-11 headgate at Mine B. The B-11 panel had been completed several days earlier at the time of this survey.

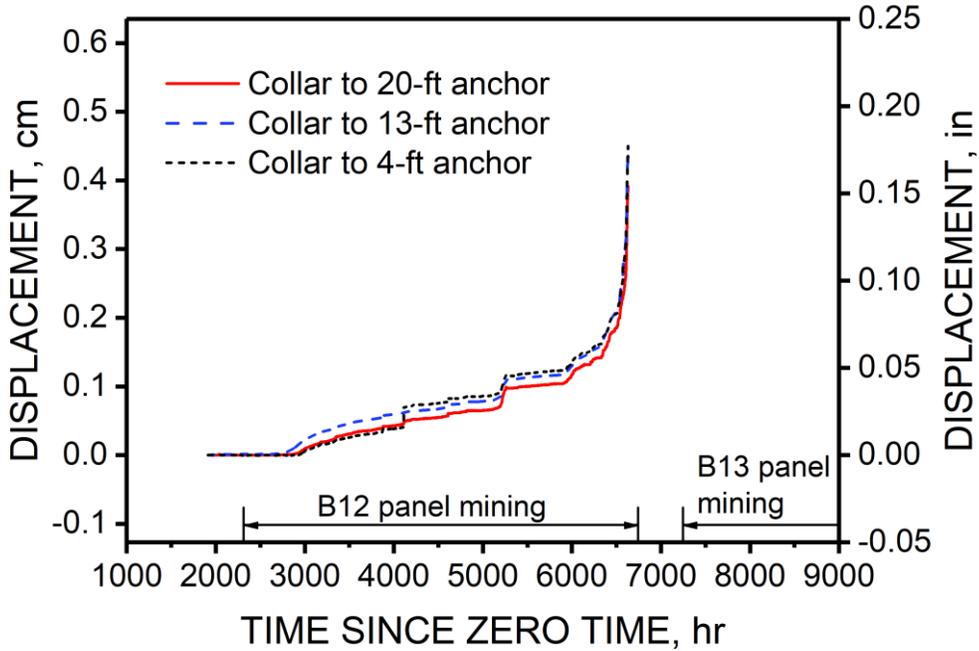
Figure H3. Displacement between collar and roof extensometer anchors at H42 at Mine B, plotted with time.
