**DYNAMIC TEMPERATURE MEASUREMENT OF OVERHEATED  
SHUTTLE CAR TRAILING CABLES IN UNDERGROUND COAL MINES**

**NIOSH  
Pittsburgh, PA**

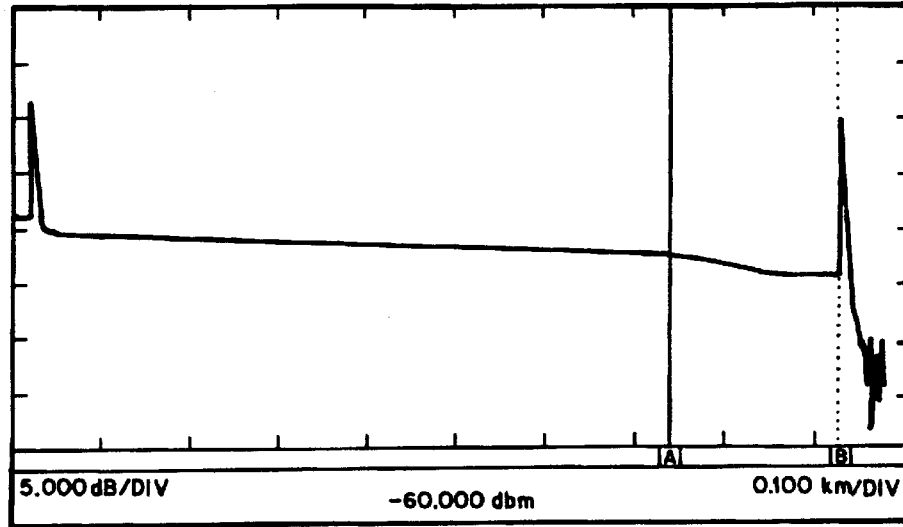
Figure 3. OTDR display.

Marker Information:

A	0.768 km
B	0.950 km
Distance	0.187 km
2 Pt Loss	2.147 dB

Optical fiber protection options were proposed by various vendors. One proposal consisted of two polyimide-coated, 50- $\mu$ m core optical fibers contained within a polyvinylidene fluoride (PVDF) loose tube buffer. A sample of this cable was incorporated into a production run of a #4 AWG conductor. An optical time domain reflectometer (OTDR) monitored the attenuation characteristics of one of the optical fibers as the sensor cable was pulled through the machine. The OTDR display showed intensity of back-scattered light as a function of fiber length (Figure 3). As the test run started, it soon became apparent the fiber was undergoing excessive stress as indicated by the signal attenuation between markers "A" and "B". The problem was caused by excessive pulling tension between the main capstan and a gear driven take-up reel. Although a clutch adjustment to the take-up reel eliminated further problems, this experience suggested more substantial protection was needed. An alternative design including stress-bearing kevlar strands was subsequently chosen. In this configuration, an inner tefzel loose tube isolates two polyimide-coated, 50- $\mu$ m core optical fibers from the kevlar. An outer tefzel tube protects the kevlar strands from abrasion.

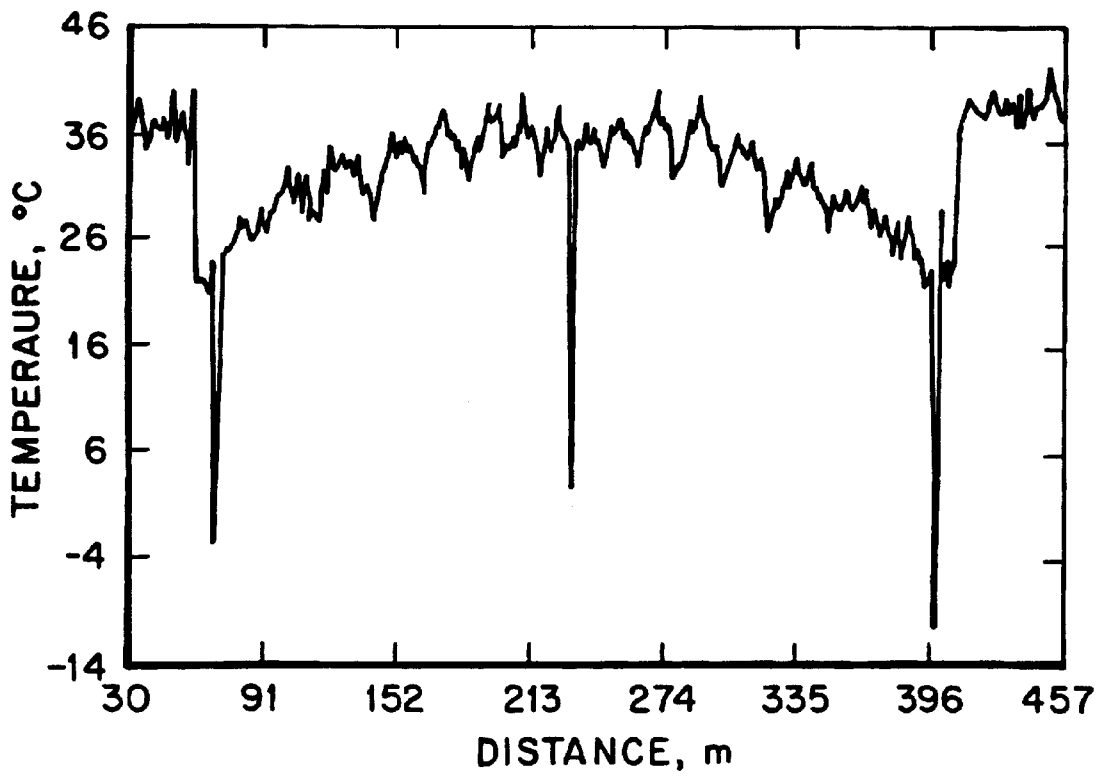
Figure 4. DTS 80 display which shows 7 layers of cable.

Researchers also conducted preliminary shuttle car tests with the fiber-optic-embedded trailing cable. The shuttle car was loaded with coal and operated in a manner similar to a room-and-pillar scenario. A typical DTS 80 display shows temperature readings as a function of distance from the instrument (Figure 4). The drum-terminated end of the trailing cable corresponds with the sharp downward peak in the center of the figure. This downward peak is caused by jumper cable connector reflections in the center of the drum and should not be misinterpreted as actual temperature. Reflections effectively blind the DTS 80 over short distances, commonly referred to as dead zones. Dead zones can be eliminated by replacing connector interfaces with splices. However, space limitations inside the drum make reliable splice installation difficult. Dead zones are an example of concepts that need to be understood when interpreting DTS 80 generated data.

The symmetrical side lobes around the central dead zone in Figure 4 represent temperature readings from two fiber-optic sensors. These jumper-connected fiber-optic sensors form one sensor loop. The periodic downward peaks indicating lower temperature are consistent with sections of cable closest to the outside of the reel. These sections of cable are most susceptible to convective cooling effects from the surrounding atmosphere. Further testing is required to make quantitative assessments of
