Determining the Root Causes of Flame Cutting and Welding Fires in Underground U.S. Coal Mines

Pittsburgh Research Laboratory

National Institute for Occupational Safety and Health

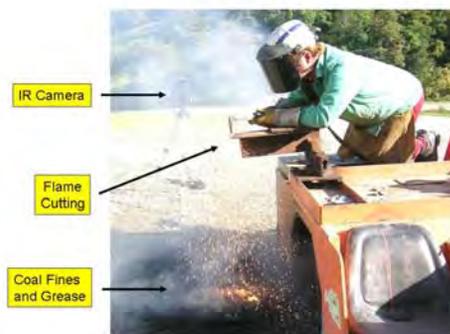
Several flame cutting experiments were performed by an experienced miner at NIOSH's Lake Lynn Laboratory to observe the effects of hot steel particles on coal fines and grease. Coal fines and grease were placed on a steel sheet (1/8 in. x 2 ft. x 2 ft.) and the miner performed a flame cutting operation directly above (Figure 7).

FIGURE 7. MINE WORKER PERFORMING FLAME CUTTING OPERATION

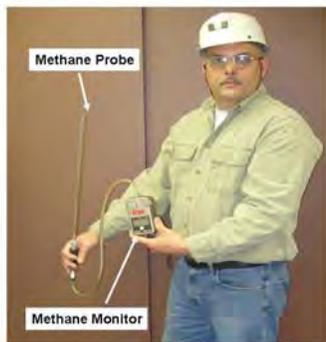
- 1) Methane checks are not being made close enough to surfaces where ignitable concentrations of methane may exist. Tests should be conducted in and around the immediate area where flame cutting and welding is conducted and where hot slag and sparks might fly. If necessary, a pump type methane monitor and probe should be used (Figure 10).

FIGURE 10. PUMP-TYPE METHANE MONITOR AND METHANE PROBE

- operations should have regular training. This training should include:
- The proper calibration and use of methane detection instruments.
 - Proper methods for tests of methane and the use of methane probes in conjunction with a methane pump.
