# Ergonomic interventions at Unimin

**W.L. Porter and A.G. Mayton**

## Abstract

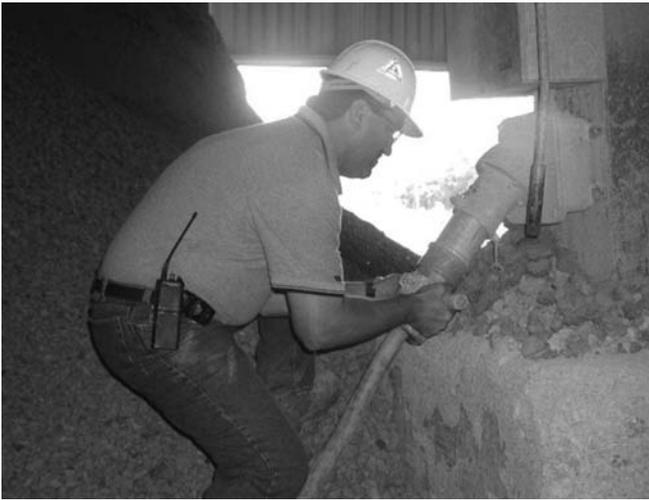
**Figure 1** — Mineworker demonstrates power connection.

During discussions with the employees, Gleason mine management became aware of difficulties in connecting and disconnecting the shredder power cable (Fig. 1). Issues of concern included:

- the aluminum sleeve became bent, which made it difficult to connect and disconnect from the receptacle;
- hardened and built-up clay on the connectors made it difficult to insert into the receptacle;
- dust on the aluminum sleeve made it more difficult to connect; and
- awkward postures (rounded back, arm position with respect to the body and standing on uneven ground) occurred when connecting and disconnecting the cable to the power source.

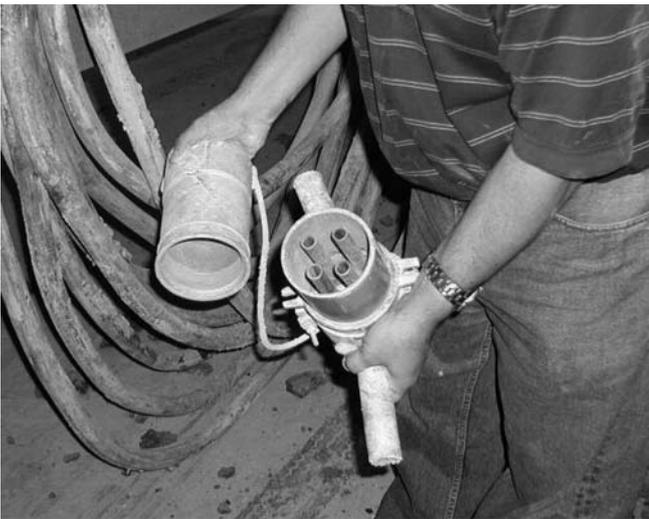
**Figure 2** — The rubber “boot” to protect the male cable connector from dirt, dust and damage.

- A rubber boot (Fig. 2) for the aluminum sleeve was installed on the male end to prevent the sleeve from bending and to keep it clean. The rubber boot was made from a protective cover for a dust collector cartridge that the mine normally stocks.
- An electric grinder was used to file burrs on the inside of the connectors to make insertion of the plug easier.
- A spray lubricant, commonly known as “Super Slick,” was applied to the contacts and sleeve of the connector to reduce friction when inserting the connector into the receptacle.

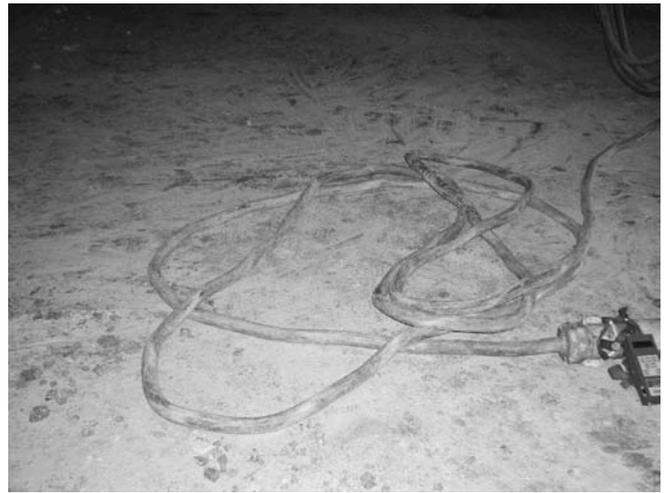
**Figure 3a** — Shredder cable haphazardly overlapped.

Afterwards, the mine management team considered a low-cost and simple solution to the cable-handling issue offered by an off-shift shredder operator who was listening to the conversation between the NIOSH researchers and a fellow operator. This involved a procedural change to cable handling that constituted a method of looping the cable in 3-m (10-ft) lengths (as seen in Fig. 3b), so that only a 3-m (10-ft) length of cable is handled at a time instead of a haphazardly overlapping bundle. NIOSH researchers determined that overlapping the cable (as seen in Fig. 3a) while unwinding it increased the force required by approximately one third, i.e., mean forces for small drag at 82.3 N (18.5 pound-force) with no cable overlap versus 113 N (25.5 pound-force) needed when overlapped cable.

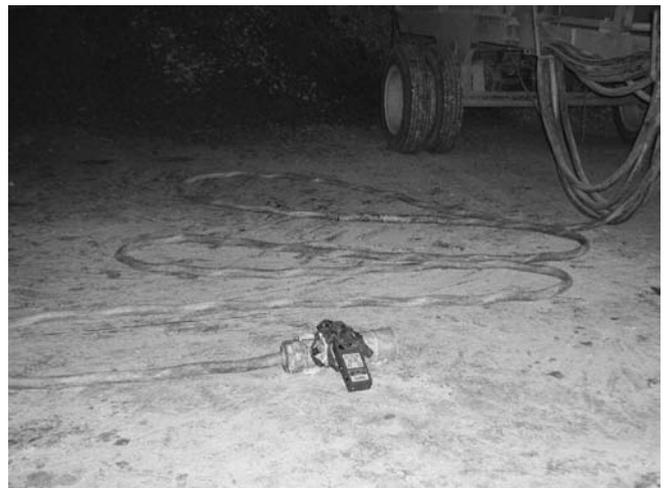
**Figure 3b** — Shredder cable evenly looped.

the cable. This solution, even though not optimal as yet, helped to reduce the amount of load handled by 28% and raised the awareness of the employees while a more cost-effective solution can be further explored. Table 2 presents a summary of the cable handling target task.

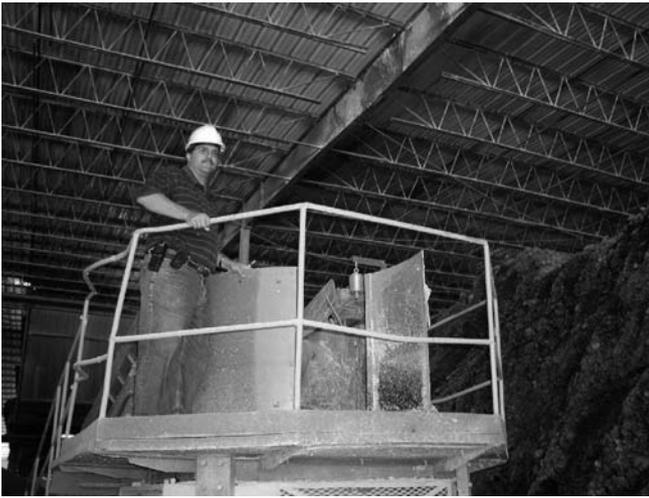
**Figure 4a** — Shredder tub with door installed.

A team consisting of mine management, maintenance personnel and shredder operators conducted intensive brainstorming sessions to reach a low-cost effective solution. It resulted in cutting the tub to create a hinged door (Figs. 4a and 4b). This intervention demonstrated the following benefits:

- It reduced the risk factors associated with leaning over the side and climbing over the side of the tub. The worker was now able to walk into the tub to perform cleaning or maintenance duties.
- It reduced the injury risk associated with lifting heavy rocks to shoulder height and above to throw them over

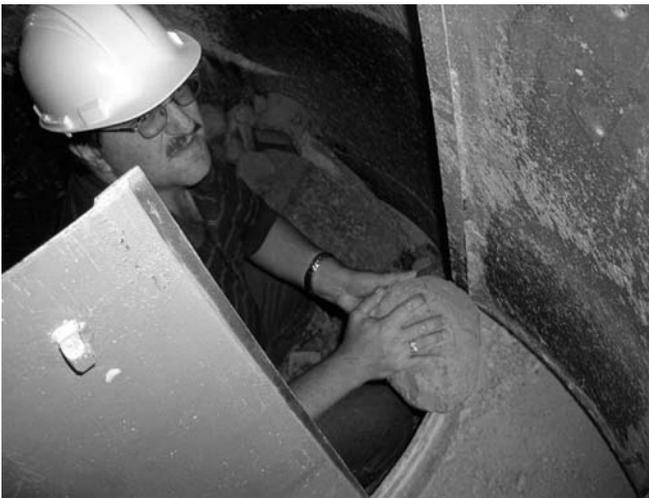
**Figure 4b** — Worker easily removing large rocks when using door.

the top of the tub side. Instead workers are able to use the door of the tub to easily slide out rocks and debris.

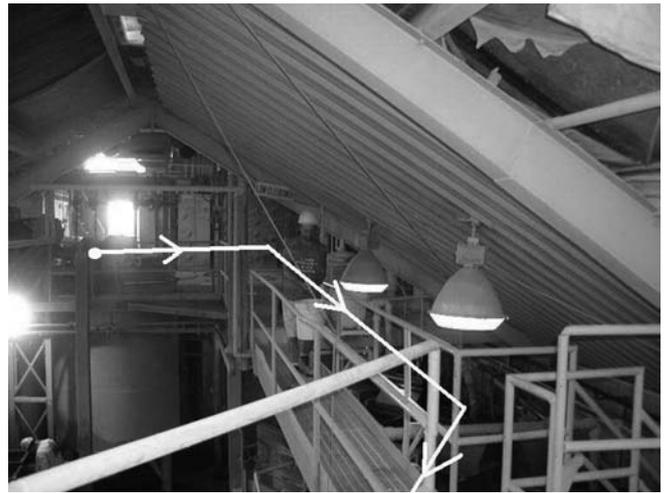
**Figure 5a —** Pre-intervention handling and carrying of the bucket (arrow depicts walking path).

**Handling sodium silicate.** Another task that was improved as a result of the NIOSH-Unimin collaboration was the handling of a clay additive, sodium silicate. The sodium silicate is added in 23 kg (50 lb) increments to the ball clay slurry up to three times a day. Originally the additive was dispensed into a bucket and then carried along a catwalk for about 15 m (50 ft) (Fig. 5a). This catwalk was very narrow and forced workers to carry the bucket one handed in front of or behind their body or to walk sideways.

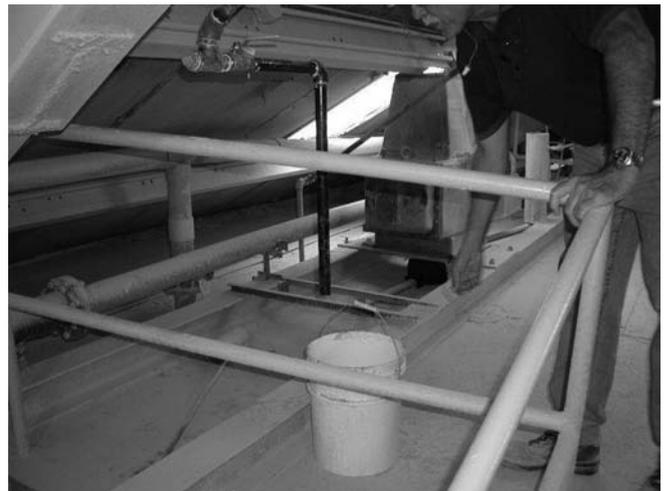
**Figure 5b —** Post-intervention filling of the bucket (occurs at end of path way shown in Fig. 5a).

NIOSH researchers recommended extending the piping for the additive over to its destination to eliminate carrying the load. As shown in Fig. 5b, it would still be necessary to pour the additive into the slurry by bucket, but workers would no longer carry it 15 m (50 ft). The cost of implementing the intervention was approximately \$300. The installation was straightforward because the additive was already piped. They simply added a pump and lengthened the pipe. The employees liked the idea and quickly put it in place.
