Proceedings: New Technology for Ground Control in Retreat Mining

Information Circular 9446

Christopher Mark, Ph.D., and Robert J. Tuchman

March 1997

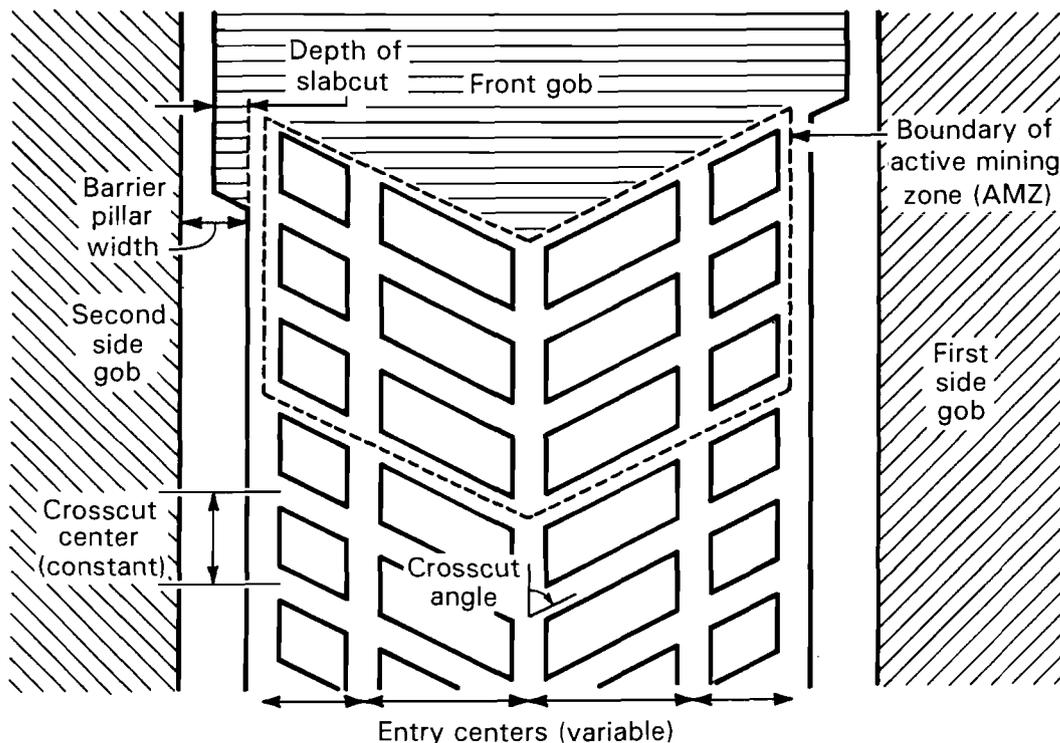
Figure 1.—Section layout parameters used in ARMPS.

The first step in using the ARMPS program is to enter the dimensions of the pillars in the working section, as illustrated in figure 1. The program can accommodate angled crosscuts, varied spacings between the entries, and barrier pillars between the active section and old (side) gob areas. Slabbing of barriers

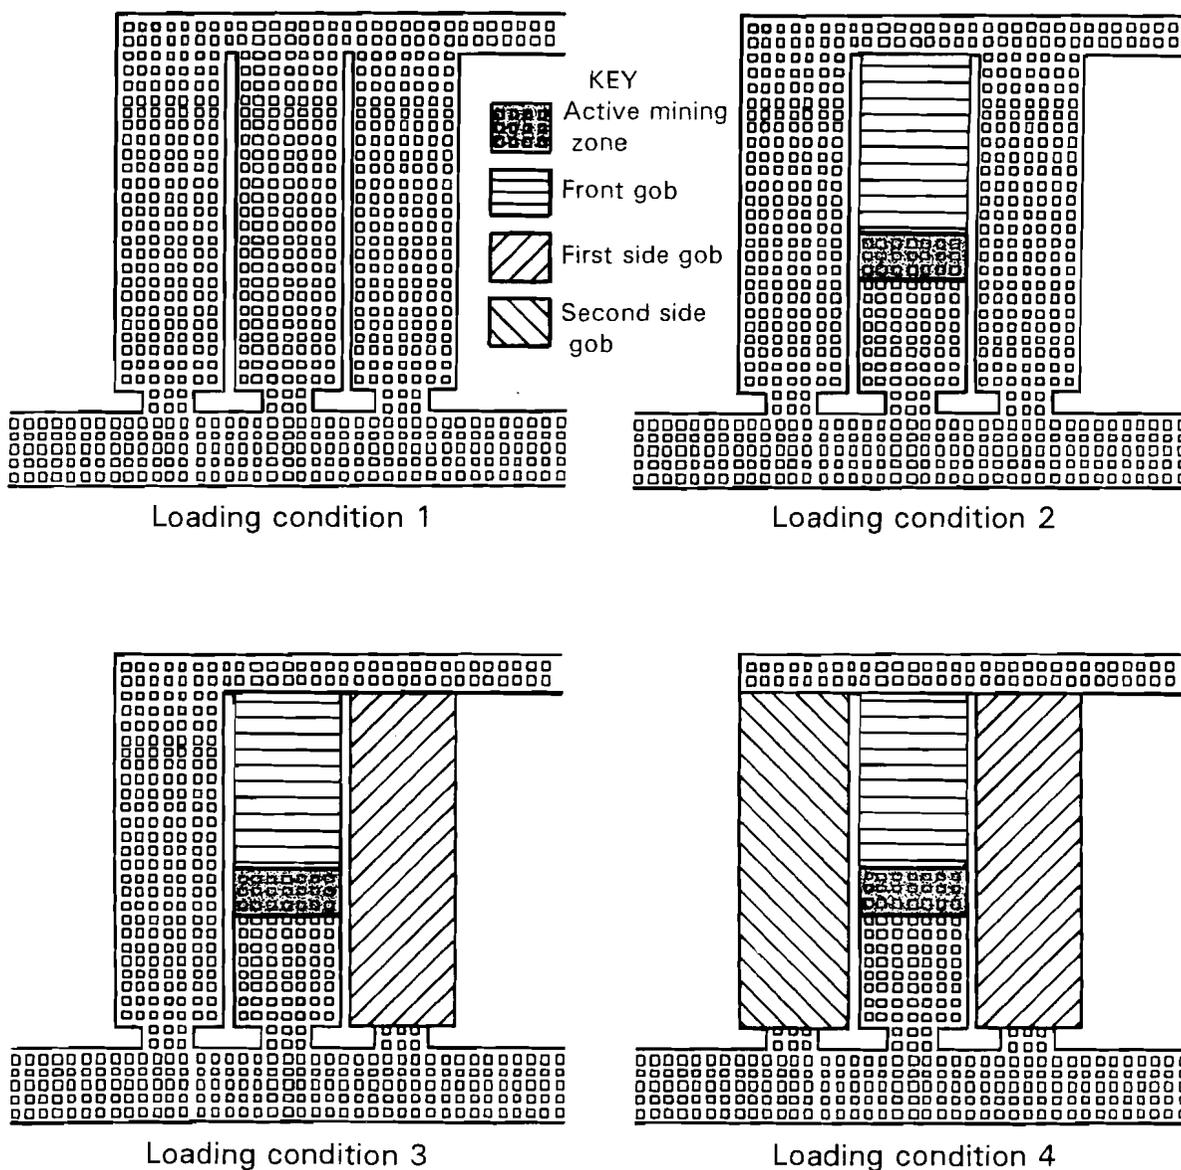
Figure 2.—The four loading conditions that can be evaluated with ARMPS.

on retreat can also be included. Other parameters that must be defined include depth of cover, mining height, entry width, and crosscut spacing. Finally, the user chooses one of four possible *loading conditions* (figure 2). The simplest, loading Condition 1, is development loading only. Loading condition 2 occurs when the active, or "front," panel is being fully retreated and there are no adjacent mined-out areas. The total applied load is the sum of the development loads and the front abutment load. Loading condition 3 occurs where the active mining zone (AMZ) is adjacent to an old (side) gob and the pillars are subjected to development, side abutment, and front abutment loads. Where the pillar line is surrounded by gob on three sides (sometimes referred to as "bottlenecking"), loading condition 4 is used. In every case, the extent of each gob is defined by the user.

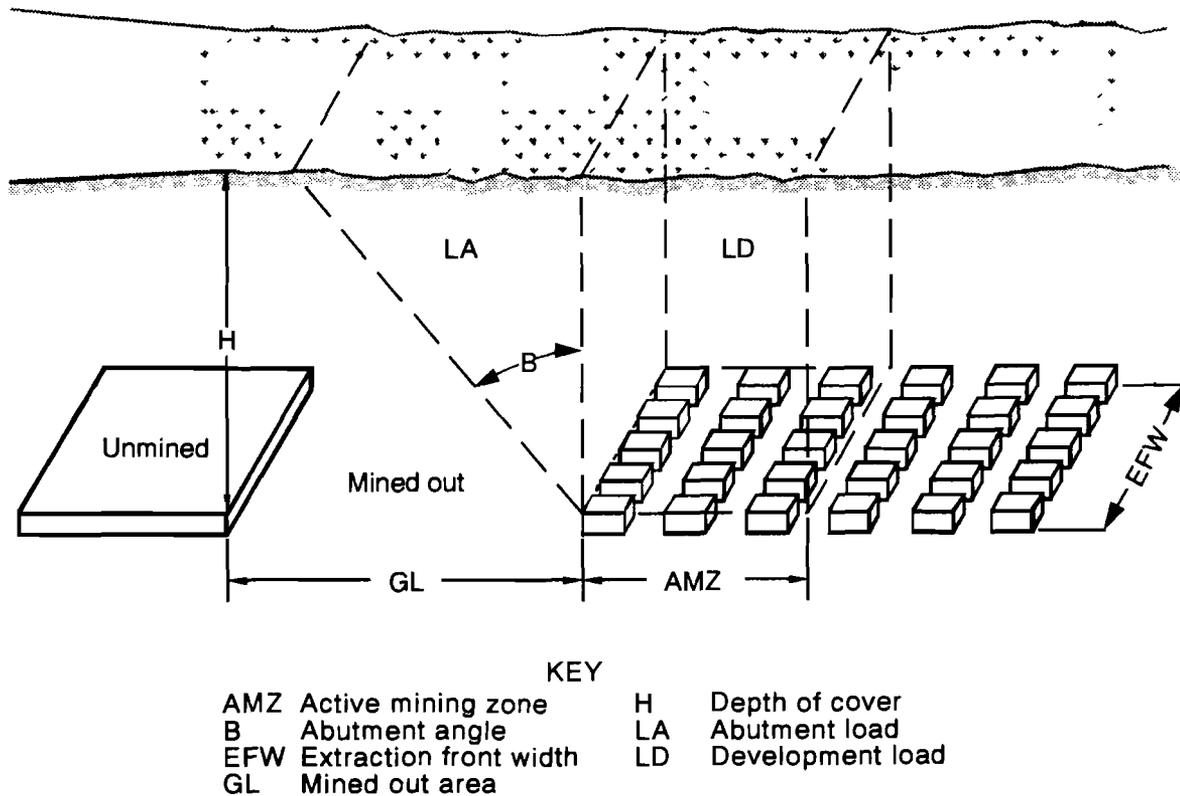
Figure 3.—Schematic showing the active mining zone, the development load, and the front abutment load.

Figure 3 illustrates the development and front abutment loads applied to the AMZ.

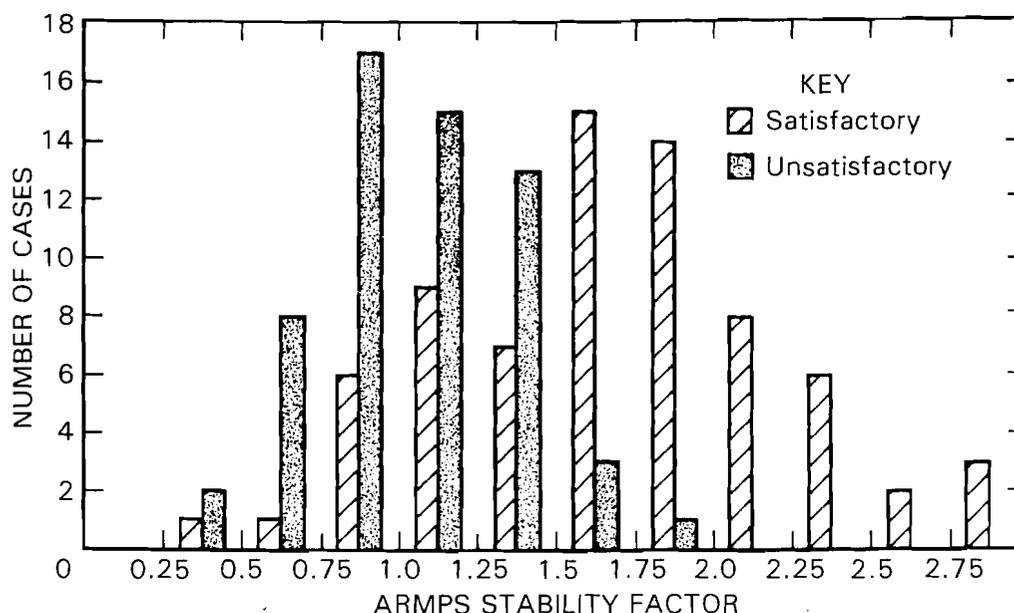
Figure 7.—ARMPS data base.

As figure 7 shows, pillar failures occurred in 93% of the cases where the ARMPS SF was less than 0.75. Where the ARMPS SF was greater than 1.5, 94% of the designs were satisfactory. SF values ranging from 0.75 to 1.50 form a "gray" area where both successful and unsuccessful cases are found.

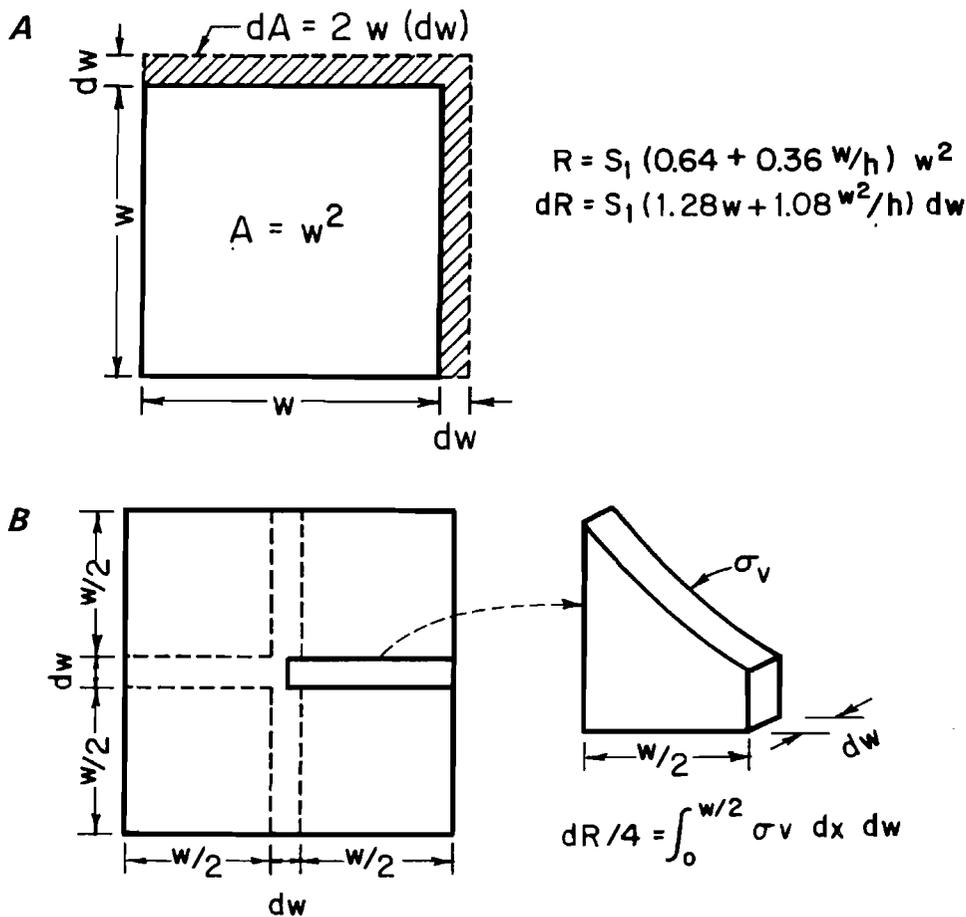
Figure A-3.—Determination of pillar stress gradients from a pillar strength formula. A, calculation of dR directly from the formula; B, calculation of dR in terms of the vertical stress gradient.

Equation A-6 is the stress gradient in the yield zone predicted by the Bieniawski formula. Stress gradients have also been derived for several other common empirical pillar strength formulas [Mark and Iannacchione 1992].

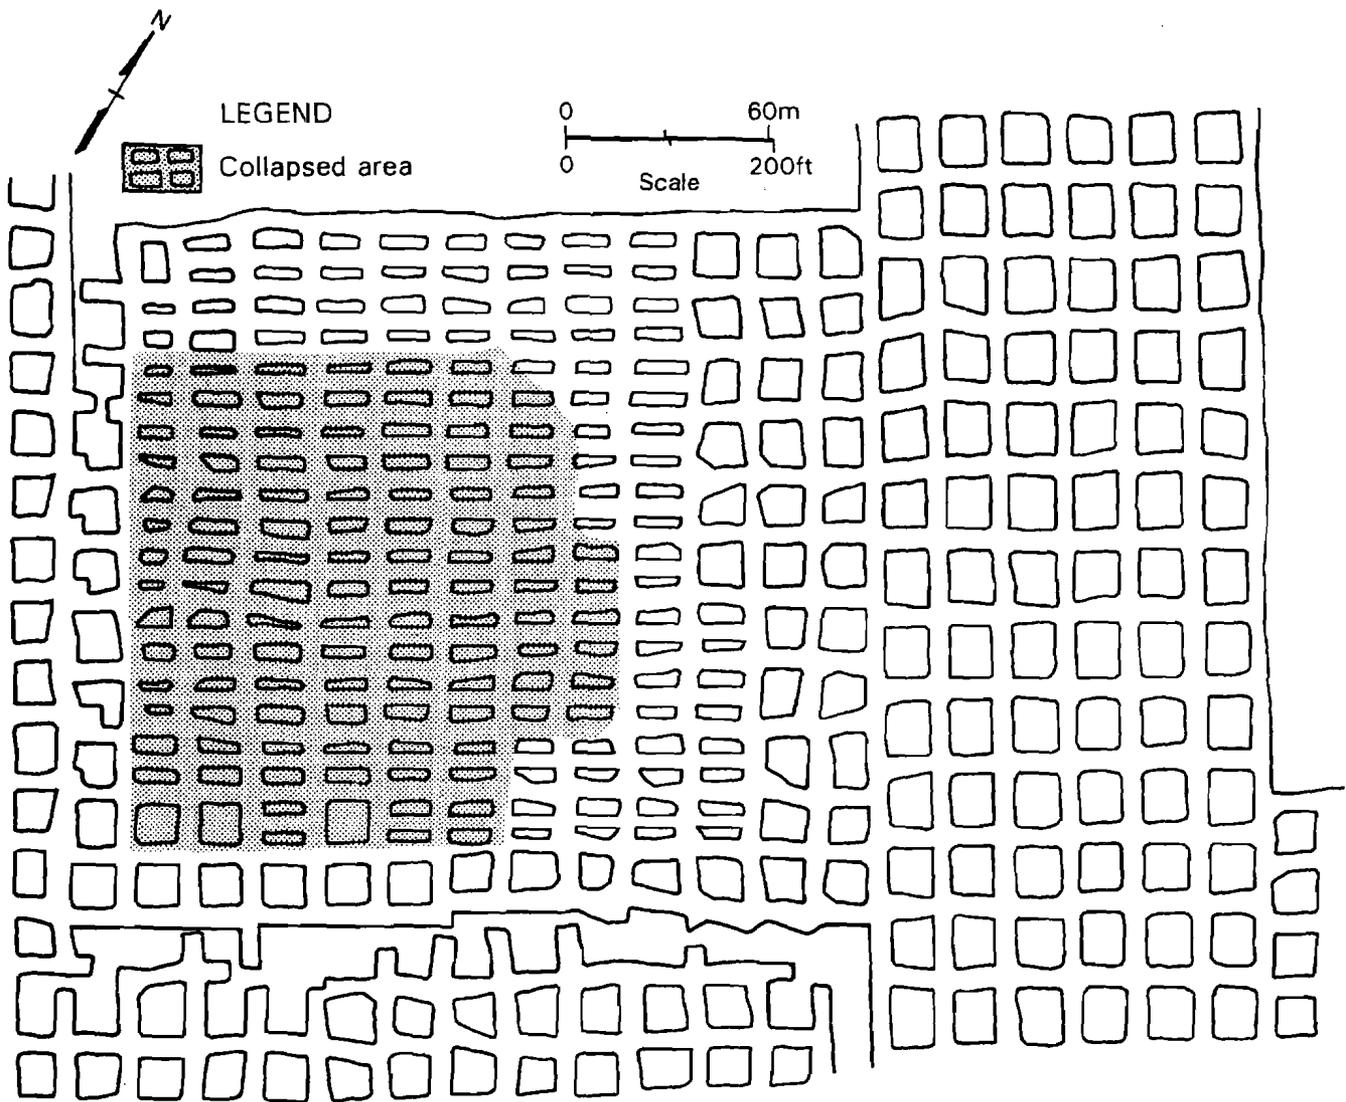
Figure 1.—Failed split-pillar workings in Mine A.

In 1991, the panel shown in figure 1 was developed. All roadways were driven on 18-m (60-ft) centers and were under 85 m (275 ft) of cover. After the panel was completed, partial pillar recovery was begun. A 6-m (20-ft) wide split was mined through the middle of each pillar, and two 3- by 12-m (10- by 40-ft) fenders with an ARMPS SF of 0.75 remained. Because of the competency of the roof and the support provided by the regularly spaced uniform fenders, no caving occurred while the panel was being retreat mined. Three weeks after the panel had been abandoned, an area measuring approximately 140 by 155 m (450 by 500 ft) containing 107 fenders collapsed. Miners on a nearby section were knocked to the floor by the resultant airblast. One miner was bounced off of a steel rail and required 26 stitches to his head. Fortunately, no miners were near the collapse. However, if the failure had occurred 15 min later, two miners would have

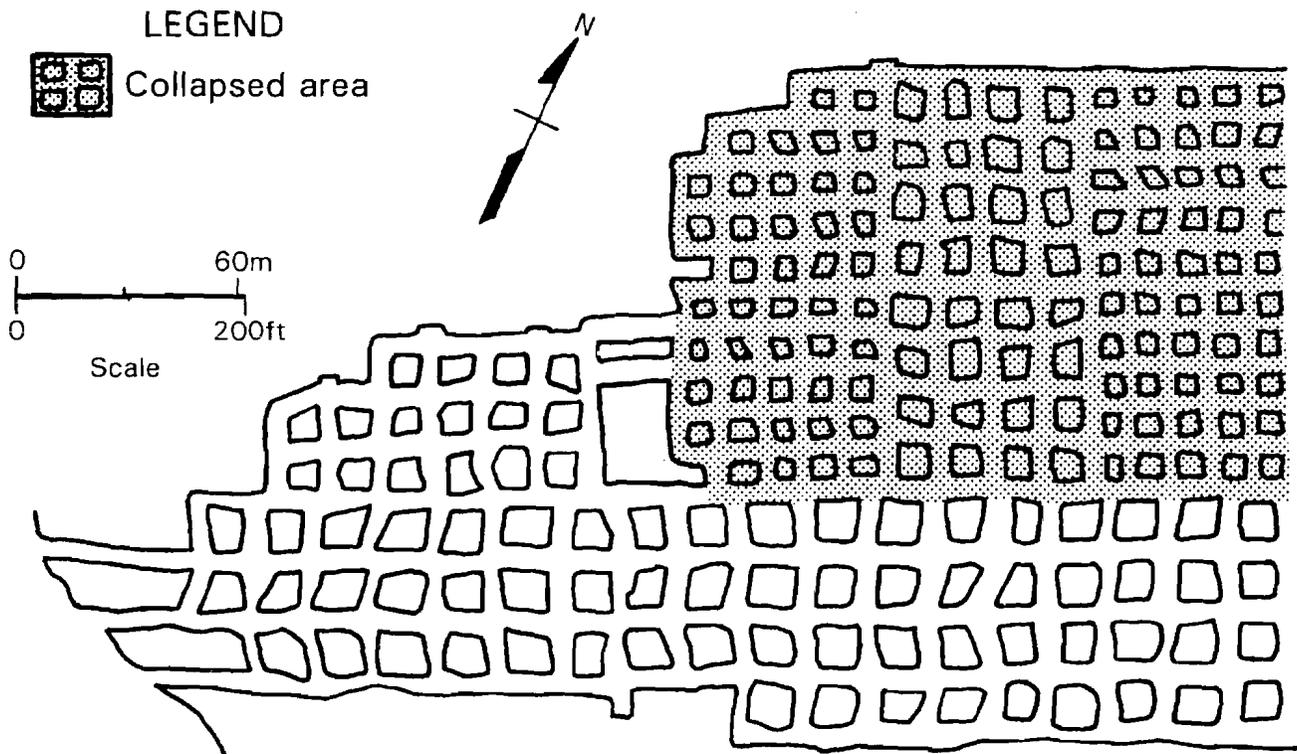
Figure 3.—Failed small-center development workings at Mine D.

In 1992, ninety-four 6- by 6-m (20- by 20-ft) pillars with an SF of 1.15 and thirty-two 9- by 9-m (30- by 30-ft) pillars with an SF of 1.45 failed. As shown in figure 3, the pillar failures occurred in a panel driven off the mains. The resultant airblast blew out 37 stoppings. The only other stopping in the mine had a hole in it. Some of these stoppings were as far away as 244 m (800 ft) from the perimeter of the collapse. In one stopping, it was determined that some of its 14-kg (30-lb) cinder blocks had been hurled 152 m (500 ft). Fortunately, the occurrence was on an idle shift, and no one was in the mine. The collapse was halted by pillars in the main entries, which were 12- by 12-m (40- by 40-ft) and had an SF of 3.33. Cover over the collapsed area was 69 m (225 ft).

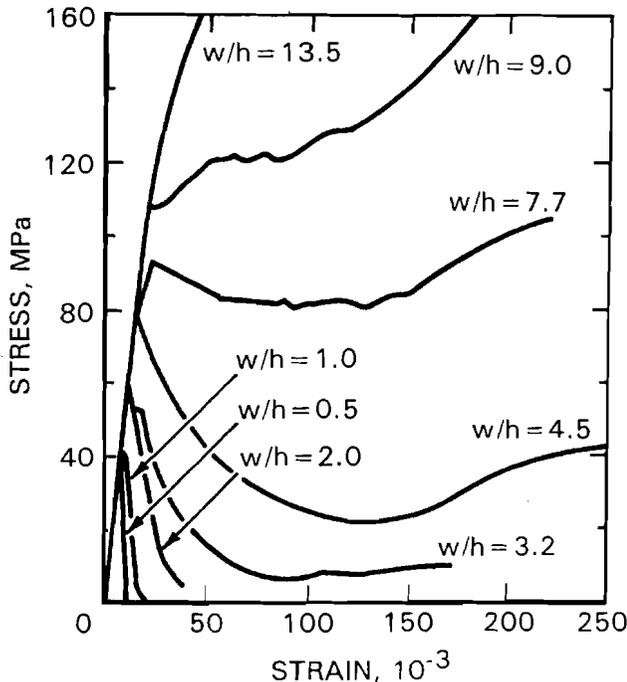
Figure 4.—Complete stress-strain curves for Indian coal specimens, showing increasing residual strength with increasing w/h ratio (after Das [1986]).

Laboratory tests have shown that the residual strength of coal specimens depends on their w/h ratio [Das 1986]. Specimens with a w/h ratio of less than 3 typically have little residual strength, which means that they shed almost their entire load when they fail (figure 4). As the specimens

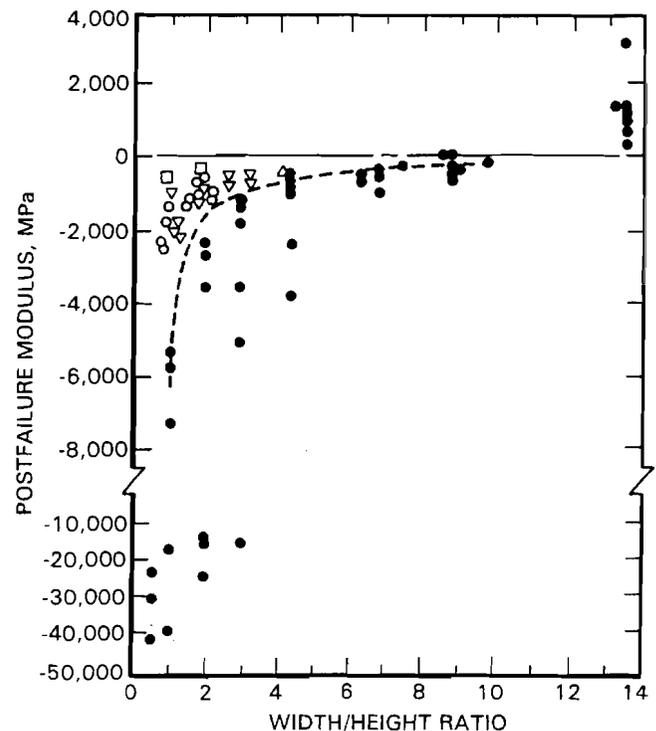
Figure 5.—Postfailure modulus of coal pillars, in situ coal specimens, and laboratory samples. Darkened circles represent laboratory tests, remaining symbols represent in situ tests [Chase et al. 1994].

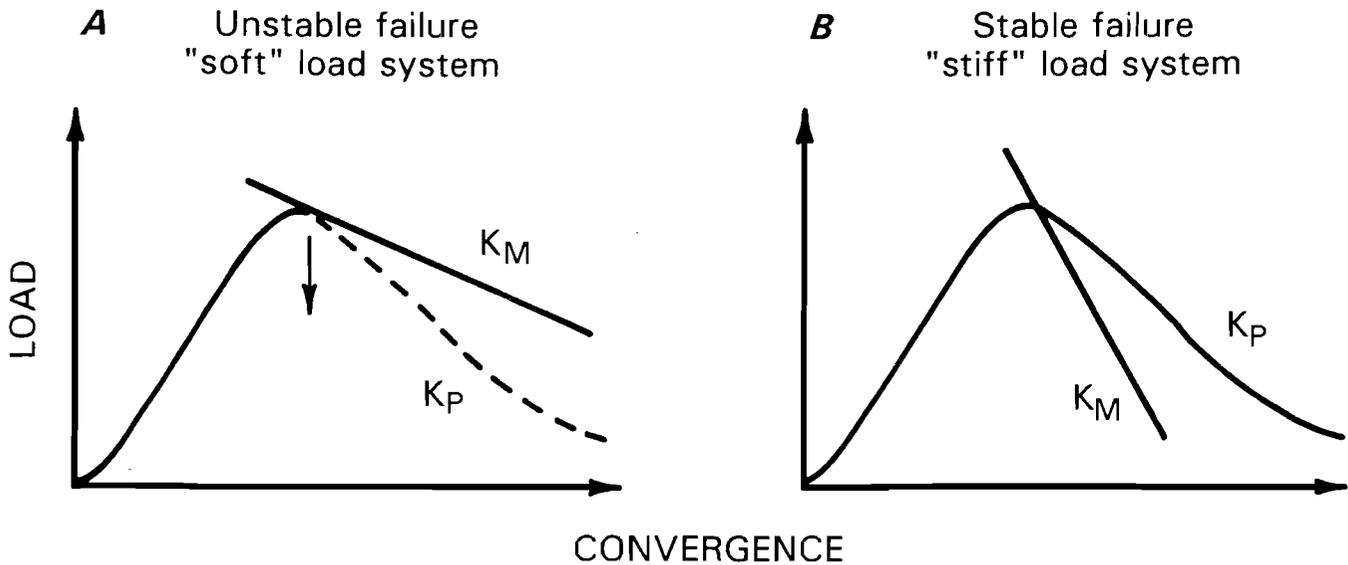
Figure 6.—Illustration of the local mine stiffness concept. A, local mine stiffness (K_M) is less than postfailure stiffness of the pillar (K_P), resulting in unstable failure. B, local mine stiffness (K_M) exceeds the pillar's postfailure stiffness (K_P), resulting in slow and stable failure.

The importance of the postfailure stiffness is further explained by the theory of *local mine stiffness*, first proposed by Salamon [1970] and discussed by Zipf [1992, 1996]. The theory states that if the pillar's postfailure modulus (K_p) is less than the stiffness of the mine roof (the local mine stiffness, or K_M), the failure is stable and gradual (figure 6B). If K_p exceeds K_M , on the other hand, the failure is sudden and violent (figure 6A). The local mine stiffness depends on the modulus of the immediate roof; floor and pillar materials; and the layout of pillars, mine openings, and barrier pillars. The postfailure stiffness, K_p , depends on the w/h ratio of the coal pillar, as shown in figure 5. Using a boundary-element method program similar to the USBM's MULSIM/NL program, it is possible to simulate both massive pillar collapses and stable, progressive pillar failures [Zipf 1996]. The behavior of computer simulations changes depending on whether the model satisfies or violates the local mine stiffness stability criterion.

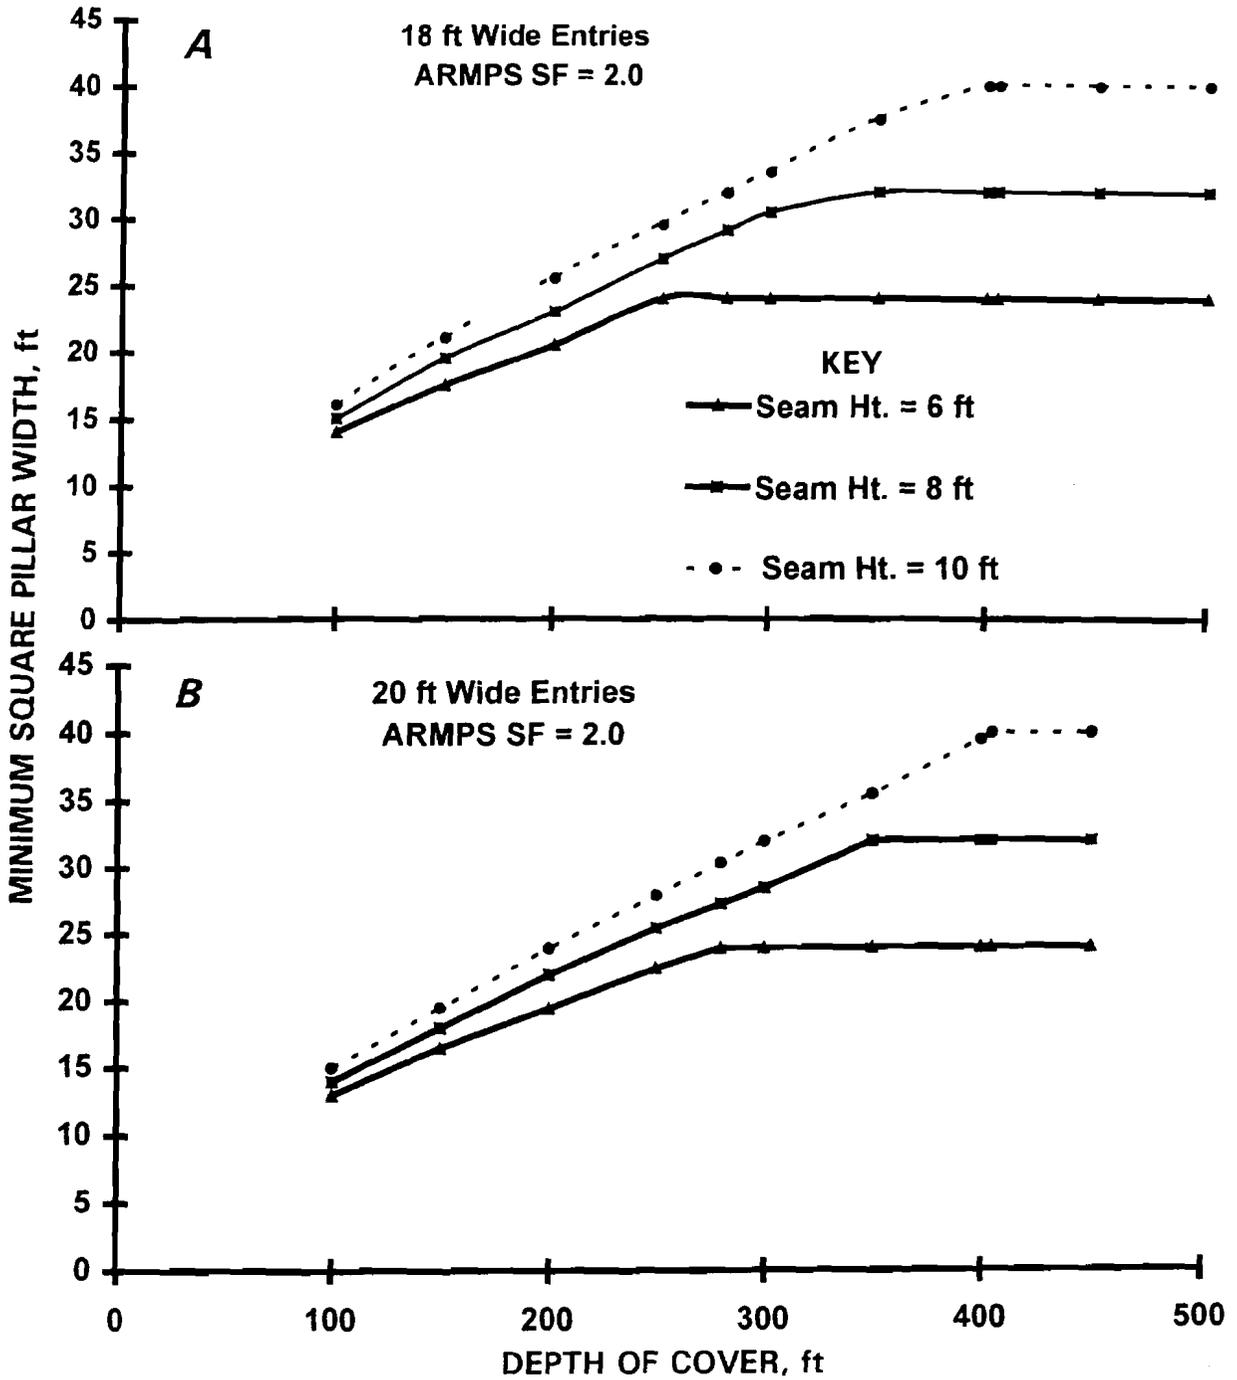
Figure 7.—Suggested minimum square pillar size to avoid massive pillar collapse. A, 5.5-m (18-ft) entries; B, 6-m (20-ft) entries.

Pillar collapses may also be avoided by maintaining a sufficiently high SF. The ARMPS case history data base [Mark and Chase 1997] suggests that normally an ARMPS SF of 1.5 is sufficient to limit the probability of pillar failure. Where slender pillars are being employed and their failure may result in a massive collapse rather than a slow squeeze, it

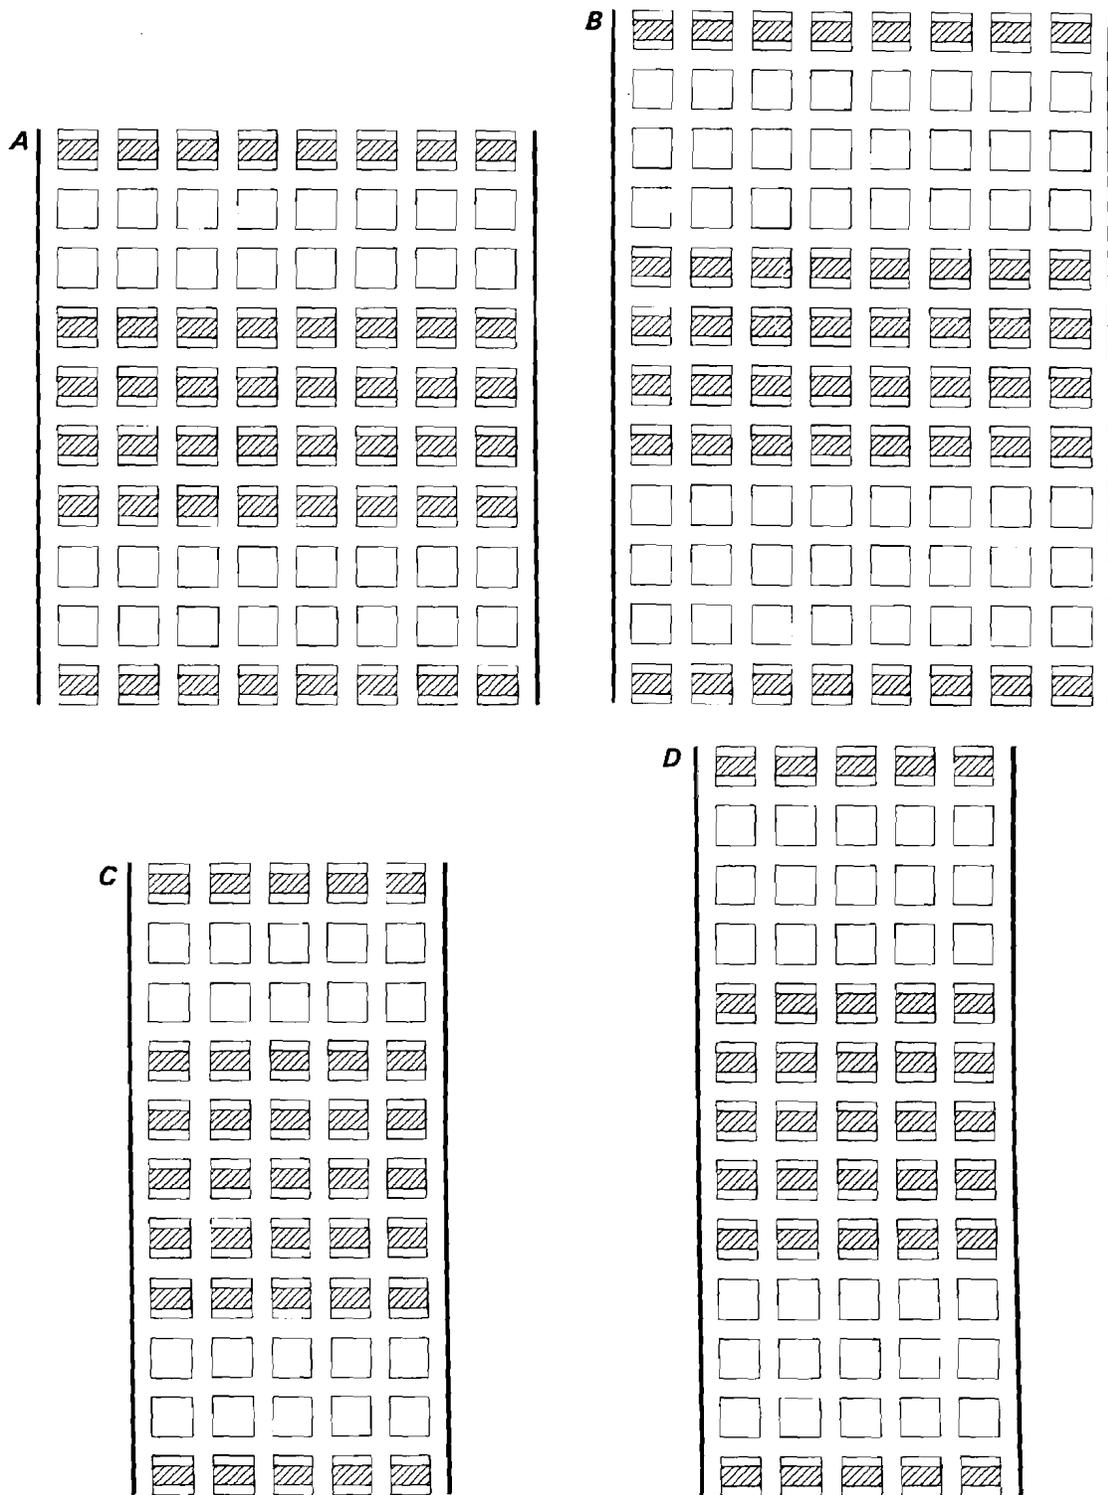
Figure 8.—Possible pillar-splitting plan for airblast control. A, nine-entry system, two rows of unsplit pillars for barrier. B, nine-entry system, three rows of unsplit pillars for barrier. C, six-entry system, two rows of unsplit pillars for barrier. D, six-entry system, three rows of unsplit pillars for barrier.

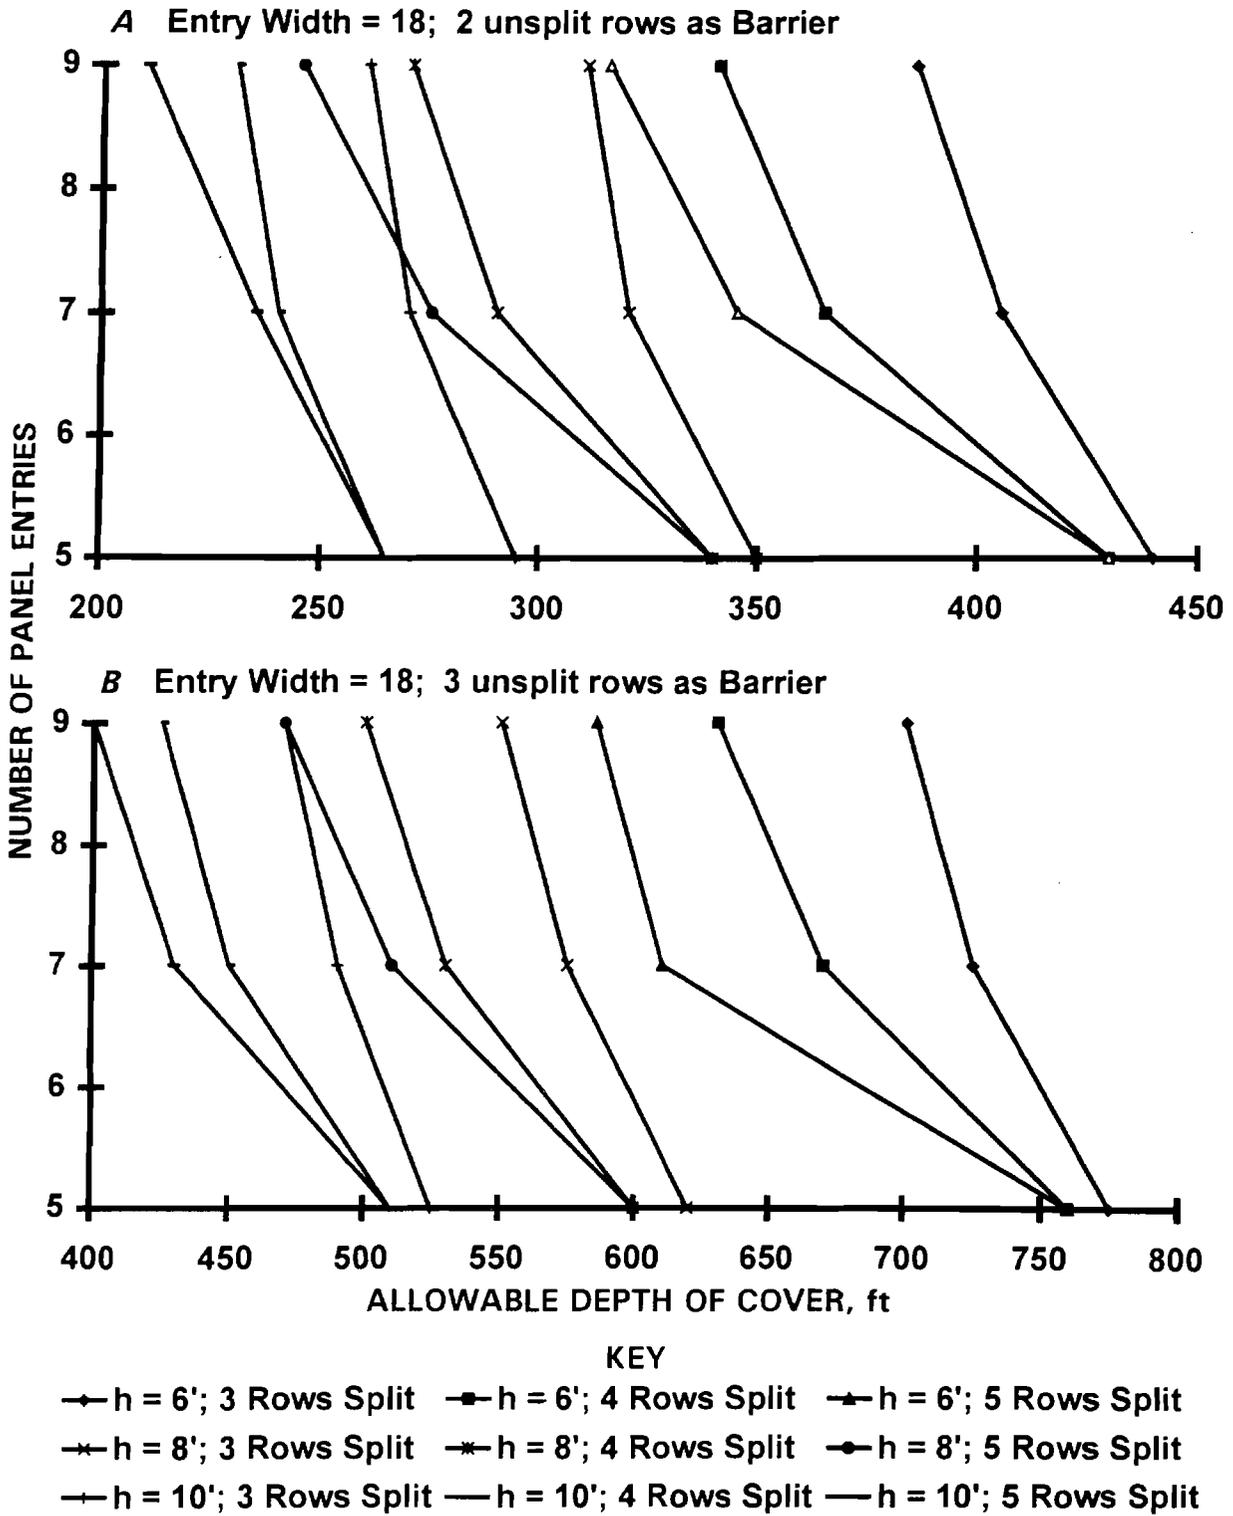
Figure 9.—A, suggested maximum depth for two rows of unsplit pillars as barrier between gob areas, 5.5-m (18-ft) entry, 18-by 18-m (60- by 60-ft) pillars. B, suggested maximum depth for three rows of unsplit pillars as barrier between gob areas, same entry and pillar sizes.

Barriers must also be left between extracted panels. These can be unsplit development pillars or solid coal. If unsplit development pillars are used, the analysis in figure 9 should apply. For solid coal barriers, figure 10 shows the suggested widths, using the same loading assumptions. For a 2.5-m (8-ft) seam, a 17-m (55-ft) solid barrier appears to be appropriate at 75 m (250 ft) of cover, and 23 m (75 ft) might be needed at 120 m (400 ft).

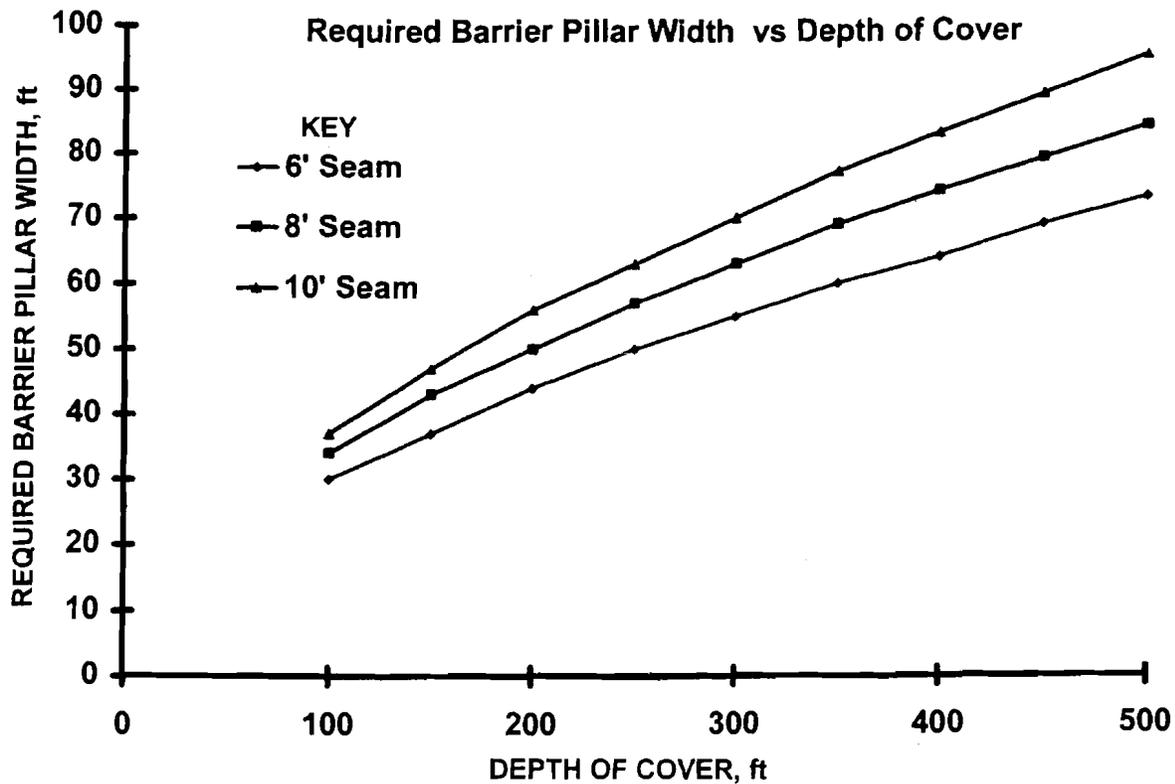
Figure 10.—Suggested solid coal barrier width between two areas where pillars have been split.

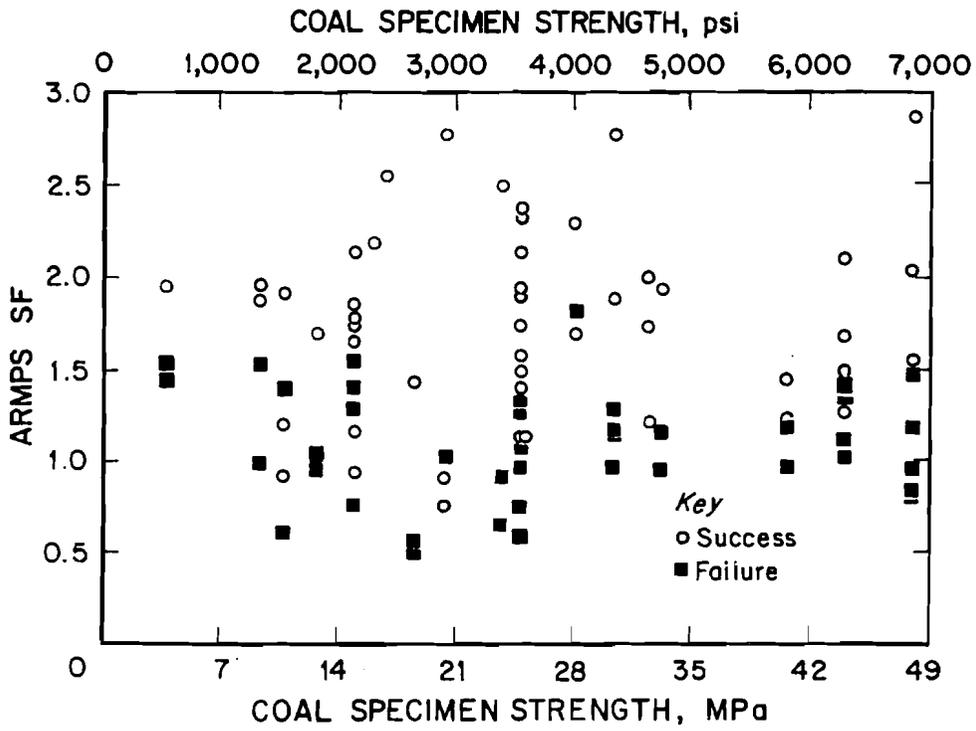
Figure 4.—ARMPS SF compared with specimen strength data.

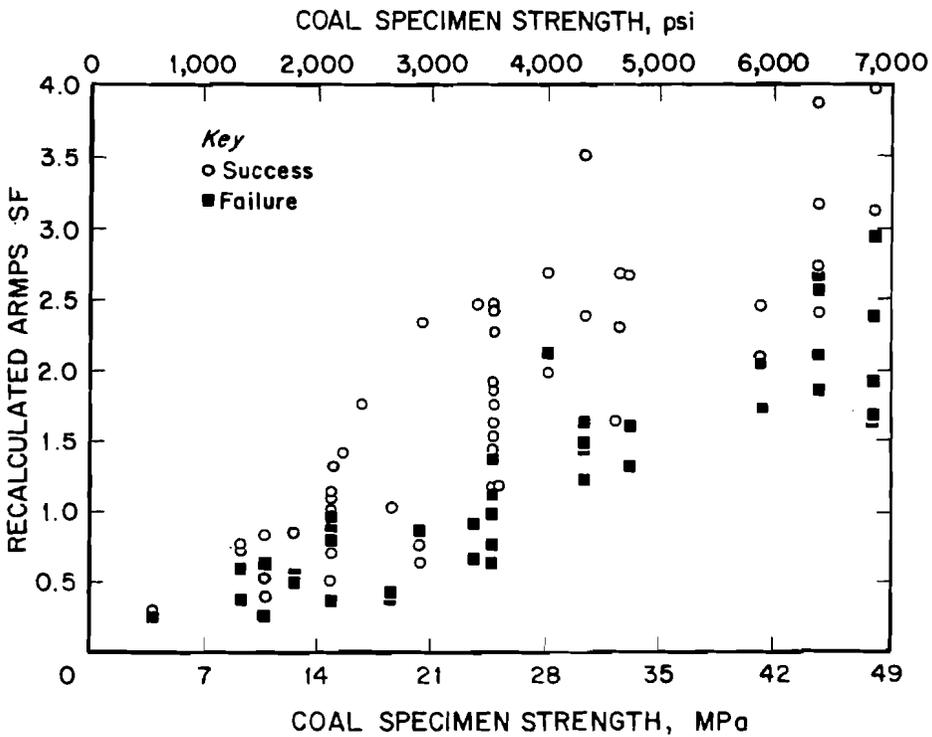
Figure 5.—Recalculated ARMPS SF compared using seam-specific coal strength data.

A third analysis applied seam-specific size-effect exponents to the coal strength data, as defined later in the "Size Effect" section of this paper. The correlation between seam strength and SF was still apparent, as in figure 5. Although the misclassification rate improved to 33%, it was still 50% greater than in the uniform seam strength analysis.

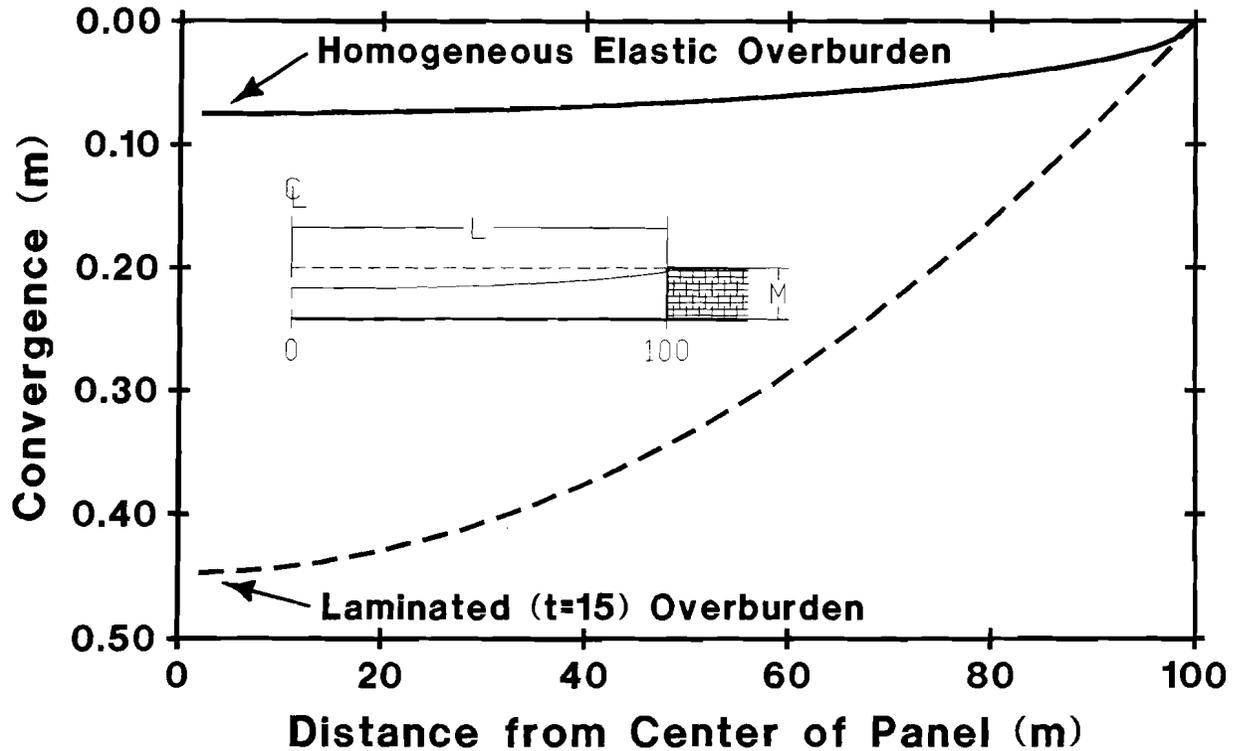
Figure 1.—Comparison of longwall convergence computed from the laminated and homogeneous isotropic models.

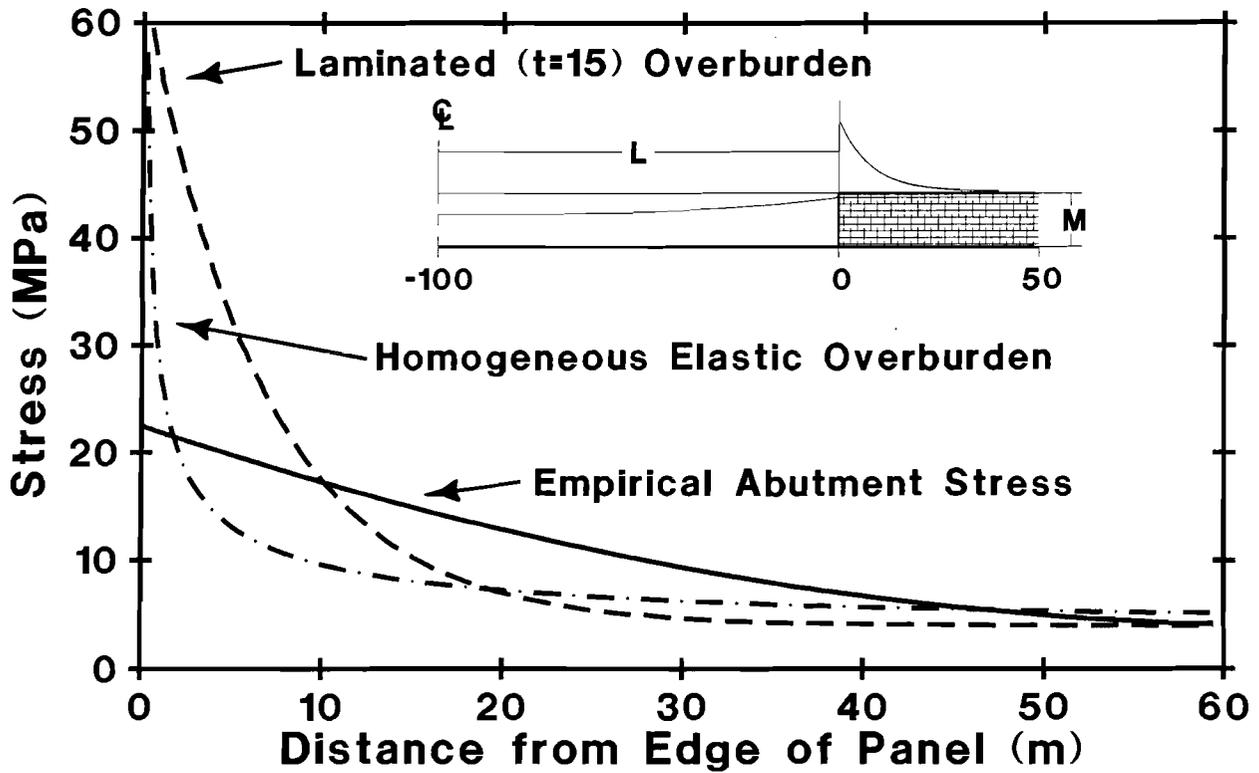
Figure 2.—Comparison of longwall abutment stress computed from the laminated and homogeneous isotropic models and from the empirical formula.

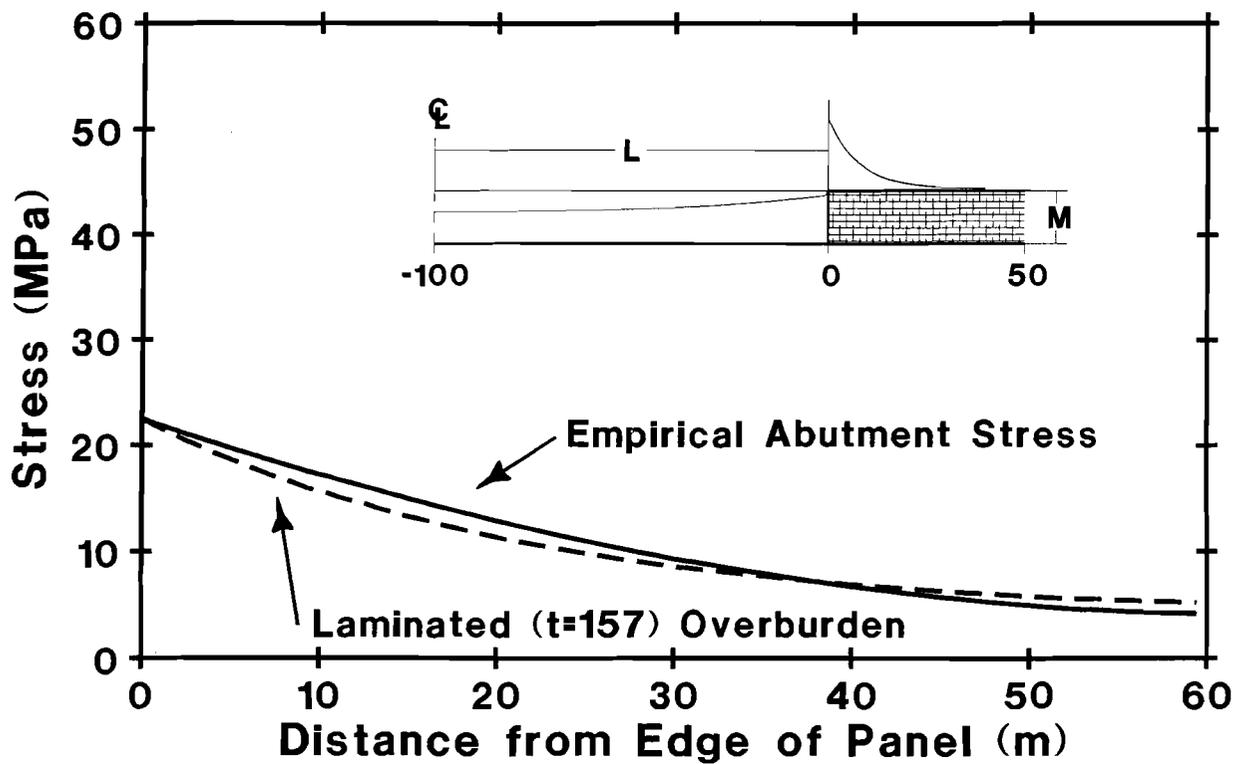
Figure 3.—Plot of the laminated abutment stress fitted to the empirical formula.

For a typical seam modulus (E_s) of 2 GPa (290,000 psi) in the laminated model, equation 15 provides a fitted lamination thickness of 157 m (515 ft). The plot of the abutment stress curve for the laminated overburden model with a fitted lamination thickness of 157 m (515 ft) is shown together with the empirically determined abutment stress in figure 3. The degree of agreement between the two curves is very good and serves to

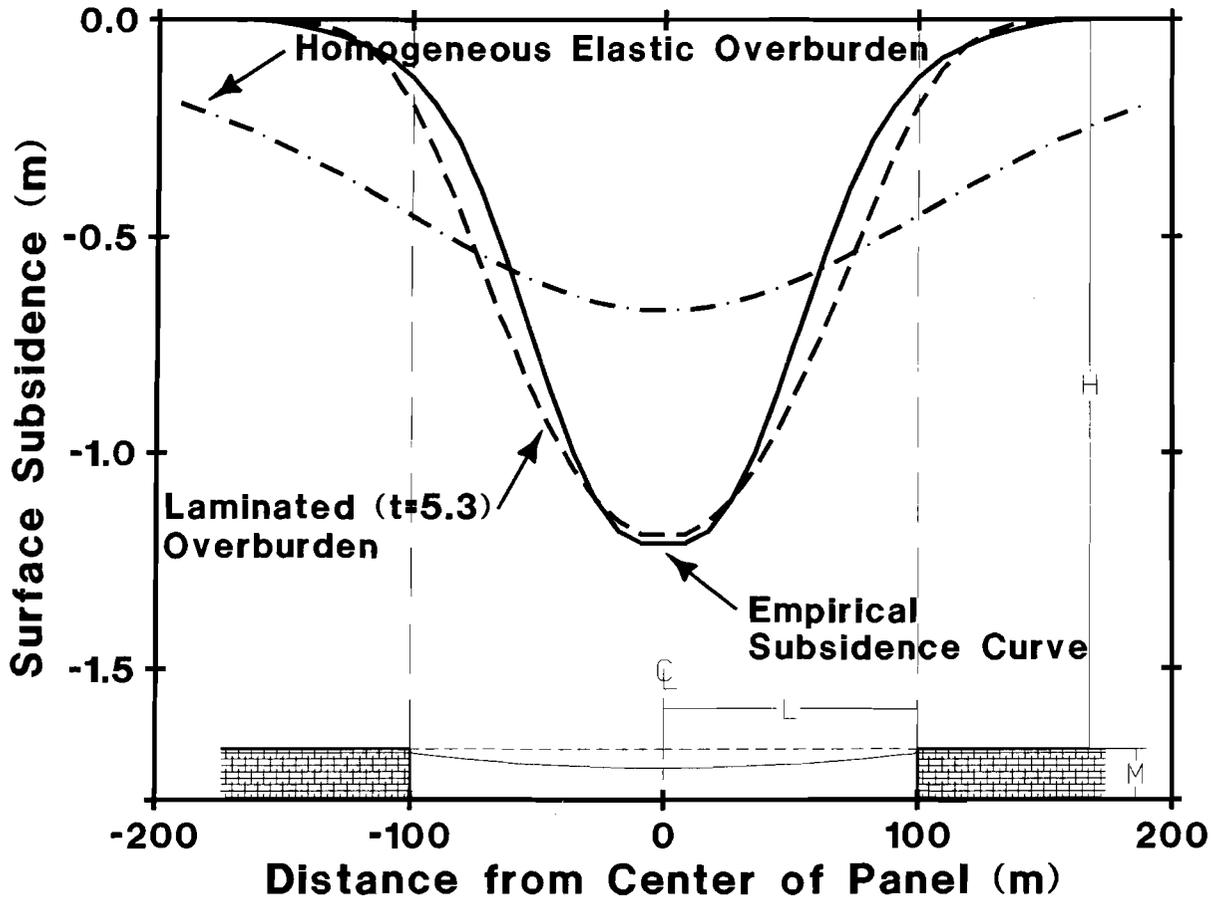
Figure 6.—Plot of the laminated and homogeneous isotropic subsidence fitted to the empirical curve.

the empirical curve. However, long before the maximum surface subsidence from the model matched the maximum empirical surface subsidence, the convergence in the seam exceeded the seam thickness. The homogeneous elastic surface subsidence actually plotted in figure 6 was determined using an elastic modulus of 1 GPa (145,000 psi). From this curve, it is clear that the homogeneous isotropic surface subsidence is naturally much shallower and broader than the empirical data, and with only one effective variable parameter (E), the homogeneous isotropic model cannot be accurately fitted to the Northern Appalachian data. This result further confirms earlier indications that the homogeneous isotropic elastic overburden could not be made to fit subsidence data in the United Kingdom [Berry and Sales 1961; Salamon 1963].
