Proceedings: New Technology for Ground Control in Retreat Mining

Information Circular 9446

Christopher Mark, Ph.D., and Robert J. Tuchman

March 1997

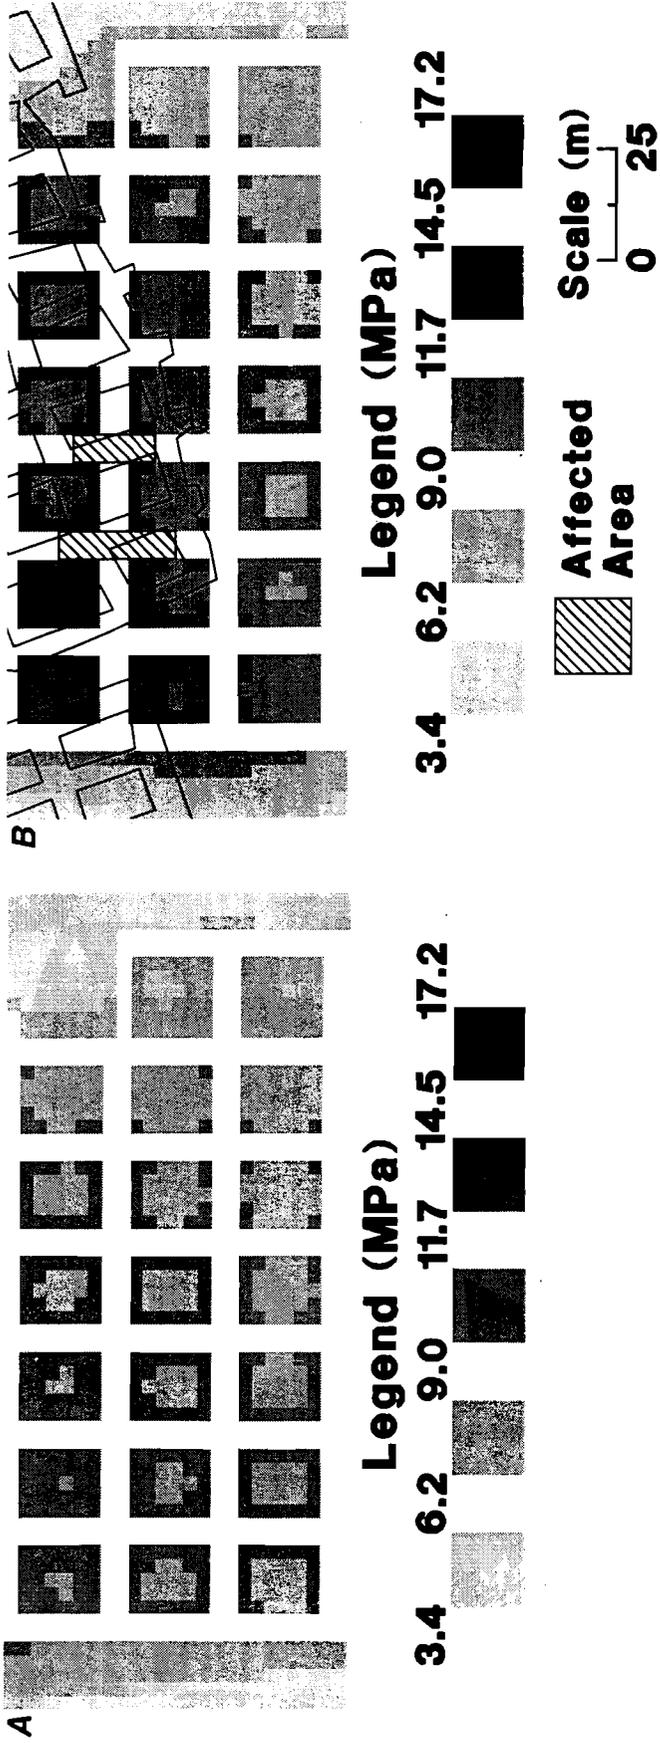
Figure 9.—Stress analysis on lower mine. A, single-seam stress; B, multiple-seam stress; C, additional stress from upper seam.

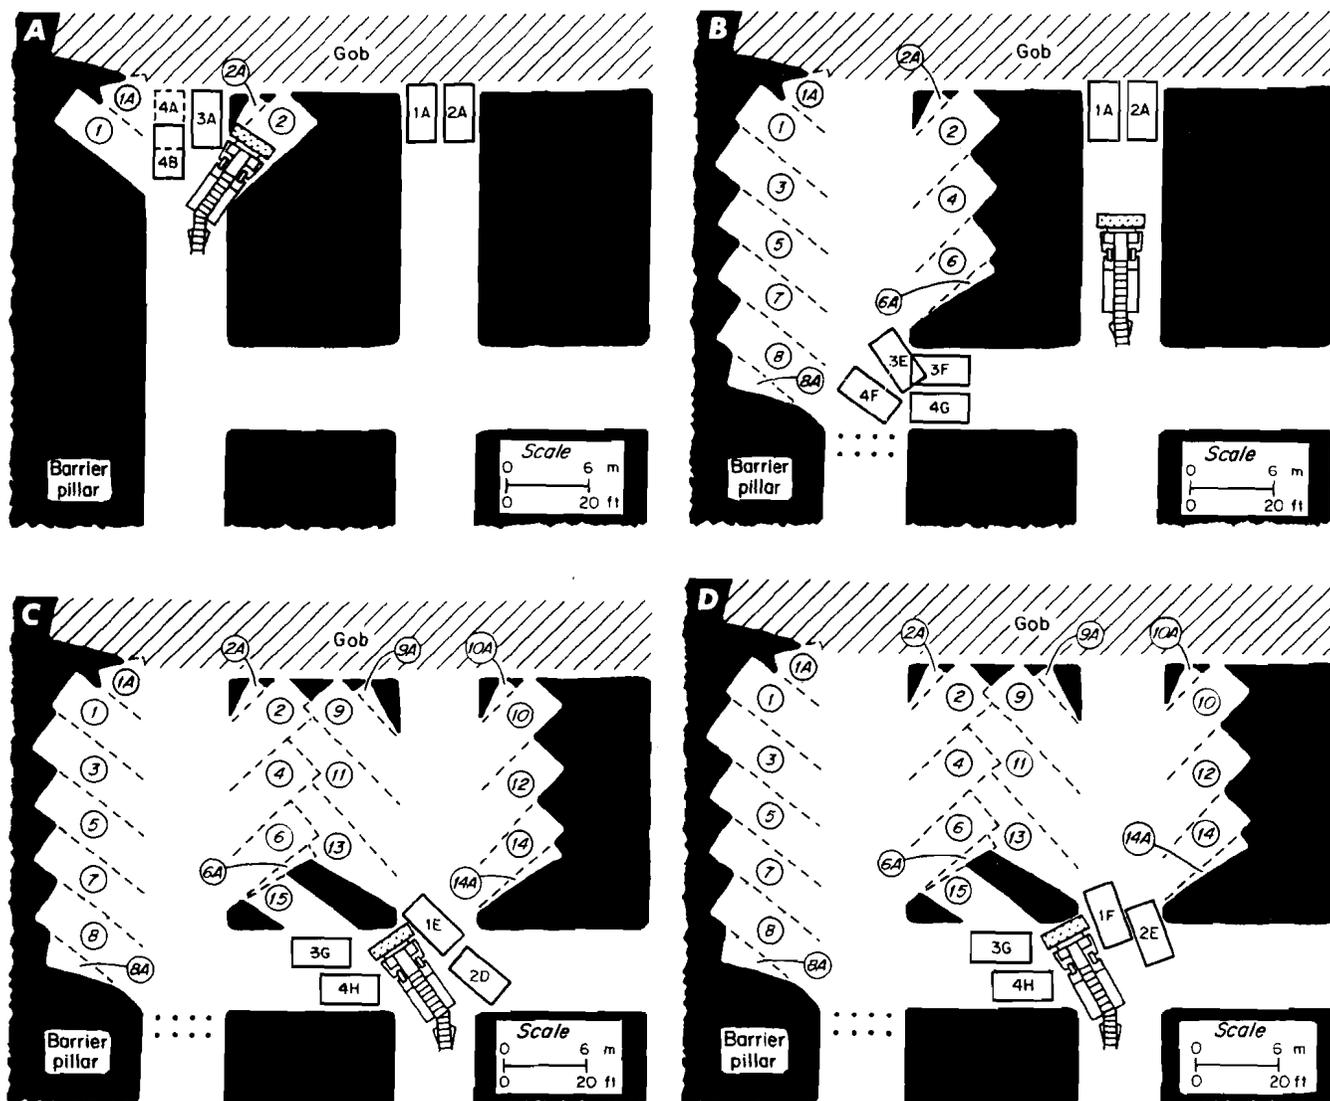
Figure 2.—Christmas tree extraction method. A, lifts 1-2A. B, lifts 1-8A. C, lifts 1-push; pushout removal with units 1 and 2 in tandem. D, lifts 1-push; pushout removal with units 1 and 2 staggered.

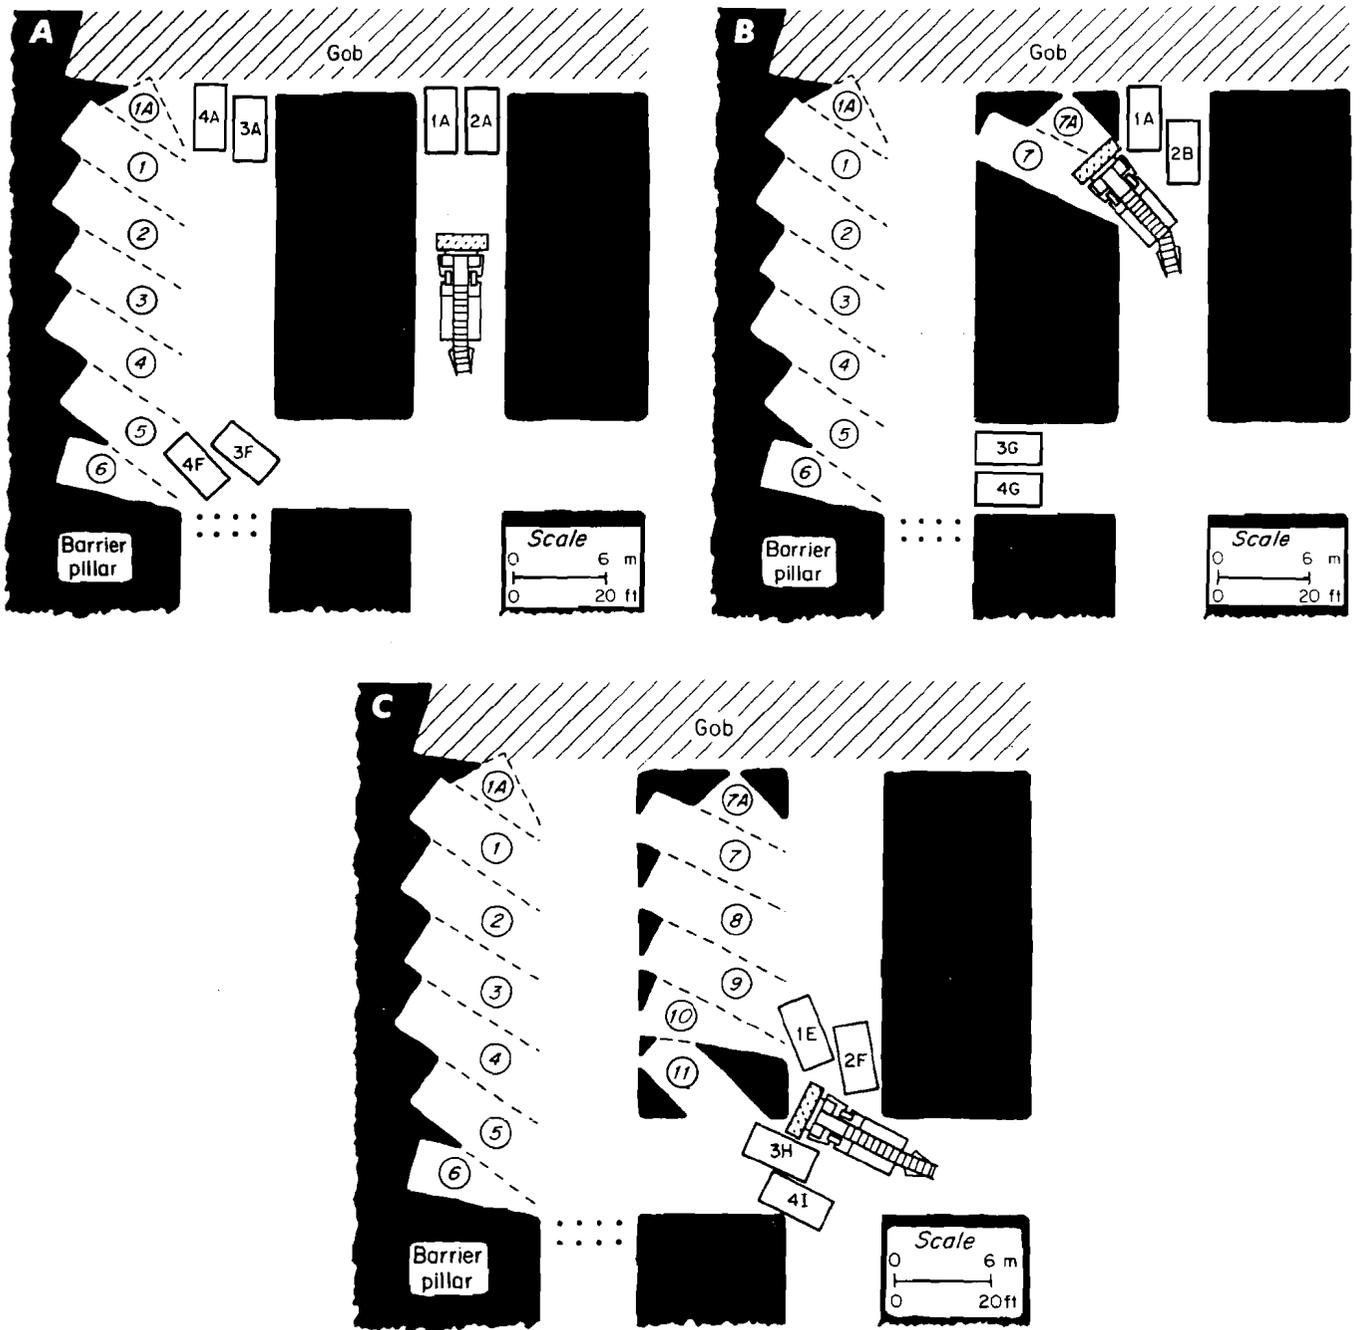
Figure 5.—Outside lift method. A, lifts 1-6; B, lifts 1-7A; C, lifts 1-push.

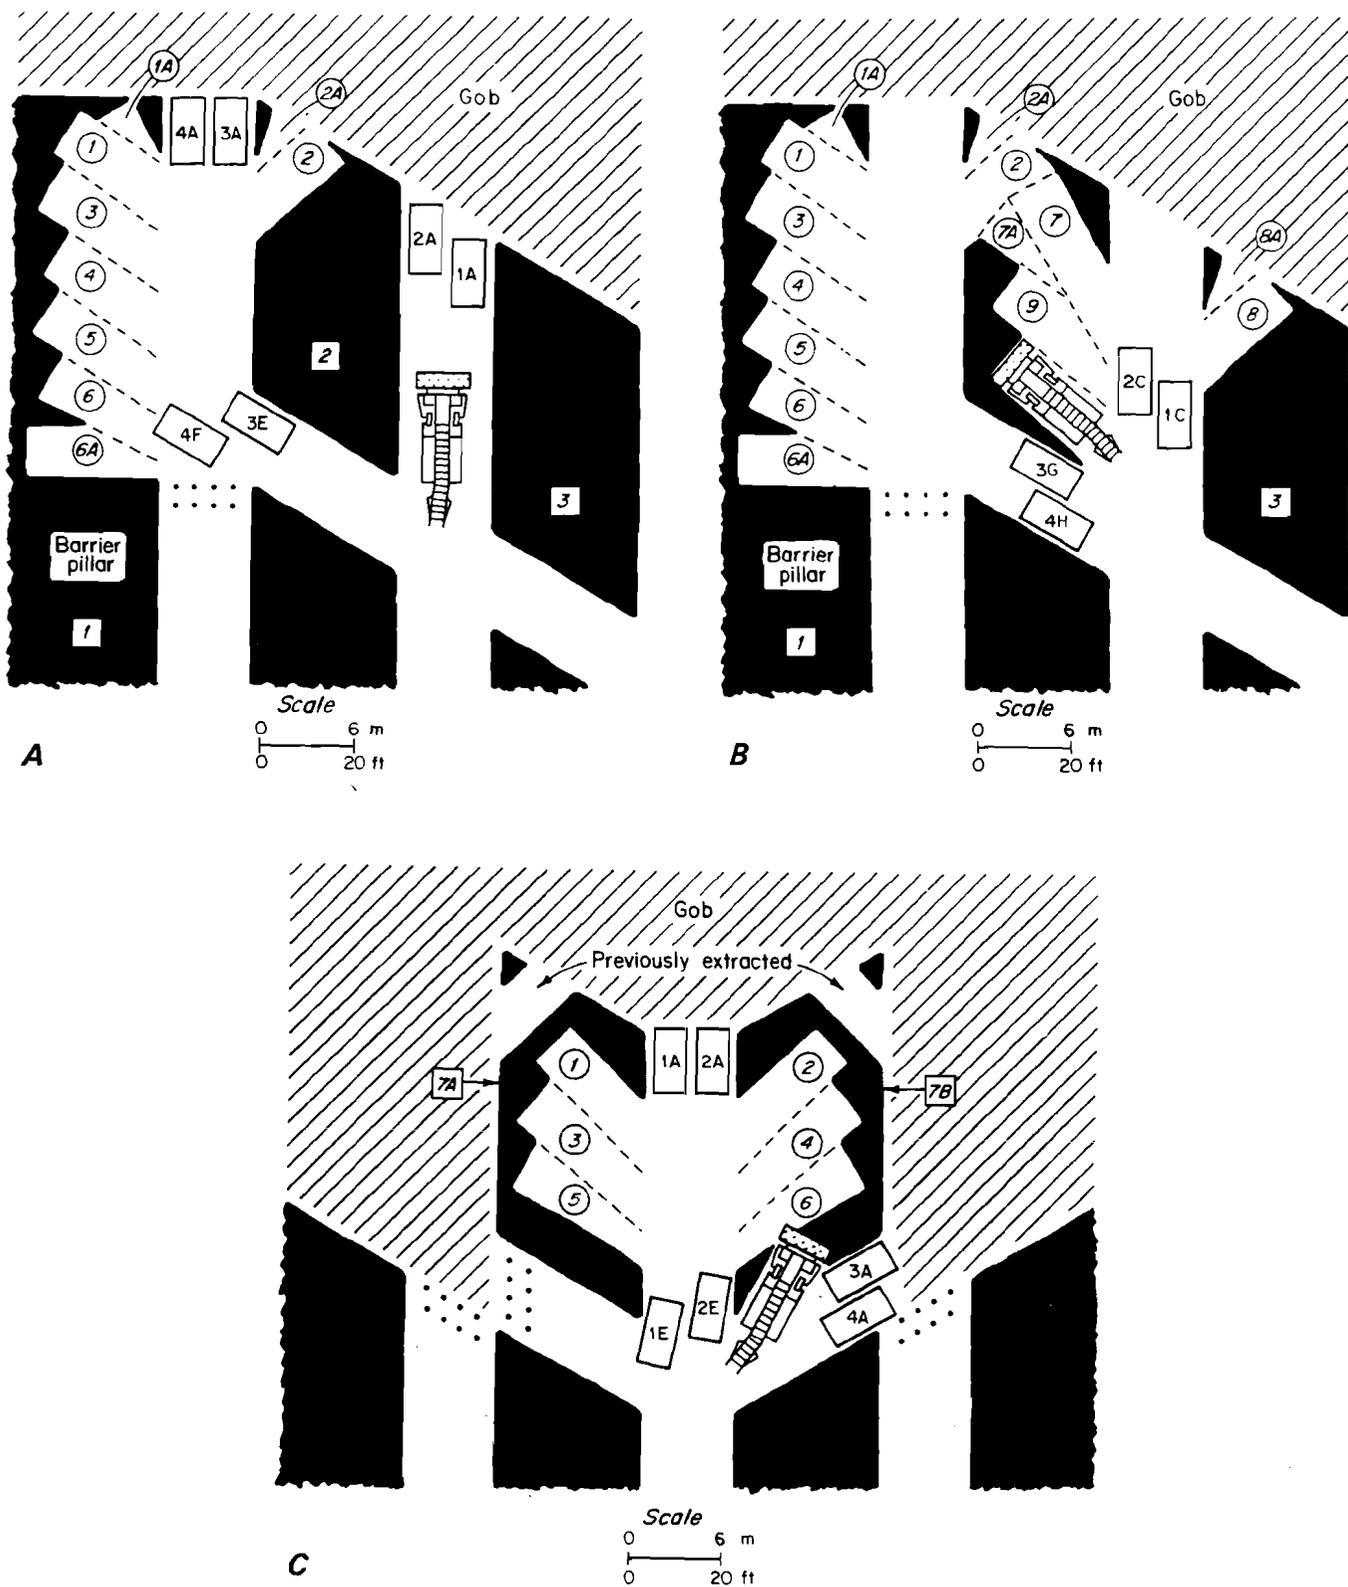
Figure 7.—Herringbone design: A, lift sequence for pillars 1 and 2; B, lift sequence for pillars 1-3; C, lift sequence for pillars 7A and 7B.

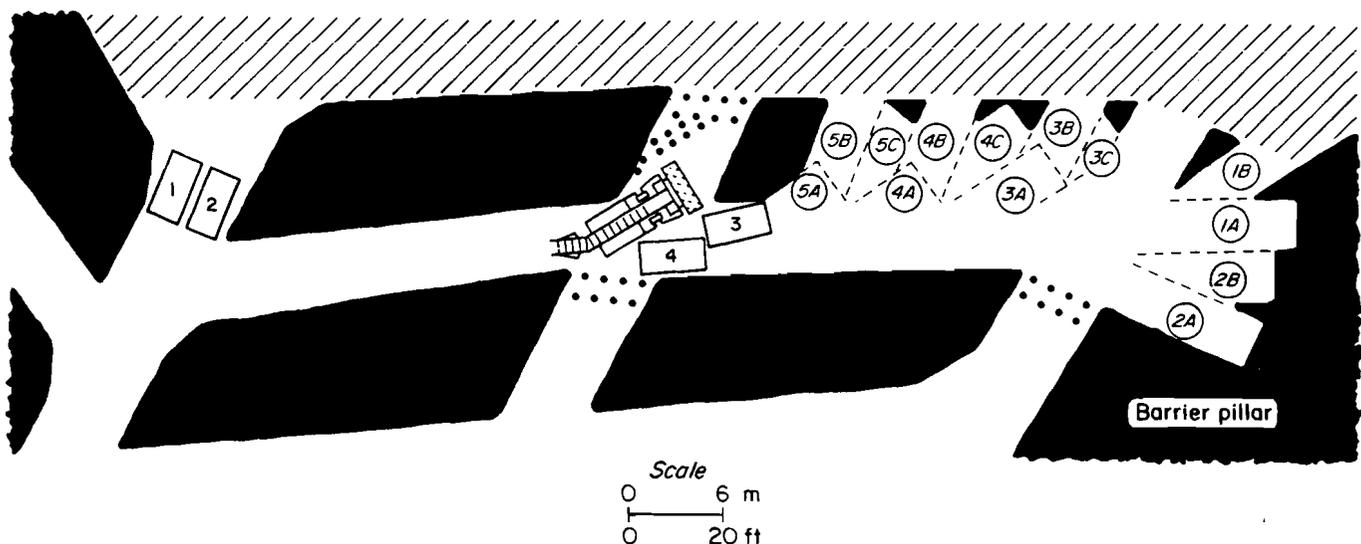
Figure 10.—Outside lift pillar extraction using temporary support fenders.

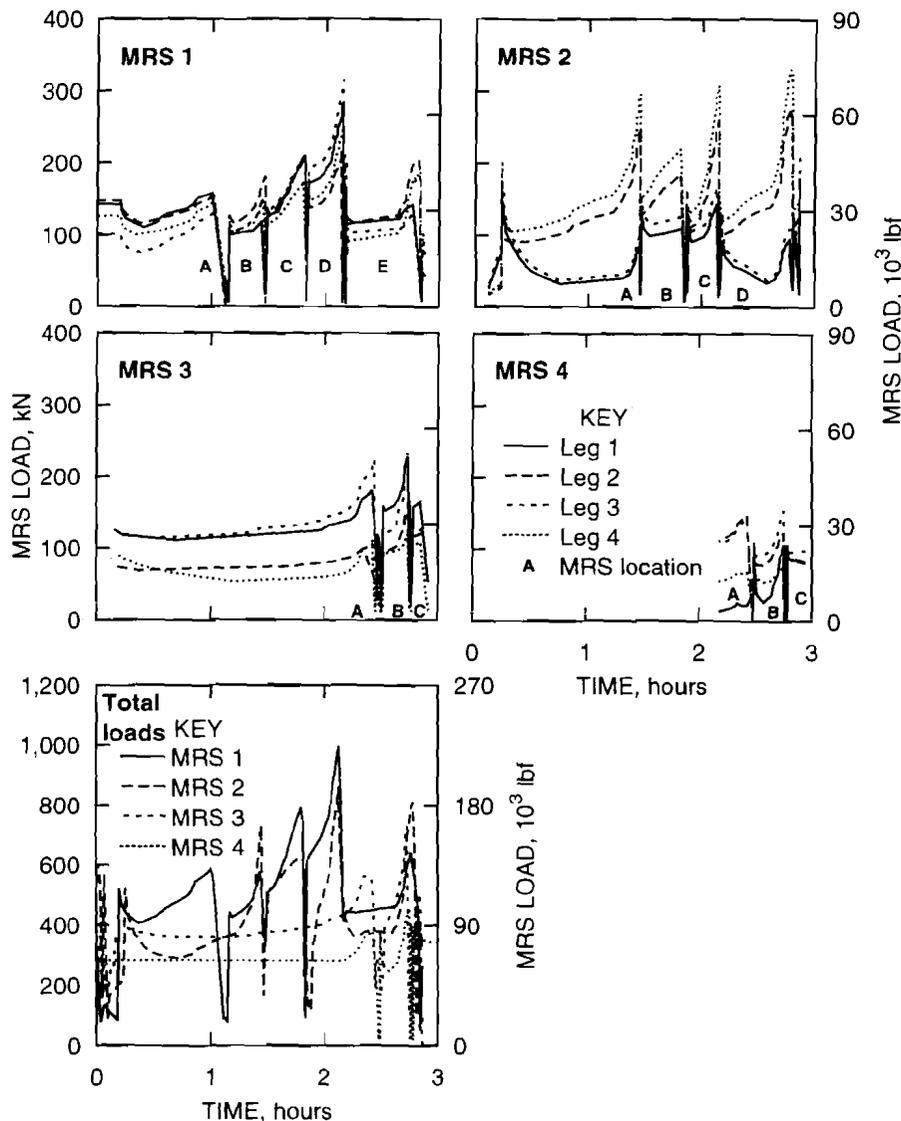
Figure 4.—Loading patterns on mobile roof supports.

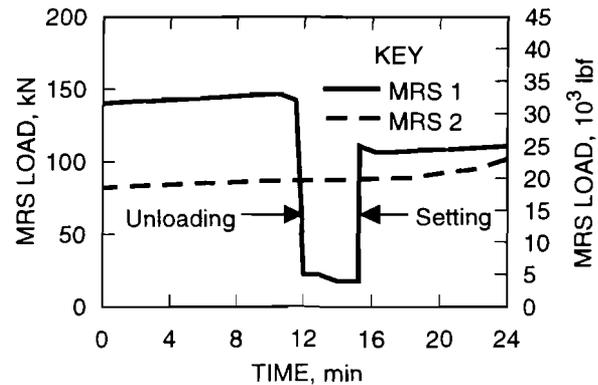
Figure 5.—Effect of MRS 1 unloading on MRS 2.

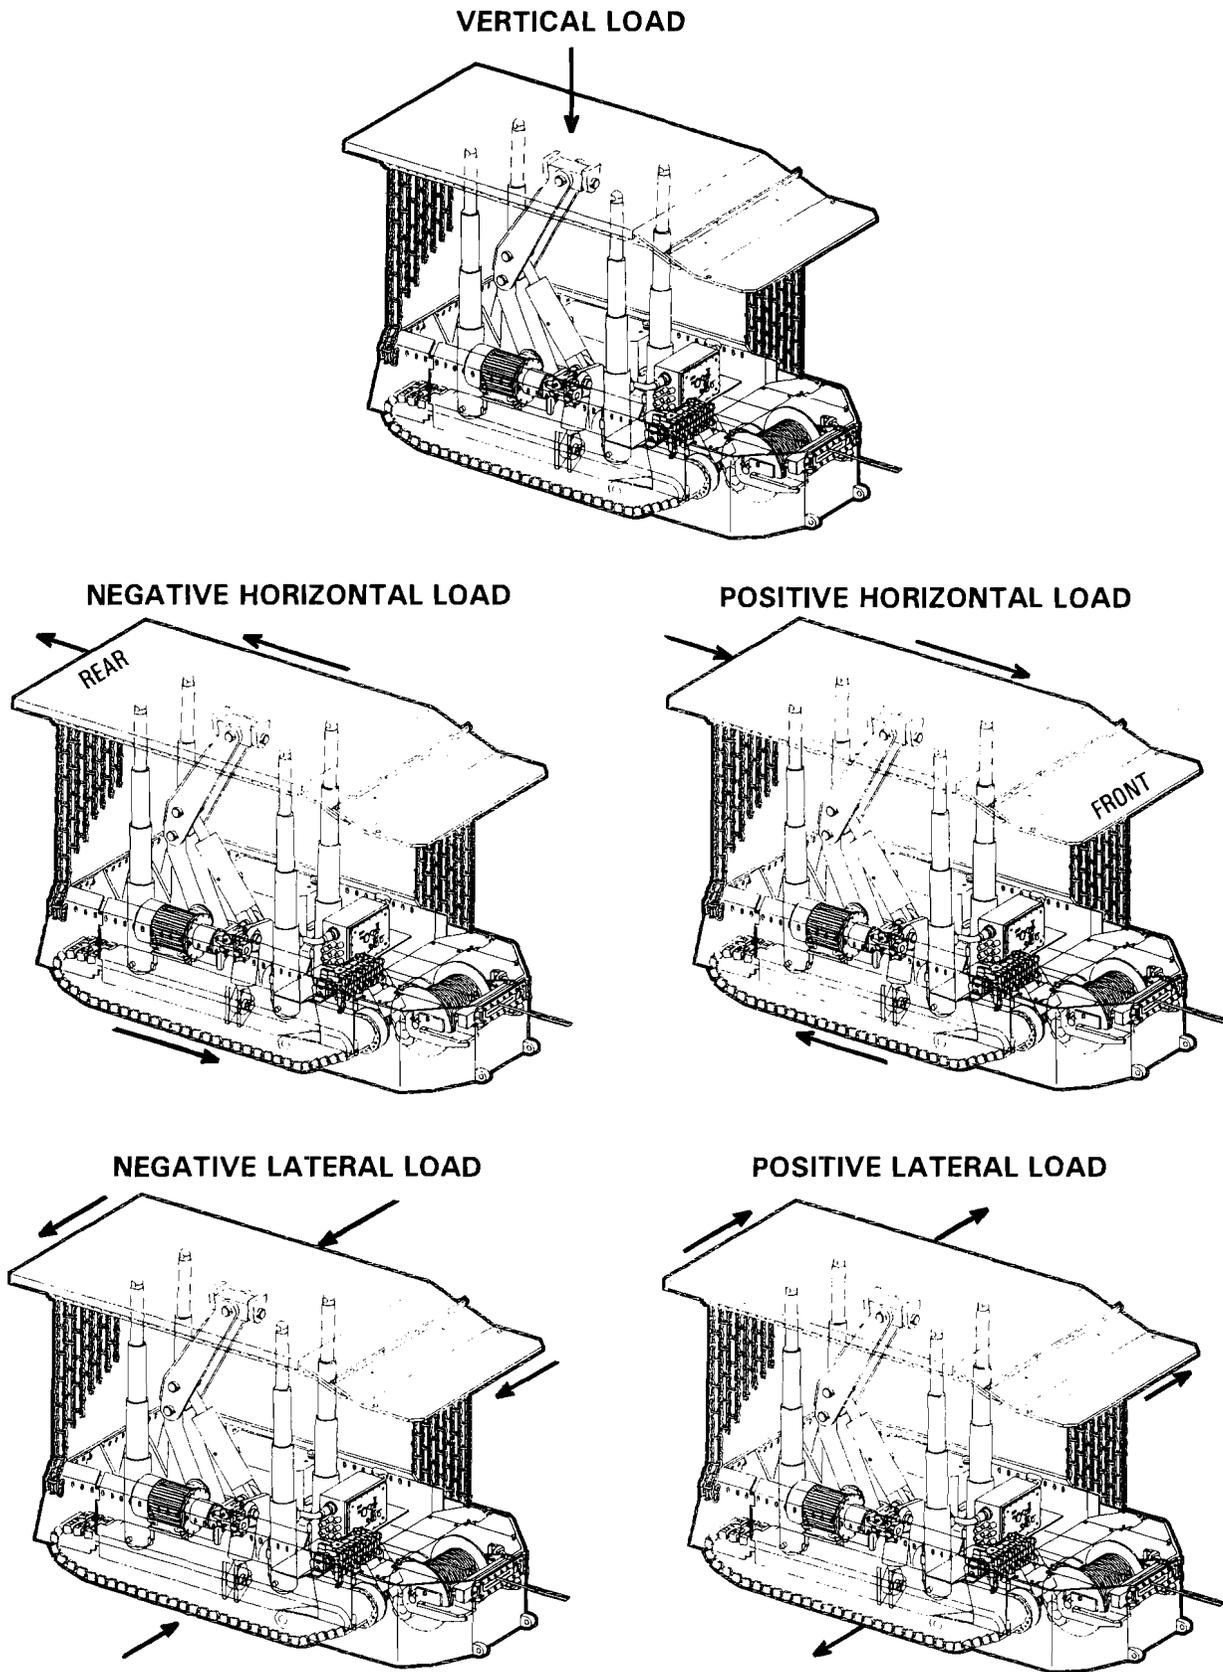
Figure 2.—Vertical, horizontal, and lateral loading applied to the mobile roof supports by the mine roof simulator.

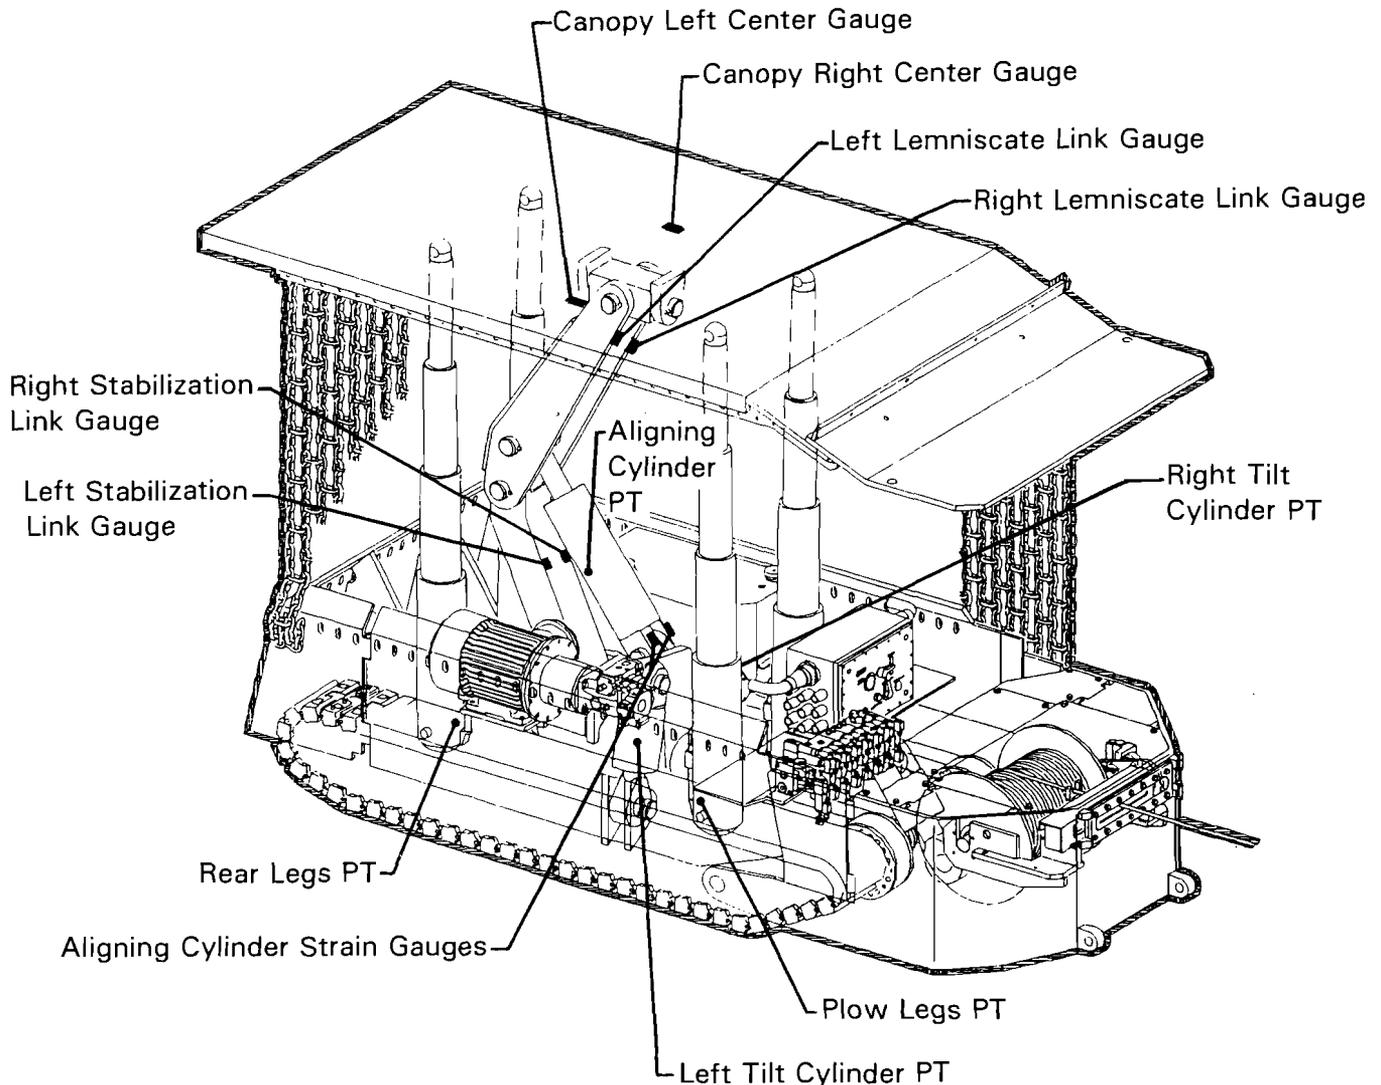
Figure 3.—Instrumentation installed on the VAMT support to assess support performance. PT = pressure transducer.

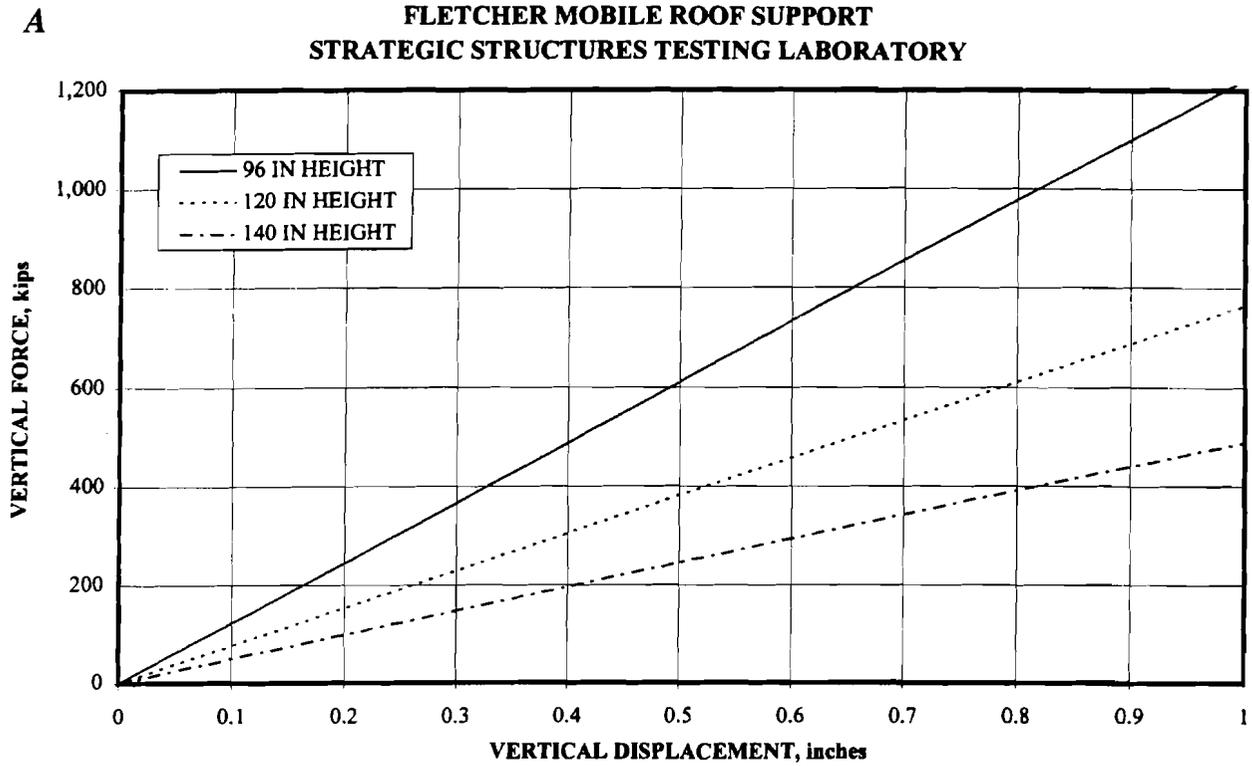
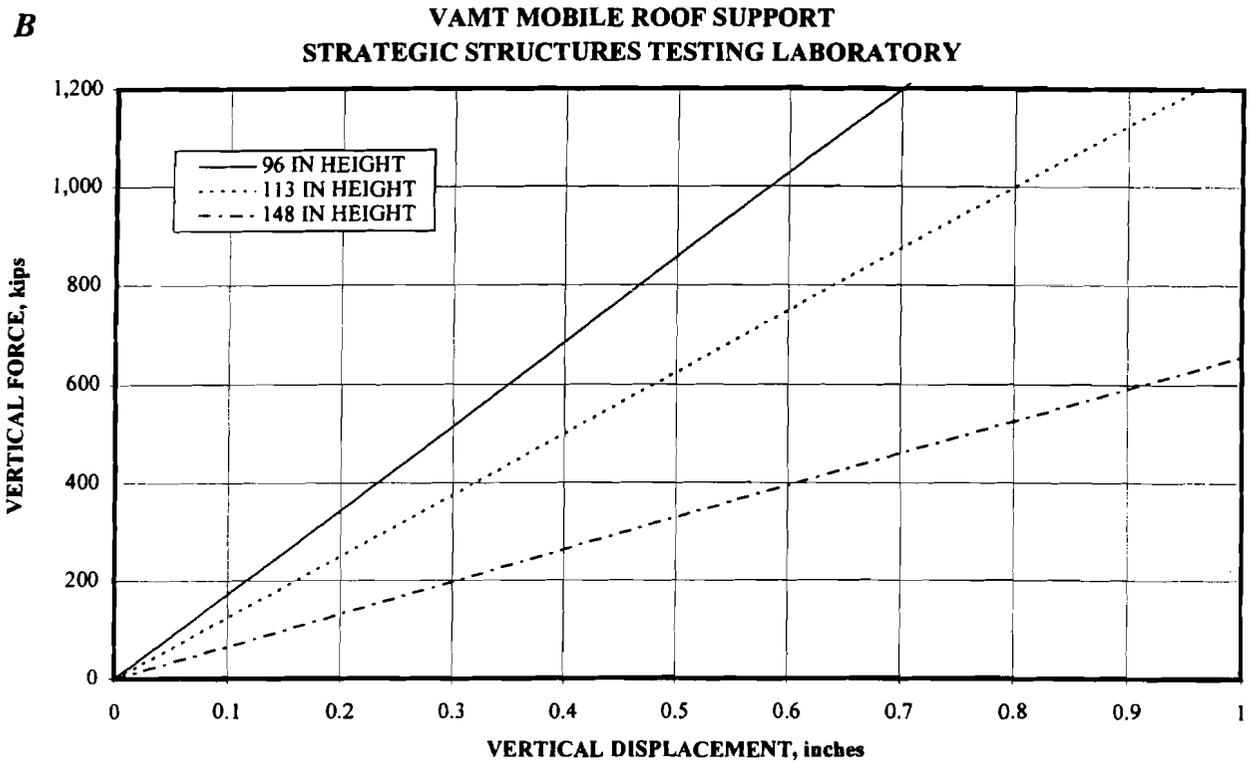
Figure 7.—Effect of support height on vertical stiffness. A, Fletcher support; B, VAMT support.

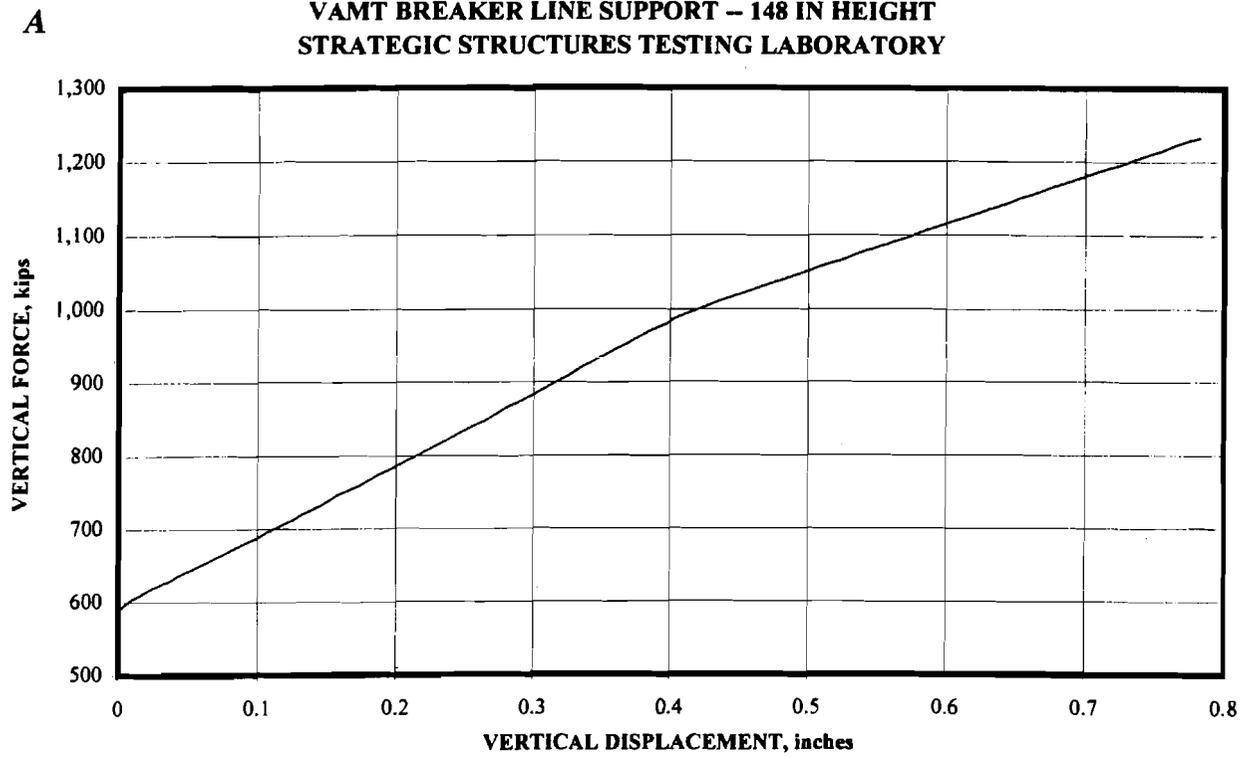
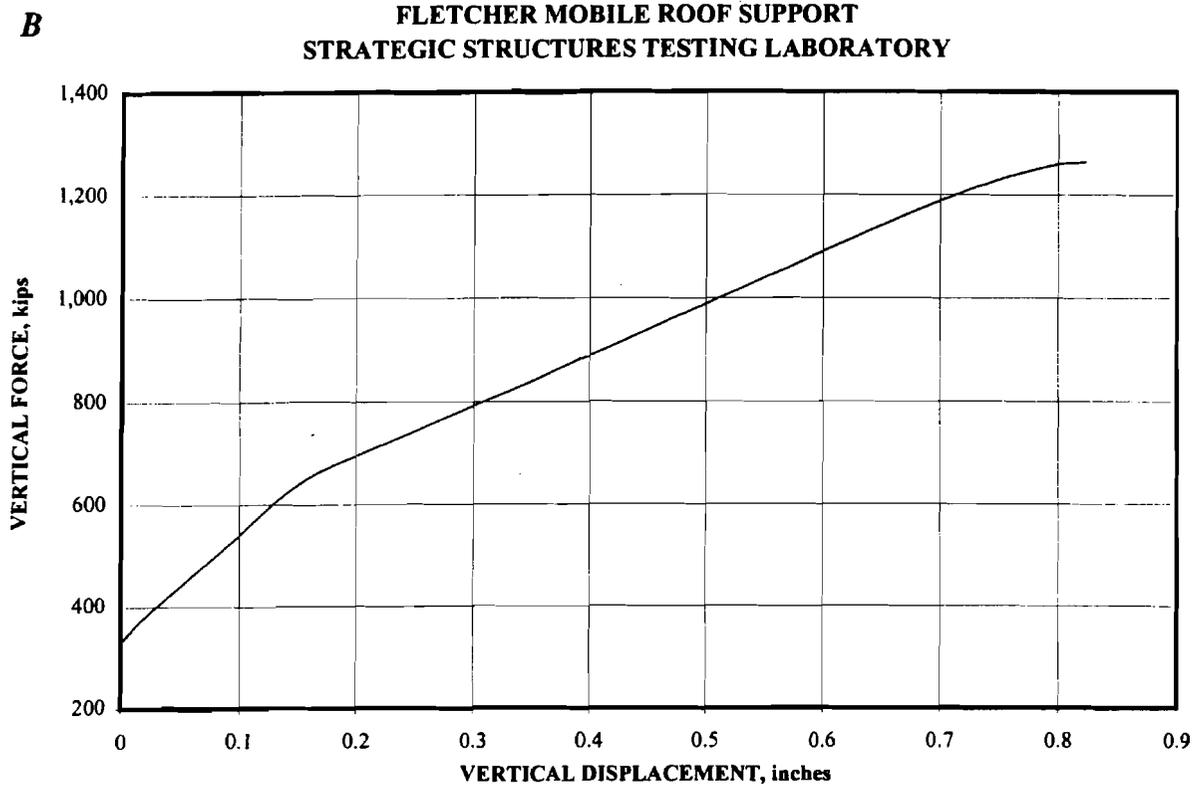
Figure 8.—A, Decrease in vertical stiffness on the VAMT support when bottom stage is fully extended at 0.4 in of displacement. B, Reduction in Fletcher support stiffness when both bottom and middle stages are fully extended at 0.15 in of displacement.

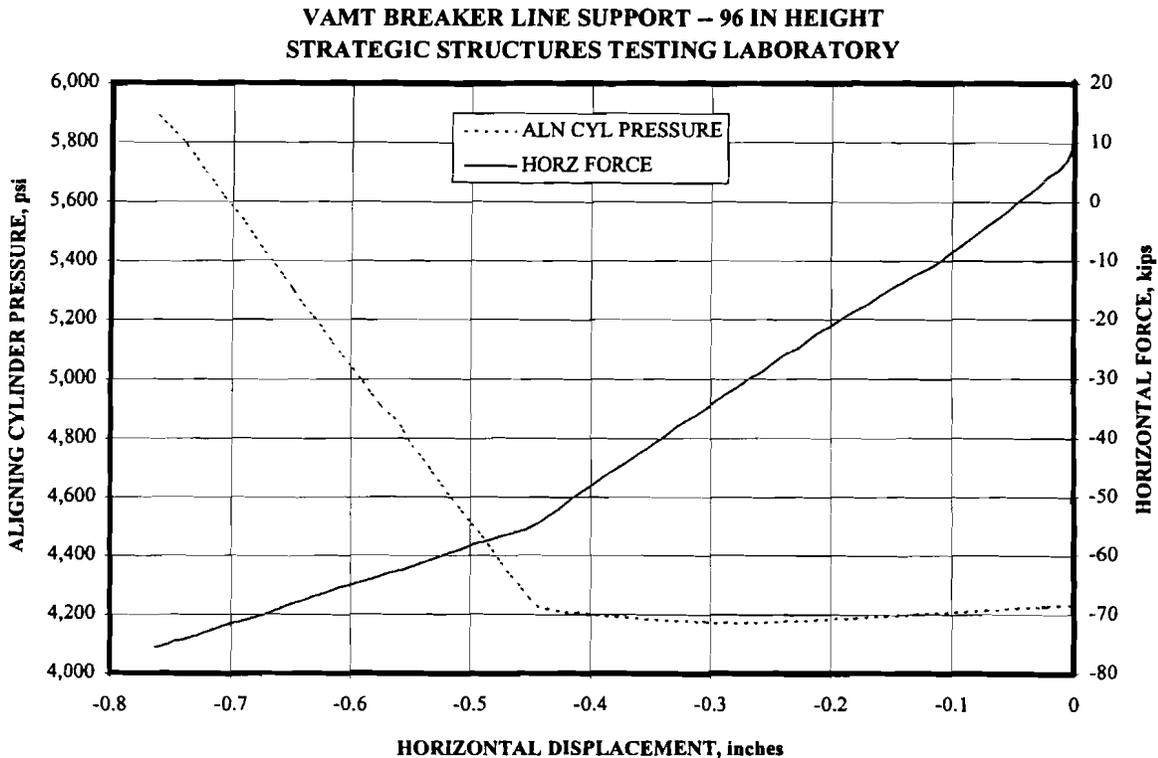
Figure 12.—Reduction in horizontal stiffness when pressure develops in the aligning cylinder.

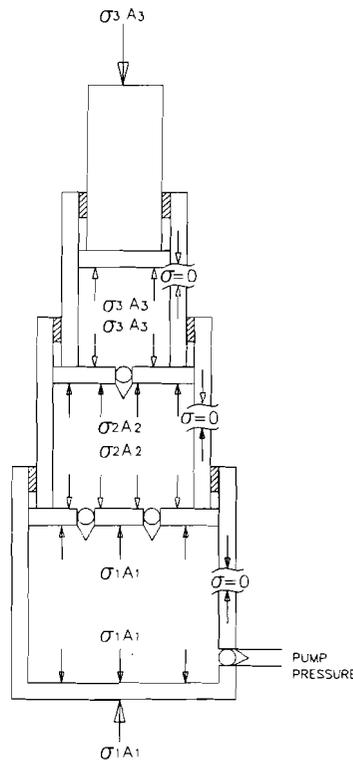
Figure 17.—Leg mechanics. *A*, bottom and middle stages fully extended; *B*, bottom stage fully extended; *C*, no stage fully extended.

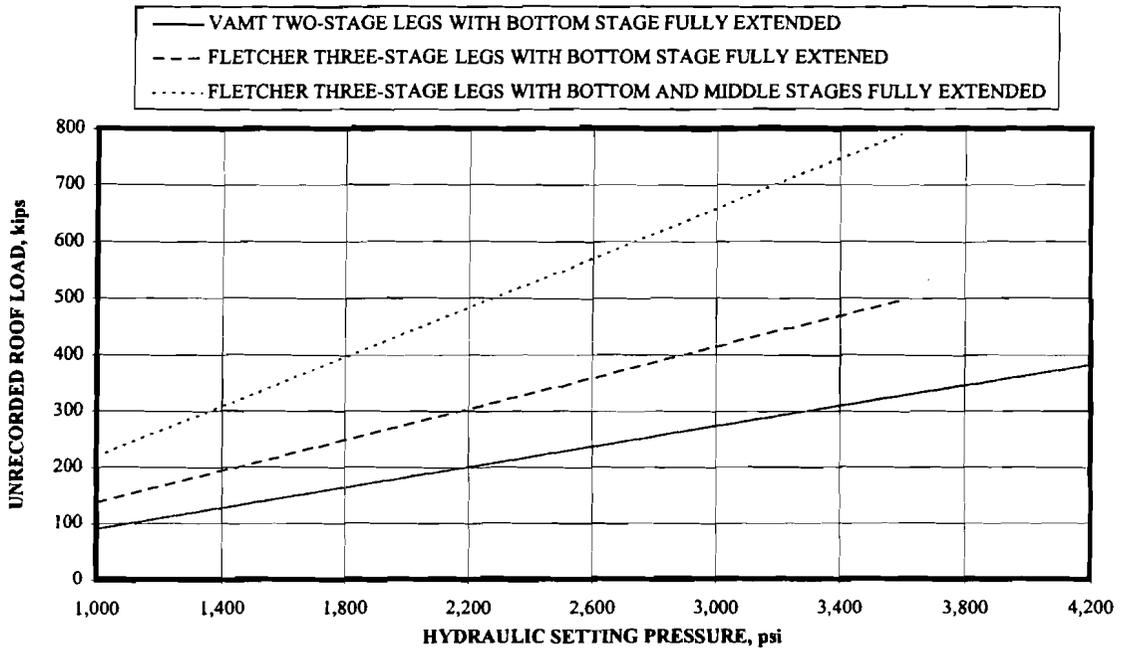
Figure 19.—Unmeasured roof load when one or more of the stages are fully extended as a function of setting pressure in the leg cylinders.

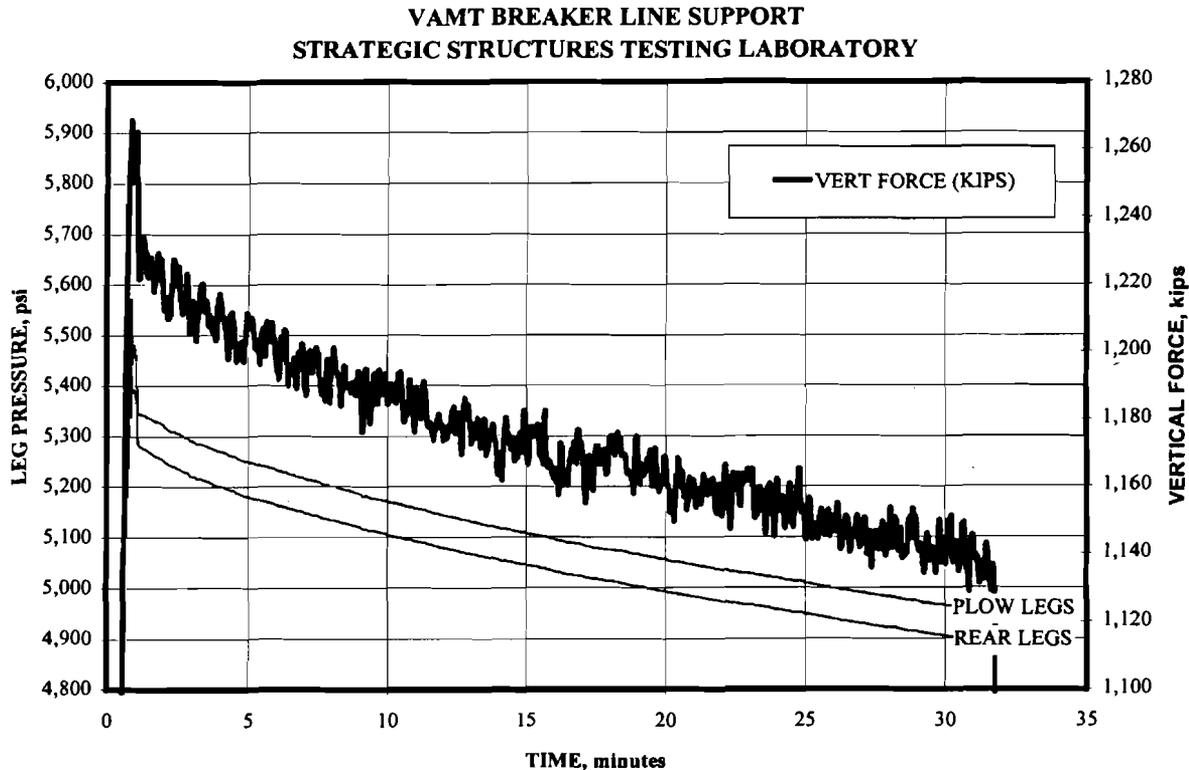
Figure 20.—Reduction in support capacity due to bleed-off of leg pressures after leg yielding.

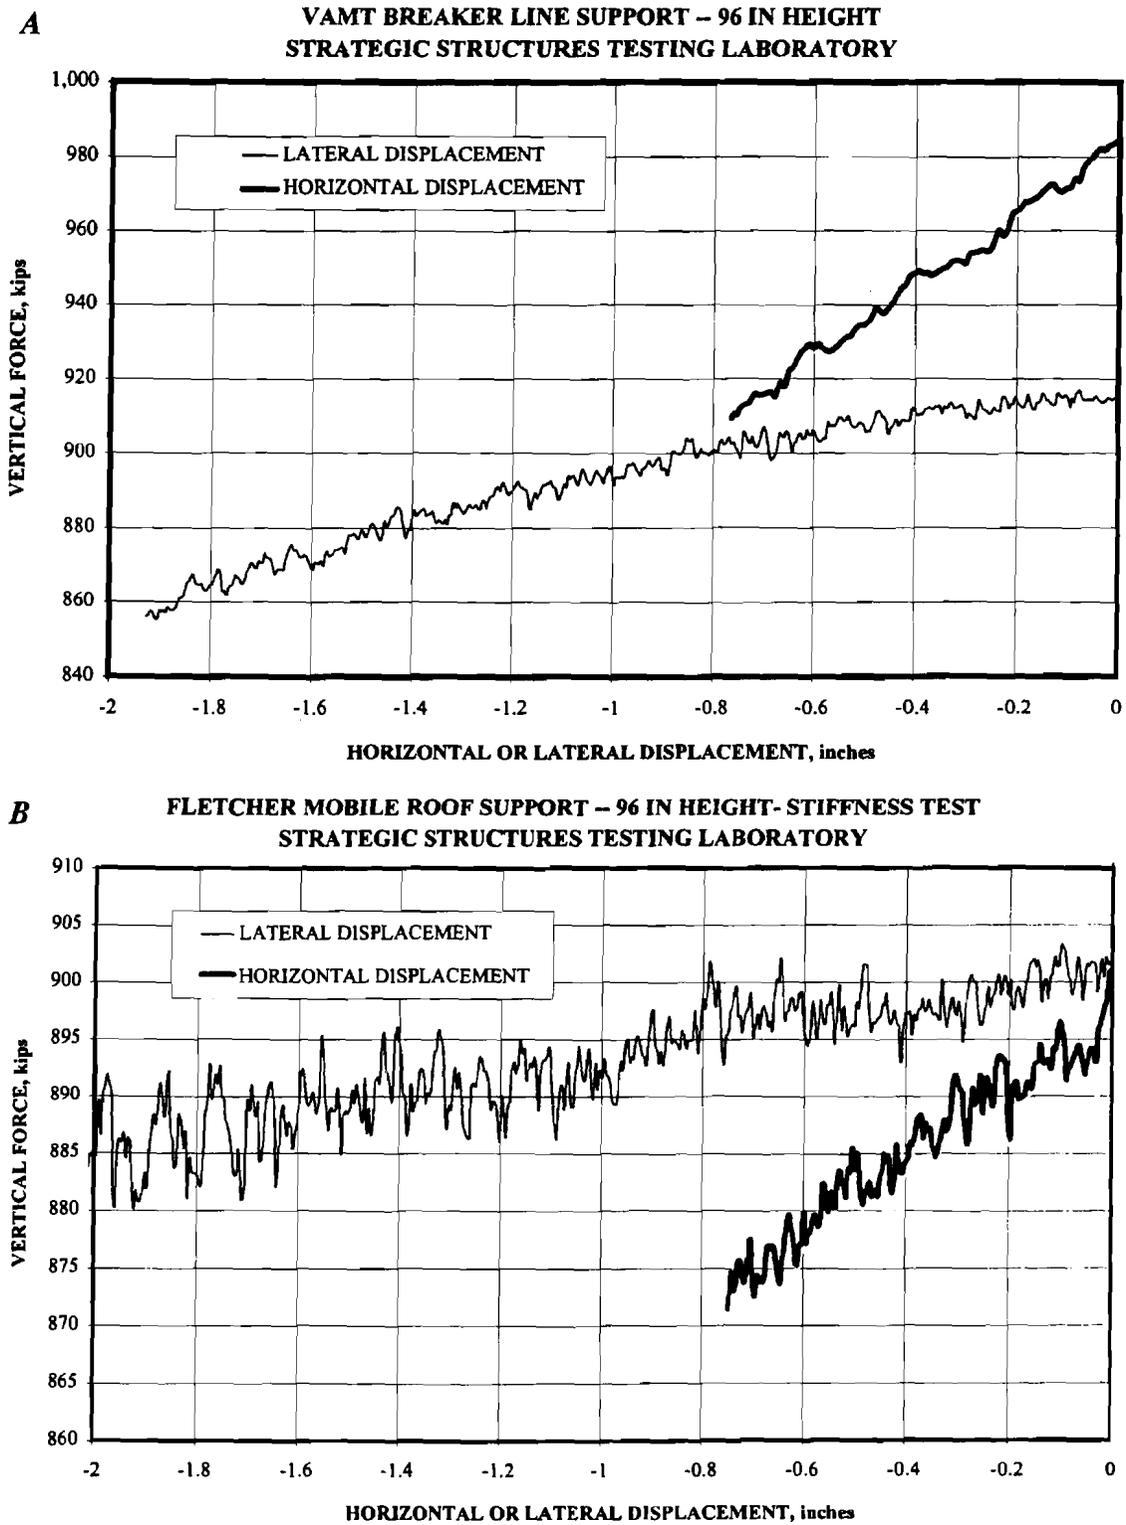
Figure 25.—Comparison of the effects of horizontal and lateral loading on reductions in support capacity. *A*, VAMT support; *B*, Fletcher support.

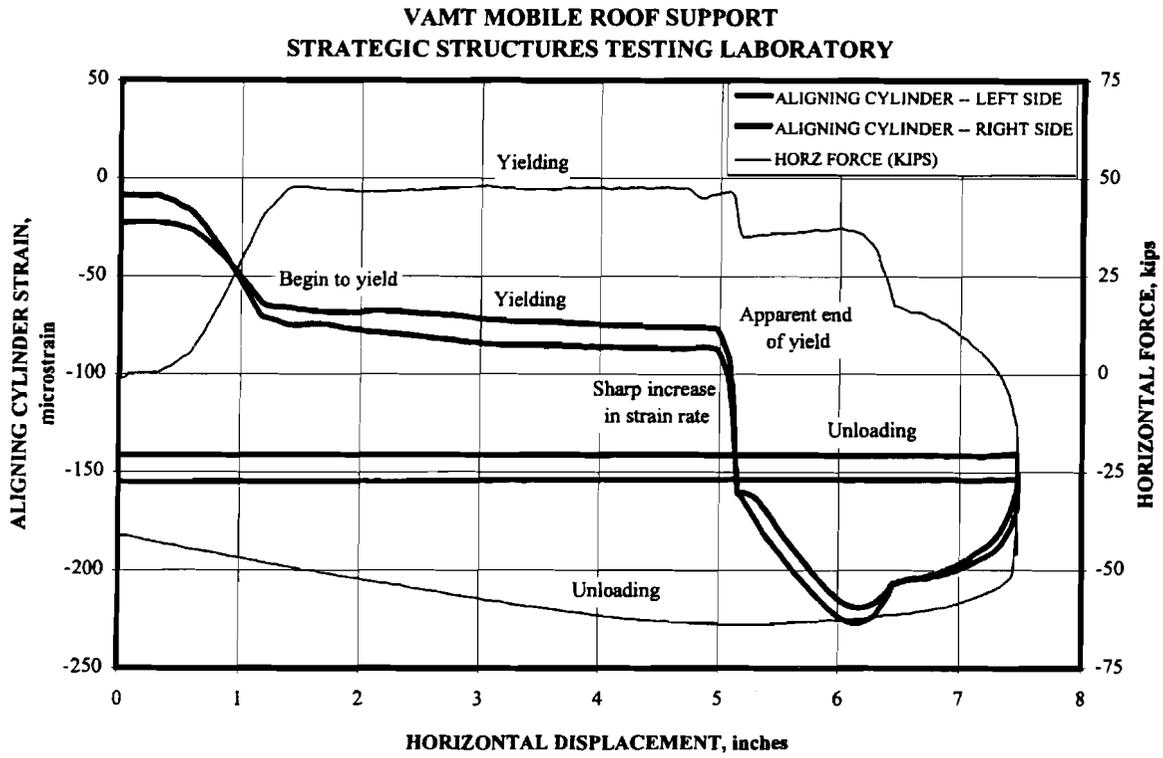
Figure 28.—Malfunction of aligning cylinder during horizontal displacement toward the plow.
