Proceedings: New Technology for Ground Control in Retreat Mining

Information Circular 9446

Christopher Mark, Ph.D., and Robert J. Tuchman

March 1997

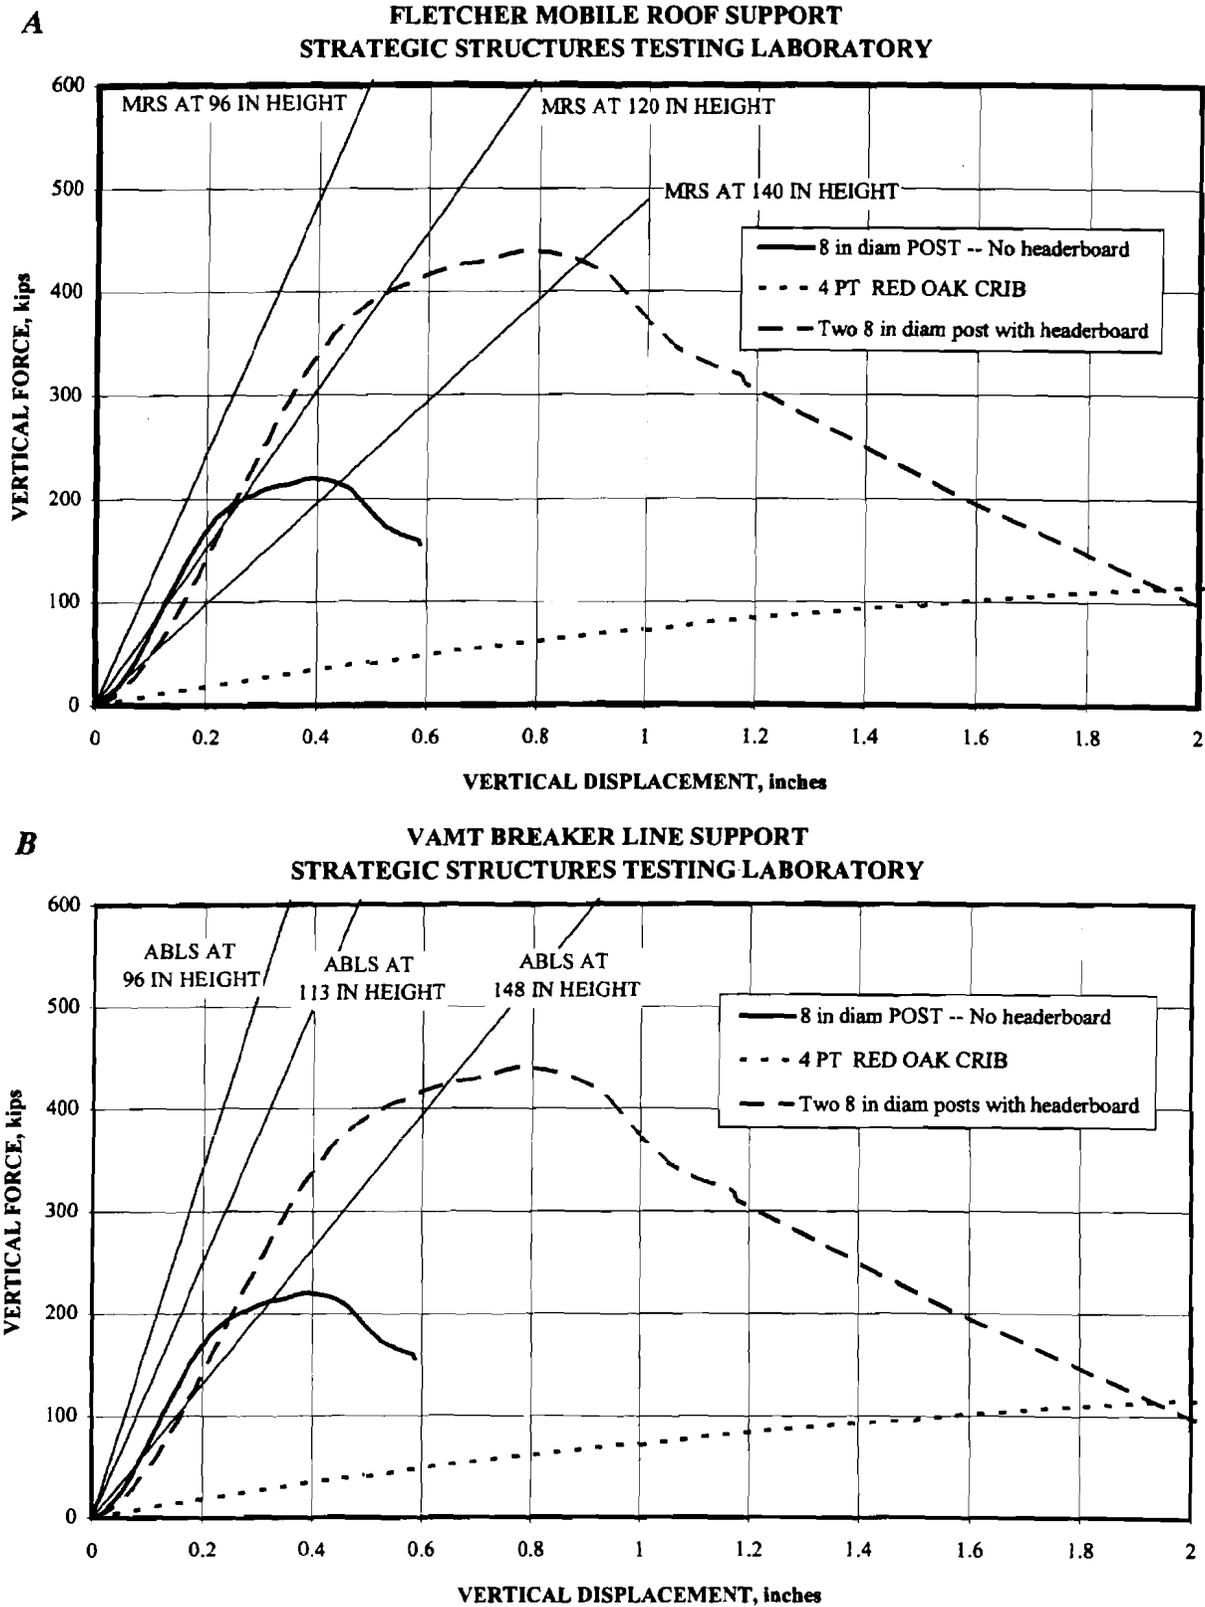
Figure 31.—Comparison of support stiffness with that of conventional timber posts. A, Fletcher support; B, VAMT support.
