Overview of coal mine ground control issues in the Illinois Basin

G.M. Molinda, C. Mark, D.M. Pappas and T.M. Klemetti

Gerologist, mining engineer, civil engineer and mining engineer, respectively,
National Institute for Occupational Safety and Health (NIOSH), Pittsburgh, Pennsylvania

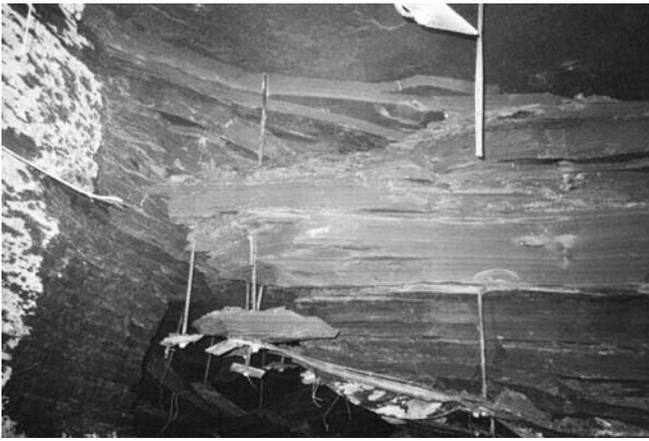
Figure 6 — Roof fall in moisture sensitive roof.

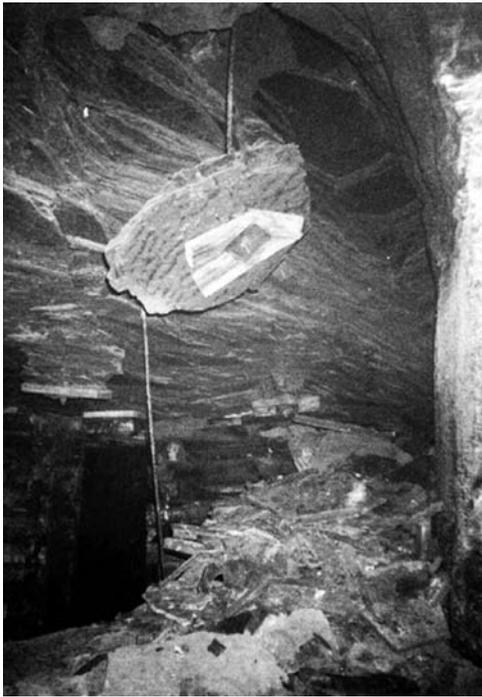
Figure 9 — Severe guttering due to horizontal stress.
