Time Dependent Roof Deterioration at a Central Ohio Coal Mine

Ted Klemetti, Research Engineer
Dave Oyler, Research Engineer
Greg Molinda, Lead Research Scientist
NIOSH Pittsburgh Research Laboratory
Pittsburgh, PA

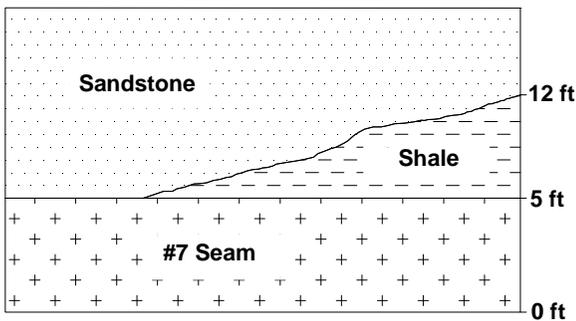
Figure 1. Generalized roof at the study.

The subject mine of this study is located in eastern Ohio in the #7 seam. The mine is a three-year-old room-and-pillar operation, with a life of ~20 years. The mains are driven from a box cut on the surface. The depth of cover ranges from 100 to 300 ft. The coal seam thickness ranges from about 4.5 to 5.5 ft. The immediate roof consists of a shale layer of variable thickness overlain by a relatively thick, strong sandstone layer. A generic depiction of the immediate roof is shown in Figure 1. Throughout the mine, there are locations where the sandstone rolls down to the top of the coal causing the shale layer to vary in thickness between 0 and 12 feet. The shale layer is weak and moisture sensitive, whereas the sandstone is strong and not moisture-sensitive.

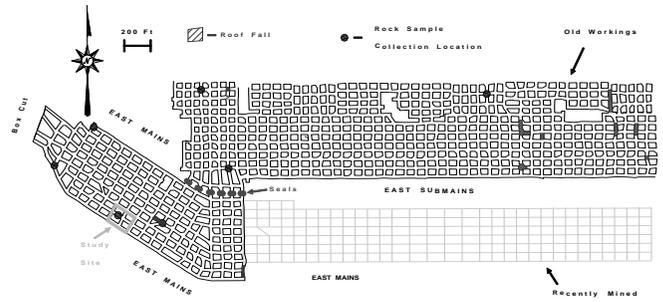
The mine layout can be seen in Figure 2. The area to the north on the map is the old workings, which are now sealed. The entries are typically 19 ft wide. The main pillars in the mine are generally 60 x 60 ft on centers. The primary roof support consists of 5/8-in, fully-grouted, 5-ft-long bolts installed 4 per row with a 4-ft spacing. In addition, four 10-ft-long cable bolts were installed in the intersections. When the mine began operation, screen was installed in four entries; 1 intake, 1 return, travelway, and the belt. Screen was not installed in the cross-cuts.

Figure 2. Study mine layout.

The study site is located on the East Mains as seen in Figure 2. The layout of the study site, including instrumentation locations and roof rock collection areas, can be seen in Figure 3. In order to

The Weatherability test was performed on 89 specimens obtained at several locations throughout the study mine, as shown in Figure 2. Figure 6 is a distribution of the results of the Weatherability Index of the 89 specimens of gray shale (Ferm No. 124) from the mine's immediate roof. The overall Weatherability Index average of the shales tested was 49%. While a majority (65%) of the values fall into the moisture sensitive range (>40%), there are a number of specimens that are not reactive to moisture. The variation in results may be attributed to the inherent variability of rocks. Rock characteristics vary widely throughout a mine as well as in a smaller sample. The variation may also be attributed to variations in bedding and spacing in the individual specimens. Another potential cause for the variation is the presence or absence of swelling minerals in the individual specimen samples.

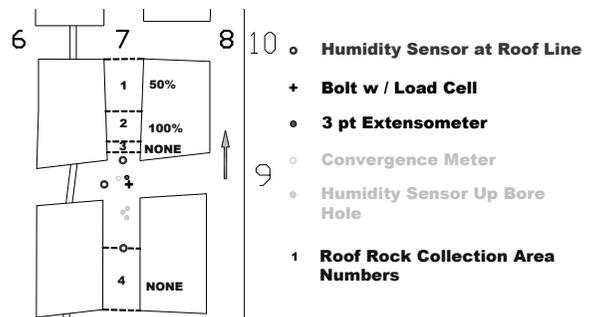
Figure 3. Study site layout with instrumentation and area locations.

Roof rock collection area 1 was sprayed with a 50% concentration of roof sealant, and area 2 was sprayed with a 100% concentration, as seen in Figure 3. The 50% concentration consisted of 50% sealant and 50% water. The remaining two areas were not sprayed with the sealant. All of the roof rock fall collection areas were originally quite similar in appearance.

The instrumentation deployed at the study site consisted of a roof-to-floor convergence monitor, roof sag extensometer, bolt load cell, and humidity and temperature sensors as illustrated in Figure 3. The convergence monitoring was intended to show the seasonal effects on the roof and floor. The swelling and shrinking of the immediate rock surrounding the openings may be captured in the convergence measurements. The mechanical extensometer and the convergence rod may allow for determination of the roof and floor convergence individually. The bolt load may be another indicator of the swelling and shrinking occurring in the roof as well as the separation occurring in the roof. The relative humidity and temperature sensors were installed to document the seasonal changes in humidity and temperature in the entries as well as determine if there was communication of humidity from the entries into the roof. These sensors were used to investigate changes in grouted bolt holes, un-grouted bolt holes, and tests holes resulting from varying weather conditions.

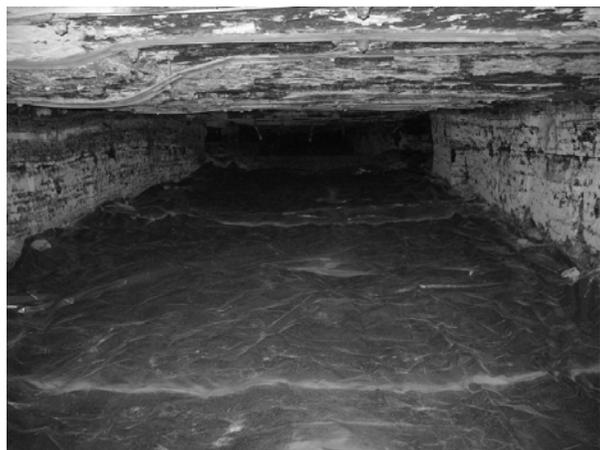
as shown in Figure 4. The tarps covering the floor were used to separate the fallen roof rock from that already on the floor. The roof rock on the tarps was collected in buckets and weighed with a portable scale. The resulting weights were recorded for each area during the visits to the study site.

Figure 4. Photo of roof rock collection areas 8-16-07, location 1.

Fallen roof rock can be an indicator of the time dependent deterioration due to moisture. The roof rock collection component consisted of four distinct areas where the floor was covered with tarps to capture the rock falling from the roof throughout the study

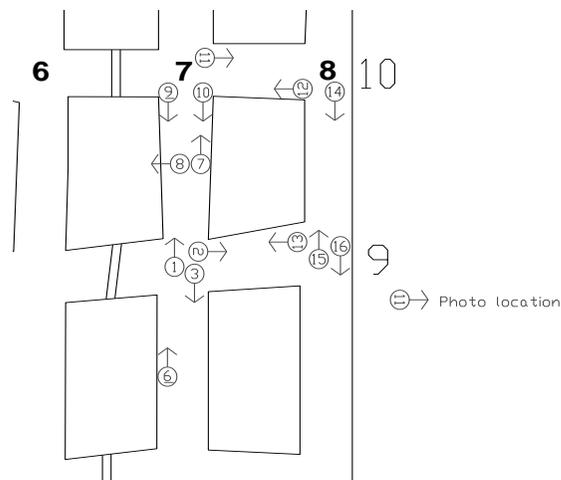
The visual observation component consisted of photographic documentation of the aging of the study site and the adjacent entry. The benefit of both the screen and sealant as well as the time dependent roof deterioration, can be seen through the photographs taken over the study period. The locations of the photos taken during each visit can be seen in Figure 5.

Figure 5. Study site layout with photograph locations.

The final method used in evaluating the deterioration of the roof was visual observation documented with photography. Several photographs were taken during each visit to document the time dependent deterioration of the roof. The locations of these photographs can be seen in Figure 5. The photograph in Figure 13 was taken on August 16, 2007, at onset of study, from the intersection in the study site looking inby, point 5 in figure 5. This photo shows minor roof deterioration and no roof rock on the tarps as would be expected at the beginning of the study. Figure 14 is a photo of the same location taken on June 25, 2008. Figure 14 depicts a much greater level of roof deterioration and roof rock on the tarp than that in Figure 13.

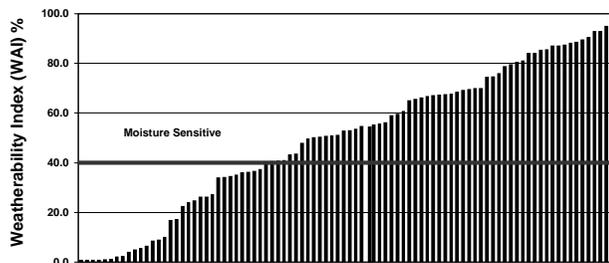
Figure 6. Moisture sensitivity variability of the immediate roof rock (gray shale, Ferm No. 124).

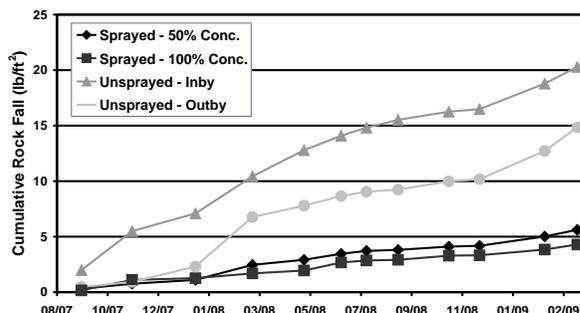
The fallen roof rock collection provided the most intriguing results from this study as presented in figure 7. The normalized average weight of roof rock collected per day was approximately

0.0069 lb/ft² in both coated areas, compared to about 0.0230 lbs/ft² for the uncoated areas. The areas sprayed with sealant yielded 2.9 and 3.8 lbs/ft² of roof rock collected during the first year of monitoring. The areas with no sealant yielded 9.2 and 15.5 lbs/ft² during that same period. The two uncoated areas showed at least 2.5 times and as much as 4.8 times the fallen rock of the two coated areas. The uncoated areas had varying roof rock falling rates throughout the study, whereas the coated areas had similar trends, as seen in figure 7. Some of the rocks collected from the uncoated areas were much larger than the rocks collected from the coated areas. There were two periods of increased roof rock fall amounts, December 2007 through March 2008 and December 2008 through February 2009.

Figure 7. Cumulative roof rock collection results.

The results demonstrate the improvement expected from sealing roof rocks when compared to the areas that were not coated with the sealant. There does not appear to be any distinct seasonal trends associated with the falling roof rock. The results also indicate that this sealant can be diluted with 50% water and still maintain the same level of protection. Since the spray sealant has no strength, it should be applied as quickly after mining as possible for the greatest effect prior to roof sag. A photo of the roof rock collection area taken on March 3, 2008 prior to rock collection can be seen in Figure 8.

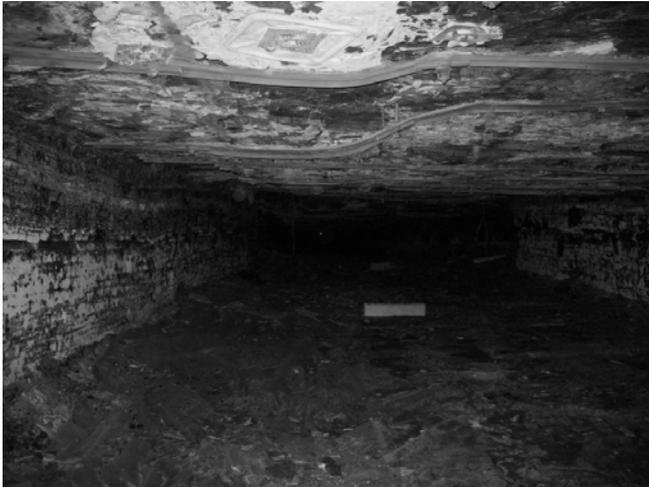
Figure 8. Photo of the rock collection area, looking inby from the intersection, taken on March 3, 2008.

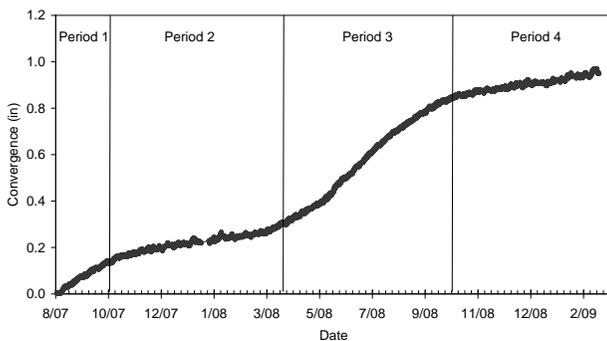
The cumulative roof-to-floor convergence for the study site can be seen in Figure 9. The plot shows that the convergence is continually increasing with time. There are four distinct periods in the figure. Periods one and three have a much higher rate of convergence compared with periods two and four. The increase in

the rate of convergence corresponds to the warmer humid months of April through September. This increase in humidity can cause swelling of the roof and floor leading to the increasing rate of convergence. Another possible factor in the changing rates is bed separation of the weakly bedded immediate roof and floor.

Figure 9. Convergence measurements in intersection of study mine.

Another instrument deployed at the study site was the 3-point mechanical extensometer intended to document the roof sag over the entire study period. The mechanical extensometer never measured any roof sag. With the extensometer showing no roof sag and the convergence rod measuring roof-to-floor convergence, swelling of the floor is probably the cause of the convergence.

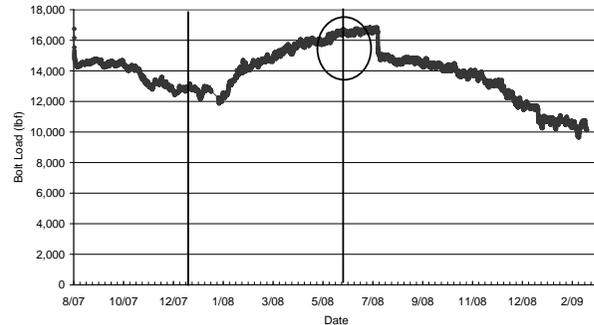
The bolt load cell shows an almost immediate reduction in load. The initial load loss is typical with a mechanical anchor bolt. This initial drop off was followed by a steady decline from September to January and a steady increase from January until mid July. In mid July there was a steep reduction in the bolt load. After this steep reduction, the bolt load has been gradually decreasing ever since. This trend, as seen in Figure 10, does not correspond to the trends of the convergence measurements. This steep reduction in July 2008 could be due to anchor slippage or roof deterioration around

the bolt plate. It appears that the bolt loading is somewhat related to seasonal trends. The mechanical bolt appears unable to sustain the full design load in this roof.

Figure 10. Bolt load in intersection of study mine.

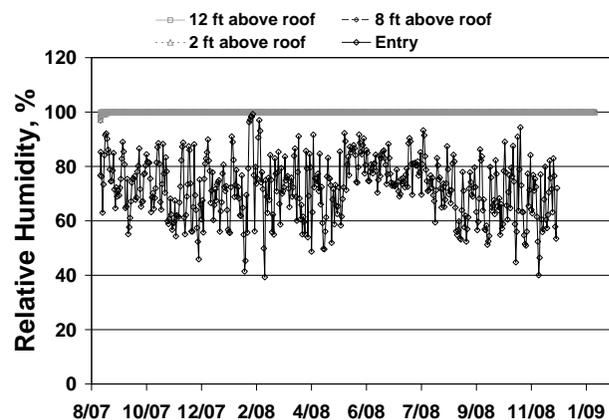
The temperature and humidity sensors showed a constant relative humidity of 100% throughout the entire year on the sensors located in all three holes at 2-ft, 8-ft, and 12-ft horizons above the roof line. A single sensor was placed approximately 1 ft above the roof line in the open hole on 28 April 2009 and has maintained 100% relative humidity ever since. The sensors in the entry varied in relative humidity from less than 40% to 100% throughout the year, reflecting the ambient conditions. The constant relative humidity in the holes, including the open hole, shows that no air transfer is occurring between the entry and the hole. It indicates that the humidity is coming from the formation rather than the humidity in the entries' air. Thus, the roof is still subjected to moisture trapped in the formation which may still be damaging the roof. The relative humidity measurements up the hole are the overlapping lines at 100% in Figure 11.

Figure 11. Open hole and entry humidity.

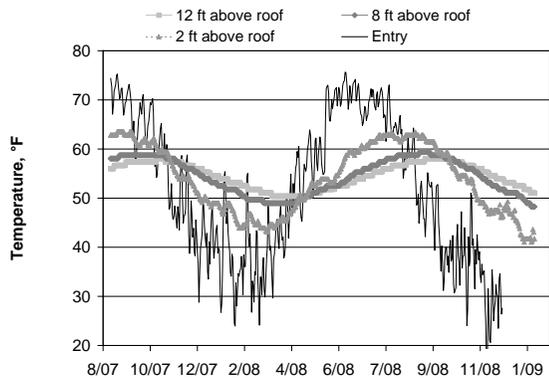
The temperature in the holes was also extremely constant on a daily basis compared with the entry measurements. The daily variation was typically less than one degree Fahrenheit in the hole sensors compared to an average of around seven degrees Fahrenheit for the entry sensors. There was also very little variation in the temperature and relative humidity measurements among the three

open and sealed holes. A sample of the temperature results can be seen in Figure 12. The temperature measurements are thicker smoother lines for the sensor up the open hole. The thinner line represents the temperature in the entry.

Figure 12. Open hole and entry temperature.

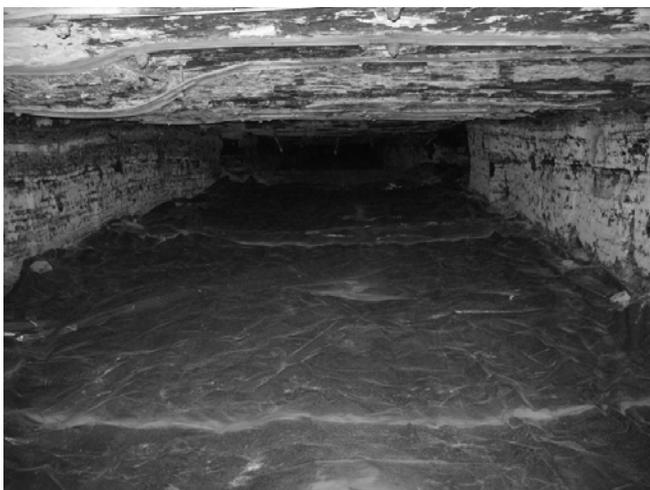
Figure 13. Photo taken 8-16-07 looking inby at study site, location 1.

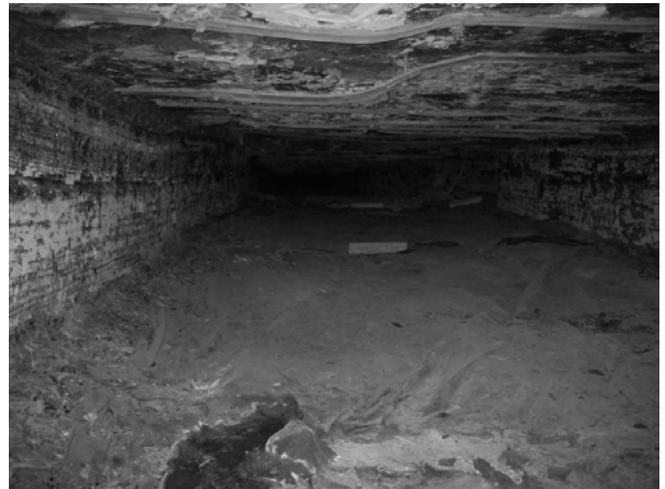
Figure 14. Photo taken 6-25-08 looking inby at study site, location 1.

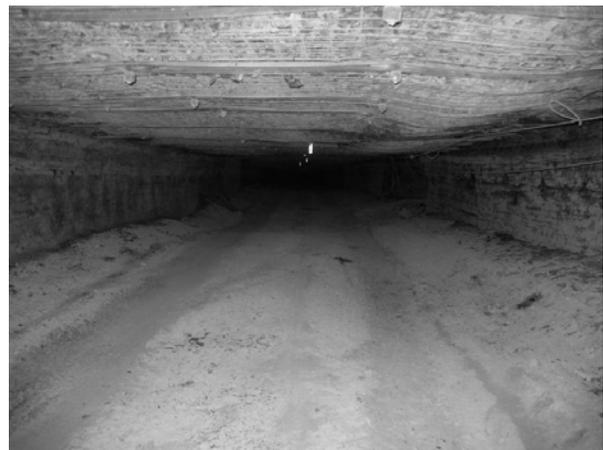
roof is screened. As seen in photo in Figure 15 taken during the 10th month of the study, the screen contained the roof rock and subsequently maintained better overall conditions. Several previous studies have shown the benefit to roof screening in moisture sensitive roof control (Molinda et al., 2003; Compton et al., 2007).

Figure 15. Photo taken 6-25-08 looking inby in adjacent entry with screen, location 15.
