DPM Workshop

Diesel Particulate Filter Application Case Study

Mark L. Good
Sr. Mining Engineer
Kennecott Greens Creek Mining Company

Kennecott Greens Creek Mining Company

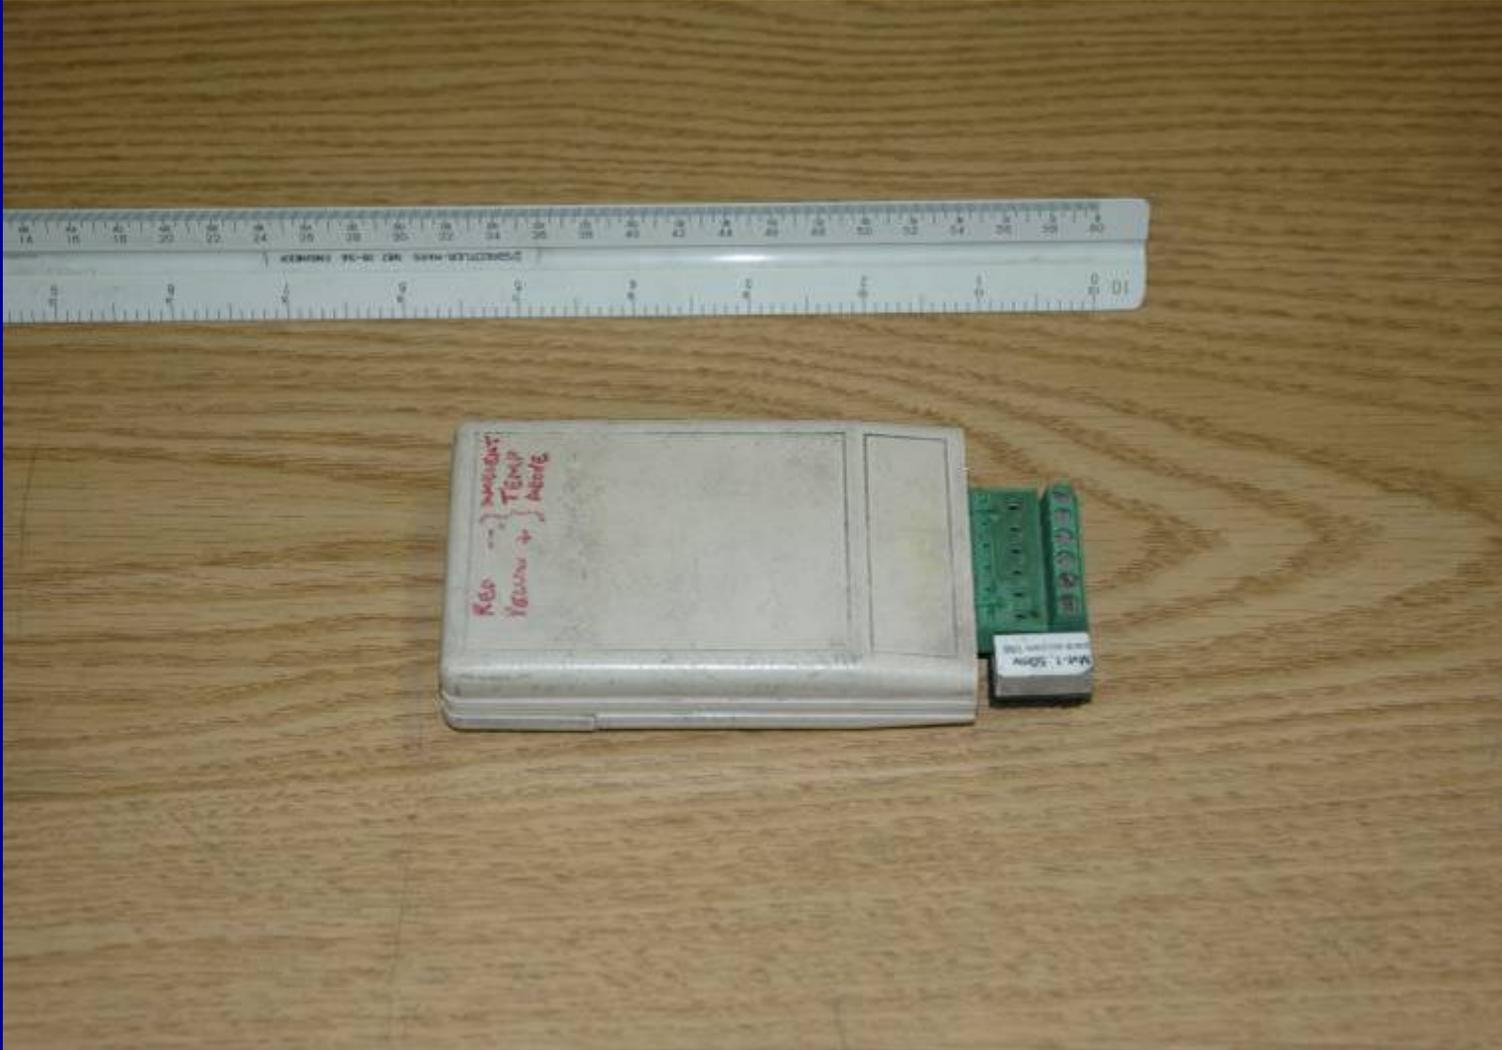
4 Channel Data Logger

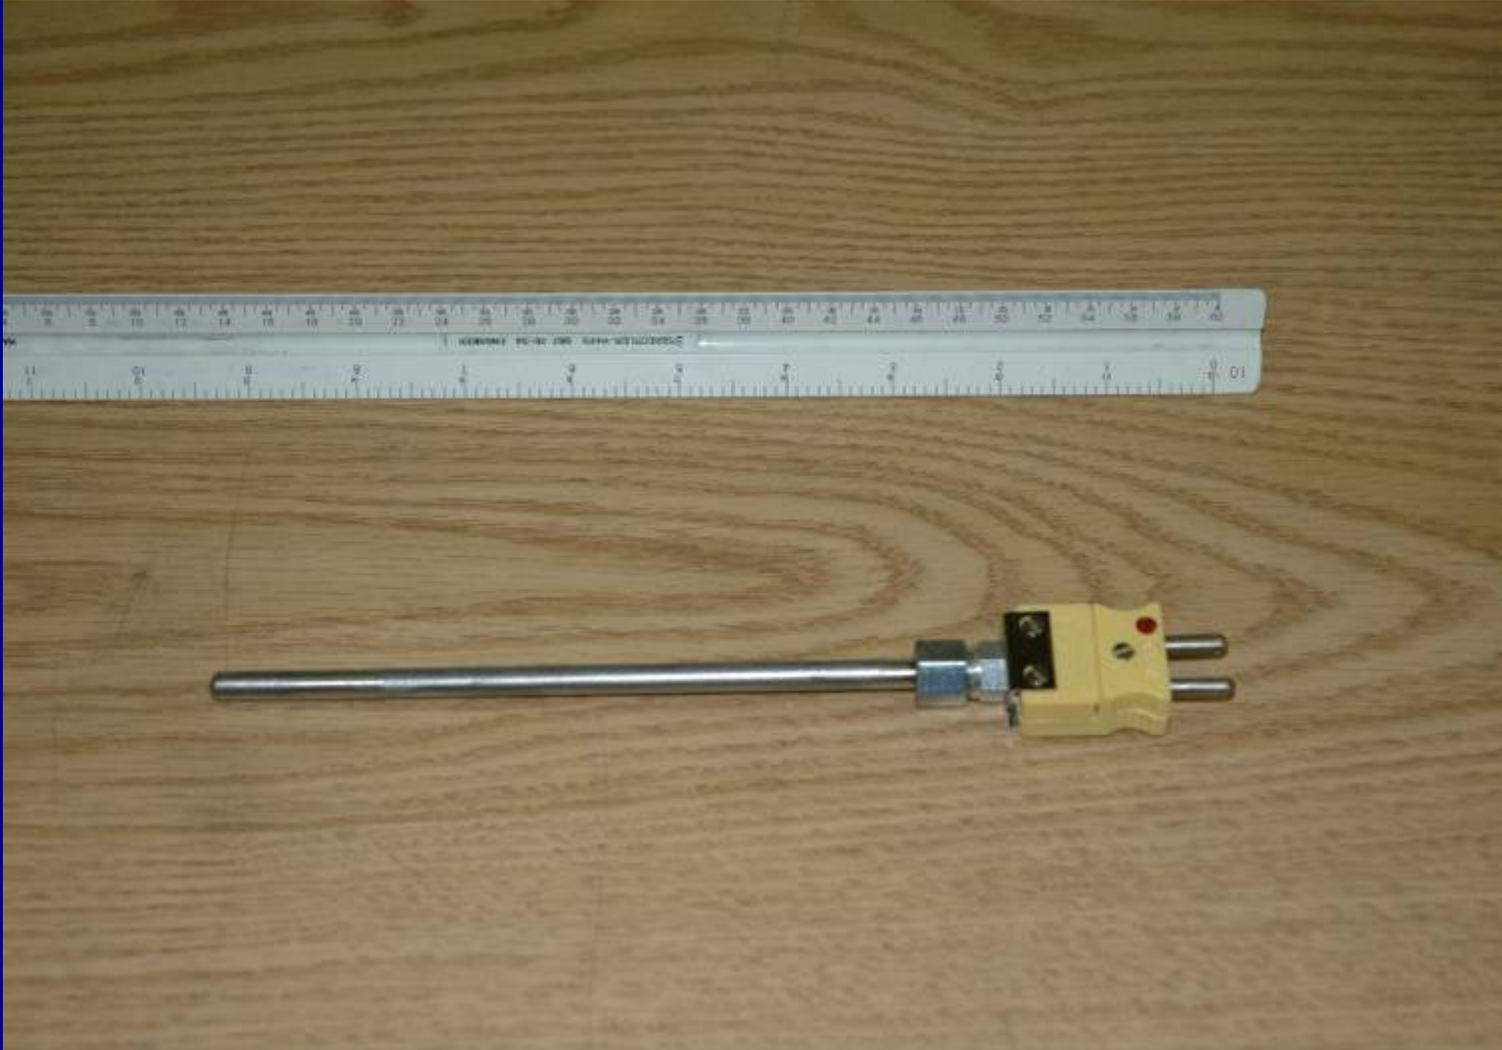
6" K type Thermocouple

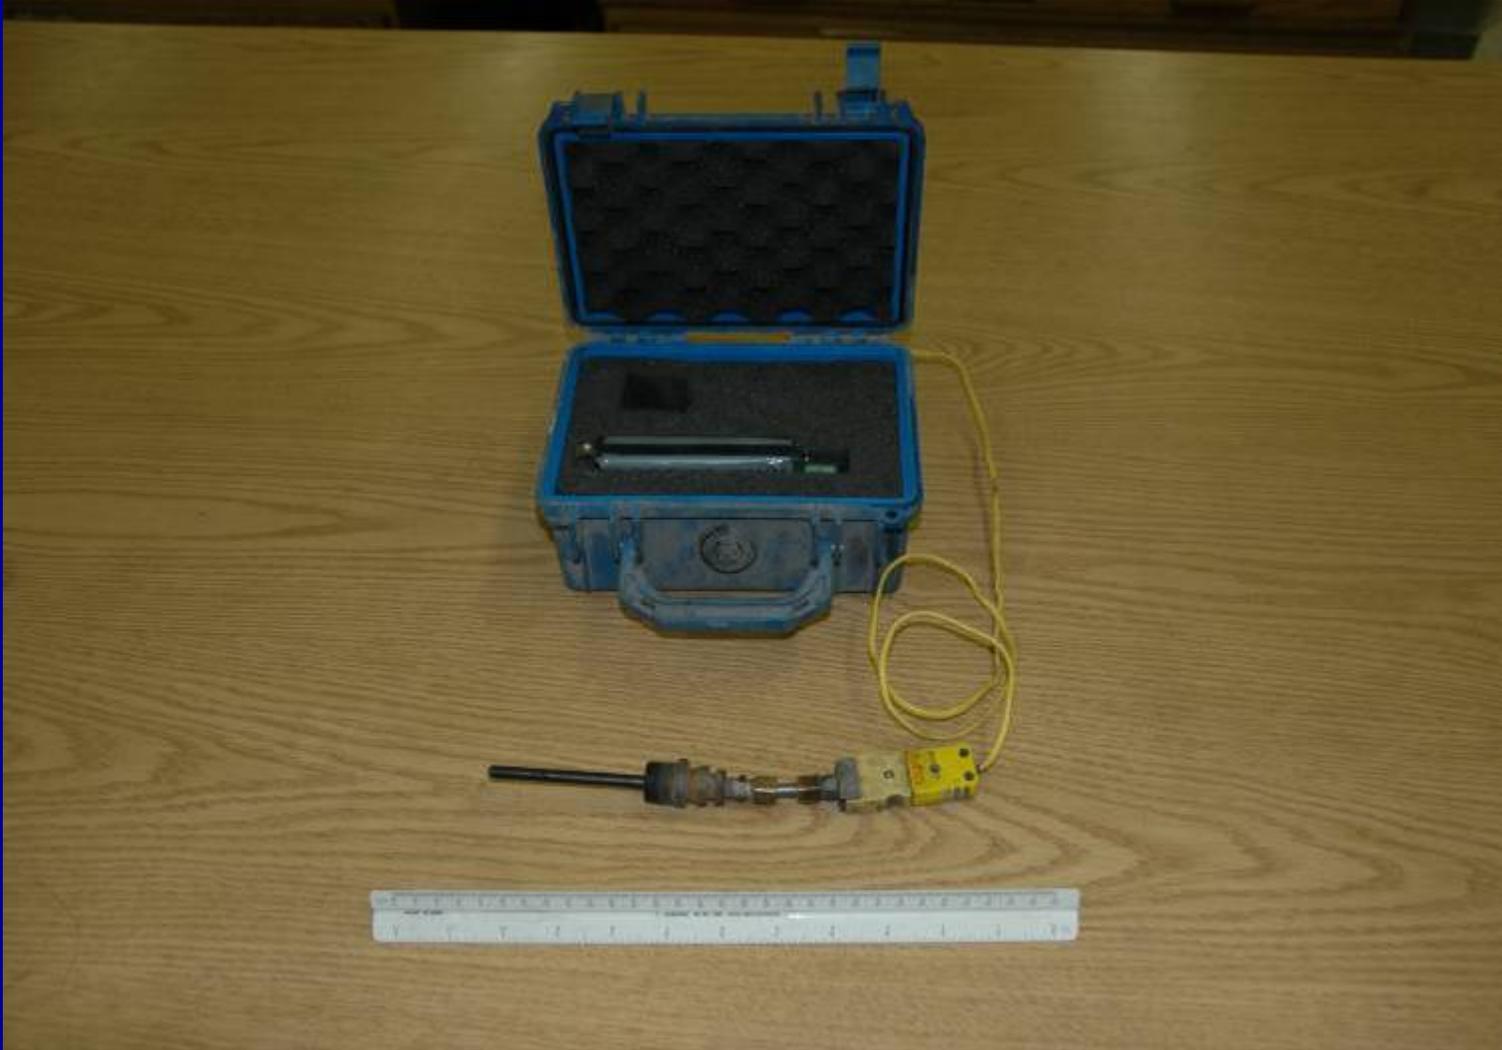
Data Logger, Probe and Case

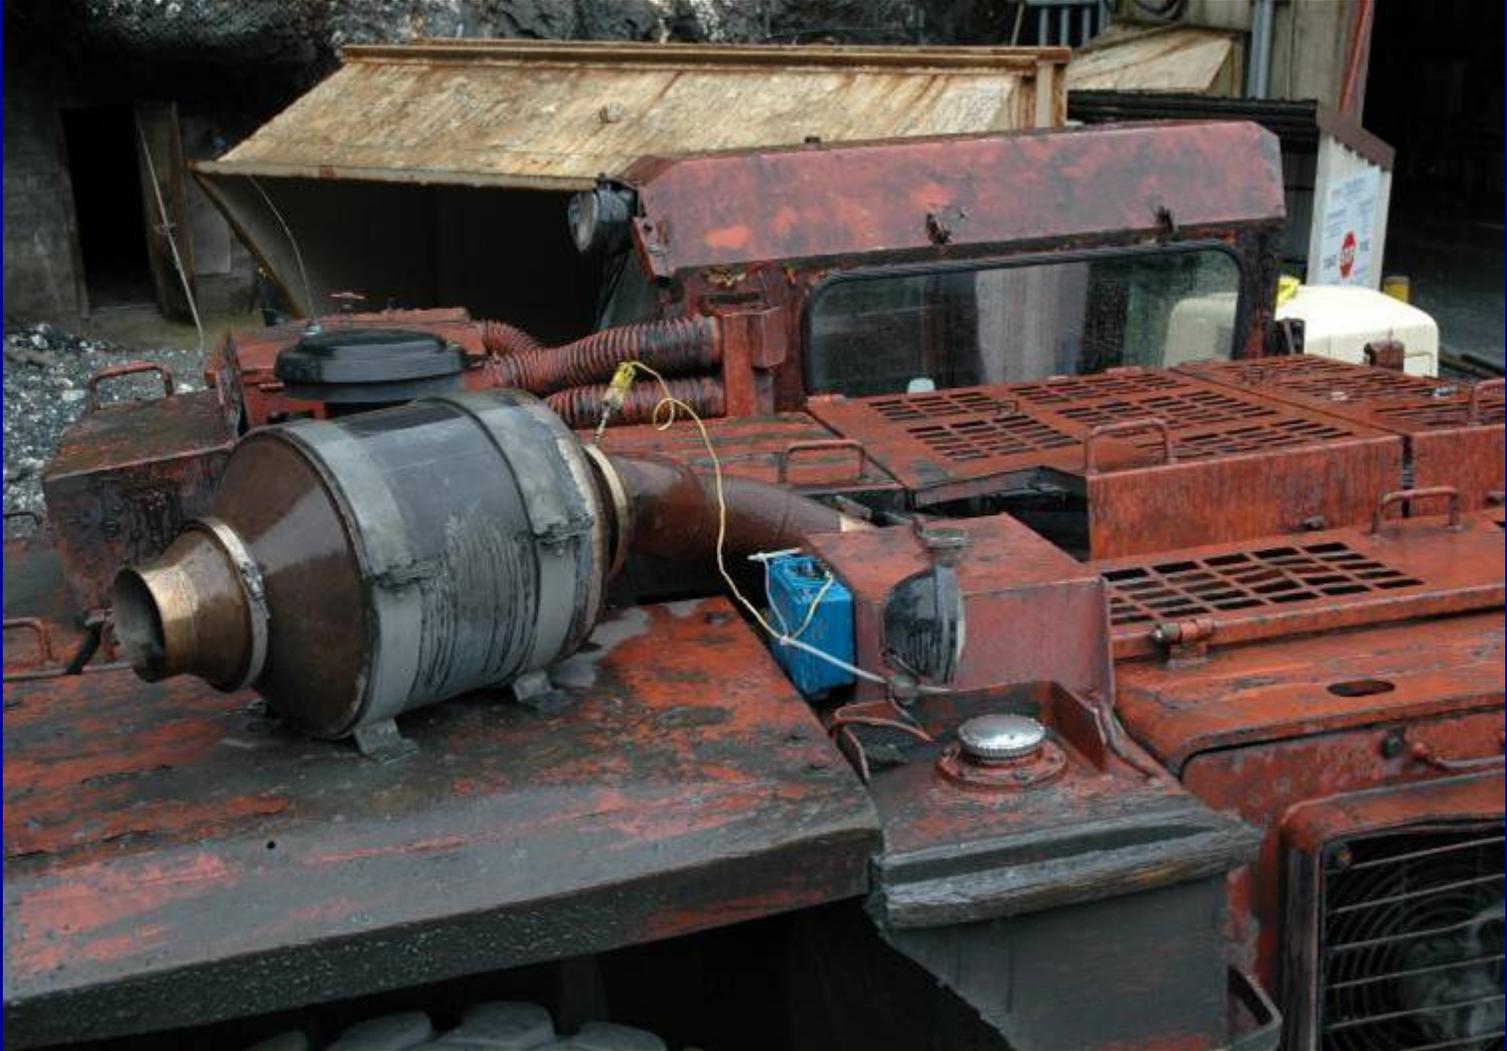
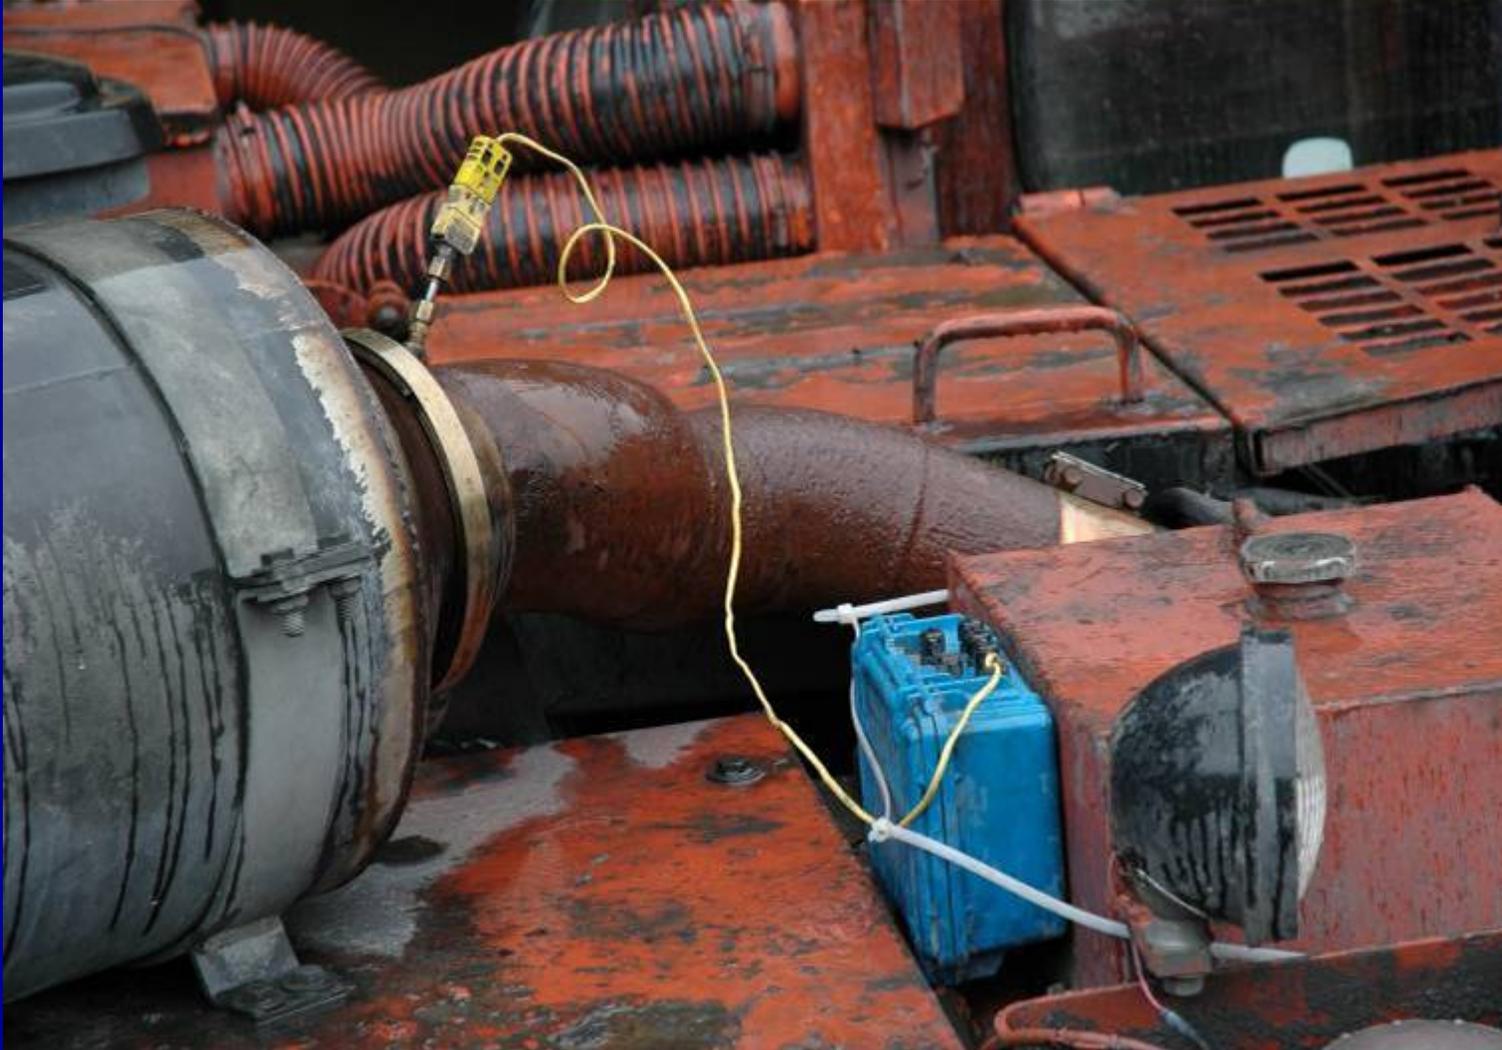
Toro 40 D Installation

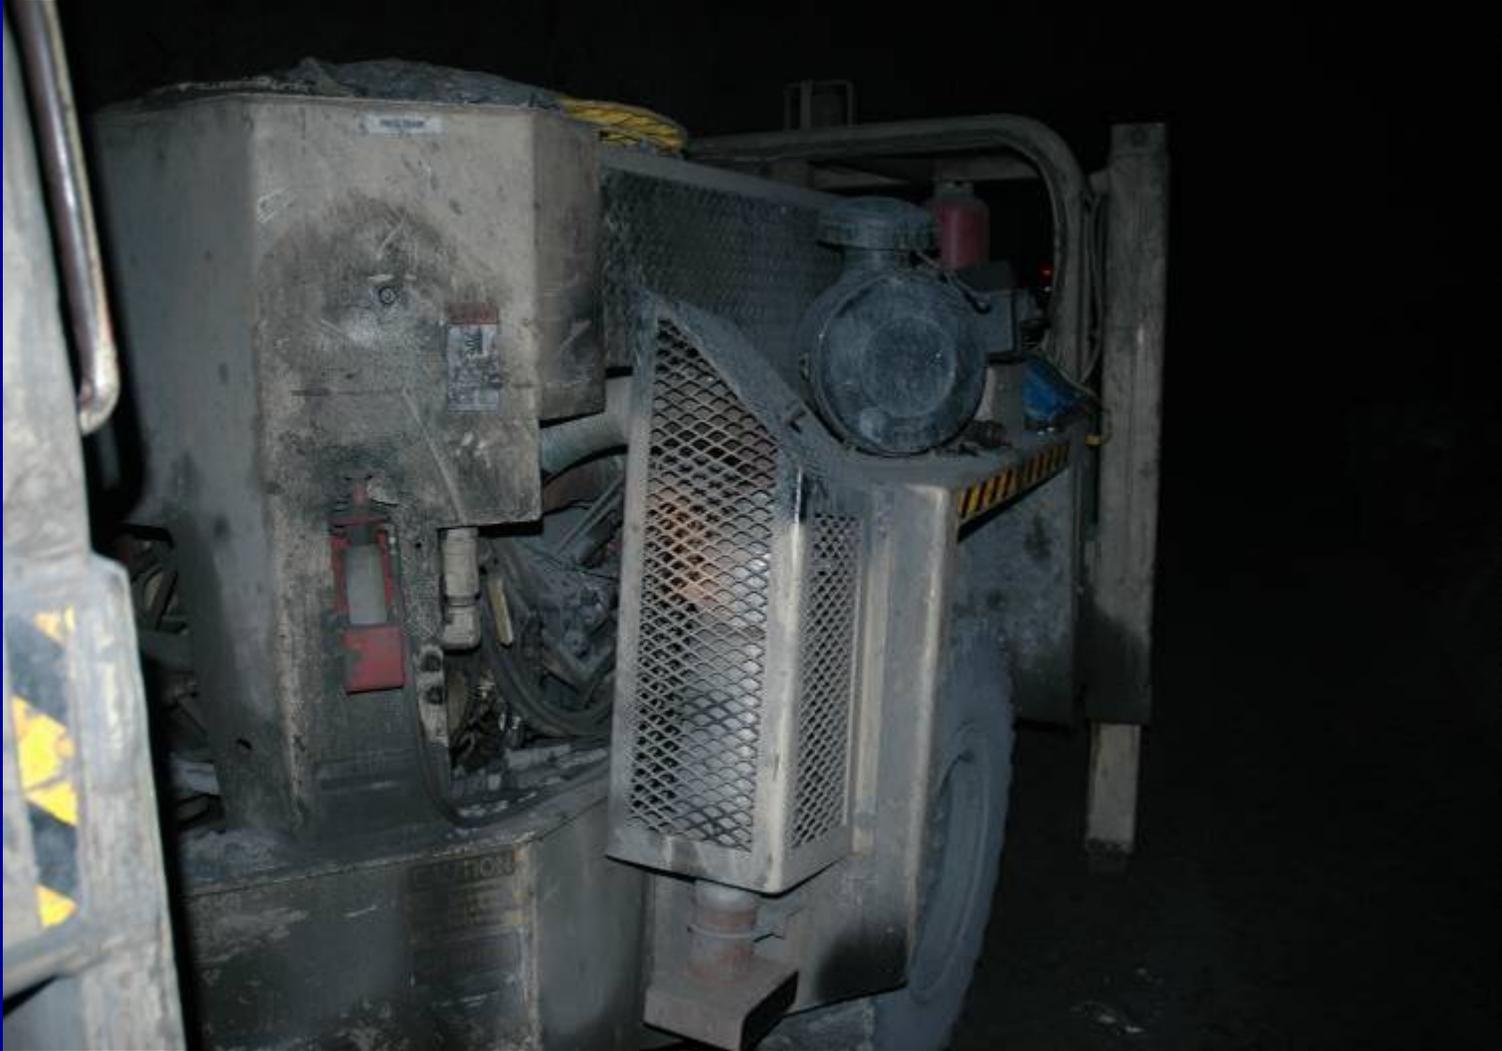
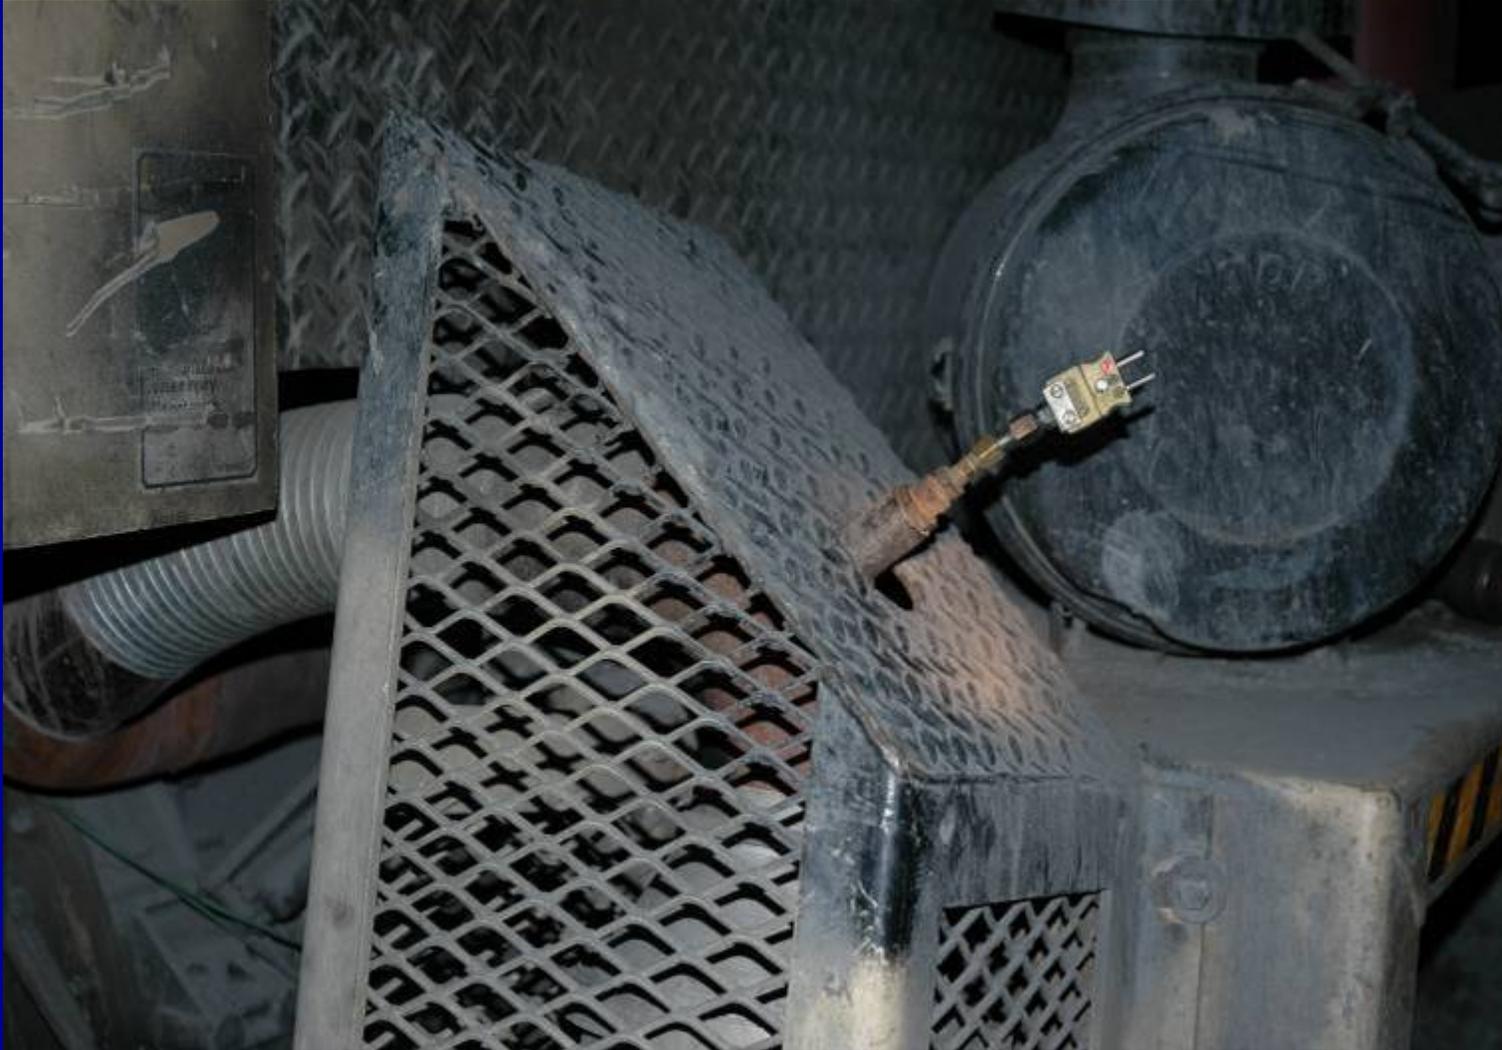
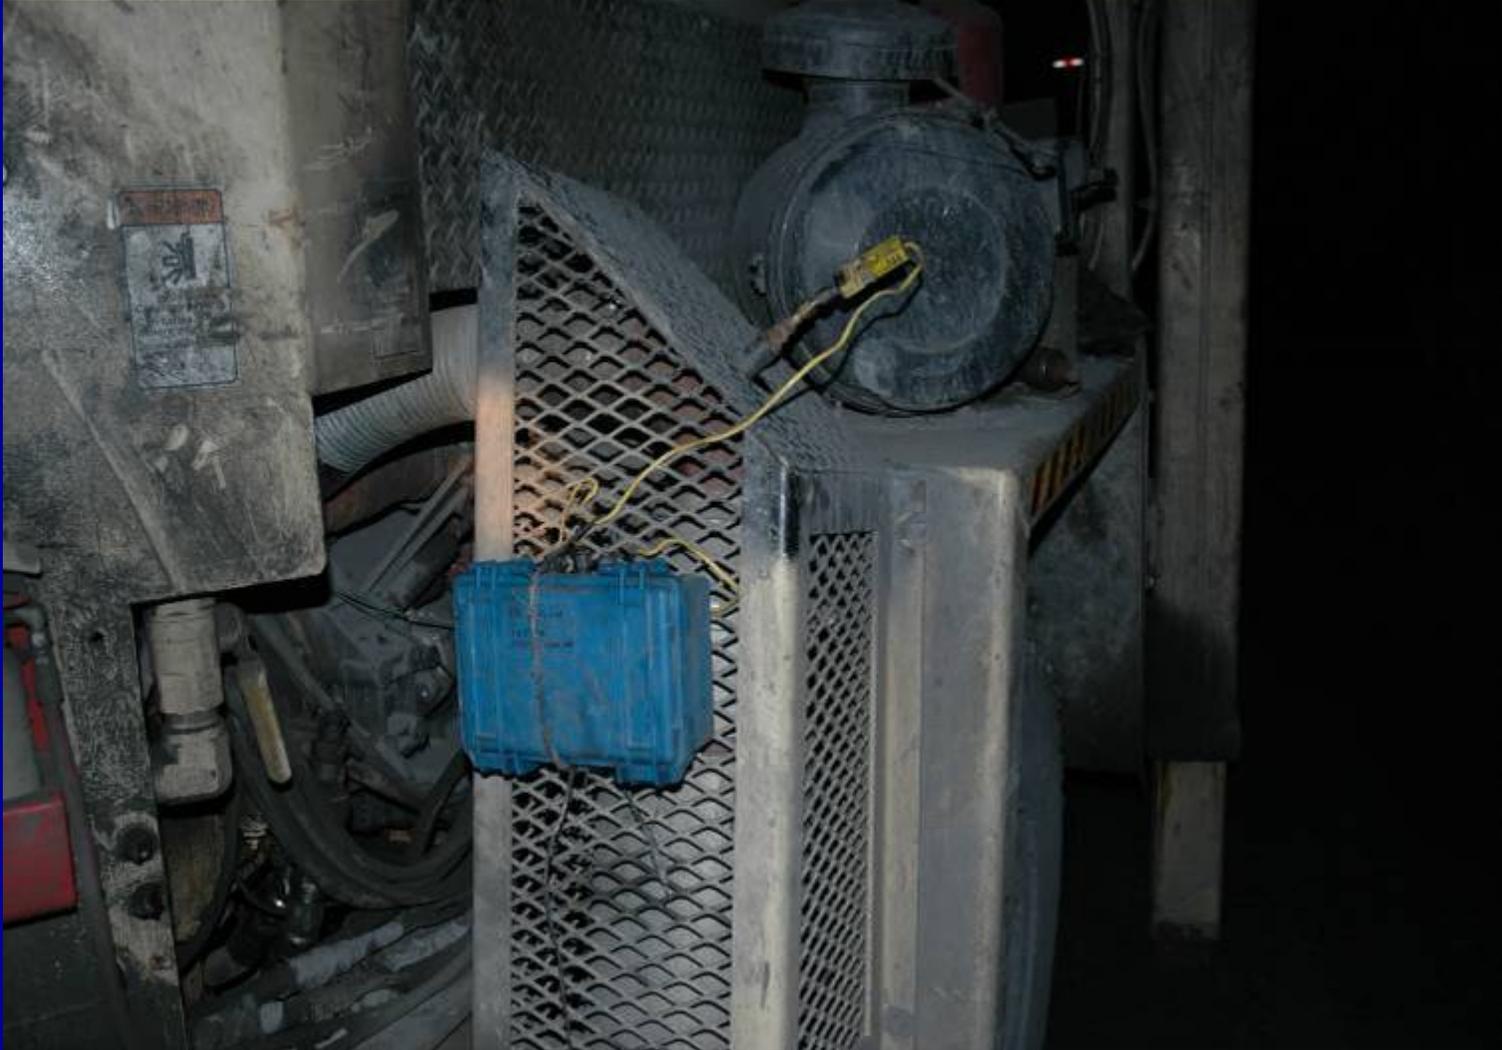
Getman A64 Installation

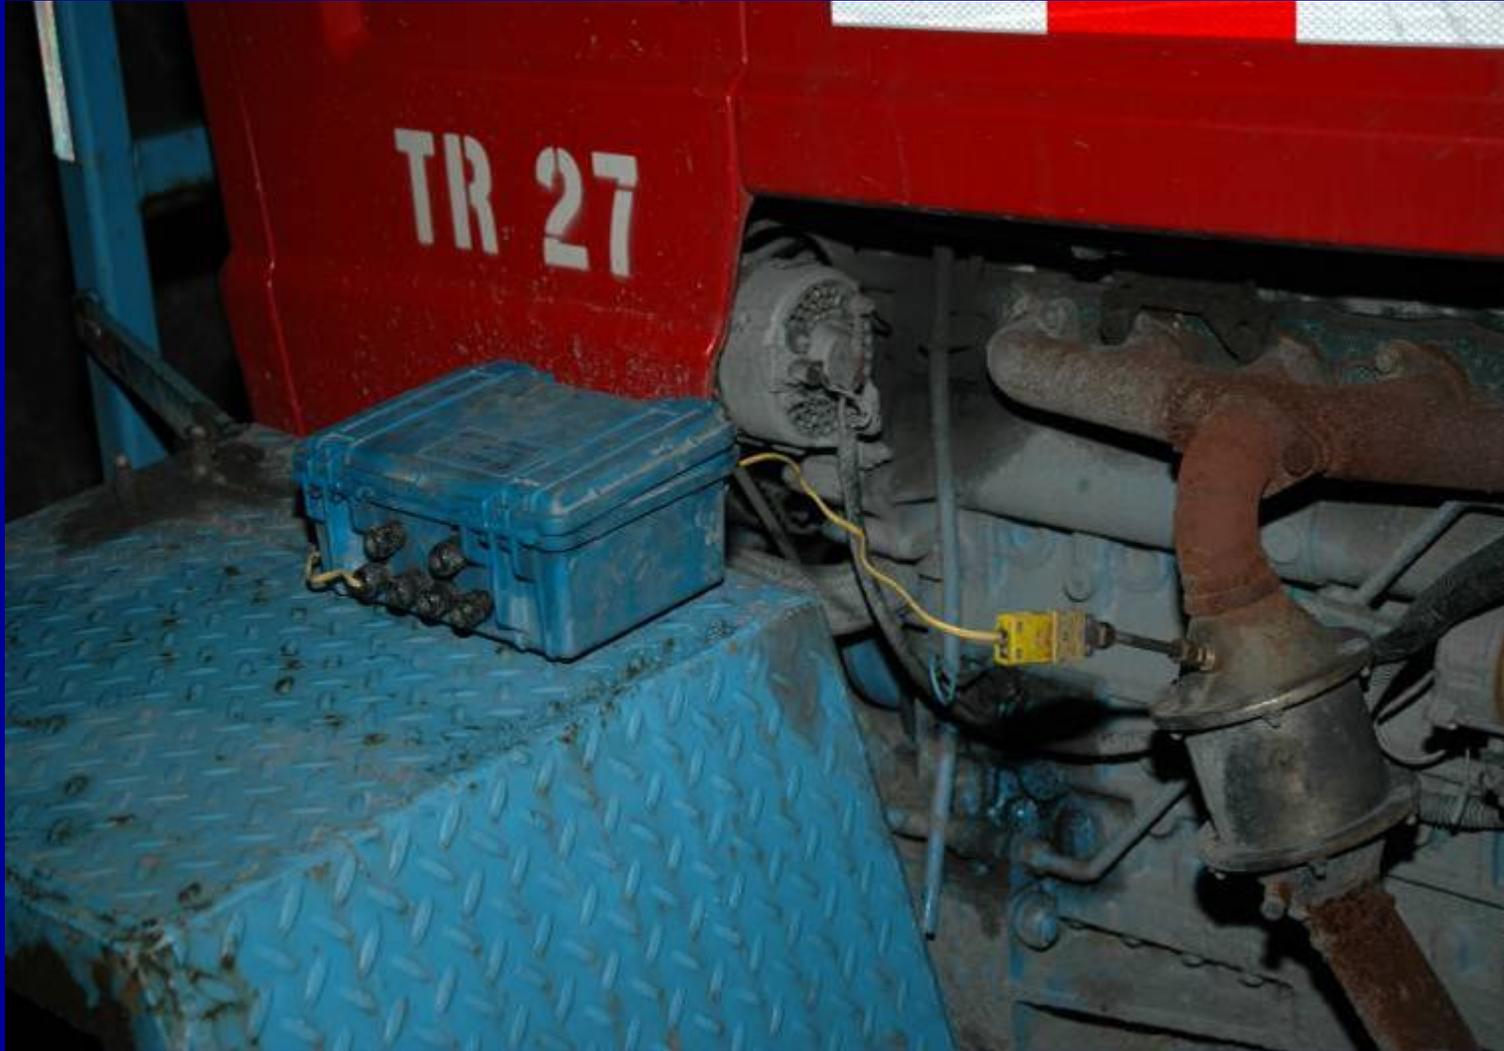
Kubota M5030 Installation

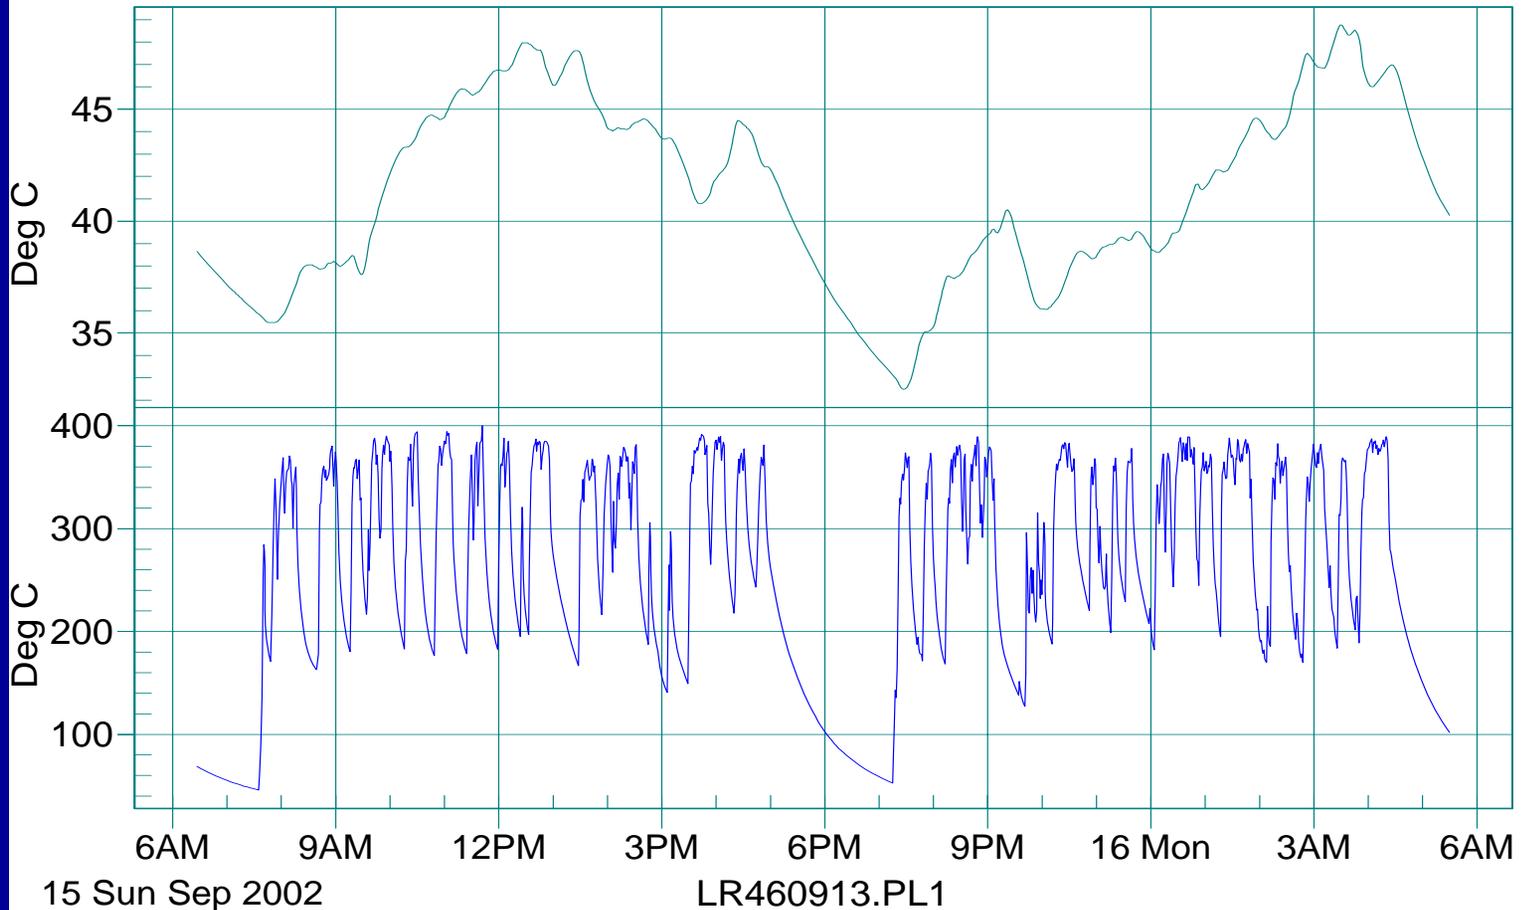
Temperature Profile

LR 46 Temperature 09/11/02

LR46 Exhaust deg C

- **Temperature profiling is imperative**
- **Data logging over several days to gain a good perspective of operating conditions**
- **Test each piece of equipment in a given production cycle**
 - **Eg; Two LHD's, similar configuration, one in remote mucking, the other in manual mucking**
 - **One configuration was successful, the other, marginal**

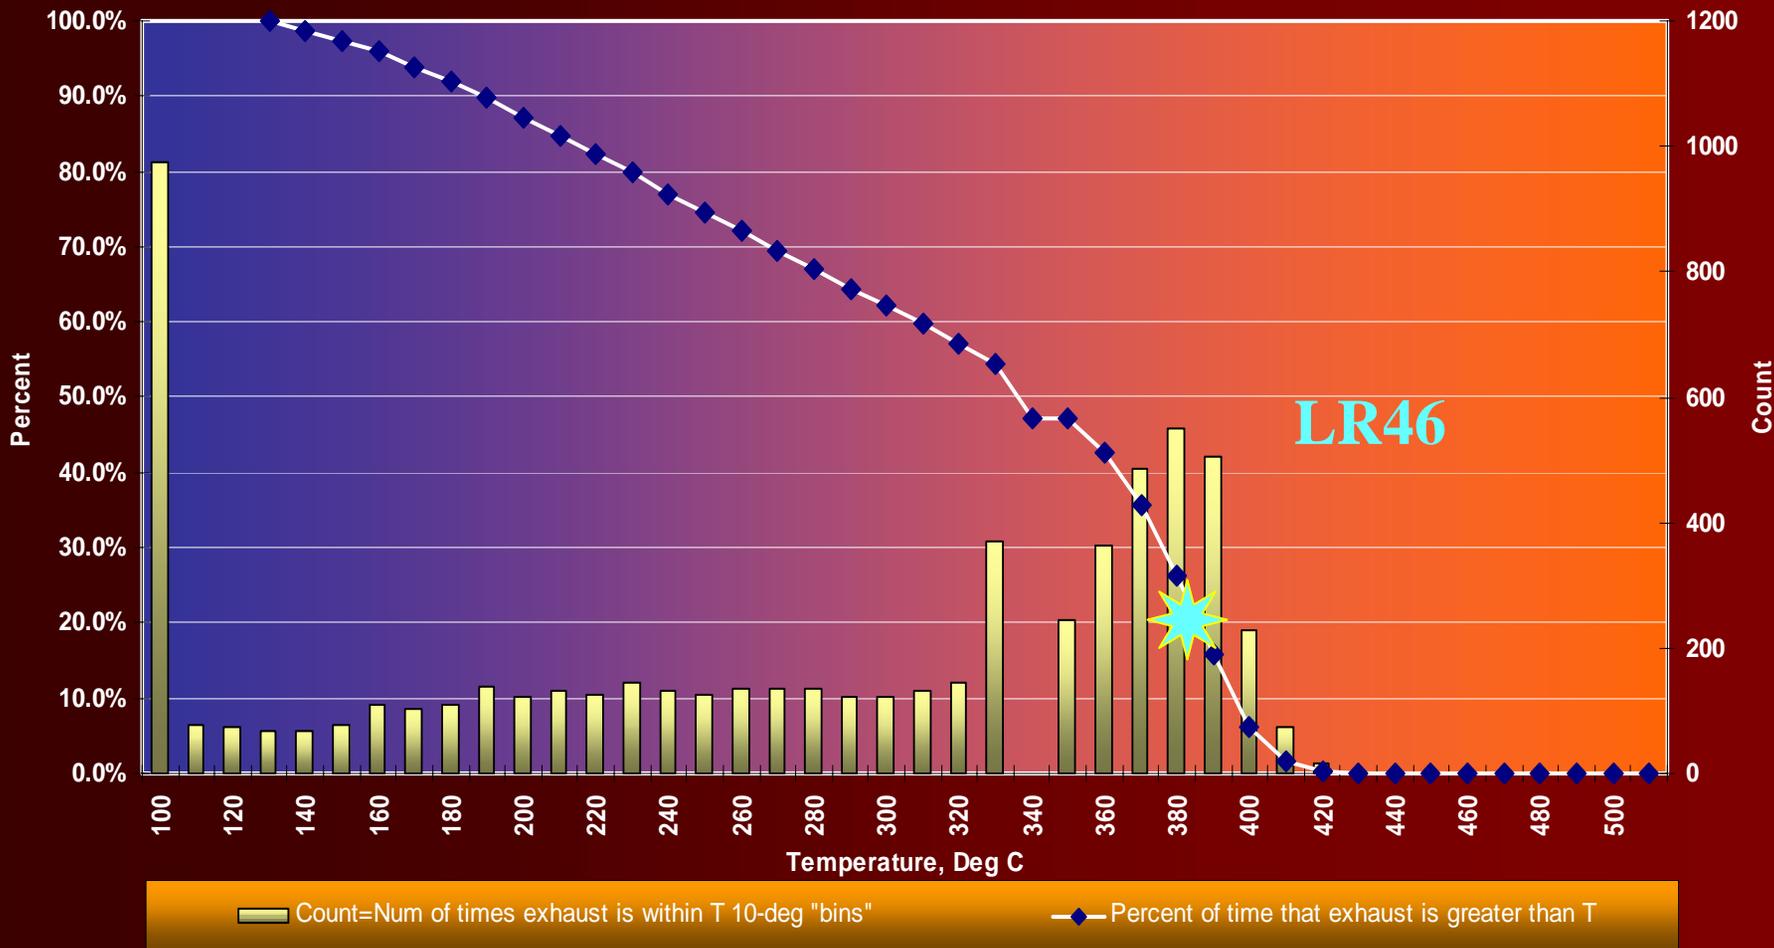
Temperature Histogram
10-degree C increments

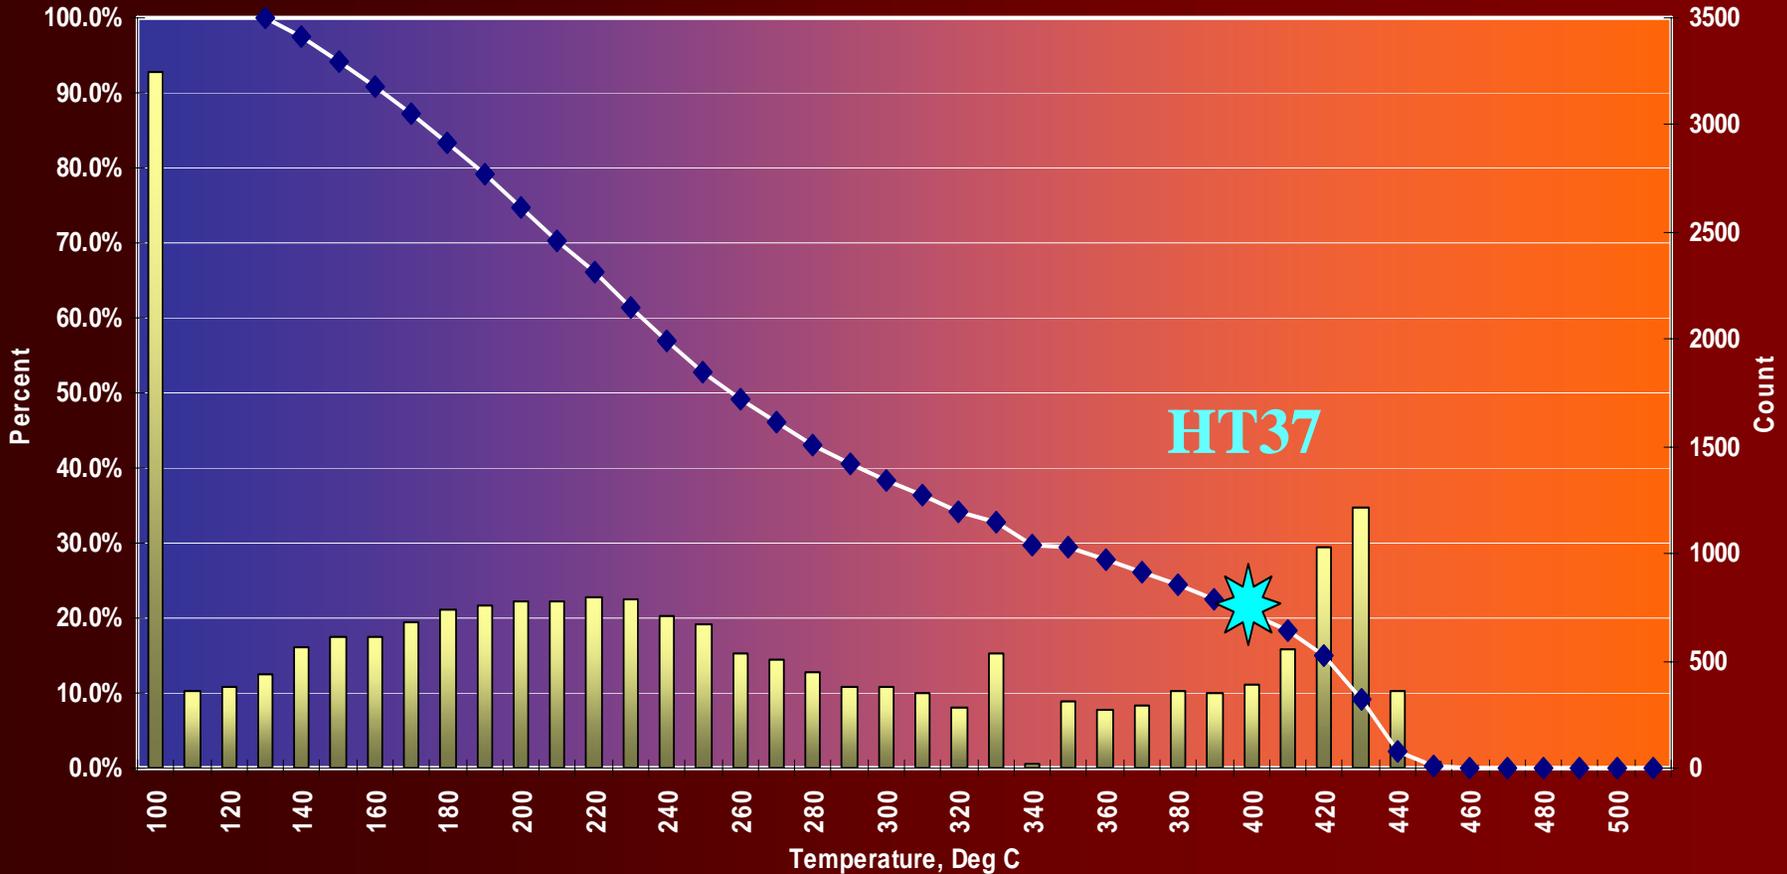
Temperature Histogram
10-degree C increments

Count=Num of times exhaust is within T 10-deg "bins"

◆ Percent of time that exhaust is greater than T

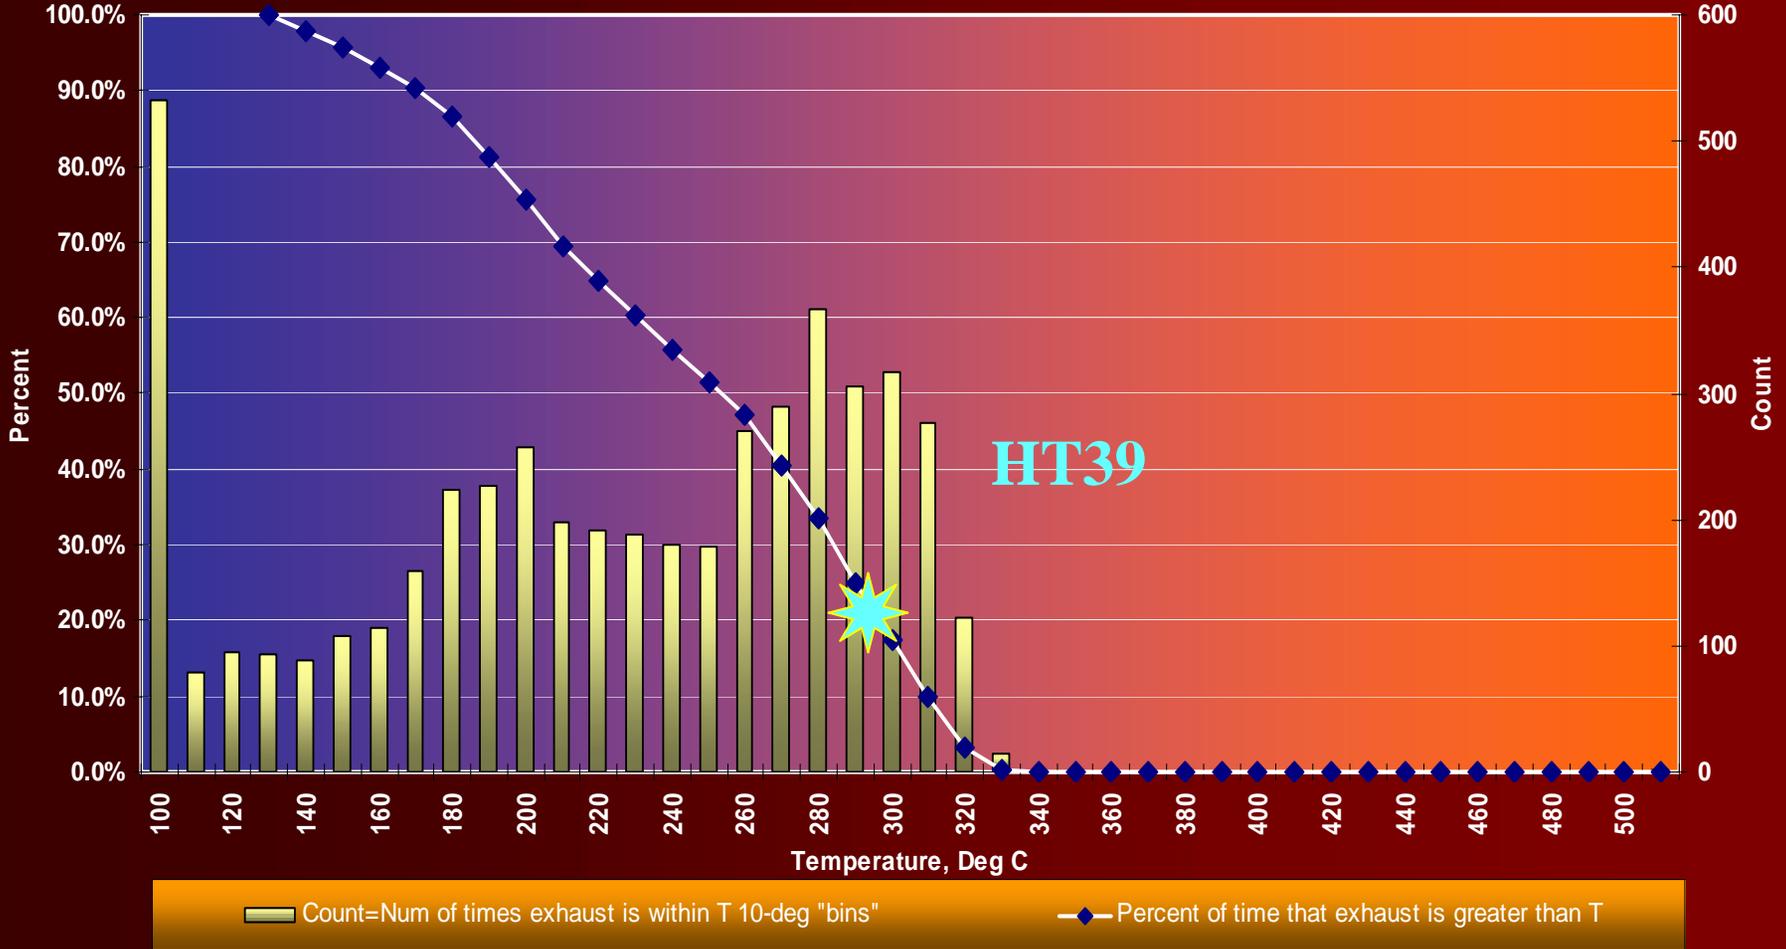
Temperature Histogram
10-degree C increments

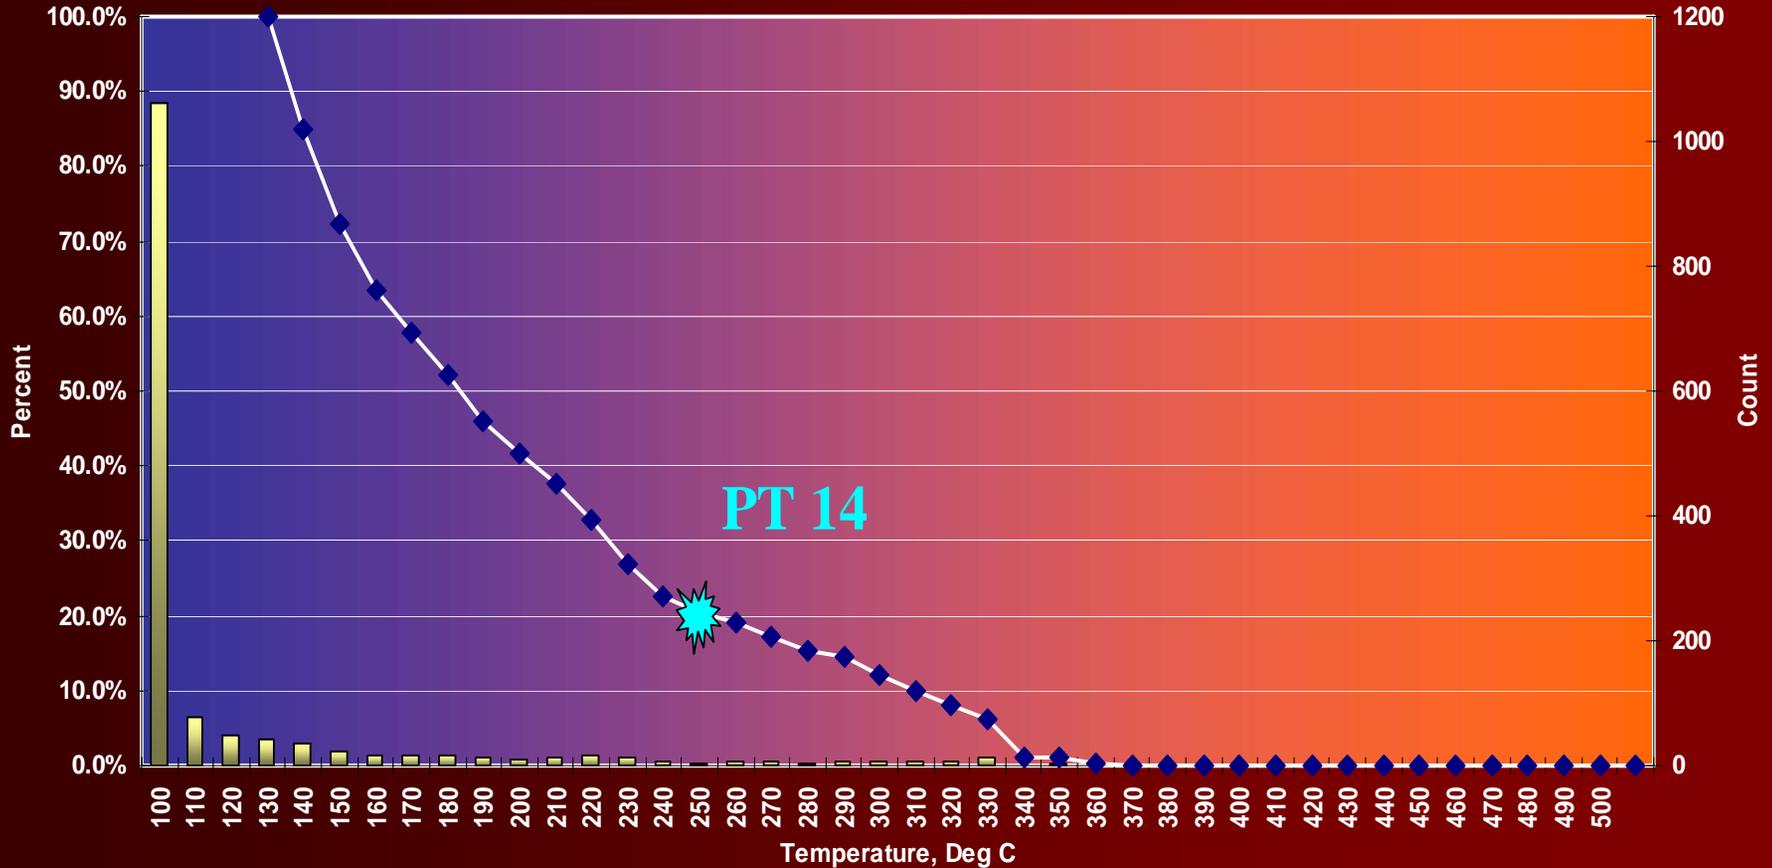
Temperature Histogram
PT14 - Mercedes 904 LA

Count=Num of times exhaust is within T 10-deg "bins" Percent of time that exhaust is greater than T
