DPM Workshop

Diesel Particulate Filter Application Case Study

Mark L. Good
Sr. Mining Engineer
Kennecott Greens Creek Mining Company

Kennecott Greens Creek Mining Company

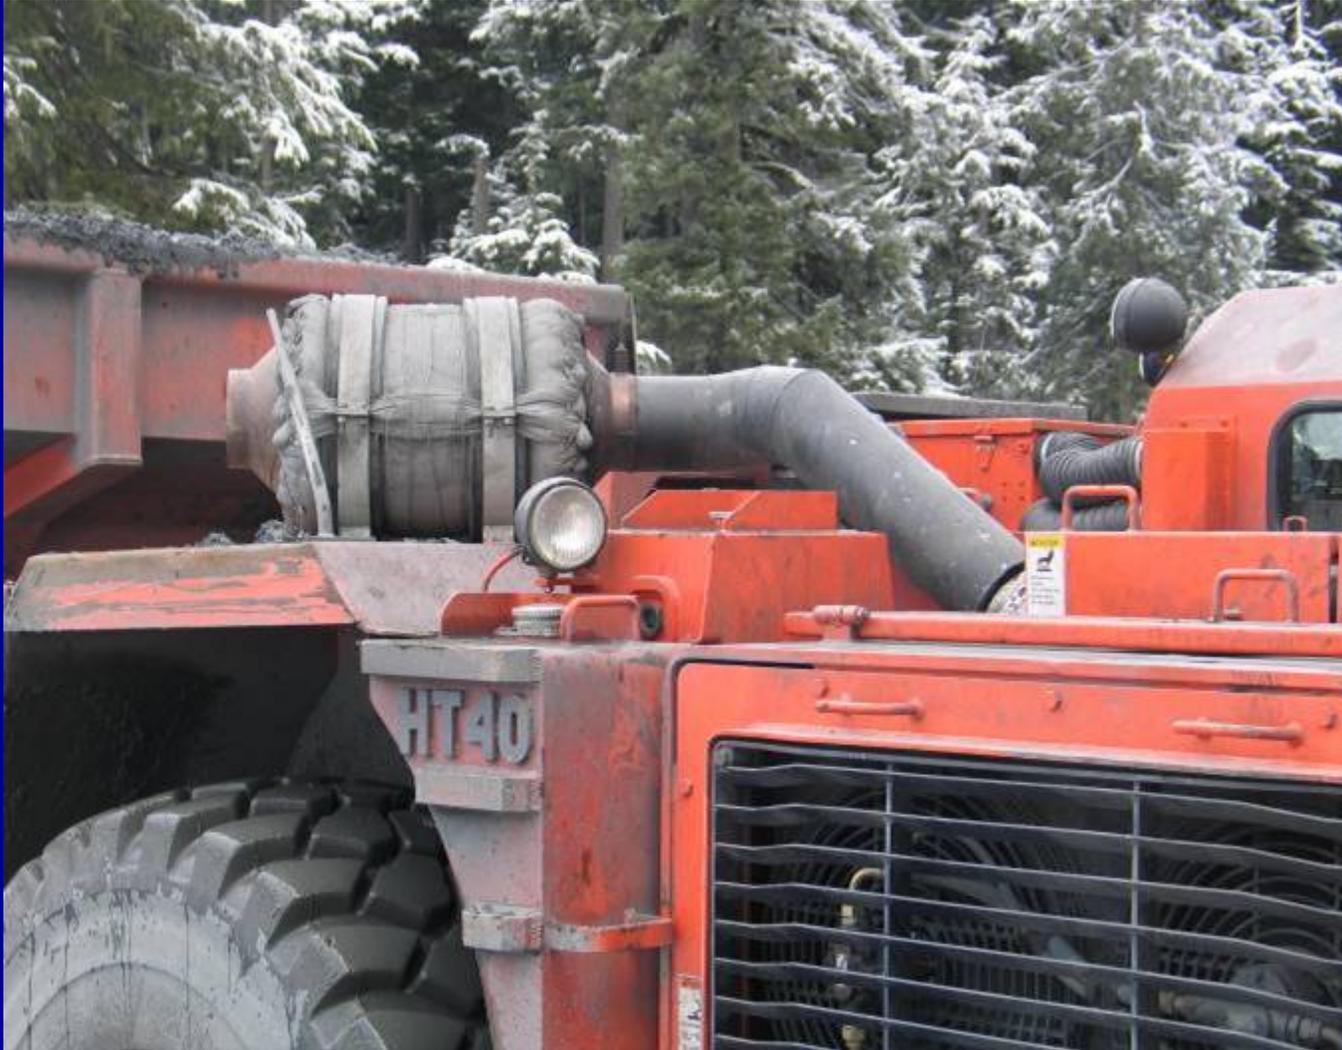
Passive Filter Installation

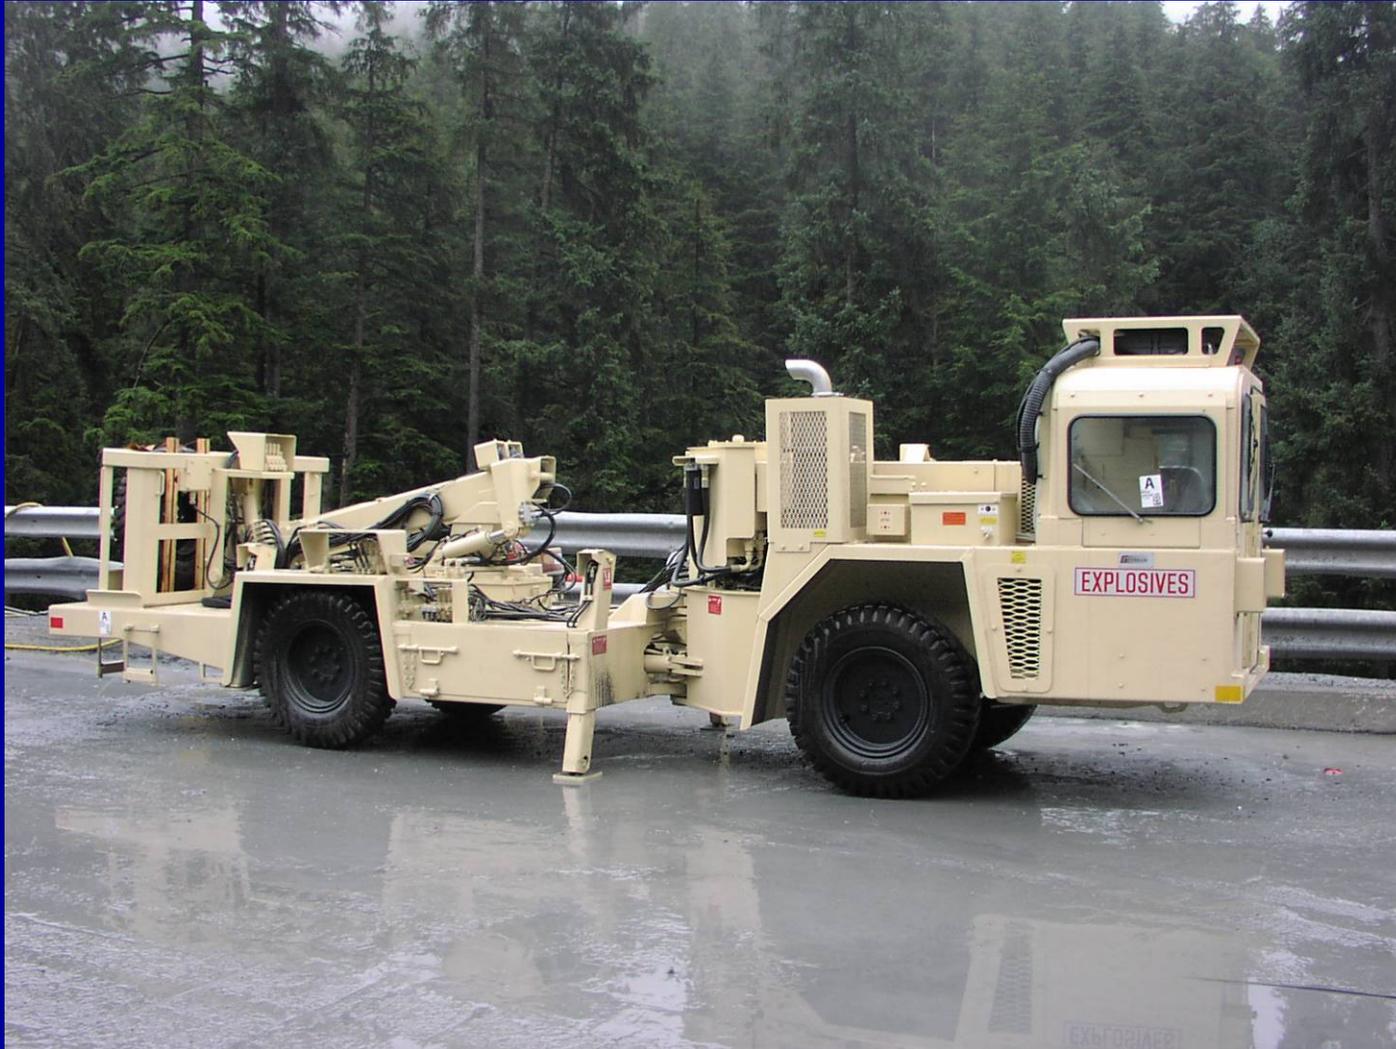
Active Filter Installation Getman A64 Powder Truck

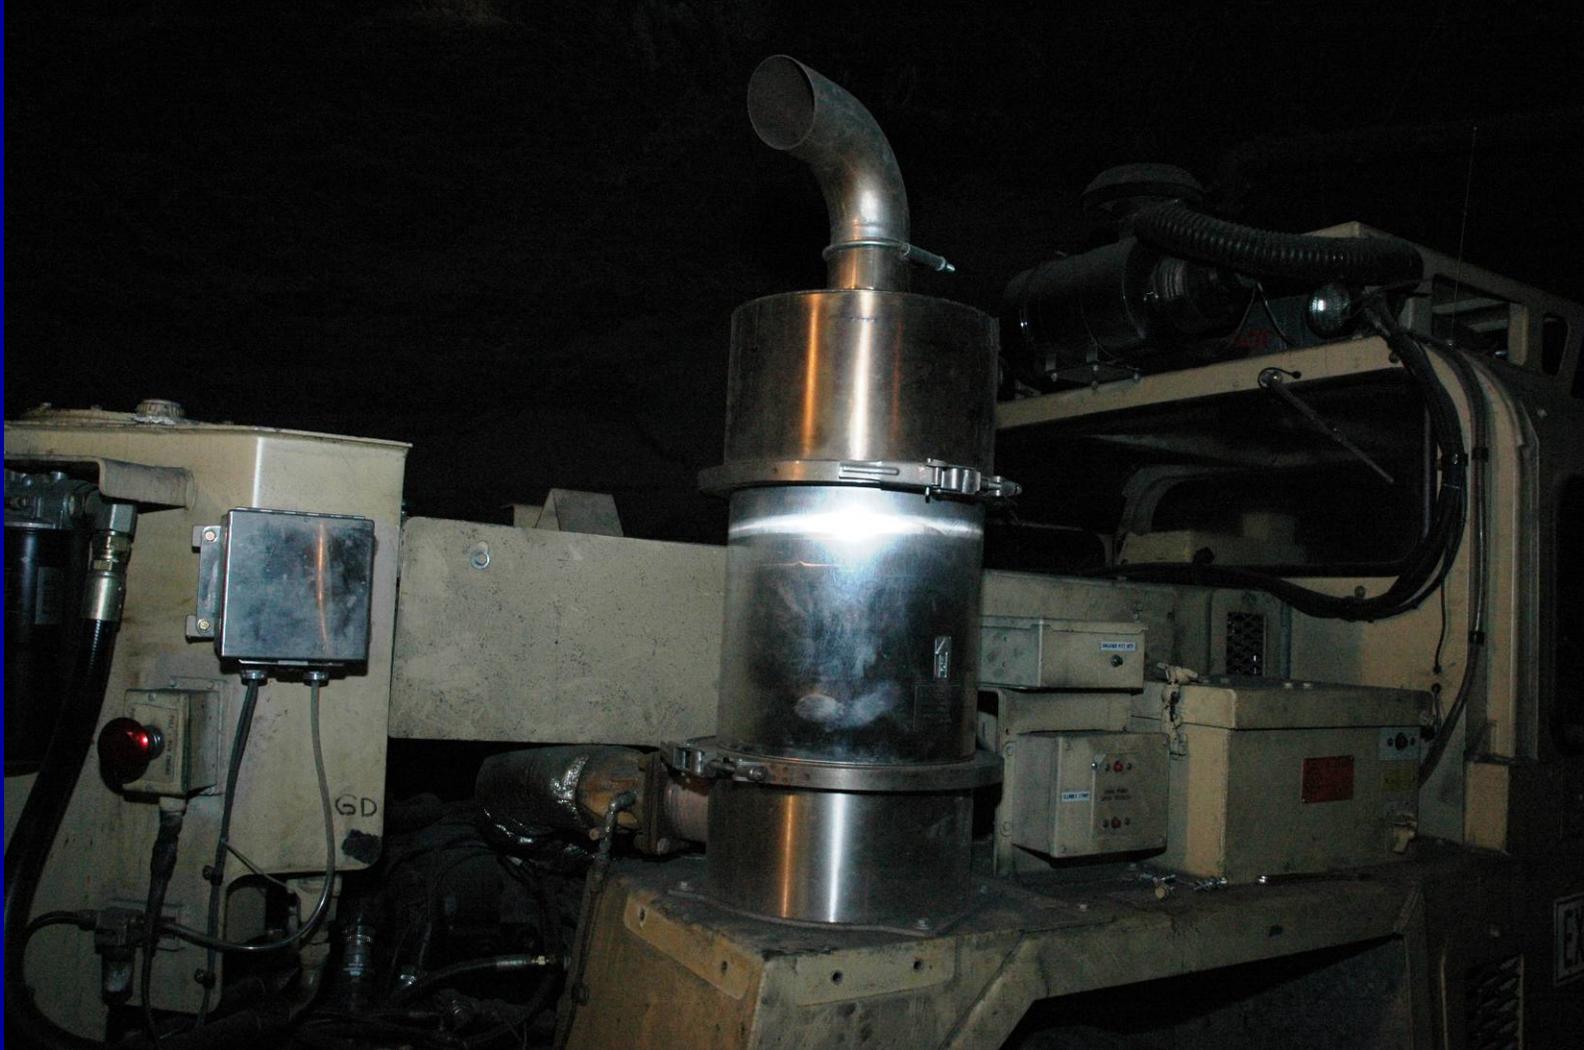
Active Filter Mounted on Getman Powder Truck

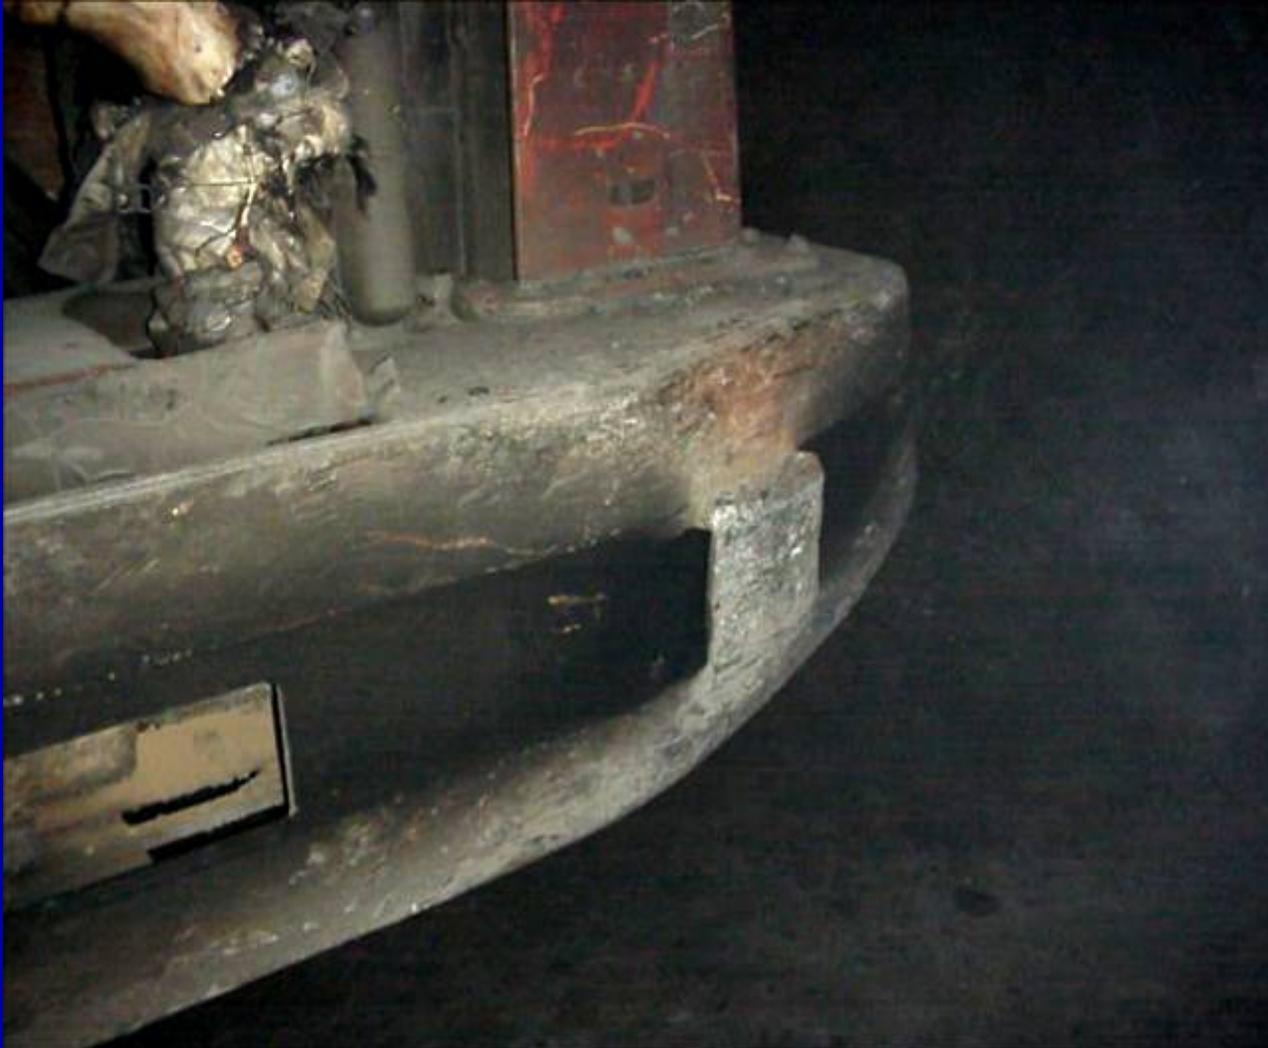
LR46 - 1 1/2 Shifts with no Filter

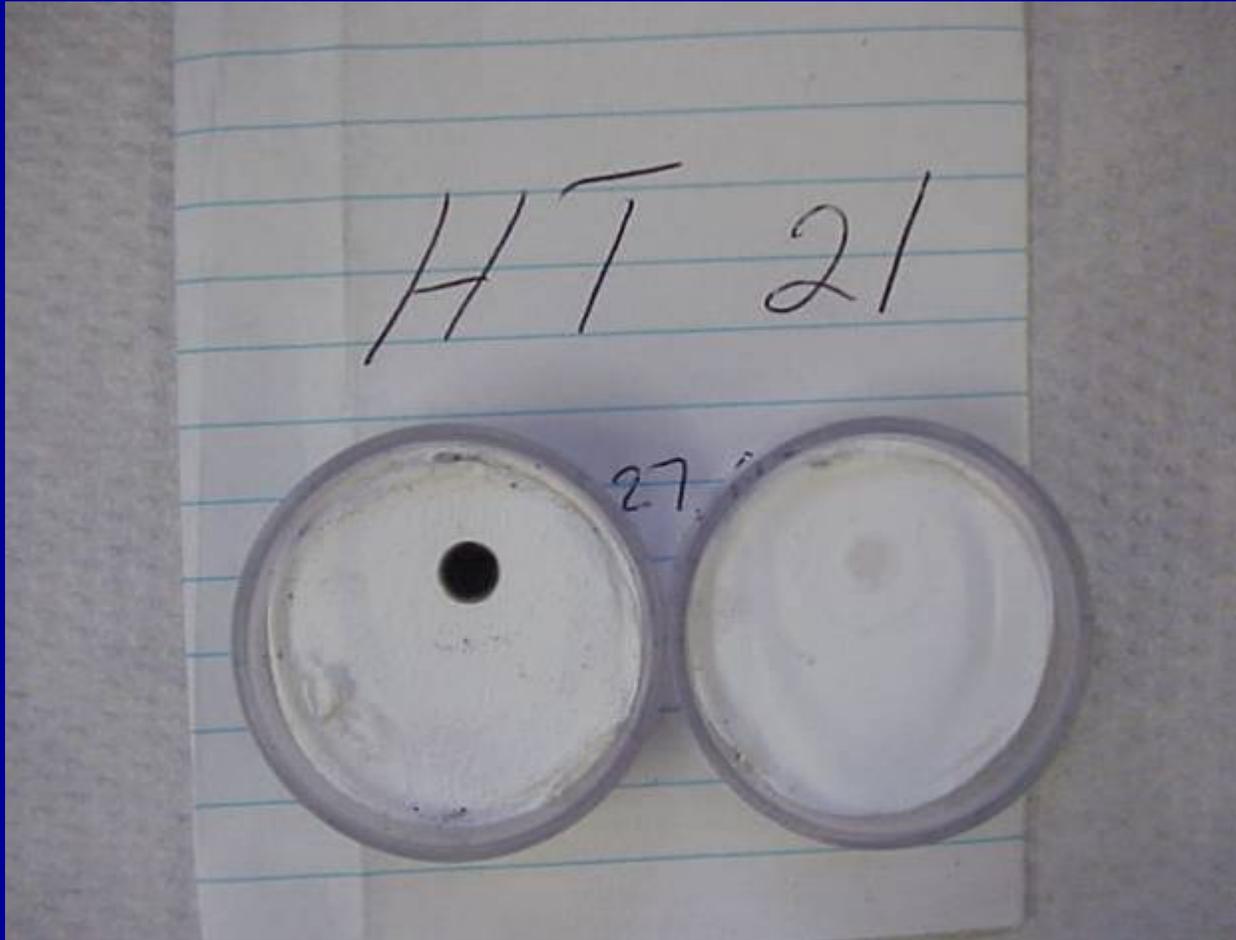
Pre & Post Filter Samples

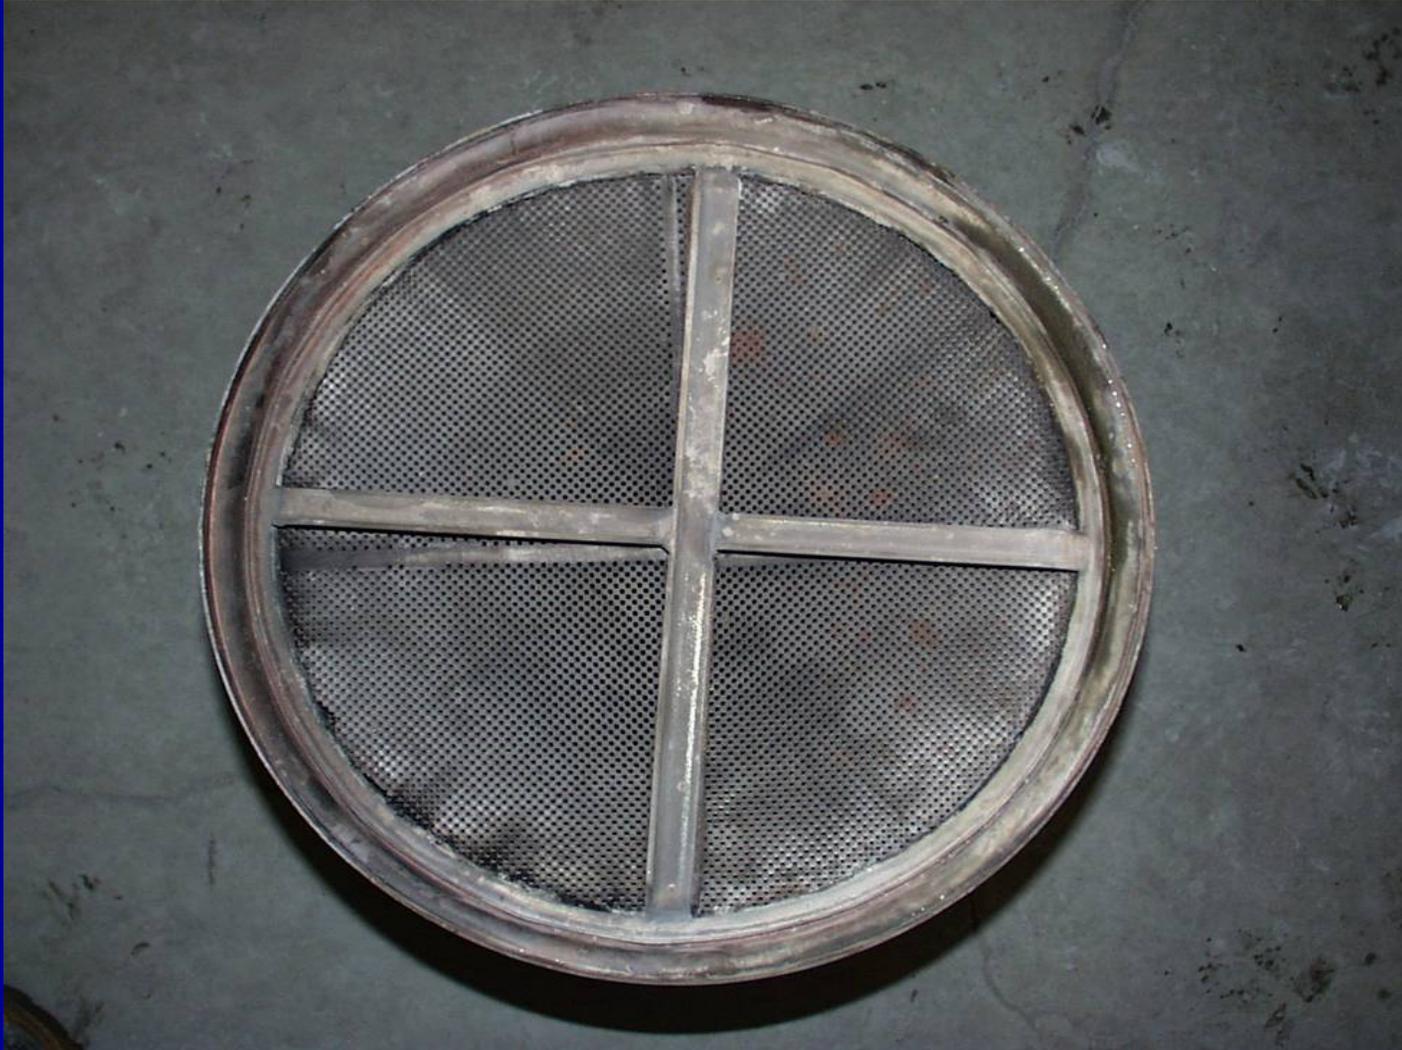
Failing Filter

Discharge Side - Soot Ghosting, Rotation

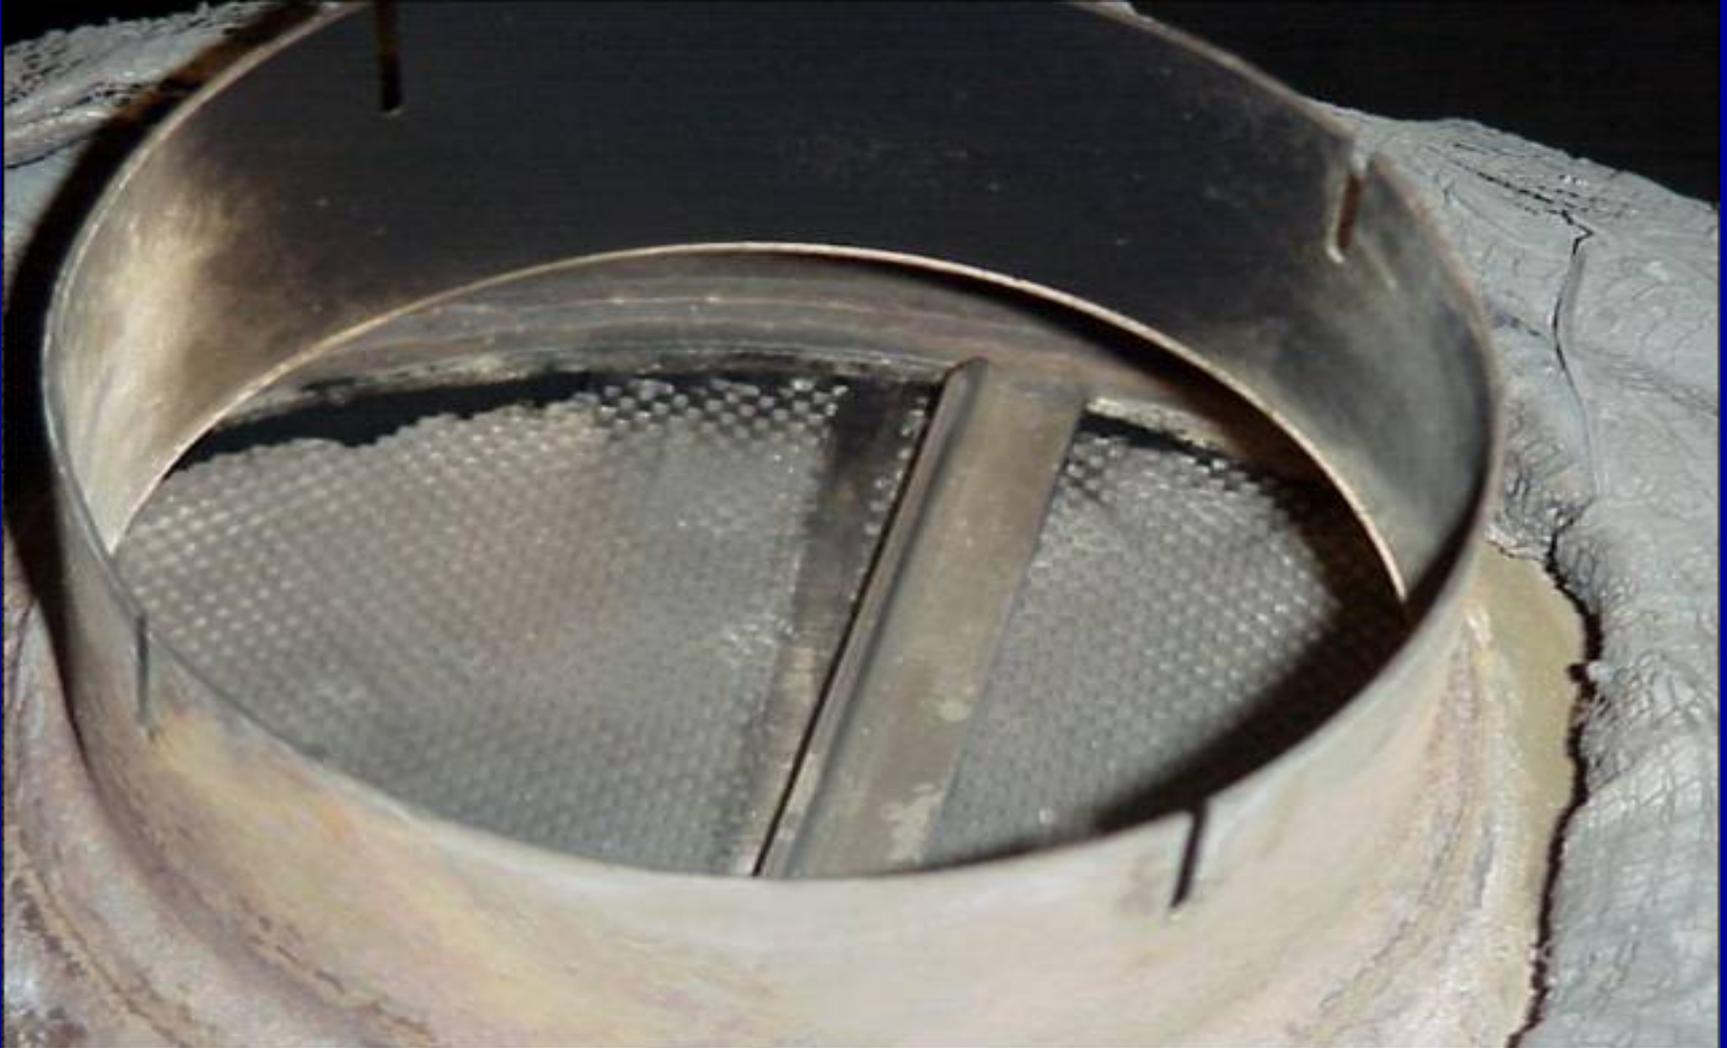
Failed Ceramic - Exhaust Bypass

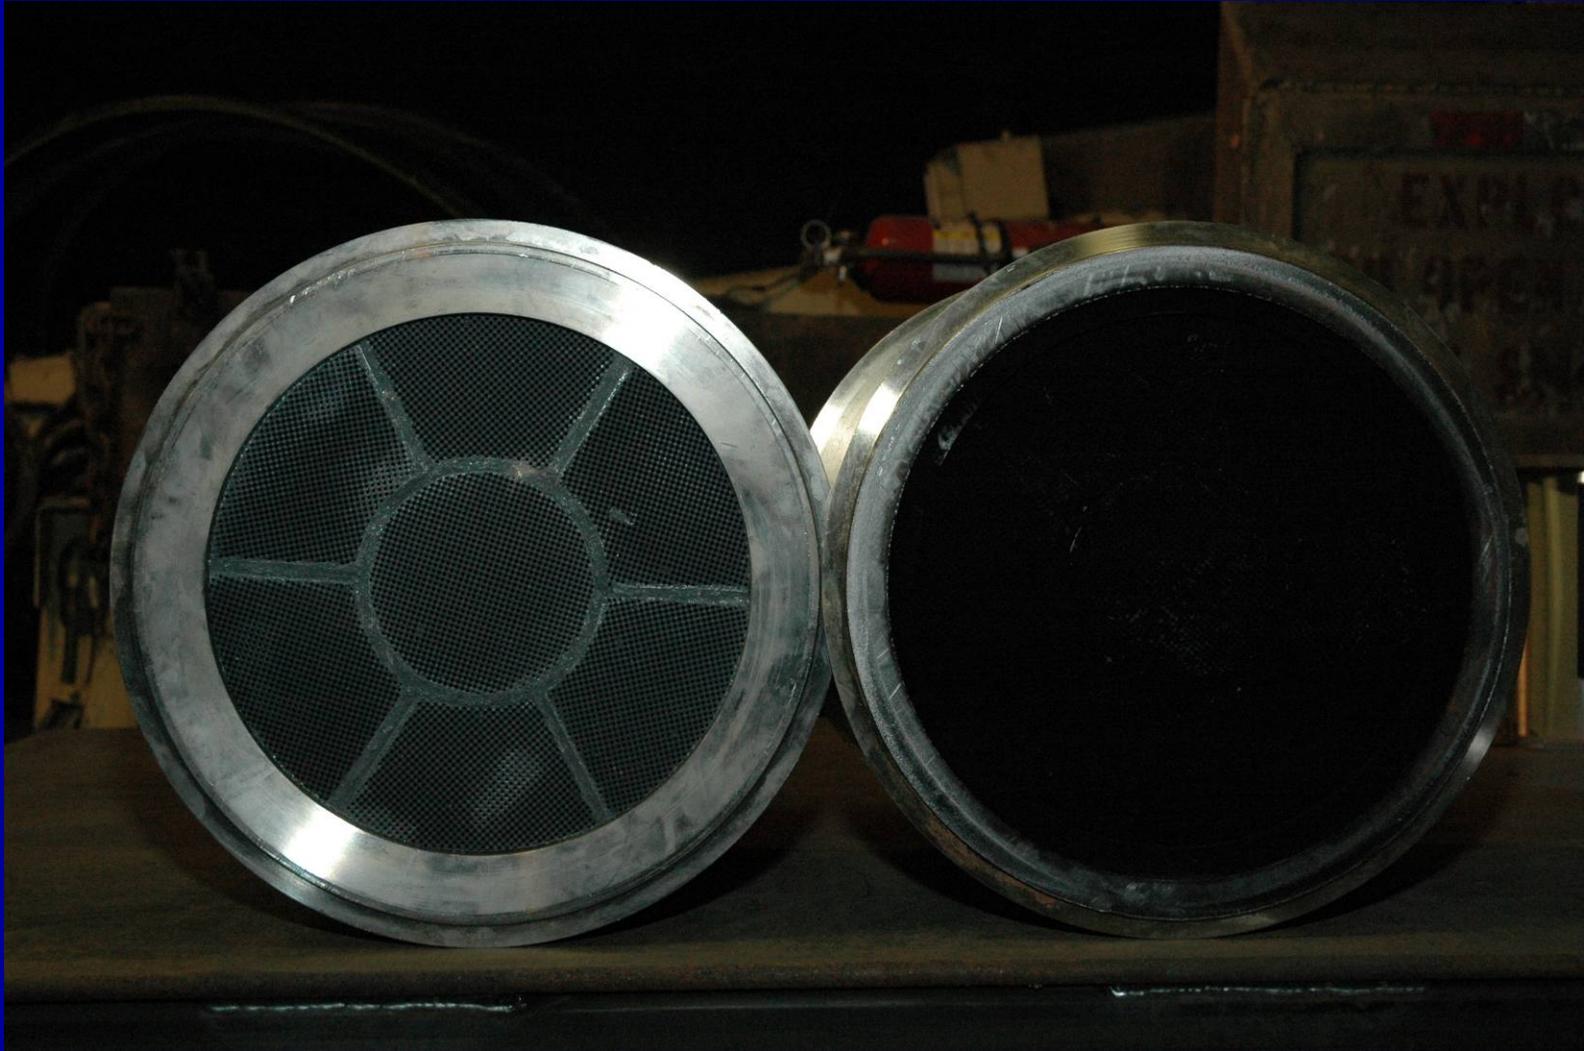
Active Regeneration Filters

Left – Clean Filter, Right - Soot Loaded Filter

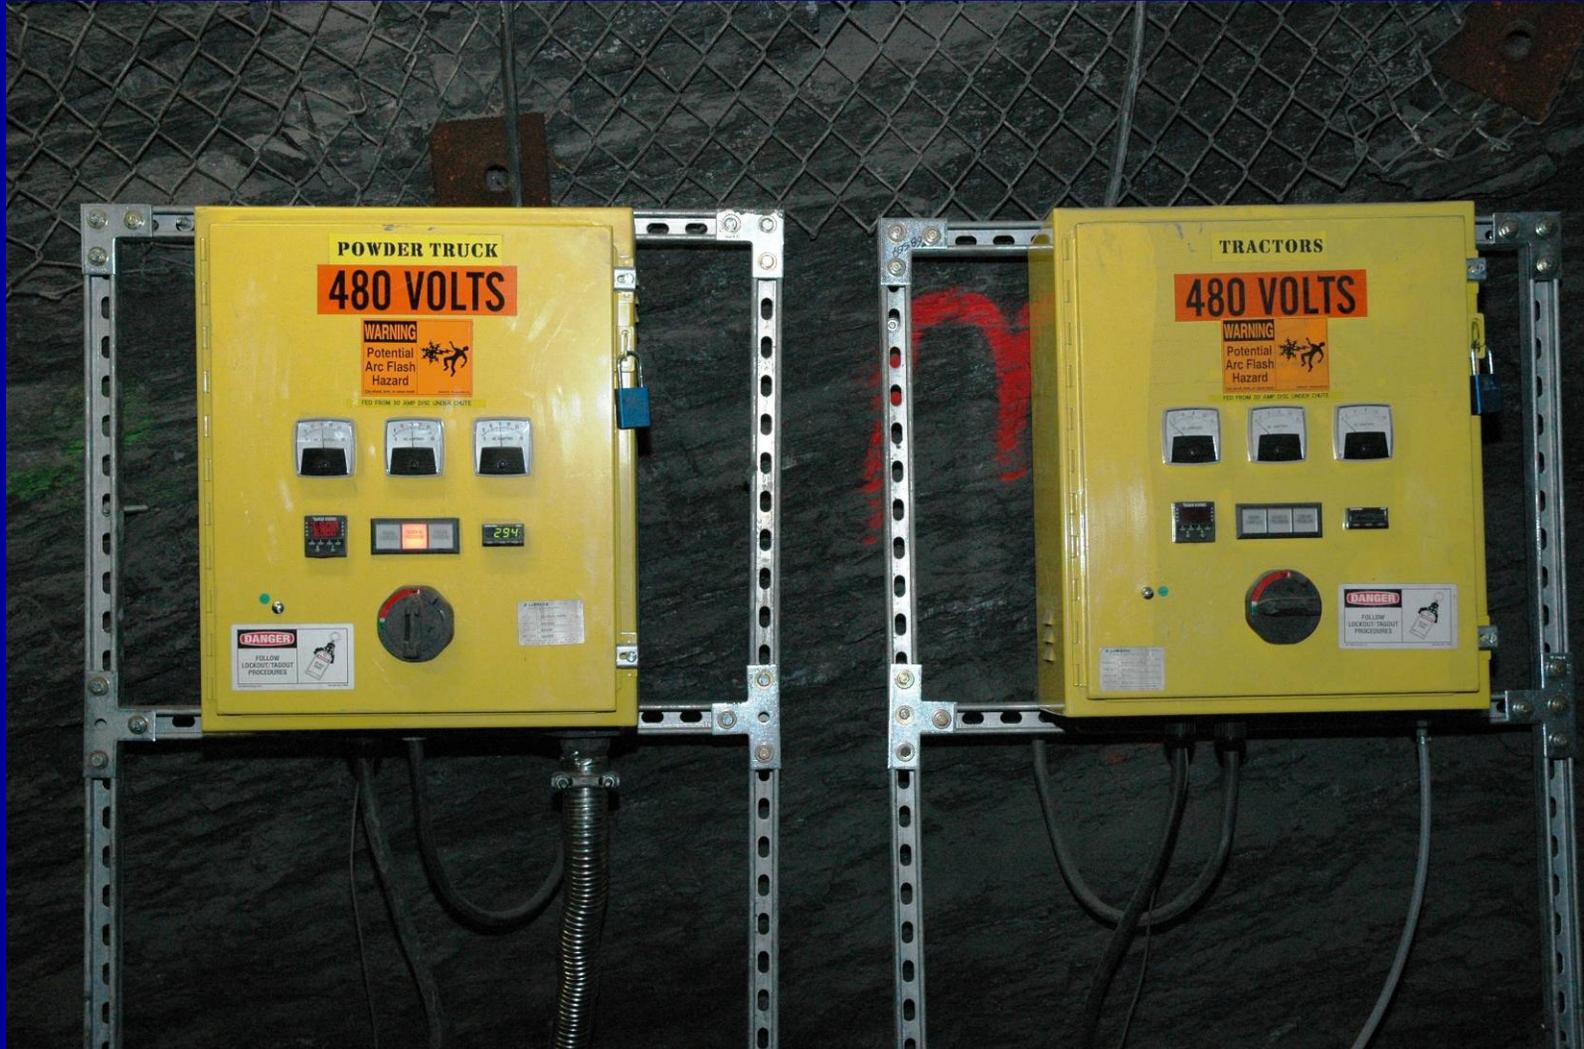
Active Regeneration Station Control Panels

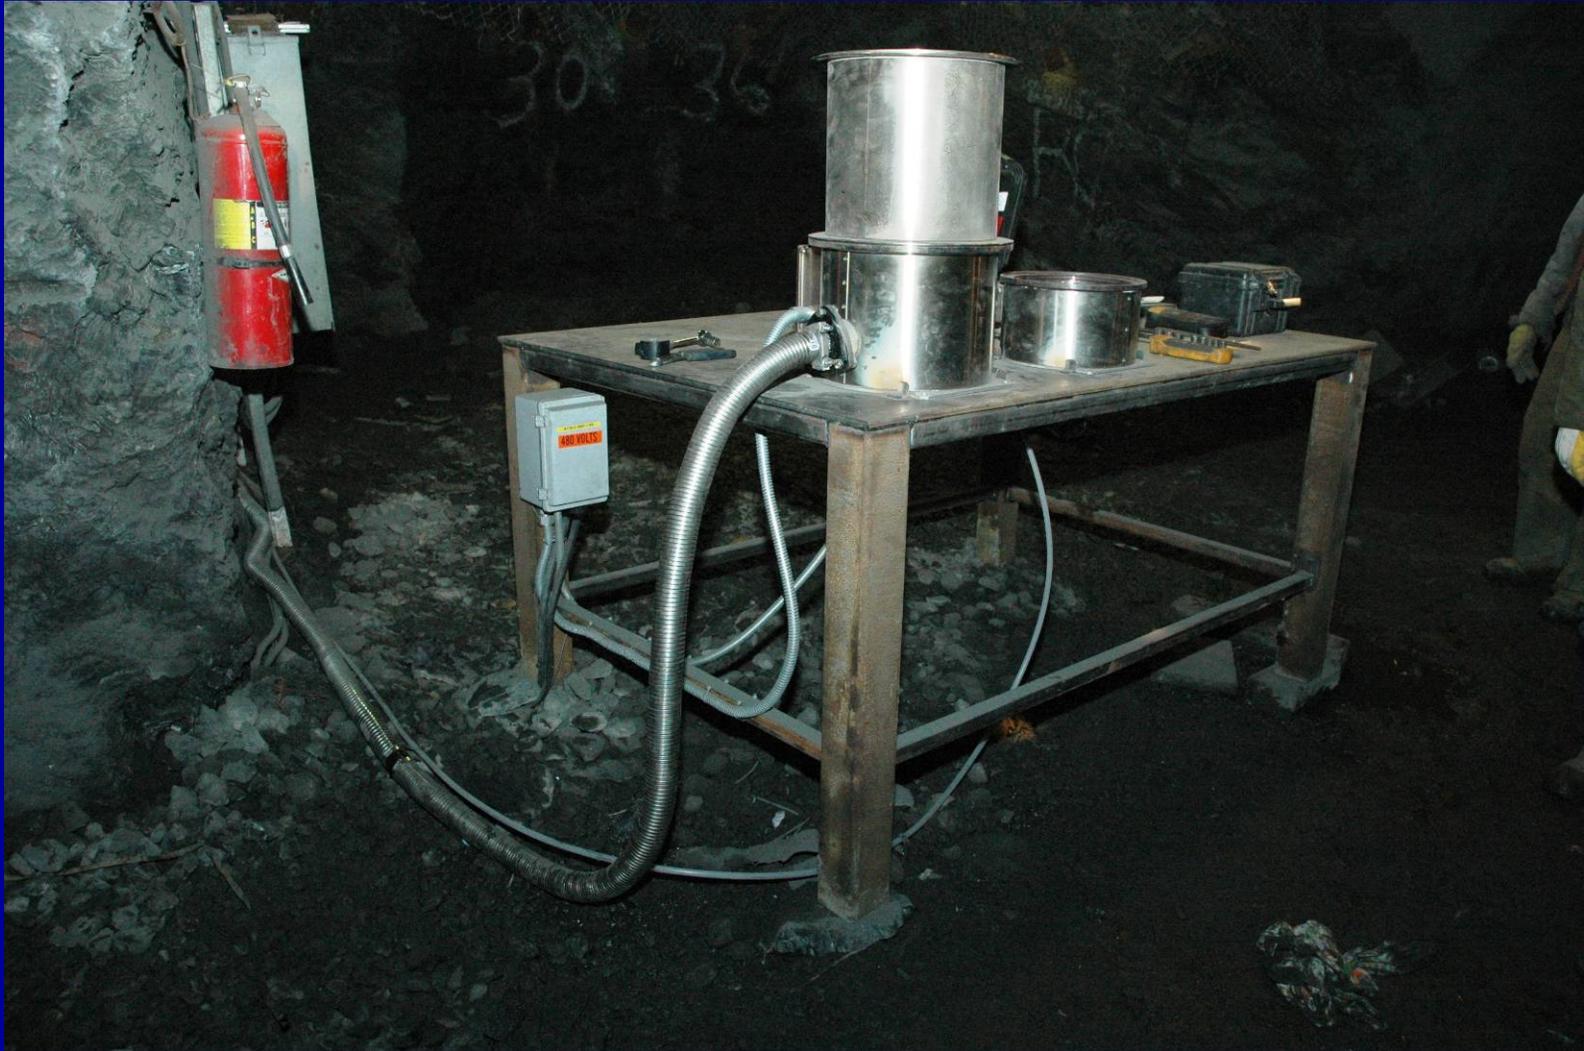
Active Regeneration Station Heater Bases

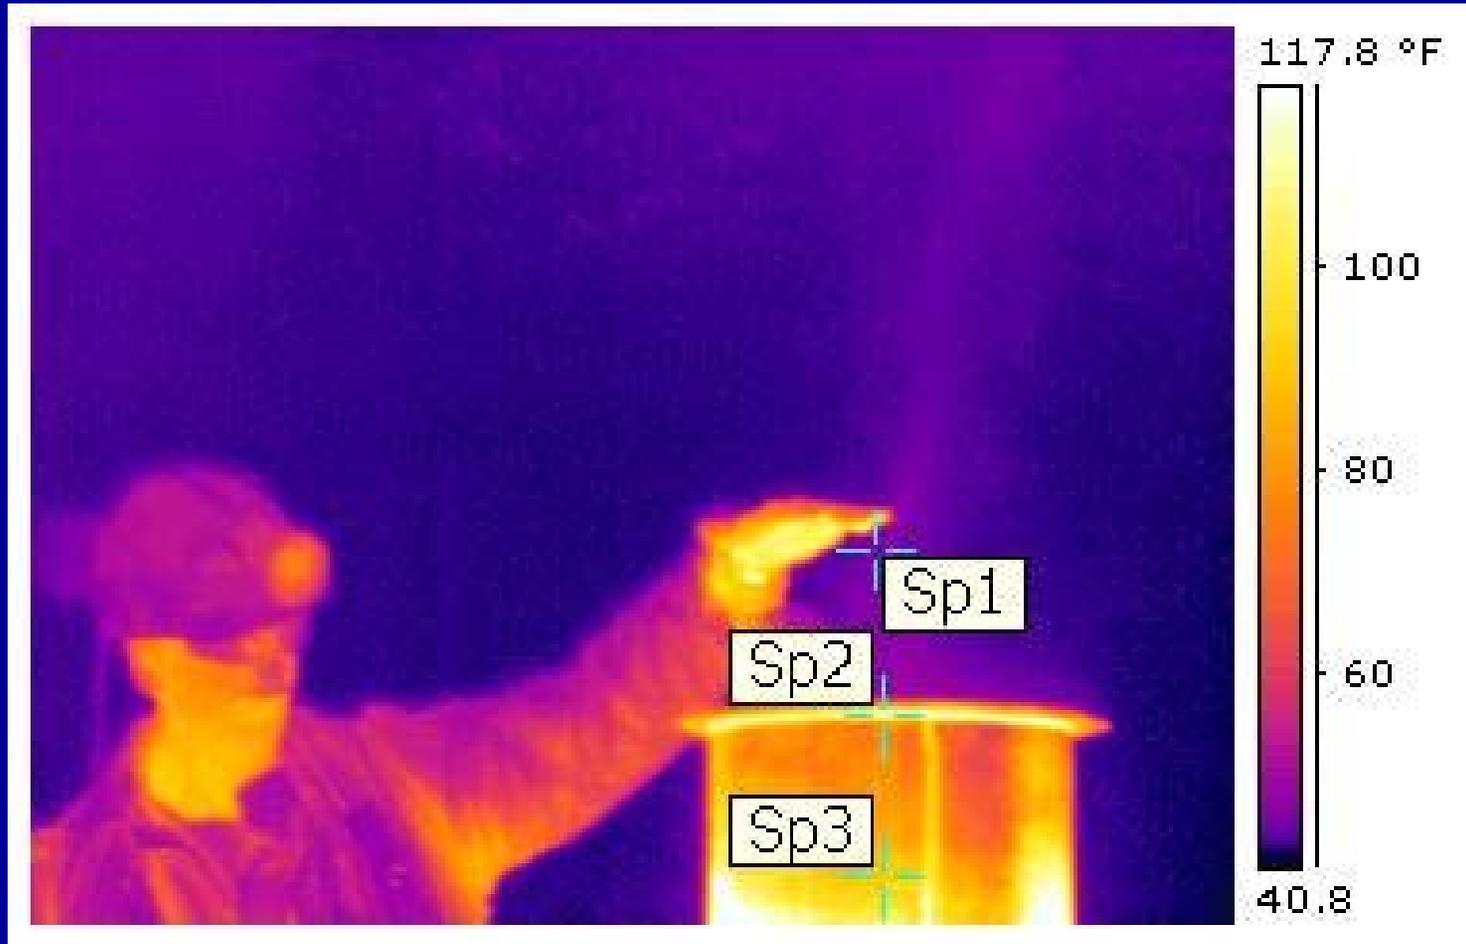
Thermograph Heat Plume of Heating Filter

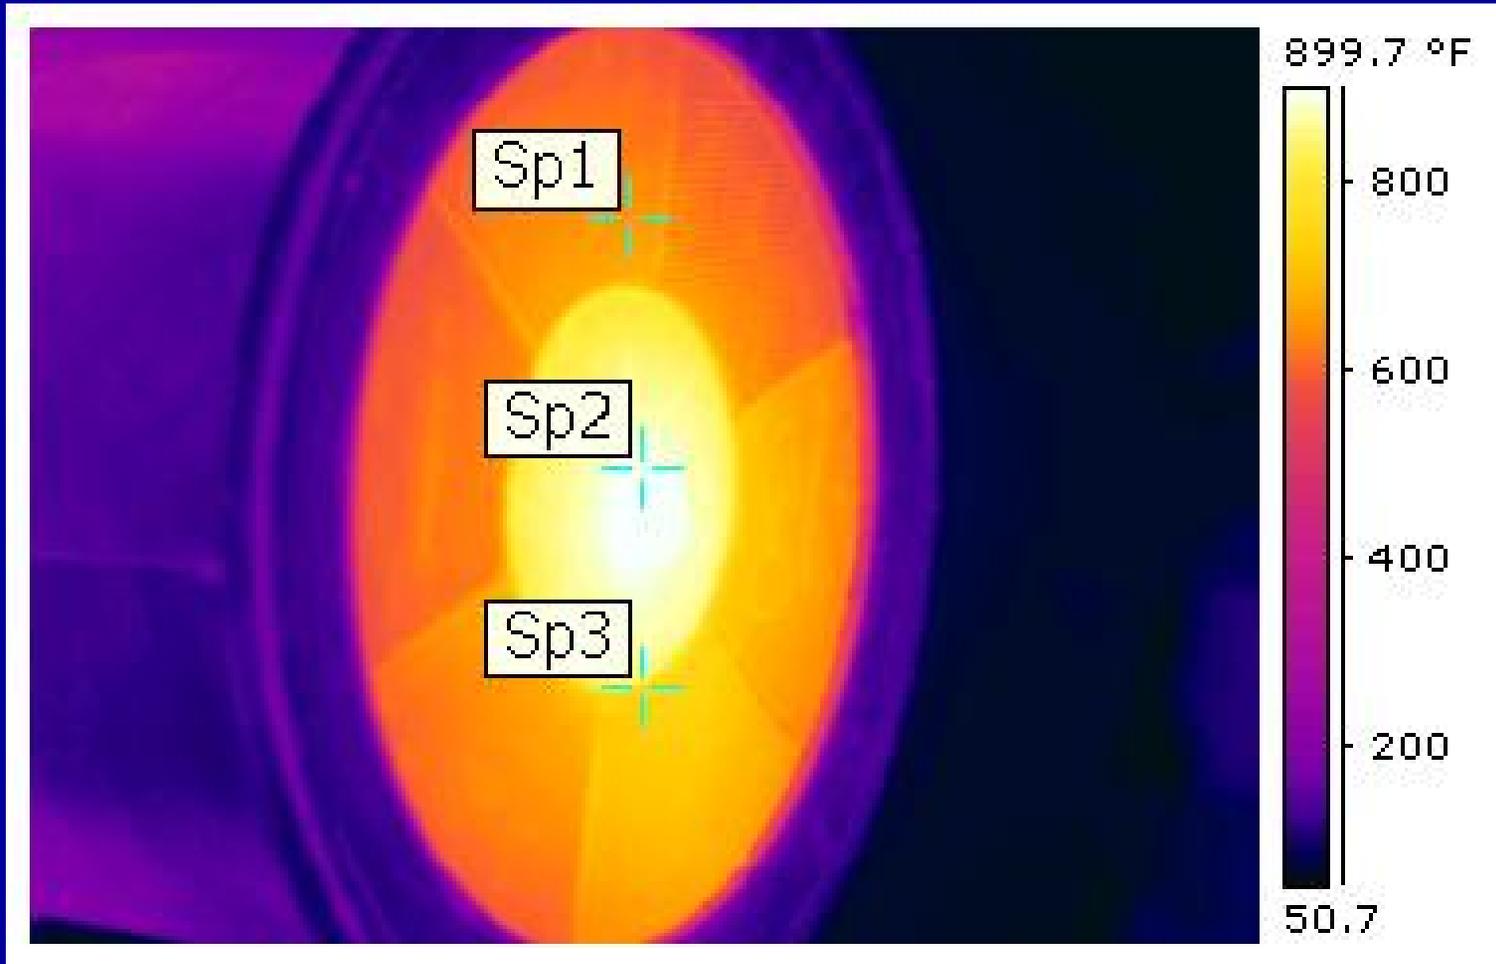
Thermograph

Discharge side of Regenerating Filter
