ASSESSMENT OF GROUND CONDITIONS NEAR A MINE PORTAL USING GROUND PENETRATING RADAR

Michael A. Trevits, Research Physical Scientist

NIOSH - Pittsburgh Research Laboratory

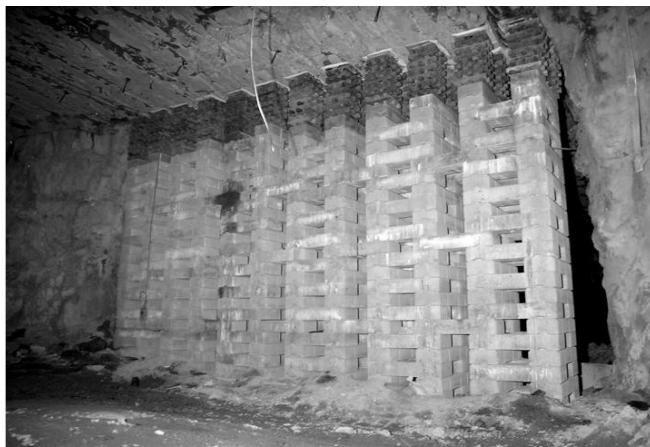
Figure 6. Crib wall to protect the secondary escapeway.

There was a concern that the roof failure could expand in two directions to include the secondary escapeway of the LLEM. It was decided to reinforce and protect the secondary escapeway and to install instrumentation to monitor the changing conditions in the

mine roof (figure 6). This work is described in detail by Dolinar (4). There was additional concern that the overburden instability could also expand and affect the structural integrity of the highwall and the No. 4 Portal. To monitor conditions along the highwall areas, several survey monuments were installed along the edge of the highwall and surveys of the position of the monuments are collected monthly. In addition, four biaxial tiltmeters were also installed along select areas of the surface deformation (figure 7). These instruments are connected to a datalogger that collects ground movement on an hourly basis. Over time, the mine roof conditions near the No. 4 Portal had deteriorated significantly and it was too dangerous to conduct a detailed underground survey of the mine in this area. It was therefore decided to investigate the overburden conditions near the No. 4 Portal remotely using GPR.

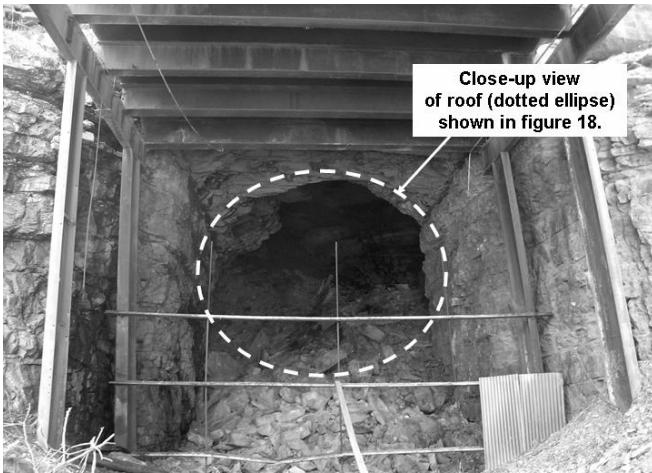
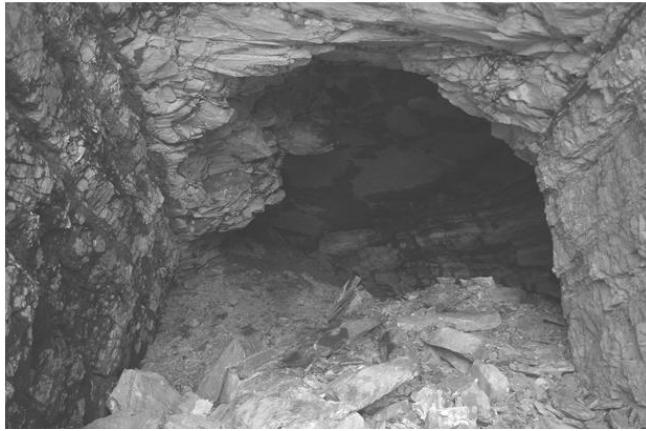
A follow-up ground truth survey of the mine roof conditions was conducted remotely from a safe area at the mouth of the portal. The observations made from the radar records appear to be correct as a large roof fall was observed near the mouth of the portal (figure 17). A close-up view of the roof conditions near the mouth of Portal No. 4 is shown in figure 18. In this figure, the roof fall appears to extend to right and towards the A to C survey reference points (note in the radar records the disturbed zones also generally extended through these survey points). Laser distance measurements of the height of the mine roof, made from the mouth of the portal show the collapsed area was within about 15 ft of the ground surface. These measurements are also in general agreement with the observations made from the 100- and 200-MHz radar records.
