CHARACTERIZATION OF JOLTING AND JARRING ON OPERATORS OF SURFACE MINE HAULAGE TRUCKS

by Fred Biggs, Richard Miller, and Walter Utt

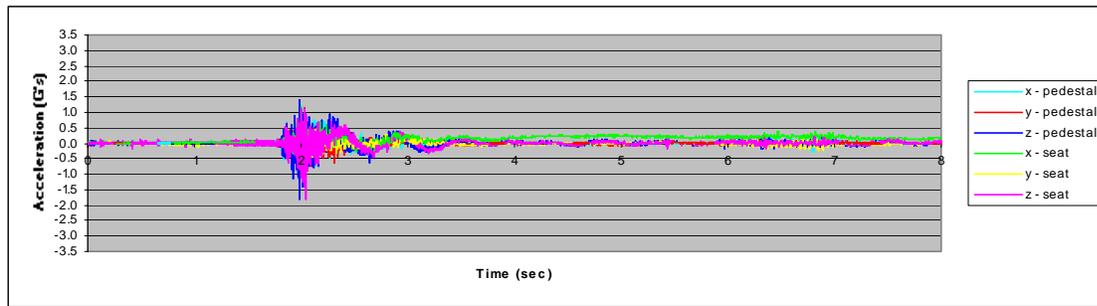
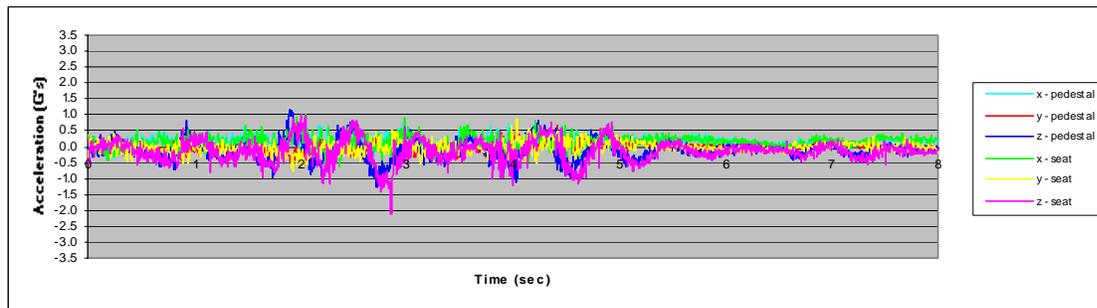
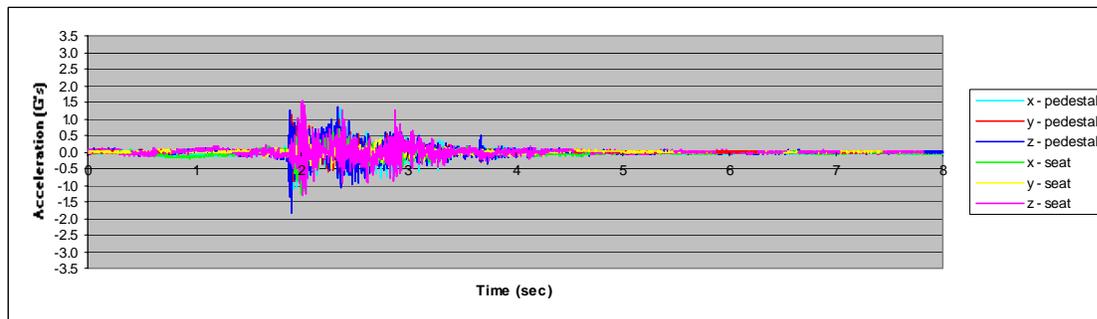
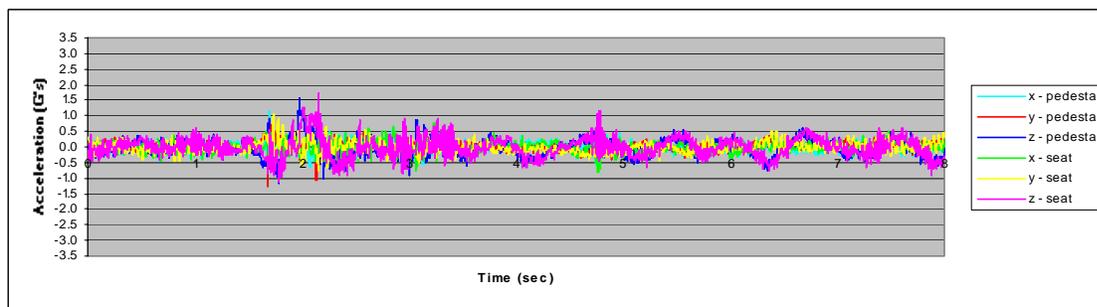
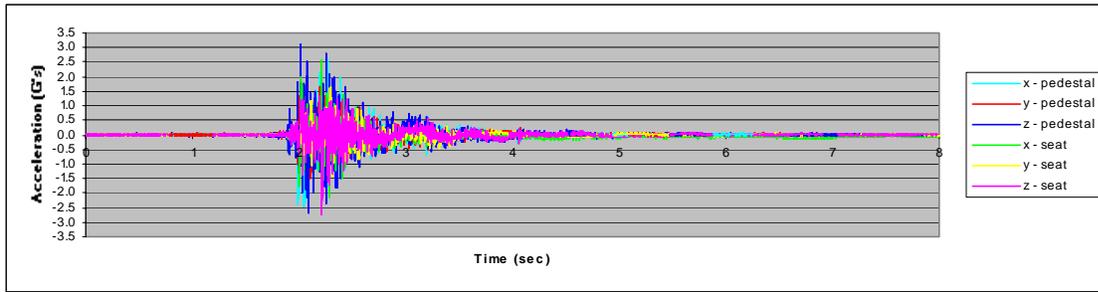
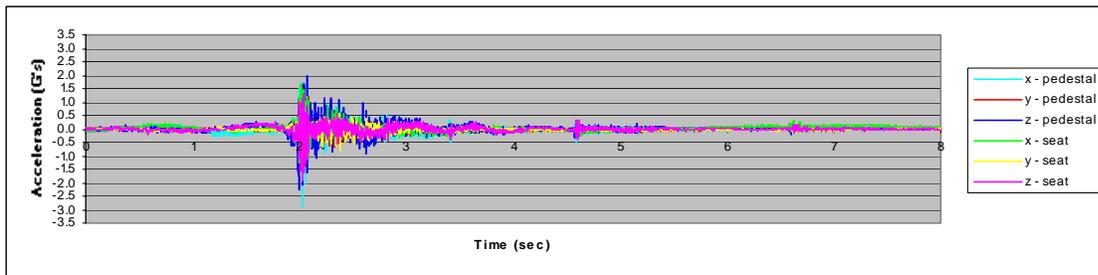
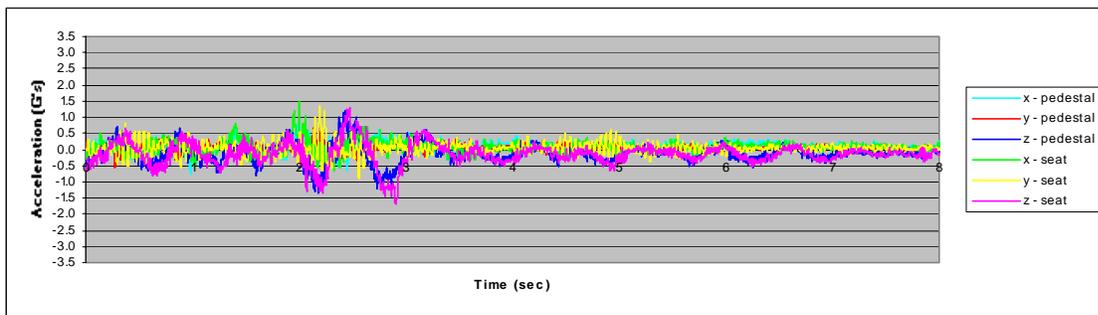
Figure 1.—Truck A shock events. A, Loading event, A1; B, rough ground event, A2; C, loading event, A3; D, rough ground event, A4; E, loading event, A5; F, loading event, A6; G, rough ground event, A7.

Figure 1.—Truck A shock events (continued). A, Loading event, A1; B, rough ground event, A2; C, loading event, A3; D, rough ground event, A4; E, loading event, A5; F, loading event, A6; G, rough ground event, A7.

The acceleration shocks for truck A are shown in figure 1 and for truck B in figure 2. Comparing the shocks on truck A with the shocks shown in figure 3 and operators' written logs, the authors determined that shock events A1, A3, A5, and A6 were caused by loading. The other three shock events on truck A (A2, A4, and A7) and all shock events on truck B were caused by rough ground, as determined by comparing figure 4 and operators' written logs. The average peak frequency of the shocks on the seat cushion in truck A was 35 Hz, and the average frequency of the "rough ground" shocks was 1.4 Hz. Interestingly, the average peak frequency of all truck B shocks was also 1.4 Hz.

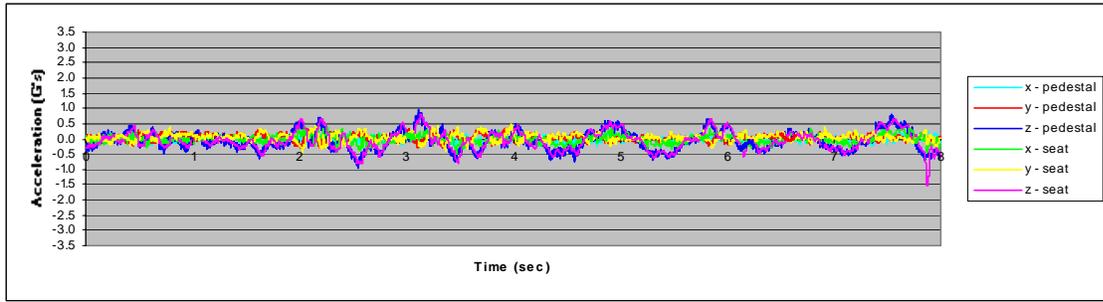
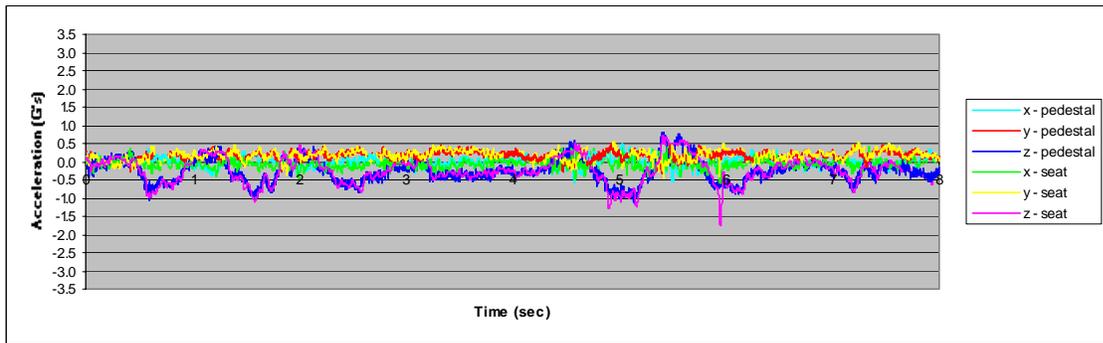
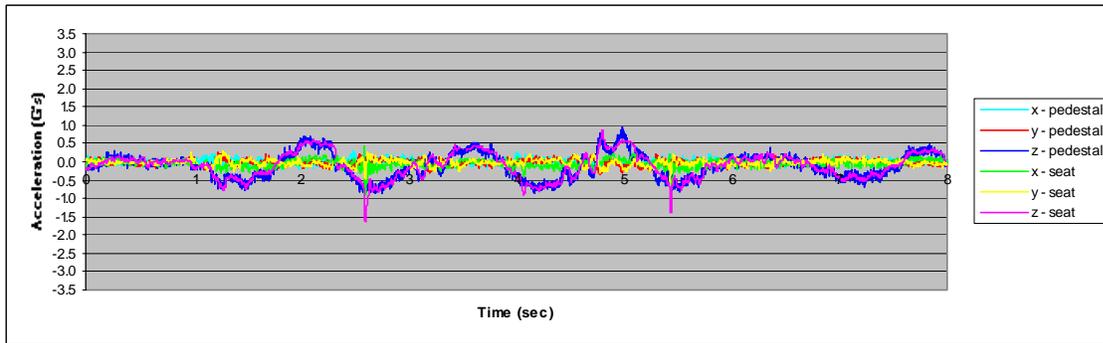
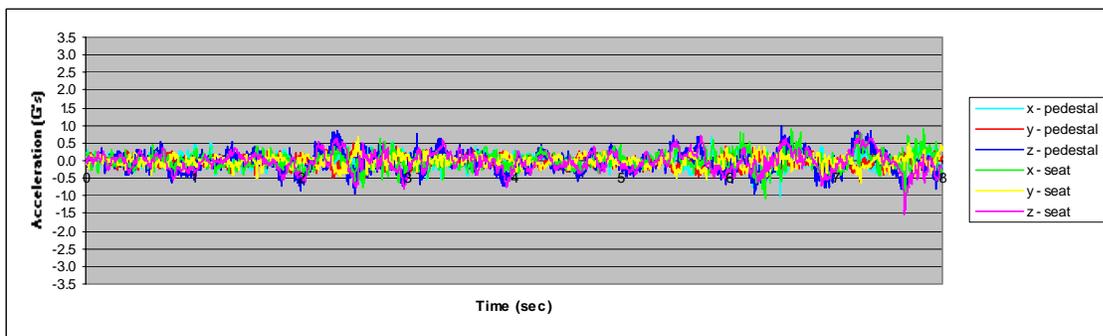
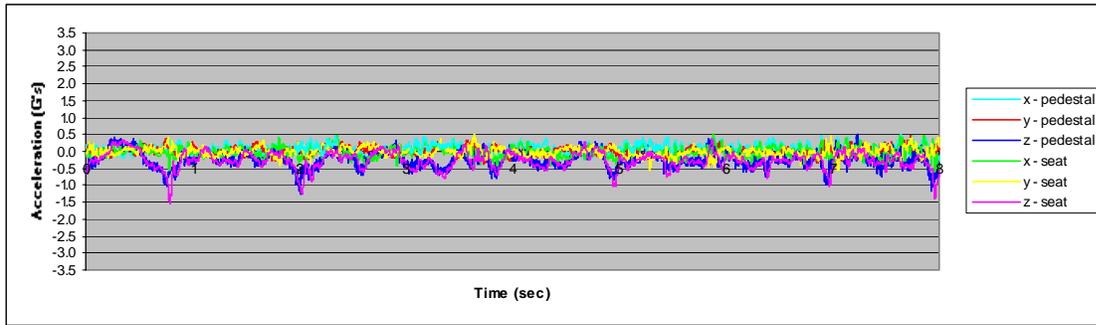
Figure 2.—Truck B shock events. A, Event 1; B, event 2; C, event 3; D, event 4; E, event 5.

Figure 2.—Truck B shock events (continued). A, Event 1; B, event 2; C, event 3; D, event 4; E, event 5.

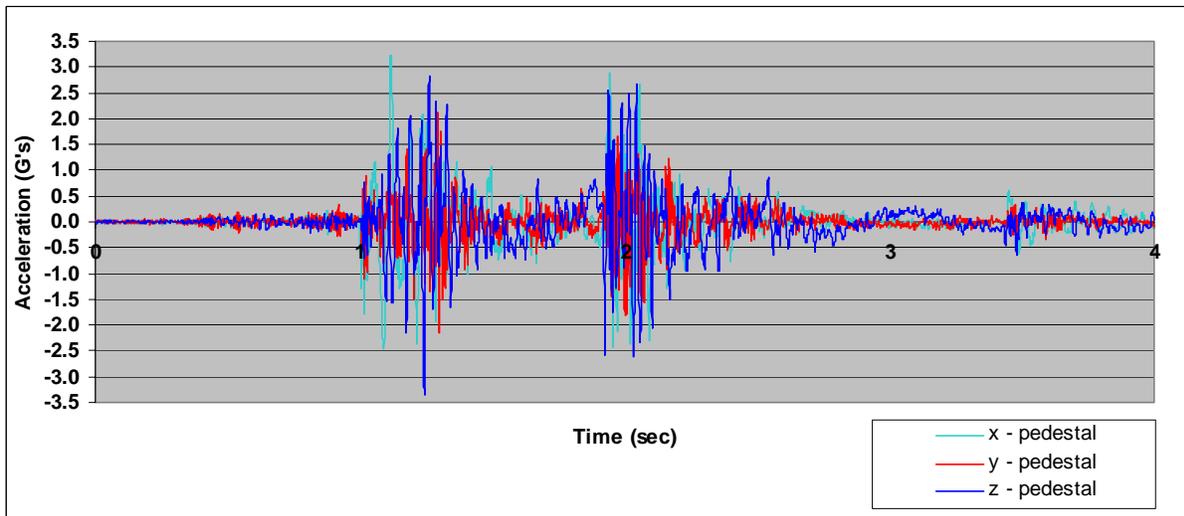
Figure 3.—Acceleration measured after dropping 1-1/2-ton rock from a height of 10 ft onto the bed of a haulage truck.

In the first test, a large rock was dropped into the bed of a Caterpillar truck from over 10 ft above the bed surface. The drop produced a distinctive curve (figure 3) in which a significant jolt was registered in the z-direction when the rock struck the truck bed. In the second test, the truck was hit from the side by a loading shovel (figure 4). To measure the magnitude of individual jolts under controlled circumstances, a third experiment was designed that involved a course (dirt road) with a series of bumps positioned randomly along the course. A truck was driven along the course at 5 mph. Figure 7 shows an empty truck going over a bump, while figure 8 shows the same truck going over a bump loaded.

The curve shown in figure 3 was subsequently recognized in the event curves generated at the mine, but the signature of the side hit by the shovel (figure 4) was not. The authors suggest that when these side hits do occur, they put the spine in a vulnerable alignment for any following shock.

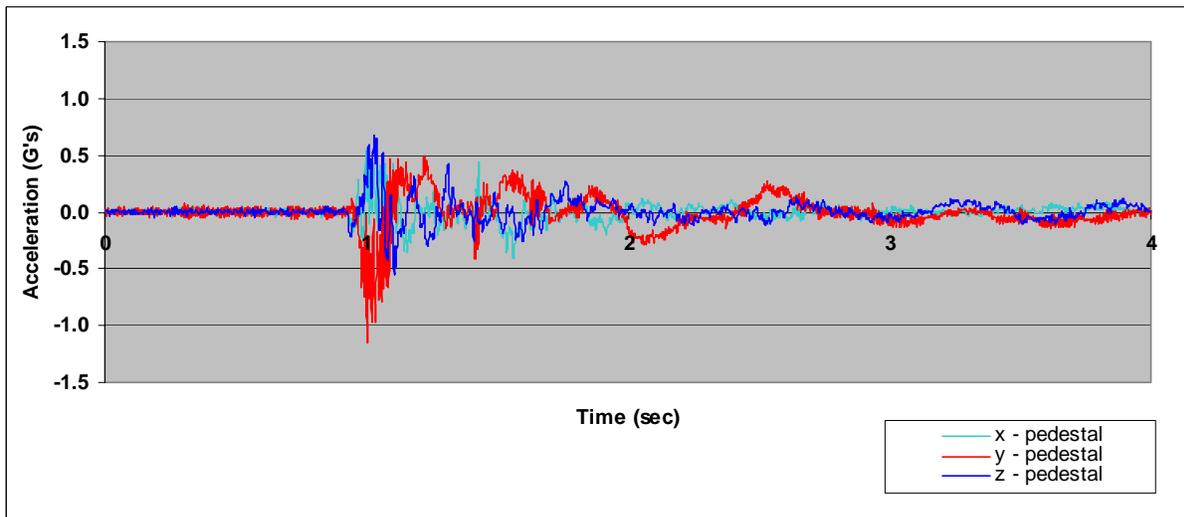
Figure 4.—Acceleration when truck hit in the side by a shovel.

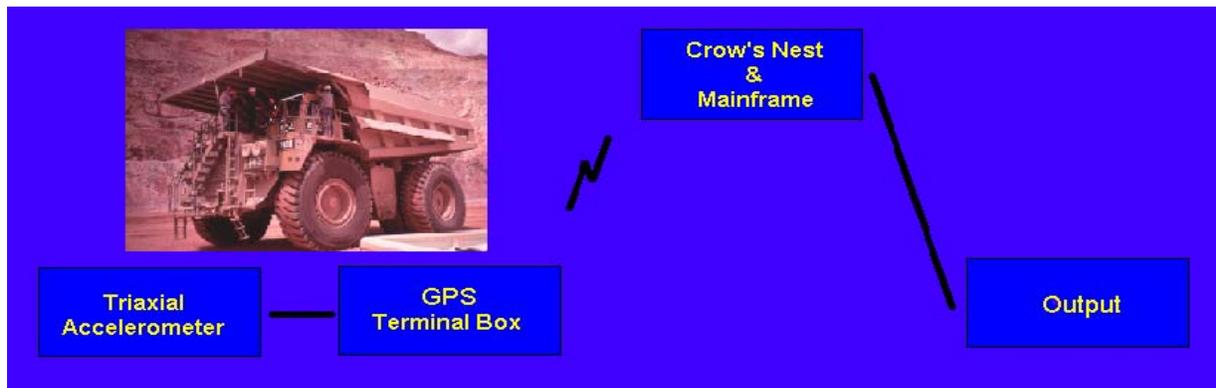
Figure 5.—GPS-acceleration data system

The output of the initial SRL experiment was an ASCII computer file containing the location of every jarring event over 2 g's (the minimum threshold the instrument could measure) over the time of the test. Although the truck traveled large sections of the mine without an event over the 2-g threshold, a group of events was recorded for an inclined section of the haulage road. Because the internal frequency filter of the GPS was set at 1000 Hz and the filter of the Dallas Instrument Saver was set at 200 Hz, many more events were recorded per hour using the GPS than were recorded using the Saver.

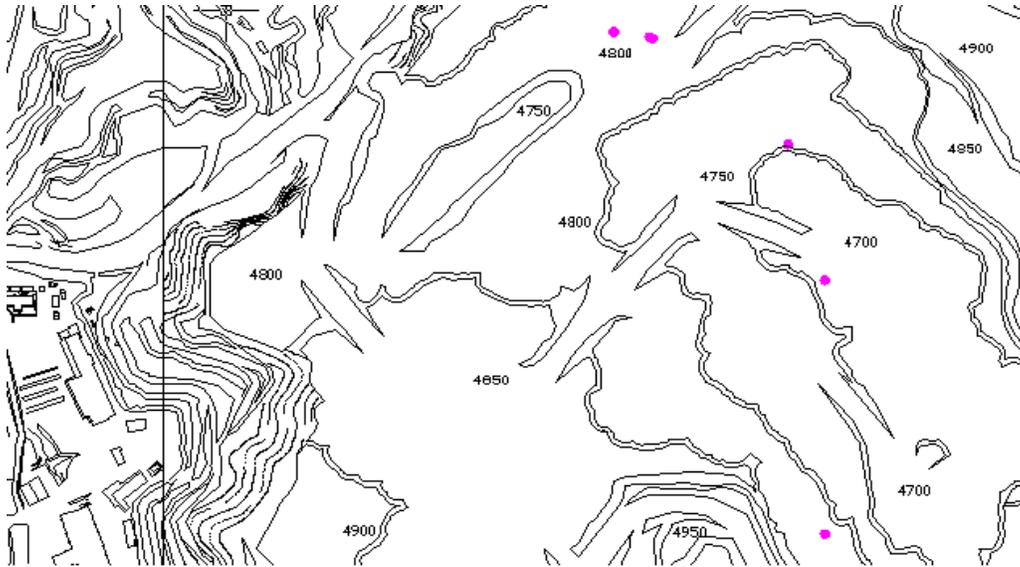
Figure 6.—Shock events A1-A6 plotted on mine map

Using the mine's GPS data, shock events A1 through A6 were plotted onto a mine map

(figure 6). These shocks occurred around an area of the mine where the trucks were being loaded. However, shocks A2, A4, A7, and B1 through B5 were caused by rough ground. A better analysis could be made if the locations of the shovels relative to the jolts and jars were known.

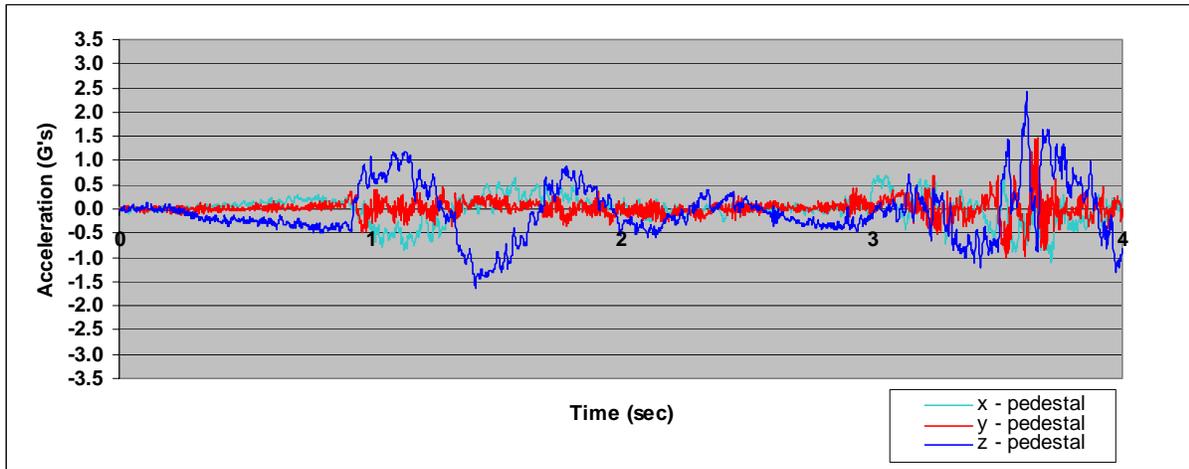
Figure 7—Accelerations on truck going over course empty.

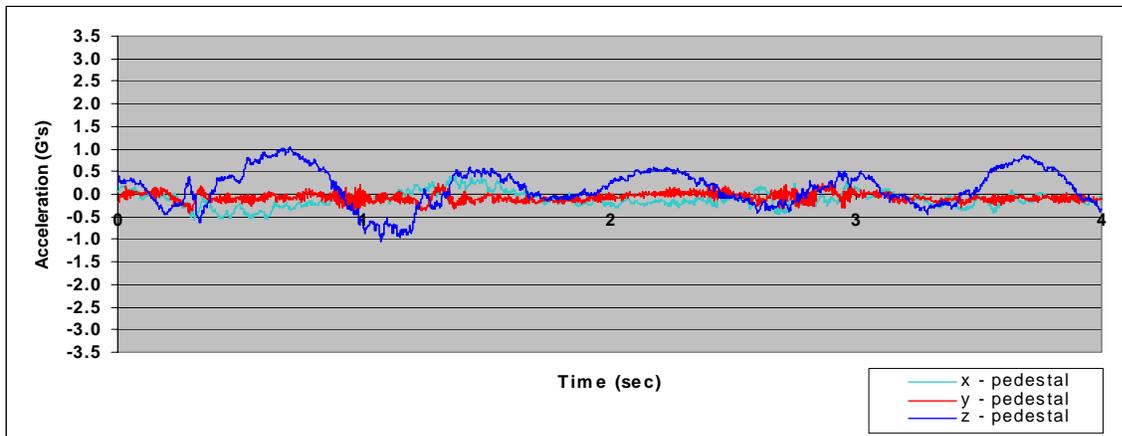
Figure 8—Accelerations on truck going over course loaded.
