## **In-Depth Survey Report**

### **Control of Methylene Chloride during Furniture Stripping**

**Tri-County Furniture Stripping  
Cincinnati, Ohio**

**170-13c**

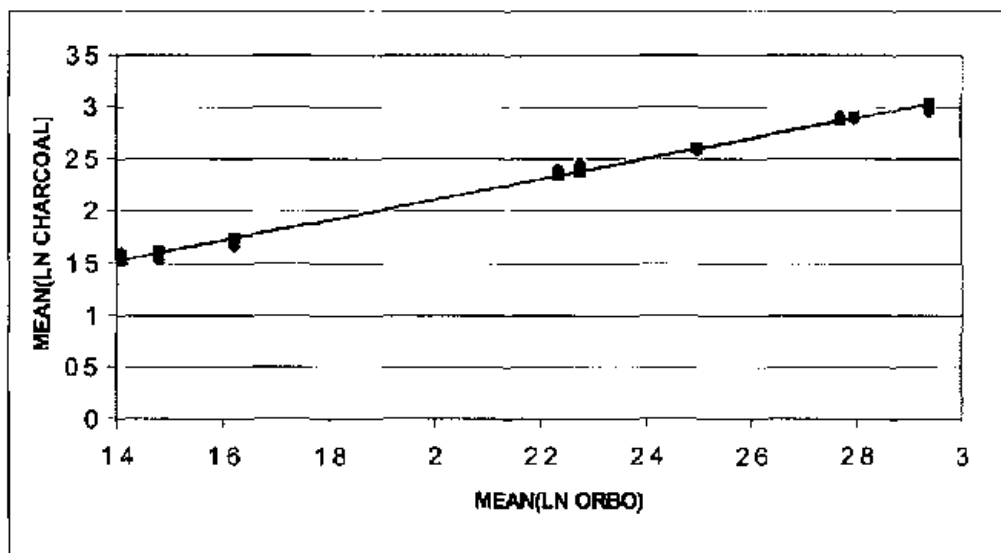
Figure 15 Mean Ln(charcoal) versus Mean Ln(ORBO) for Stripping in Survey 3 & 4 Fitted Equation  $LN(charcoal) = 0.135 + 0.989 \cdot LN(ORBO)$ ,  $R^2 = 0.987$   
 Note Run 5 in Survey 4 and Run 1 in Survey 3 excluded

For all samples, the two methods were statistically different, however, the two values were highly correlated ( $R^2=0.98$ ). The ratio of charcoal to ORBO was found to be 1.15:1, charcoal samples were 15% higher than ORBO samples.

During the second, third, and fourth surveys both the charcoal sampling media and the ORBO sampling media were used side-by-side. Sampling results using the charcoal media were found to be approximately 15 percent greater than when using the ORBO media for the three surveys. Since during the fifth and final survey only the ORBO media was used, a conservative approach was used to estimate the charcoal media breathing zone exposures. The passive samples were not found to be significantly different from the charcoal or ORBO samples. Although this was a very small study, it is an important finding because furniture stripping owners are most likely to use the passive sampling method.
