Mine Safety and Health Administration
110 Gott Road
Princeton, West Virginia 24740

September 30, 1980

SUBJECT: Report of investigation of nonfatal coal outburst accident, Beatrice Mine, Beatrice Pocahontas Company, Keen Mountain, Buchanan County, Virginia, August 18 and 21, 1980

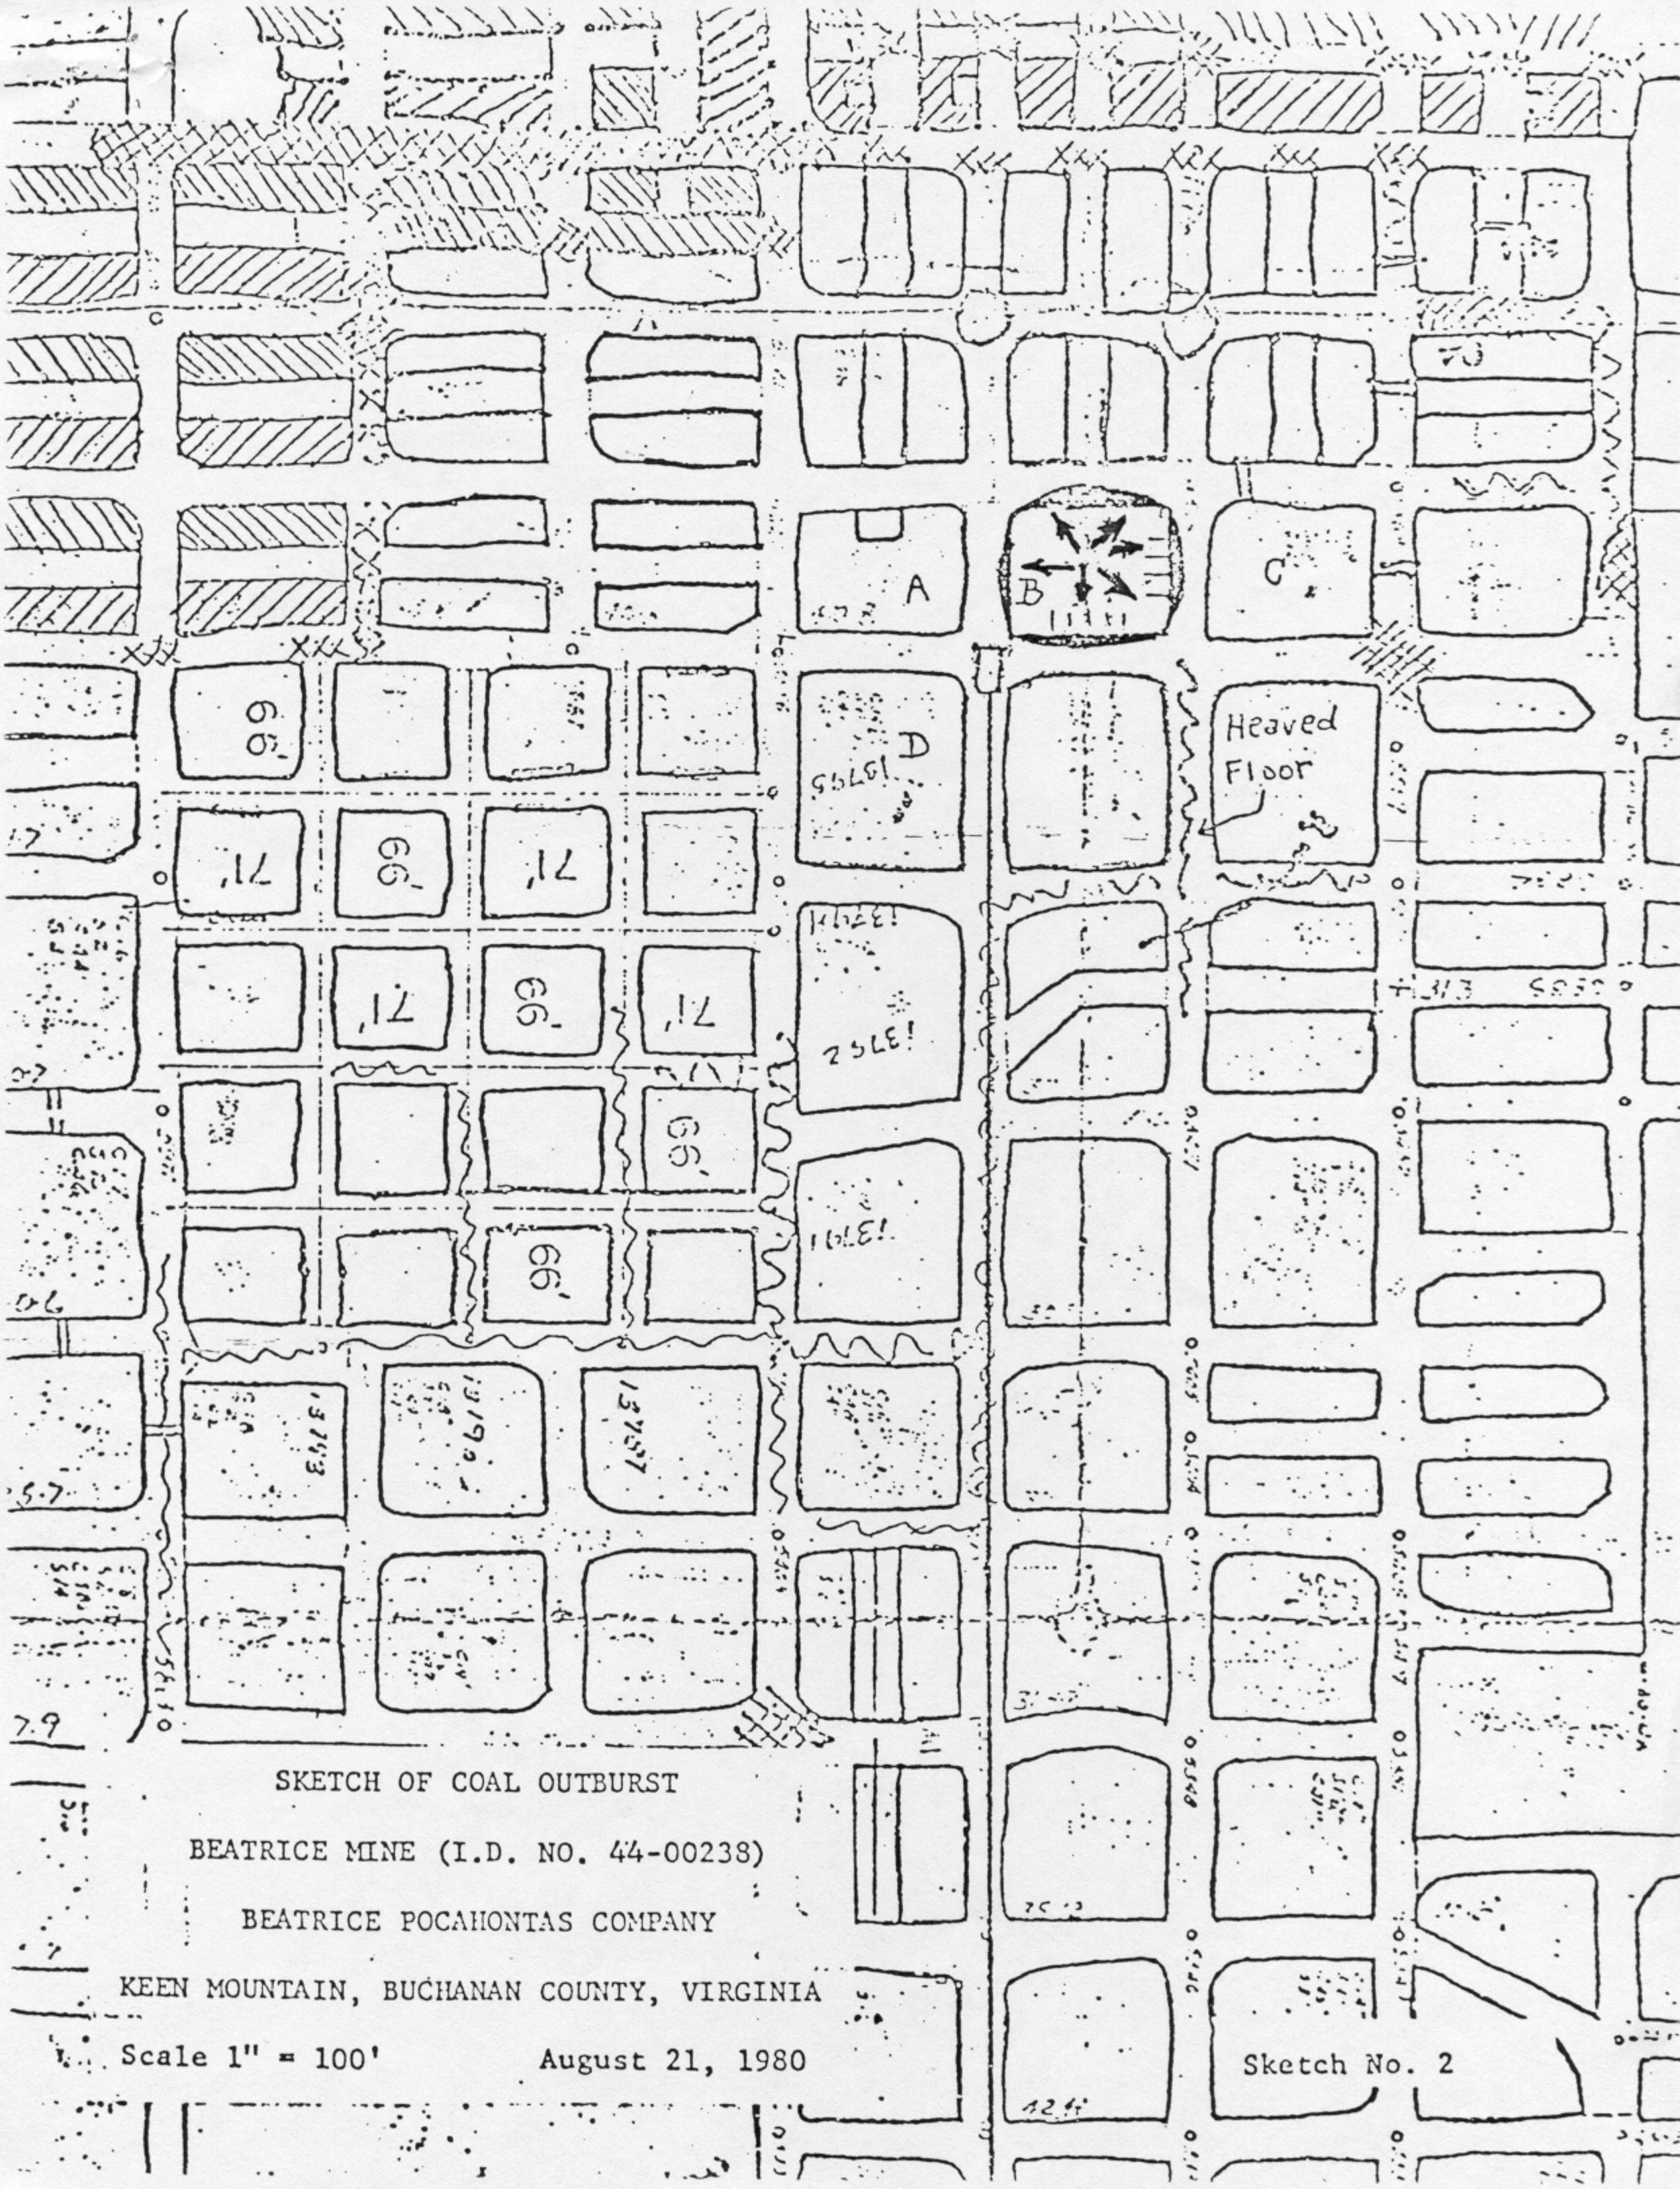
Sketch No. 2

Blasting holes were drilled, charged, and fired along two sides of pillar B (Sketch No. 2) and blasting immediately induced an outburst about 4:30 a.m., August 21, 1980 (owl shift). The outburst affected the entire pillar and apparently destressed it. Maintenance men and the drill crew were the only personnel in the section since this was a nonproducing shift and all were intentionally isolated from the active pillar.

since pillar mining was resumed in April 1980; however, in view of the subject events it was decided to split additional chain pillars before resuming pillar recovery and to volley fire before mining the pillars in the area where firm floor was predominant. It is interesting to note that the overburden in this area ranging from 1,360 to 1,520 feet in thickness is less than in any area where outbursts had occurred previously in this mine. The main contributing factor is apparently a dispositional change in floor condition.
