Health Hazard Evaluation Report

HETA 88-068-2077
SCHMIDT CABINET COMPANY
NEW SALISBURY, INDIANA

HETA 88-068-2077
OCTOBER 1990
SCHMIDT CABINET COMPANY
NEW SALISBURY, INDIANA

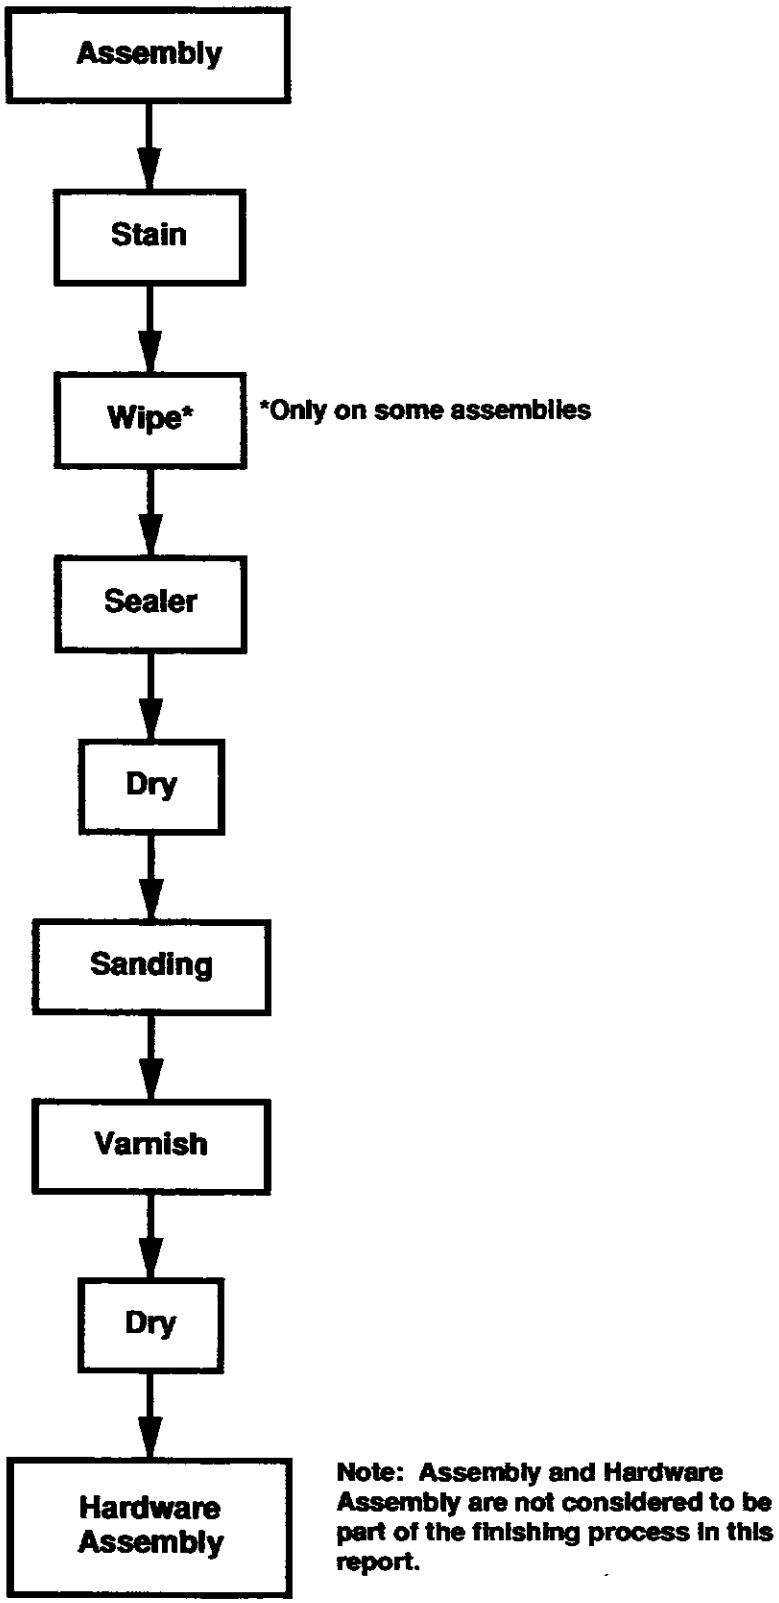
Figure 1. Process Flow
Schmidt Cabinet, New Salisbury, IN
HETA 88-068

The company manufactures the finished cabinets from various hard woods. The process flow for the Finishing area is presented in Figure 1 while Figure 2 shows a layout of the part of the plant containing the Finishing area. The hazard evaluation request concerned only the finishing department (see Figure 2).

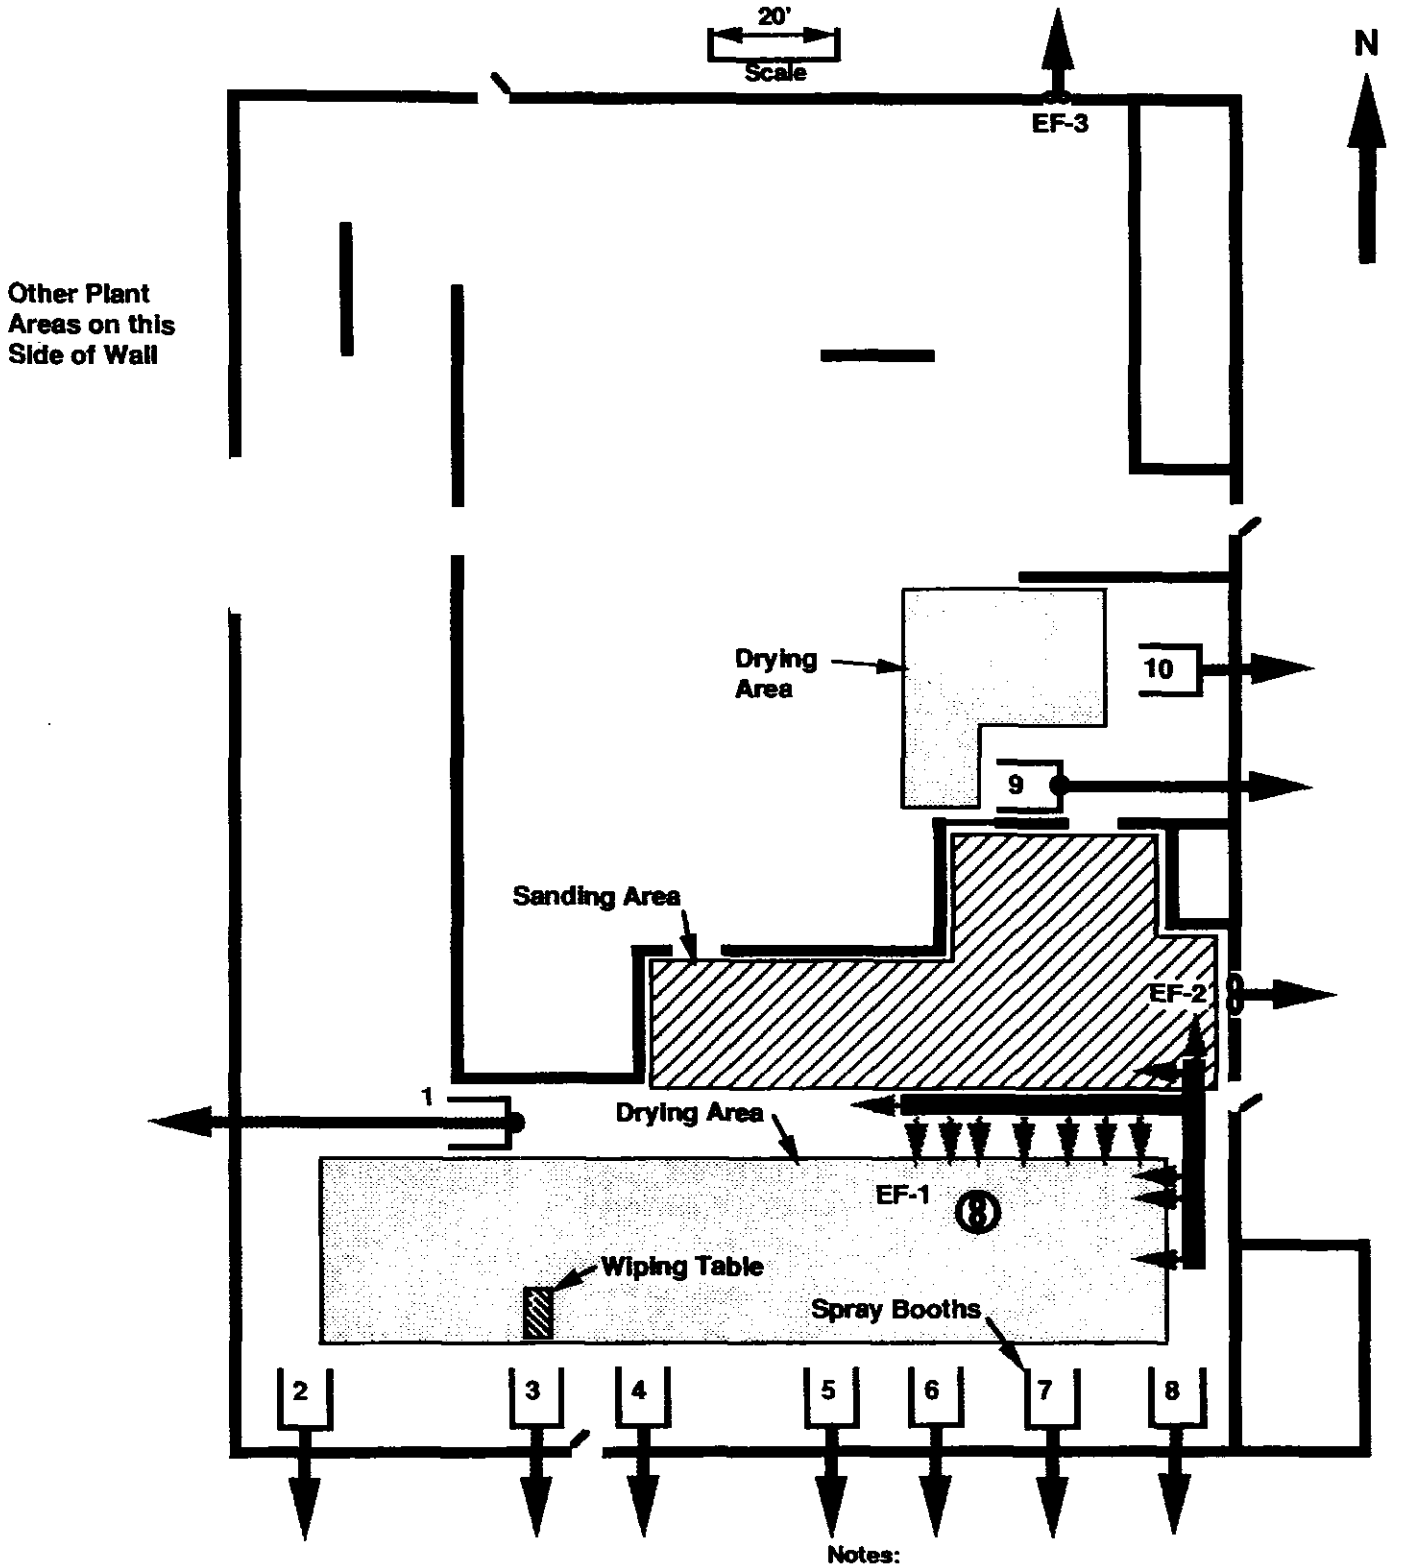
Figure 2. Finish Room Floor Plan
Schmidt Cabinet Co.
New Salisbury, IN
August 25, 1988
HETA 88-068

Makeup air, when not supplied by the air handler, is pulled into the Finishing area through the doors, from other parts of the plant and through leaks. Makeup air being pulled from other areas and through doors was shown by smoke tests. The movement of the draft air was shown to be tangential to some of the booth faces or, opposite to the normal air flow direction into some of the booth faces. This type of air motion can defeat contaminant control by pulling contaminants out of the spray booth due to a syphoning effect. Additionally, a swirling motion can be created inside the booth which can diminish hood effectiveness. Consequently, contaminants are carried from one area to another with the draft air. This contributes to contaminant concentrations detected on general area samples collected away from the booths.

The placement of EF-1 was also only partially effective. The shortest distance between the main contaminant source and the ceiling is about ten feet for parts placed directly under the fan. Those sources located at the west side of the Finishing area are almost 100 feet away. Two feet is the greatest distance a source should be from the exhaust in an open area. The large distance between the drying parts and the exhaust fan makes them very susceptible to the effects of drafts as observed during the smoke tests. In addition, air was blown across the ceiling by the air handler. This air pulled smoke from just above the parts to the ceiling, and then blew the smoke-laden air across EF-1's opening.

A third path for recirculating air into the plant is through the air handling unit. The exhaust duct for EF-1 is crowned with a "Chinese cap" type rain cap. This type of rain cap, besides having the disadvantage of being an energy waster, forces contaminated exhaust air toward the roof. Under certain wind conditions, a pocket of air is trapped over the roof. Contaminated air from EF-1 could be trapped in the pocket of air. The air handling unit intake is located about 20 feet laterally from the exhaust, so the unit can pull its air from within the same envelope of trapped air as that into which EF-1 exhausts.

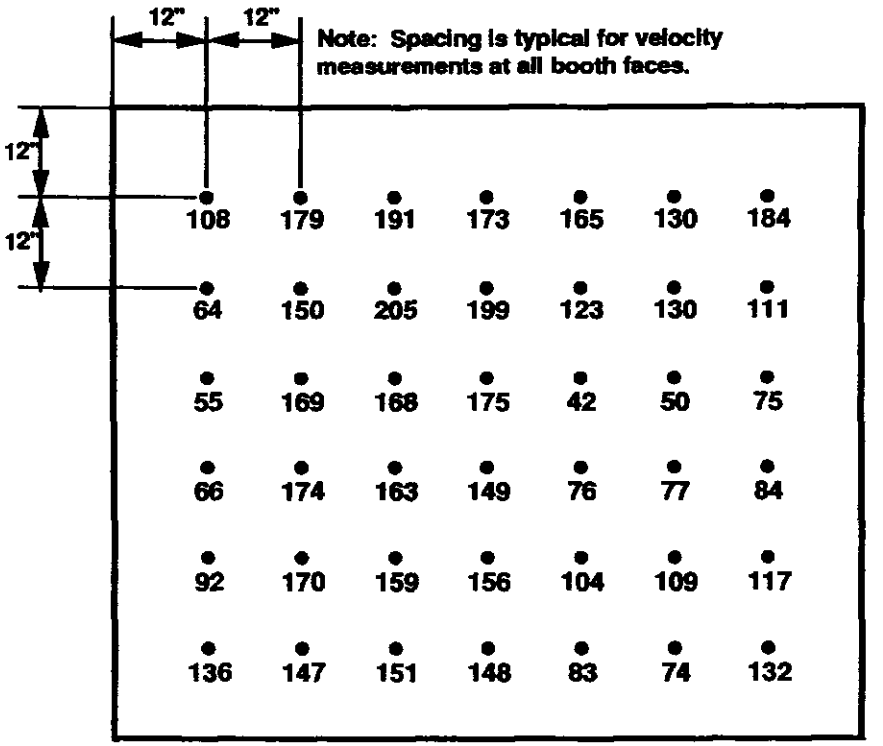
Booth B1

The actual effectiveness of the booths is believed to be very good when not disturbed by drafts or improper spraying practices. Figure 3 shows the face velocity measurements made on three booths. All of the measured booths had average face velocities within the 100-150 fpm band recommended by the ACGIH Ventilation Manual. Other organizations and OSHA have similar recommended air velocities.

however, for two of the booths was much greater. These two booths coincidentally were the two with the lowest overall average face velocity. On all of the booths, average velocities tended to be lower than those found at the booth centerline. This means that if the spraying is done with the part positioned as close to the centerline of the booth as possible, there should be few problems and the height at which the spraying is performed makes little difference.

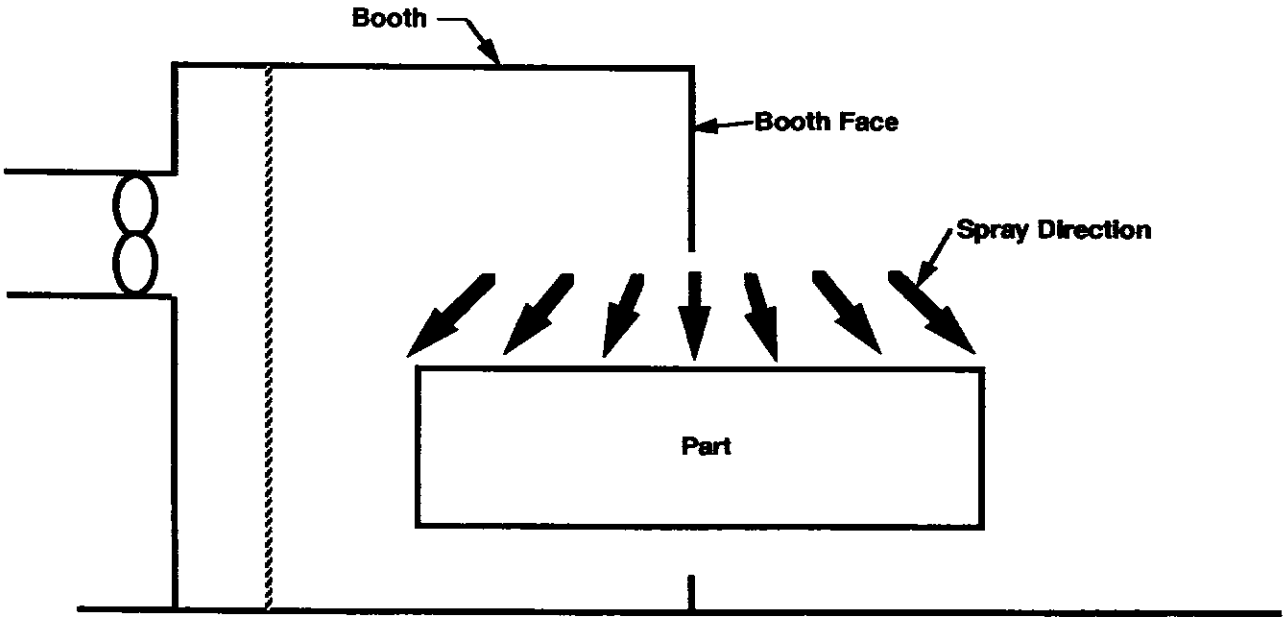
Current Method for Spraying Large Parts

While spraying some of the larger parts, some workers were observed to place the part only halfway into the booth. Then, the workers stood at the midpoint of the part's side and sprayed the part along its length. In so doing, the worker would spray toward the back of the booth at the start, but finish by spraying in the direction opposite the booth face. The result was that the coating material was sprayed away from the control zone of the booth. Additionally, contaminants from the spray may be entrained in the air being pulled into the booth and can pass through the breathing zone of the worker as he or she works in the booth.
