HAZARD EVALUATION AND TECHNICAL ASSISTANCE REPORT
HETA 89-276-L2093
LOCKHEED AERONAUTICAL SYSTEMS COMPANY
MARIETTA, GEORGIA
JANUARY 1991

HETA 89-276-L2093
JANUARY 1991
LOCKHEED AERONAUTICAL SYSTEMS COMPANY
MARIETTA, GEORGIA

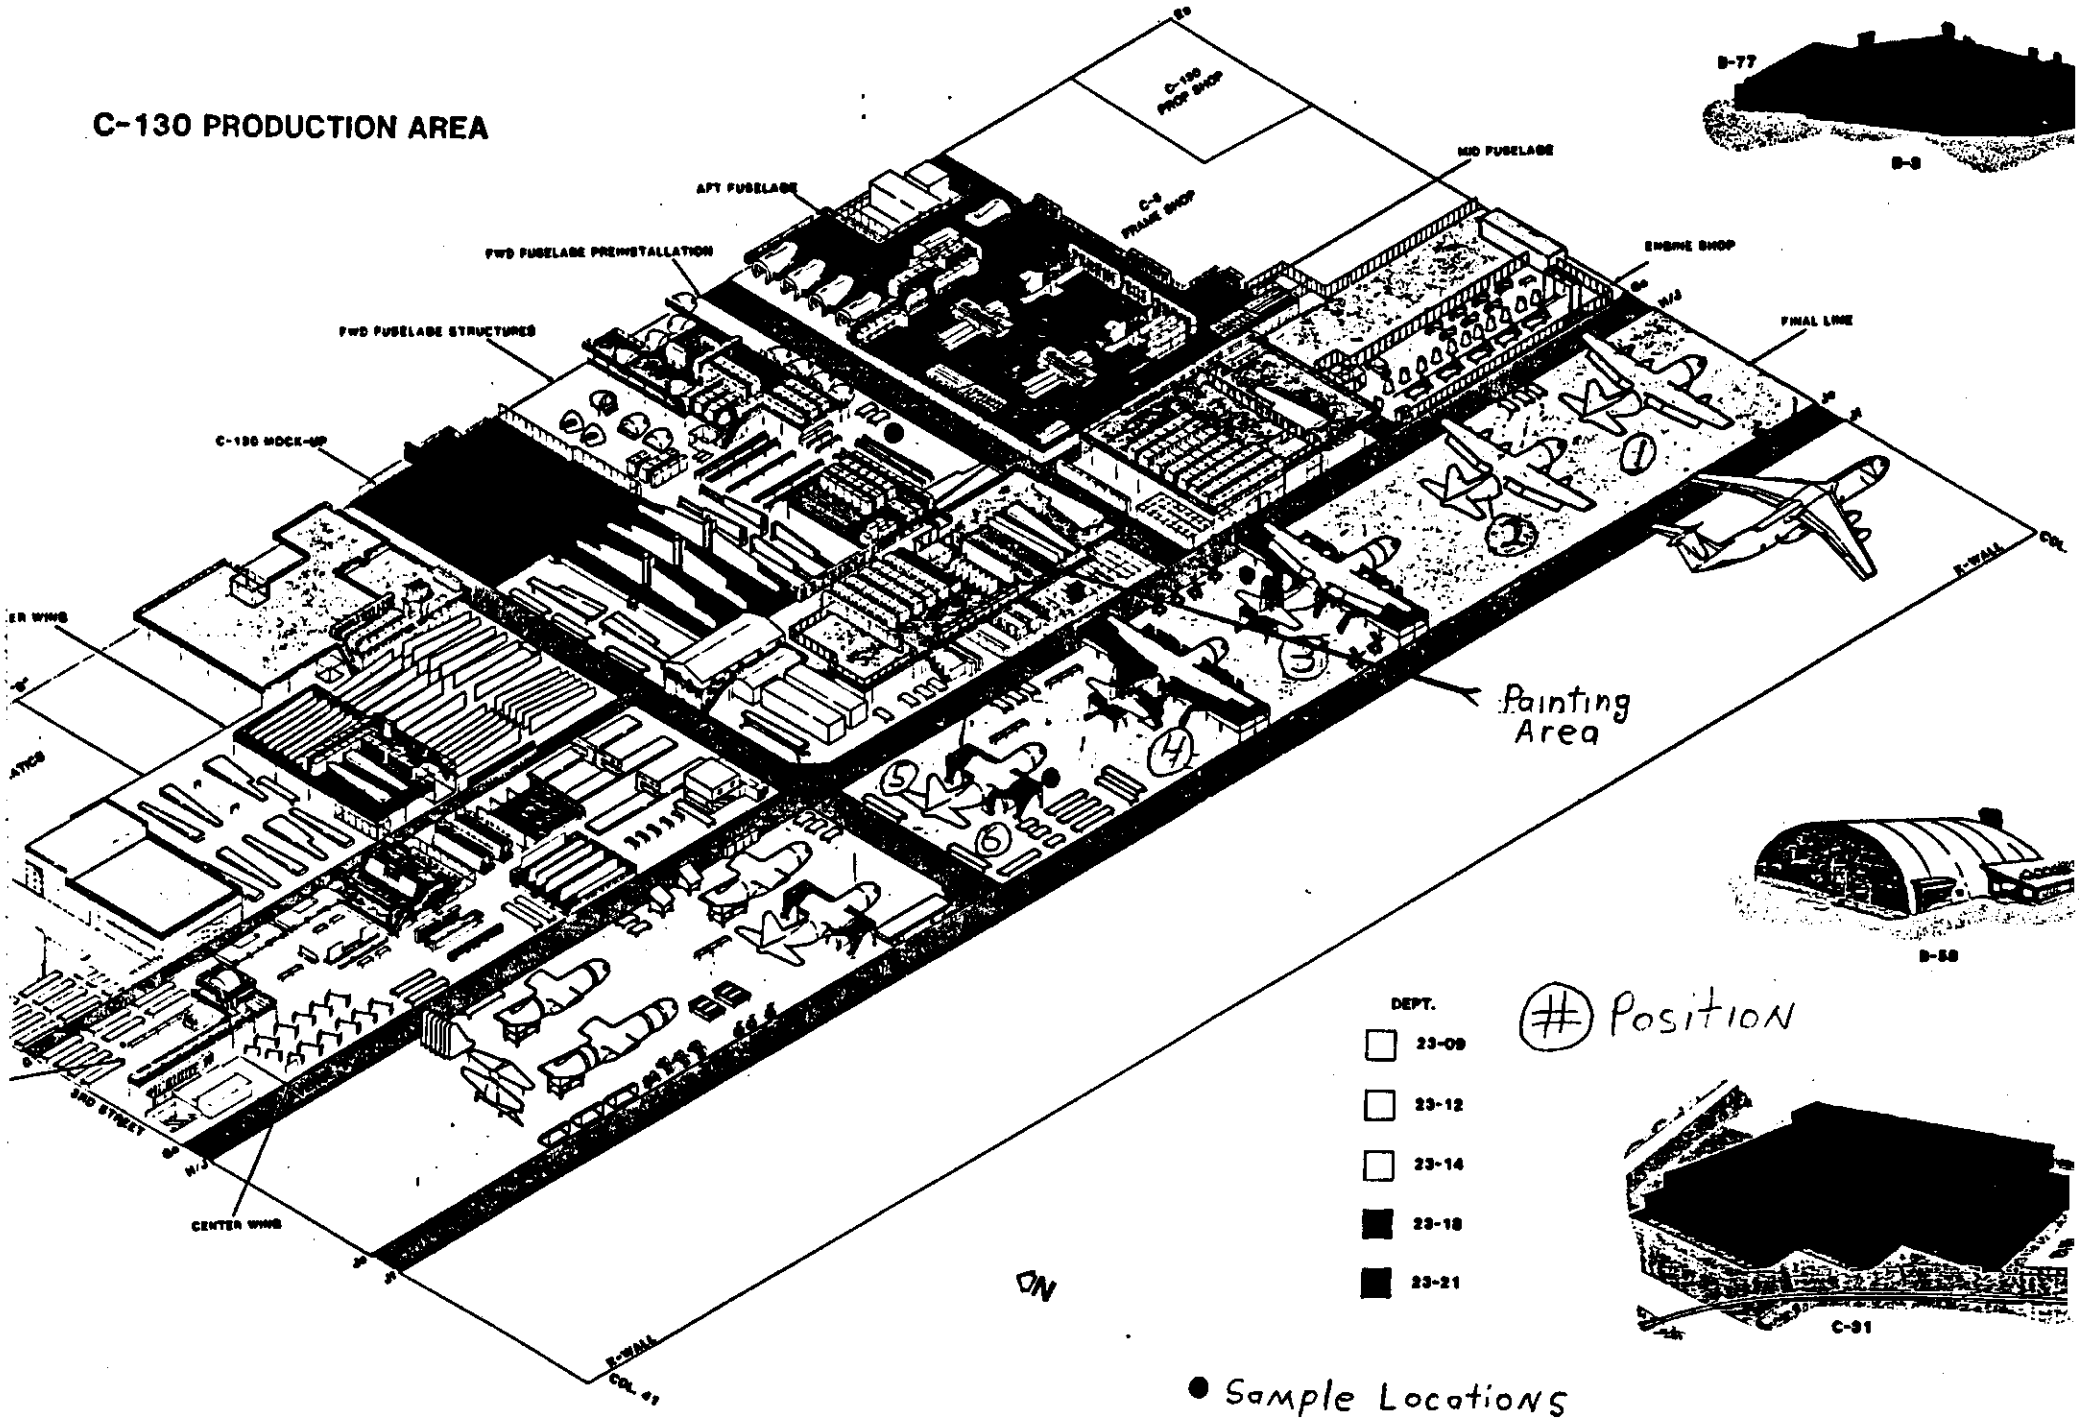
FIGURE 1

In Building B-1, aircraft are located in each of six positions along the final assembly line. The most completed aircraft occupies Position 1 (see Figure 1). Although the main body of the aircraft is painted in a separate paint hanger, touch-up painting is done out in the open at various locations within and near the final assembly line. These painting jobs are normally done by the same two workers. At the time of the initial NIOSH survey,
