Health Hazard Evaluation Report

HETA 90-370-2107
MOORE BUSINESS FORMS
ANGOLA, INDIANA

HETA 90-370
April 1991
Moore Business Forms
Angola, Indiana

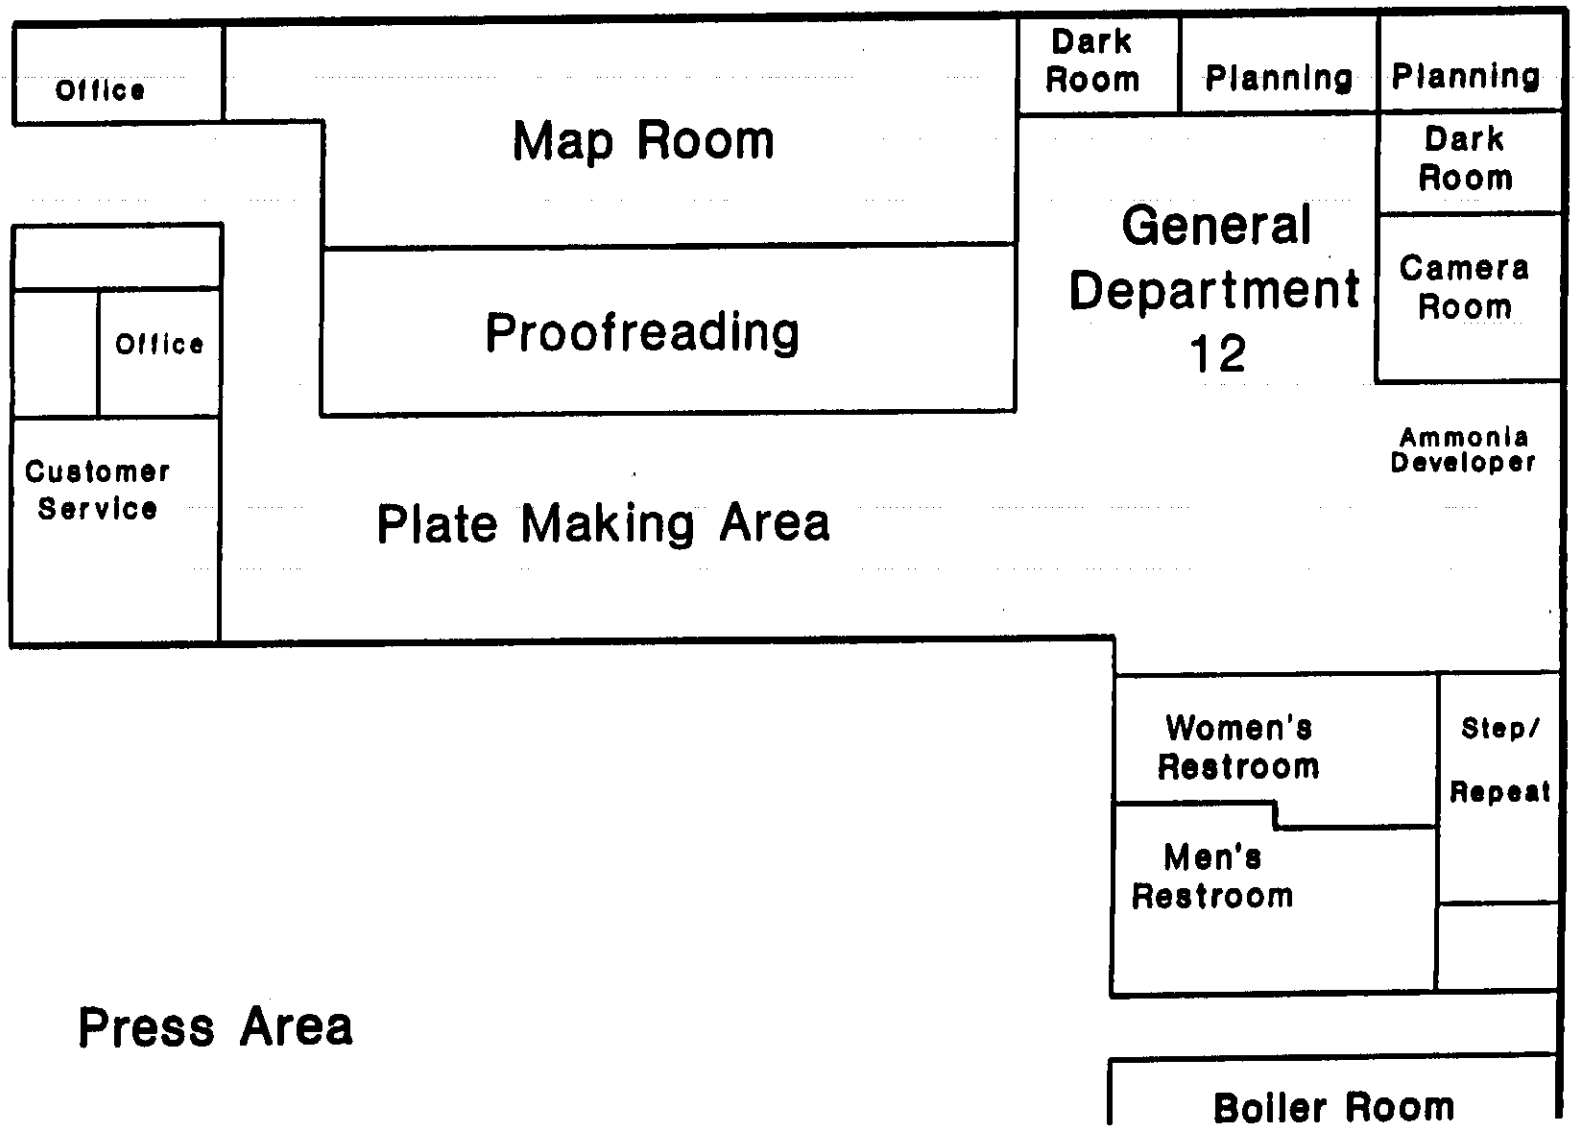
Figure 1: Preliminary Department

The Preliminary area was found to be under negative pressure relative to the adjacent Press area. Fresh air intakes serving the Preliminary area were close to ammonia exhausts and plumbing vents on the roof, resulting in possible re-entrainment of contaminated air. A source of possible biological contamination was discovered within a large air conditioner unit serving the Preliminary area. Several of the canopy exhausts were found to have inadequate capture efficiency.

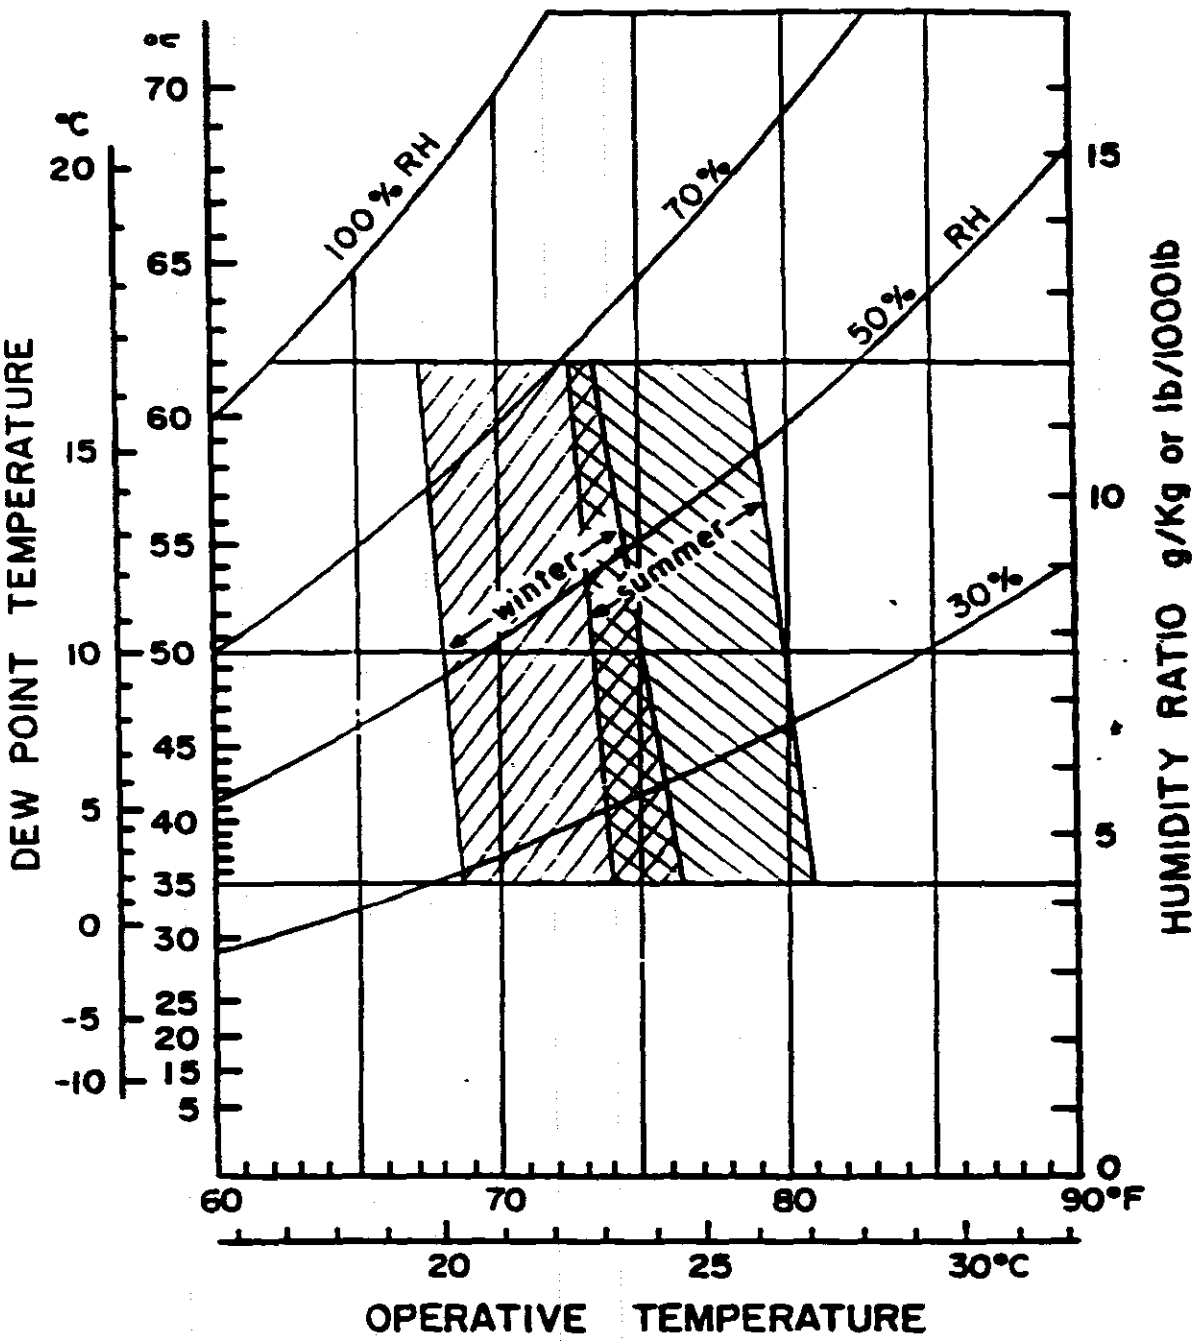
Figure 2

On November 6, 1990 temperatures ranged from 69 to 76 °F, and RH ranged from 36 to 44 percent. On December 19, the temperatures ranged from 65 to 74 °F and RH ranged from 28 to 36 percent. The temperature and humidity values were generally within the ASHRAE ranges specified in Figure 2. The measured values at various locations can be found in Table 4.

2. In office areas, any modification to the HVAC system should maintain a minimum fresh air intake of 20 cubic feet per minute (cfm) per occupant, as recommended by ASHRAE.[4] Relative humidities and temperatures should be monitored on a regular basis. If the values fall outside the ASHRAE criteria specified in Figure 2, further adjustment or modification of the system is needed. As part of the HVAC modifications, a humidification system for the entire Preliminary area may be necessary. The humidification system should be independent of the current boiler heating system. After installation, maintenance and routine inspections of the system should be instituted.

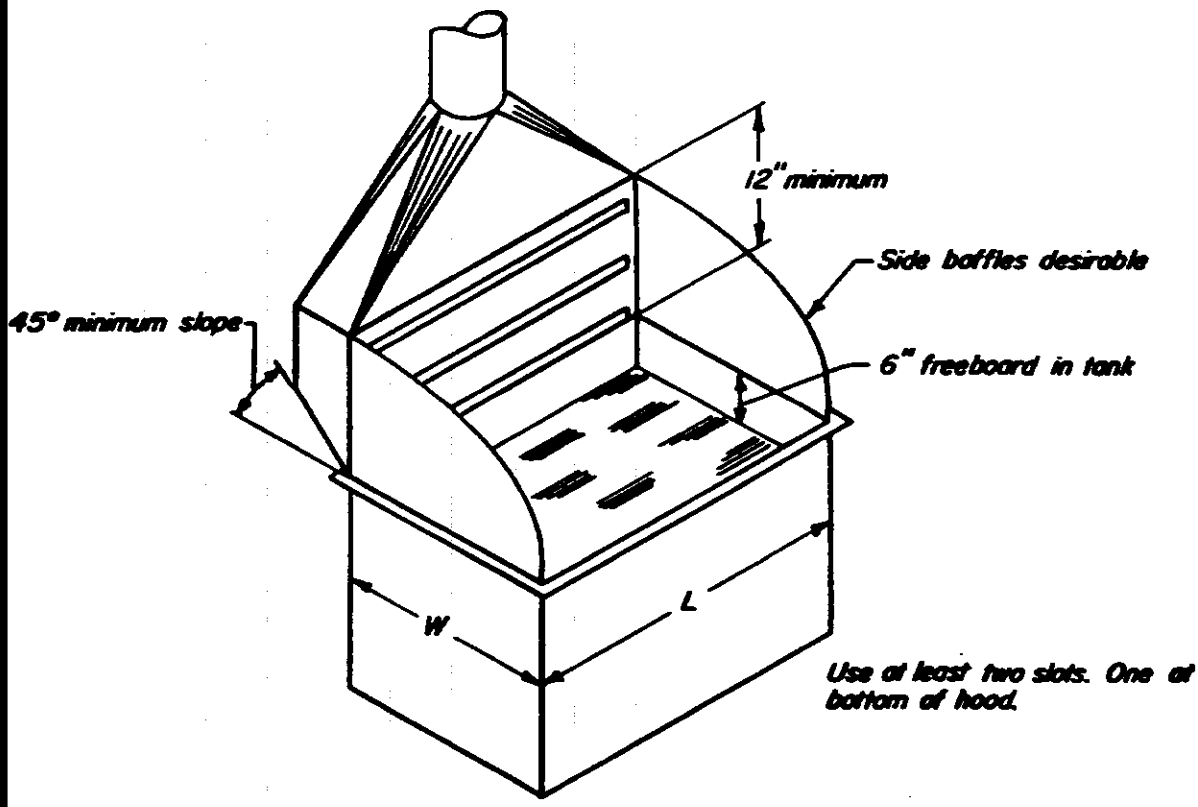
Figure 3

7. The Flex-light® washout unit is equipped with a canopy hood surrounded by plastic. Although the hood appears to have adequate capture efficiency, the worker is forced to work under the hood, causing potential vapors from the open tank to flow past his breathing zone before entering the hood. This hood should be removed and replaced with a slotted exhaust, as described in Figure 3.[10]

Q = 150 cfm/sq ft of bed (150LW)
Slot velocity = 2000 fpm
Entry loss = 1.78 slot VP + 0.25 duct VP
Duct velocity = 2500-3000 fpm
W not to exceed 36"
