Observations and evaluation of floor benching effects on pillar stability in U.S. limestone mines

G.S. Esterhuizen, D.R. Dolinar & J.L. Ellenberger.
National Institute for Occupational Safety and Health, Pittsburgh, USA.

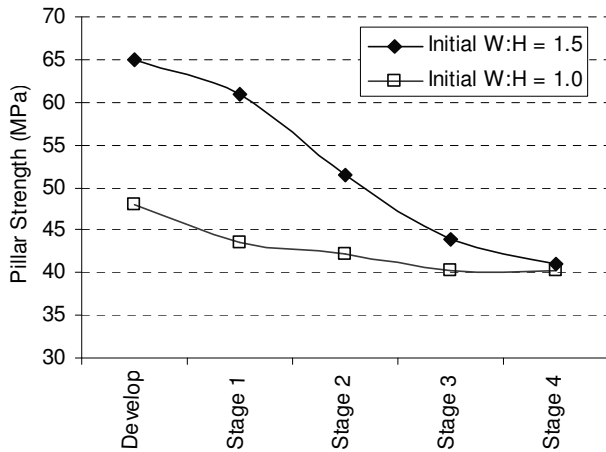
Model results for pillar strength at the various stages of bench mining are presented in Figure 4, which shows how the pillar strength is progressively reduced as bench mining is carried out around the pillar. The model results show that strength of the pillar with W:H=1.0 is reduced by about 16%, from its initial value of 48 MPa to a final value of 40 MPa. The pillar with W:H=1.5 experiences a

Figure 4. Results of FLAC3D modeling showing strength reduction of pillars with initial W:H=1.0 and 1.5 from initial development through various stages of bench mining. Final W:H ratios at Stage 4 are 0.5 and 0.75 respectively.

reduction in strength of 37% from the development stage to the fully benched stage.

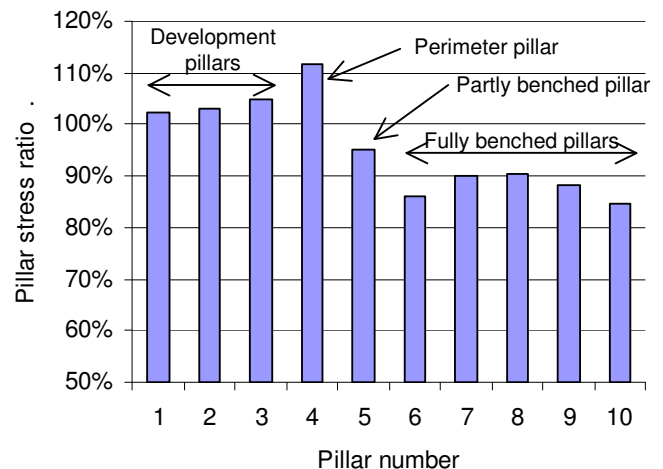
Figure 6 shows the average stress in the pillars obtained from a model in which half of the pillars have been benched. The results show that the development pillars at the edge of the benched area are subjected an increase of about 12% in their average stress. The results further show that the stress in the partly benched pillar is lower than the stress in the adjacent pillar that has not been benched yet, indicated as "perimeter pillar" in Figures 5 and 6. The lower stress in the partly benched pillar can be explained by the fact that its stiffness is reduced by the increase in height of one of the sides of the pillar, causing the load to be transferred to the stiffer development pillars. It can clearly be seen that the fully benched pillars are at a reduced stress level, owing to their relatively low stiffness. As benching continues, the stress in the fully benched pillars is expected to gradually

Figure 6. Results of Examine 3D model showing the average pillar stress during bench mining as a ratio of the average pillar stress prior to bench mining.

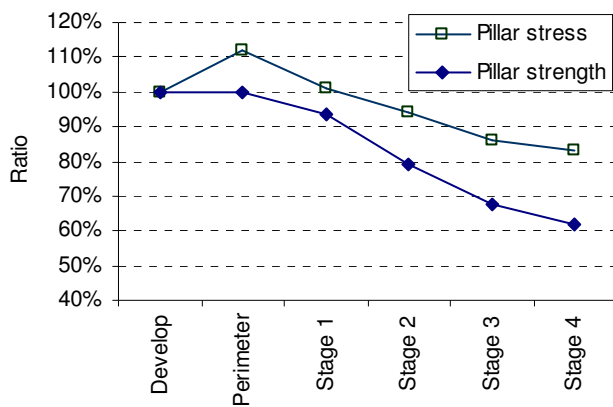
Further results, showing the changes in the average vertical stress in a pillar at the various stages of bench mining are presented in Figure 7. The figure also shows the associated changes in the pillar strength for a pillar with W:H=1.5, as previously presented in Figure 4. It can be seen that the pillar stress is a maximum just before benching starts around the pillar. As soon as one side of the pillar has been benched, the average pillar stress decreases, owing to the increased height and reduced stiffness. The average pillar stress continues to decrease as benching progresses, until the pillar is fully benched. The stress in the fully benched pillars will gradually rise as the benching face moves away. Full tributary loading can re-establish in the benched pillars if the mined area is sufficiently large.

Figure 7. Change in the average vertical pillar stress and strength during various stages of bench mining, for a pillar with W:H=1.5 based on FLAC3D and Examine3D results.

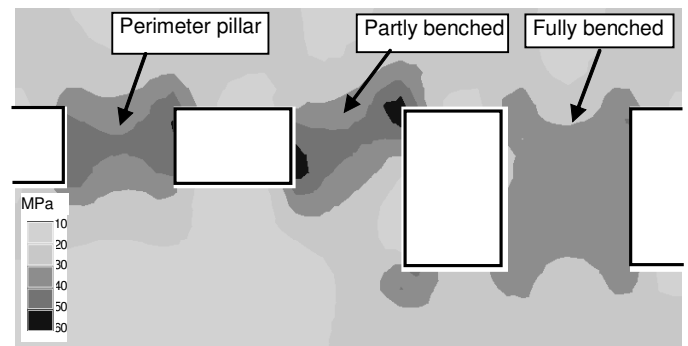
The numerical models confirm that elevated stresses can occur in pillars around the perimeter of a benched area. However, the existence of reduced stresses in the partially benched pillars seems to be in conflict with the field observations, which indicate that elevated stresses exist in the partially benched pillars. Nearer inspection of the model results show that stresses are not symmetrically distributed within pillars at the edge of a benched area, shown in Figure 8. It can be seen that zones of high stress exist within the partially benched pillar that are absent in the perimeter pillar, although the average vertical stress in the two pillars may be similar. The elevated local stresses are likely to

Figure 8. Section through the central part of an Examine 3D model showing maximum principal stress contours in and around pillars at the edge of bench mining. Contours in MPa.

contribute to the failure observed in the partially benched pillars in operating mines.

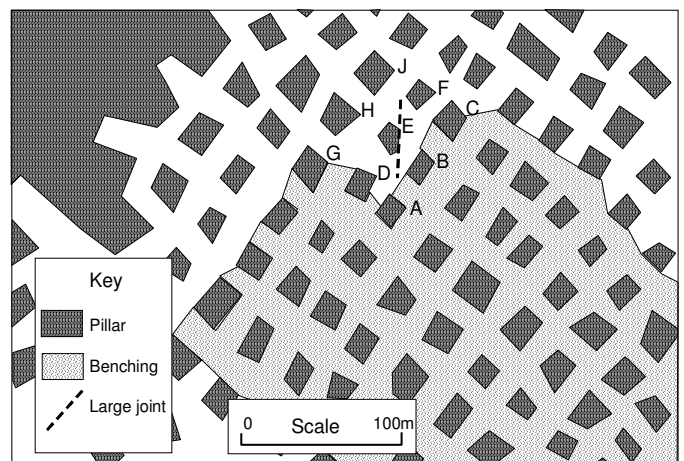
Pillar instability was observed adjacent to an area of bench mining at a mine that is extracting a near horizontal limestone bed. Spalling of the pillar ribs, resulting in hourglass formation, was observed. In the area of concern, the pillars were square with side dimensions varying between about 12.2 and 15.2 m and were initially benched to 15.8 m high. Further benching was carried out, which increased the pillar height to 27 m. The room width was measured to be about 16.4 m, and the depth of cover is 140 m. The average pillar stress is about 15 MPa, based on the tributary area method. However, the irregular pillar shapes and effects of benching resulted in variable stresses in the pillars. The width to height ratio of the benched pillars was as low as 0.44 in the 27 m high area. Figure 9 shows a plan of the mine

Figure 9. Plan view showing layout of pillars and bench mining at case study mine as modeled using the Examine 3D software.

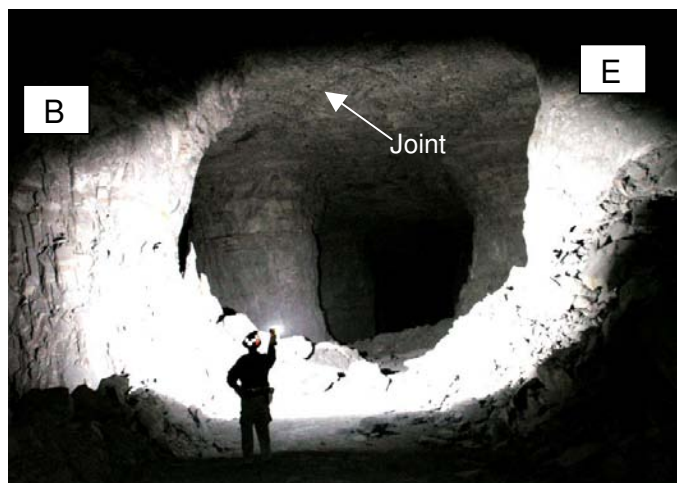
The initial development mining was carried out about 15 years ago, but the final benching stage was carried out less than 5 years ago. A number of pillars were reported to be progressively spalling to the current hourglass shape at the perimeter of the benched area. Figure 10 shows the conditions of pillars B and E. Evidence of fracture through intact rock and slab formation was seen. Pillars A, B, D and E showed open vertical fractures and there were large slabs lying on the mine floor around the pillars. Pillar E was considerably reduced in size, owing to the presence of the large joint that intersected one of its corners and caused the corner to slough. The remaining part of the pillar was in a poor condition, containing many stress related fractures and slabs. Pillars C, F, H and J were in a relatively good

Figure 10. View of pillars showing slabbing and rubble from rib failure, Pillar B on left and Pillar E on right in photograph.

condition and did not show any signs of stress damage.

The pillars labeled A, B, D and E in Figure 10 are clearly exposed to elevated loading. Spalling to an hourglass shape, open fractures and slab formation are all well known manifestations of pillar overload. A 3D model of the area was set up using the Examine 3D software. The model simulated an area of about 300x300m with the pillars in question located near the center of the model. Two stages were modeled. The first stage simulated a condition prior to bench mining and the second simulated the benched configuration shown in Figure 9. The results showed that prior to bench mining, pillars D, E and F were slightly more stressed than the surrounding pillars owing to their smaller size. The stress distribution in the pillars after benching is shown in Figure 11. It can be seen that pillars D, E and F contain the highest stresses and A, B and C have already been partly relieved of stress by the bench mining. Pillar E carries the highest stress, because it is smaller than the other pillars, and is stiffer than the partially benched pillars. The relatively lower stresses in pillars A, B and C is expected, since their height has been increased by benching, and they have shed stress. However, as benching approached these pillars, the stresses will have been elevated and is likely to have caused the observed damage. The benching configuration, which forms a protruding right-angle, also contributes to the elevated stresses on these pillars.

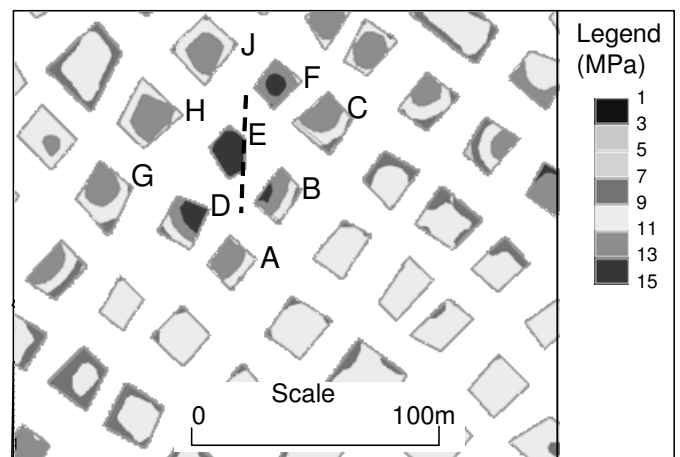
Figure 11. Examine 3D results showing contours of maximum principal stress in the pillars.
