LINE OF DUTY DEATH REPORT

F2026-04

Truck Company Firefighter Dies after Floor Collapse at Basement Fire in a Multi-Family Residential Structure – Illinois

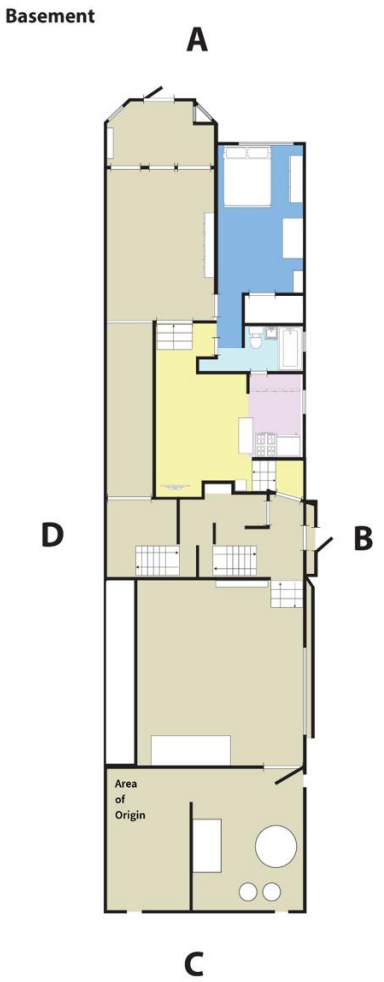
Sketch of basement floor plan, not to scale or exact dimensions.
(Courtesy of fire department)

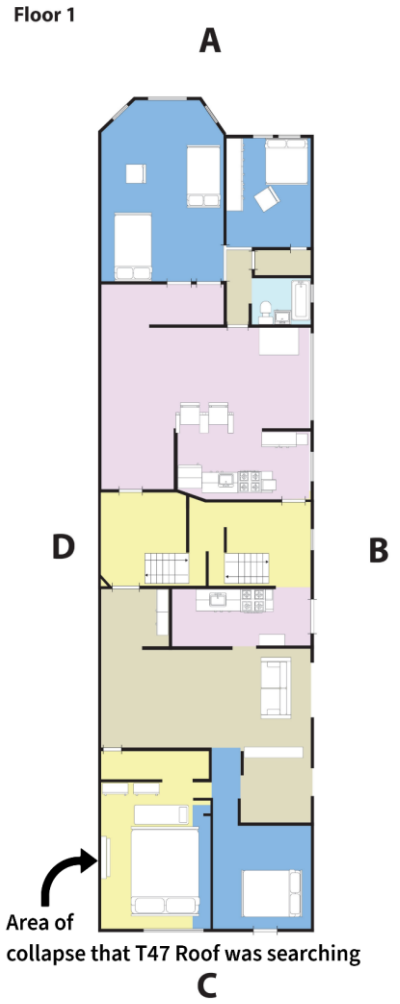
Sketch of upper floor plan, not to scale or exact dimensions. (*Courtesy of fire department*)
