NIOSH FIRE FIGHTER FATALITY INVESTIGATION AND PREVENTION PROGRAM

LINE-OF-DUTY DEATH REPORT

Lumber mill silo fire and subsequent explosion kills two firefighters and critically injures thirteen more – Maine

F2026-07 ME · August 2026

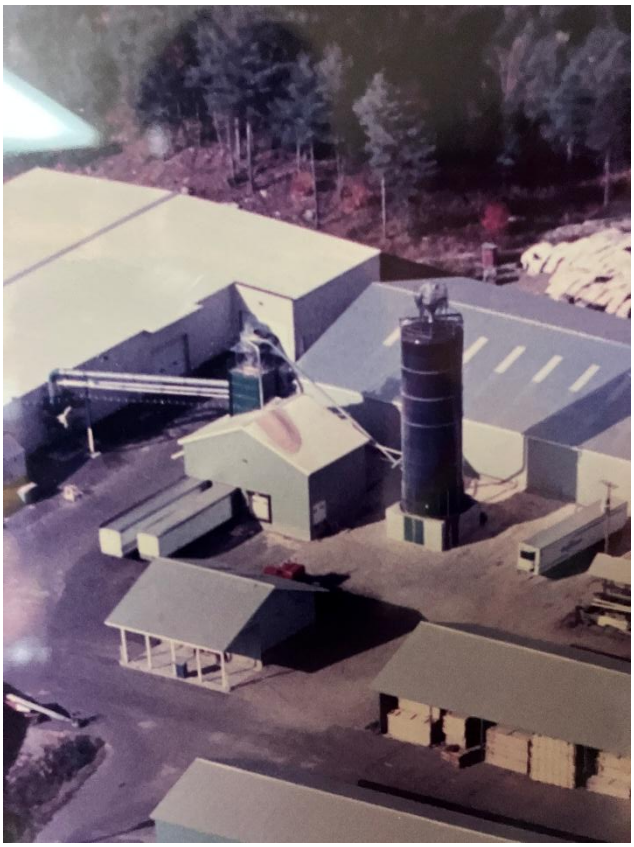
The incident silo was located at bagger #2. It was a 20 ft x 60 ft oxygen-limiting Harvestore® silo. The silo was bolted to the top of a concrete room that was 22 ft x 10.5 ft. The top of the room had an auger system that pulled wood shavings and sawdust into a 3 ft diameter hole. The hole led into a square chute that led to a pipe to a blower outside the room that transported the wood shavings to the bagger machine. The room contained electrical panels for the systems and had double wooden entry doors on Sides Alpha and Charlie. An air-material separator was installed on the roof of the silo.

The lumber mill purchased the incident silo used in 1993. In later years, the facility engineer modified it. A dry sprinkler system was installed in the room below and in the top of the silo headspace. The sprinkler system was connected to a local monitoring system. When either sprinkler was activated, a siren, water bell, and beacon were activated to alert facility employees. Per the lumber mill's emergency evacuation and fire prevention plan, the bagger machines were shut down in the event of a fire. Facility employees and firefighters interviewed by NIOSH were unaware that the silo at bagger #2 was oxygen-limiting or what unique hazards this type of silo had compared to conventional types. *More about types of silos and their characteristics can be found under more information.*

Image 3. View of incident silo at bagger #2, Side Alpha, pre-incident. (Source: Lumber mill)
