REPORT#: 19MA072

REPORT DATE: December 18, 2023

Rigging Crew Leader Crushed by Light Tower Weight — Massachusetts

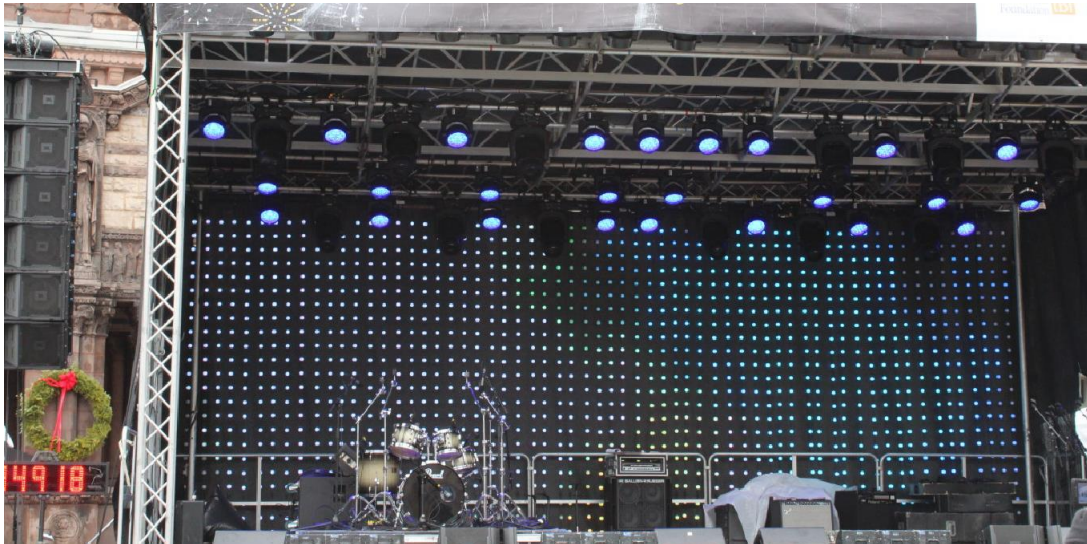
Figure 1 – Stage and rigging with lights (image from First Night Boston X/Twitter, [@firstnight](#))

An image of the completed stage and rigging setup is shown in Figure 1. Additional light towers were set up around the venue.

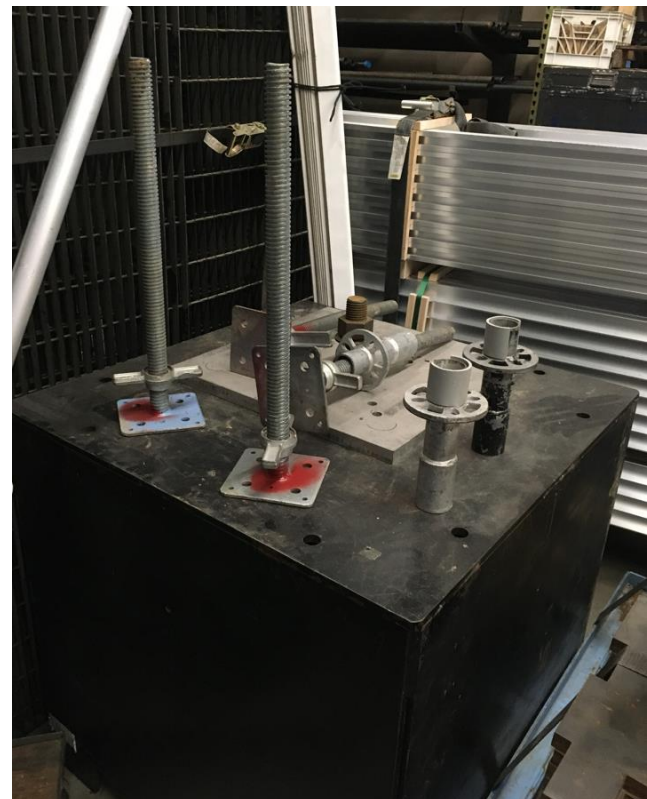
Figure 2 – Ballast weight (FACE investigator photo)

The ballast weight that was involved in the incident weighed 3,200 pounds (Figure 2). It was a 36" cube consisting of concrete with rebar reinforcement within a welded steel plate shell. The sides of the steel shell were 3/8" thick and the top was 5/8" thick. Holes and connections for anchoring the rigging components were built into the ballast. Various connection pieces are visible in Figure 3 which shows the ballast in storage at the company. While some weights used by the company had cutouts or holes that ran through the weight for use when lifting with a forklift, the weight involved in the incident had four feet and a gap between the feet for lifting, as seen in Figure 2.

The weight of the ballast and its position on the telehandler caused the ballast to slide or tip off of the tines. The ballast first struck the victim in the head and then fell on the victim's torso. Multiple workers at the site were able to roll the

Recommendation #1: Employers should ensure that employees are not within the fall zone of material being transported.

Discussion: The fall zone of an object is the potential path the object will take if it tips or falls uncontrollably. The higher an object is lifted, the larger the fall zone becomes. Falling object hazards are a common concern in several work settings, such as construction, tree care, and stone slab transport. These hazards can exist when materials are moved using equipment. In general industry, OSHA regulation [1910.178](#) (m)(2) Powered Industrial Trucks requires no employee to be permitted underneath or passing underneath components or loads held by a powered industrial truck, such as a telehandler. Several preventative measures can be implemented to ensure the safety of employees. Ensuring employees are not positioned within the fall zone of an object will help prevent employees from being struck or crushed by a dropped object. Keeping the load low to the ground and no higher than is necessary to safely operate the equipment is a

way to reduce the fall zone and hazard. Additionally, employers should ensure that transported materials are properly secured and stable prior to transport.

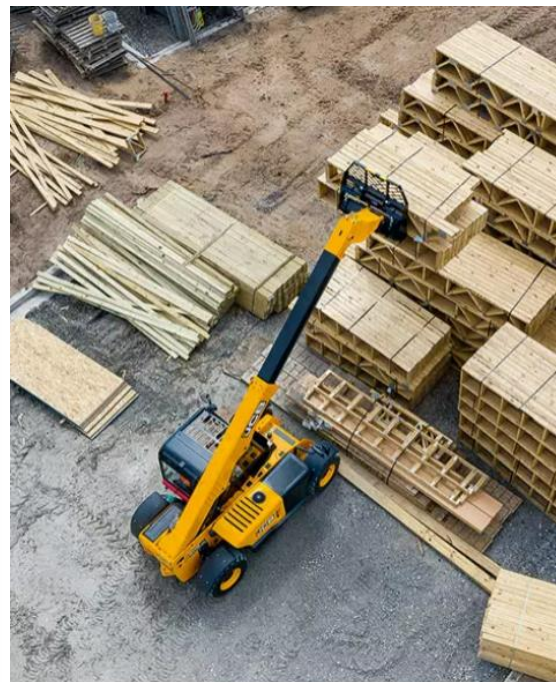
Figure 5 – Telehandler (manufacturer image)

Also involved in the incident was a diesel-powered four-wheel steer/four-wheel drive all-terrain telehandler (Figure 4). This type of equipment is a [class 7](#) rough terrain forklift with variable reach. It had a maximum lifting capacity of 5,500 pounds with the boom retracted. It had a lifting height of 20 feet and a load capacity of 3,900 pounds for vertical lifts. With the boom extended to its full reach of 11.5 feet, the lifting capacity was 1,750 pounds. The vehicle was six feet and two inches tall and six feet wide at its widest point at the tires. The wheelbase was seven feet and ten inches from axle to axle, and the overall length of the base unit was 13 feet and one inch plus the length of any attachment. The telehandler was equipped with a fork attachment.

The telehandler had three selectable steering modes: two-wheel steer; four-wheel steer that allowed for tighter turns; and crab steer that allowed for sideways movement.

In this case, the equipment operator was appropriately trained to operate a different type of forklift and not the all-terrain telehandler. The ground conditions at the site consisted of paved areas, pavers, and packed soil. It may have been appropriate to use a different forklift class, on which the operator was trained, at the site instead of the telehandler. The scope of the project and materials, as well as available equipment and trained operators, should be considered during project planning and implementation. Ensuring that equipment operator training is complete is a critical component of an employer's safety and health program.

Recommendation #3: Employers should ensure that employees who operate equipment are properly trained.

Discussion: OSHA requires that operators of equipment like the telehandler involved in this incident be [properly trained](#). The operator must have demonstrated competent operation of the equipment after that training. The training is required to have several elements that are specific to the particular equipment. These elements include, but are not limited to, general equipment operation and the specific controls and instruments of the unit, steering and maneuvering, visibility and restrictions on visibility that may be caused by a load, and fork or attachment operation and limitations. Other required training elements include vehicle capacity, vehicle stability, surface conditions, load stability,

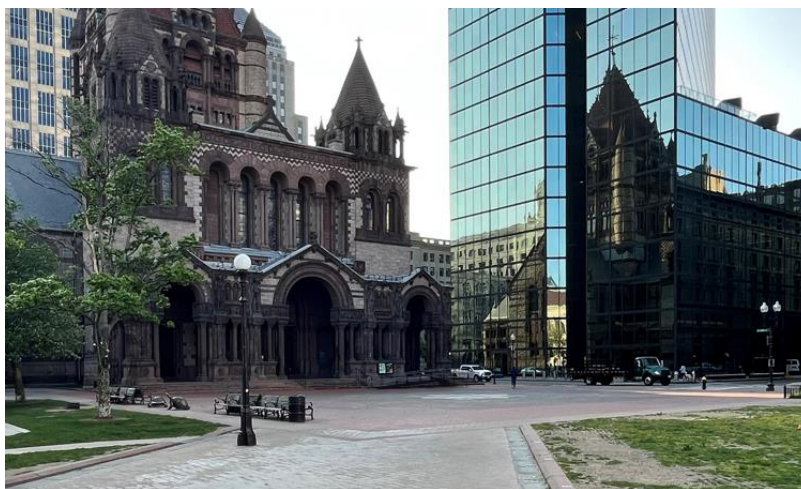
Figure 7 – Park and paver stone area where the stage was erected (FACE investigator photo)

The incident occurred at a park in a city center (Figure 7). The open area public space was being converted into an entertainment venue (Figure 8). The paver stone space that held the entertainment rigging and staging was approximately 12,200 square feet of the outdoor space. The lawn space in front of the stage area was approximately 16,500 square feet. The outdoor cobblestone and green space were mostly flat.
