FACE IT: Report Visual Extension

Oil and Gas Delivery Driver Crushed Between a Dozer and a Semi-truck While Connecting Towline—West Virginia (FACE 2015-01)

REPORT#: 2015-01 REPORT DATE: April 18, 2018

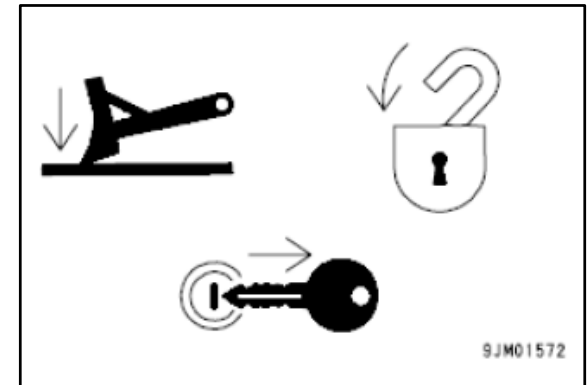
Warning label from the Komatsu operations manual.

- **Employers should:**
 - Ensure employees follow safe operating procedures as written in the equipment's operations manual.
 - Implement standard operating procedures for equipment operations such as parking and towing.
 - Use a job hazard analysis (JHA) to identify and eliminate towing hazards.
