4 Career Fire Fighters Killed and 16 Fire Fighters Injured at Commercial Structure Fire – Texas

Executive Summary

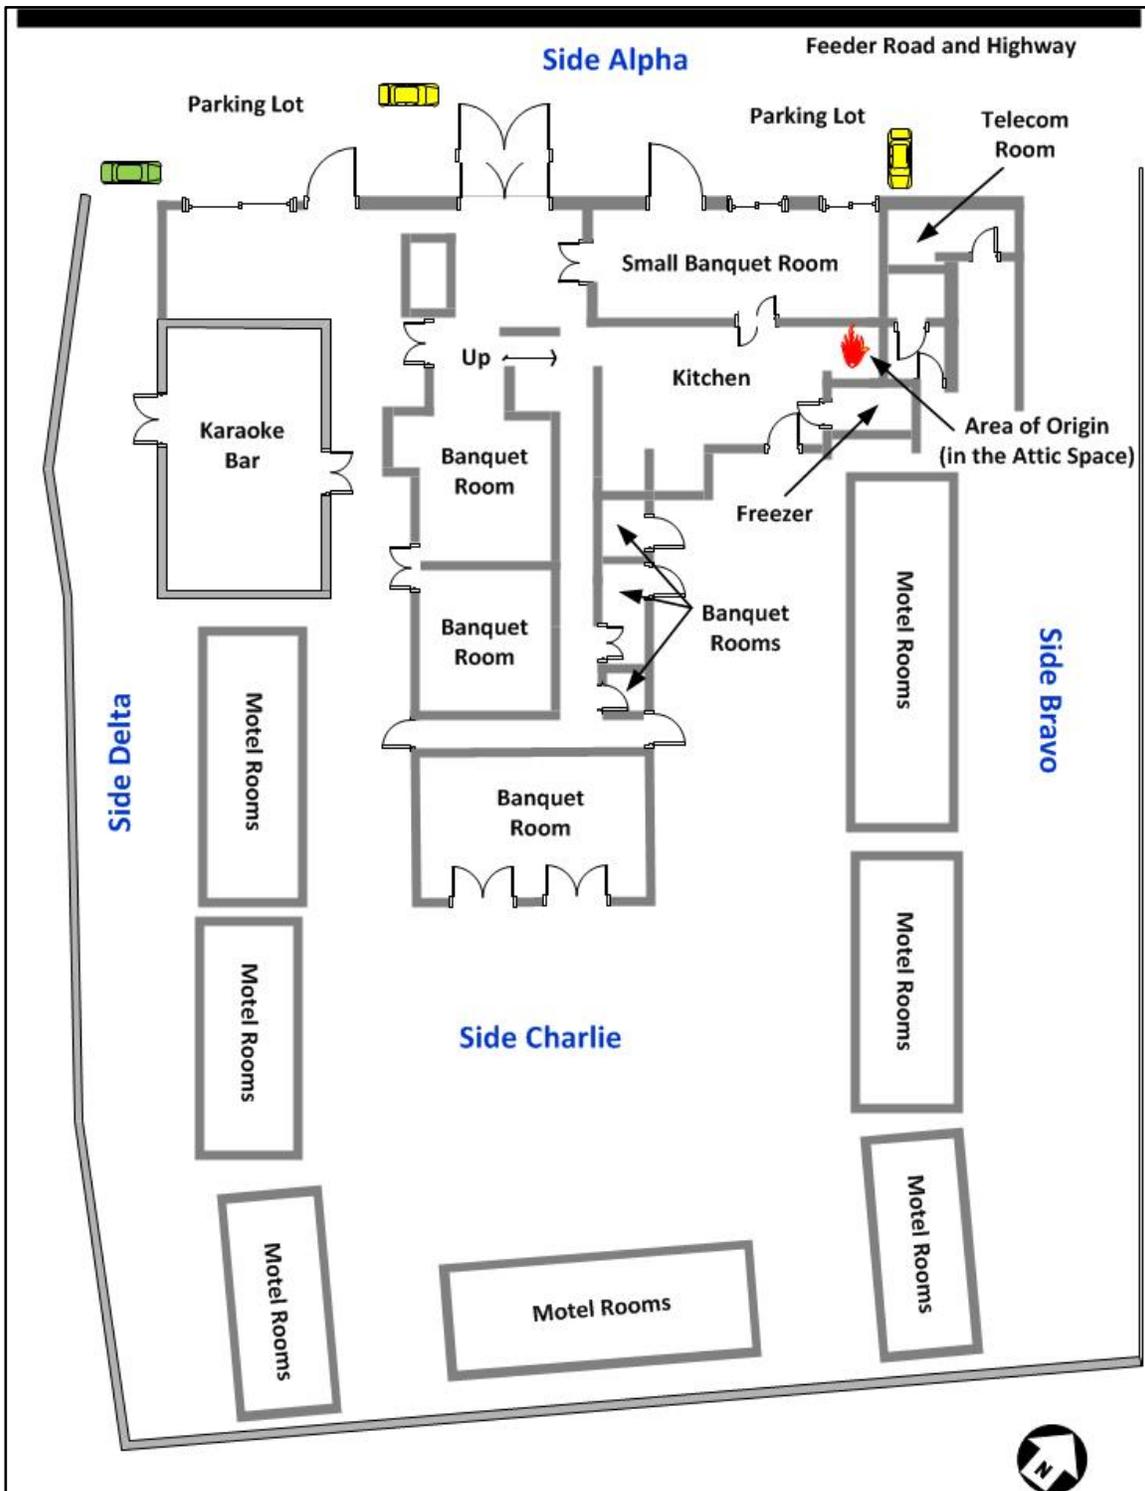
Diagram 1. The site plan for the motel, restaurant, and bar. The area of origin was determined to be in the attic/crawlspace above the kitchen.

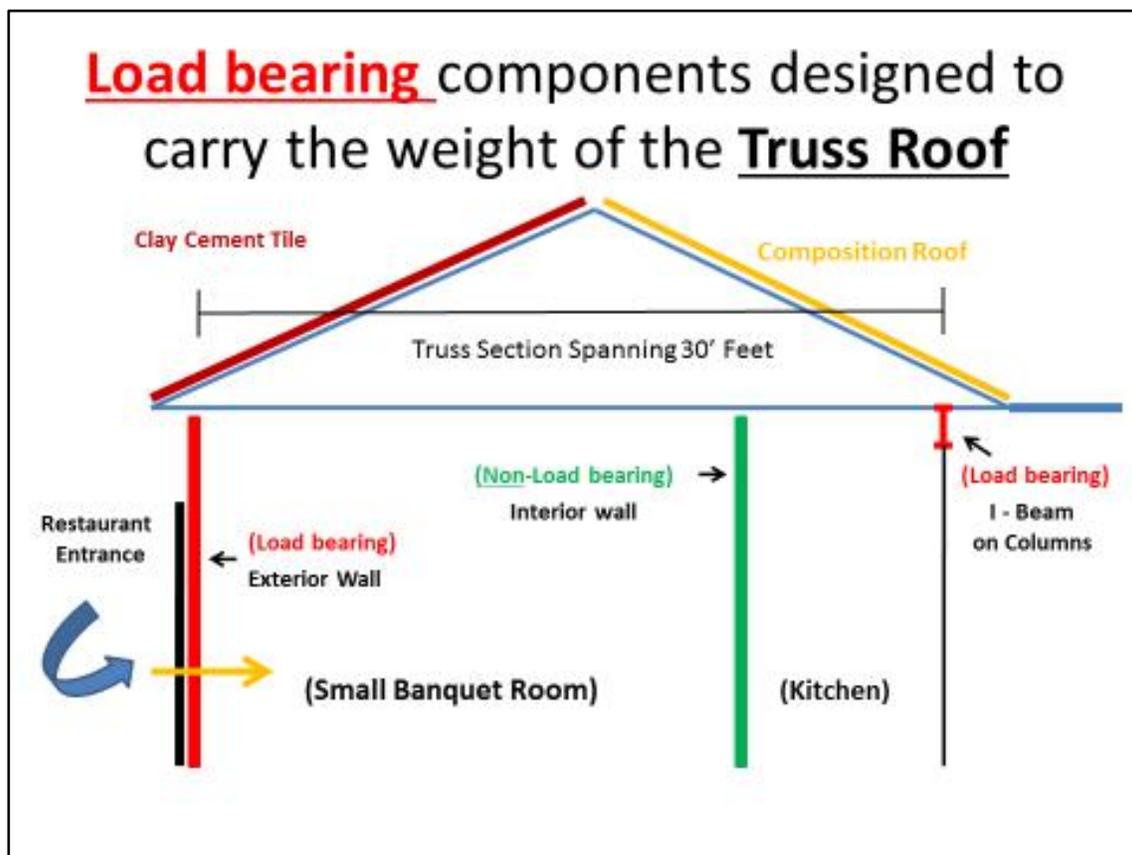
The restaurant facility located at the east side of the main entrance (lobby building) with its main entrance on Division Alpha, had a gable-style roof assembly constructed of an engineered wood truss components incorporating a lap-nailed truss configuration. This type of truss configuration is not commonly found or referenced in fire service case studies or incidents. Unlike other conventional engineered gable truss systems that utilize sized wood components that are fastened and secured utilizing a metal-plate-connected (MPC) that result in an engineered truss, the lap-nailed wood truss system utilizes nails (versus MPC) as the mechanical fastener to secure the truss components together in an assembly to provide structural support as a configured truss component. The truss webs and cords are configured in their defined orientation and angles and fastened utilizing a defined quality and sized metal nail fasteners and connected on the vertical face of the corresponding truss component.

Diagram 2. The truss roof design of the small Banquet Room and the Kitchen.
(Diagram courtesy of the fire department)

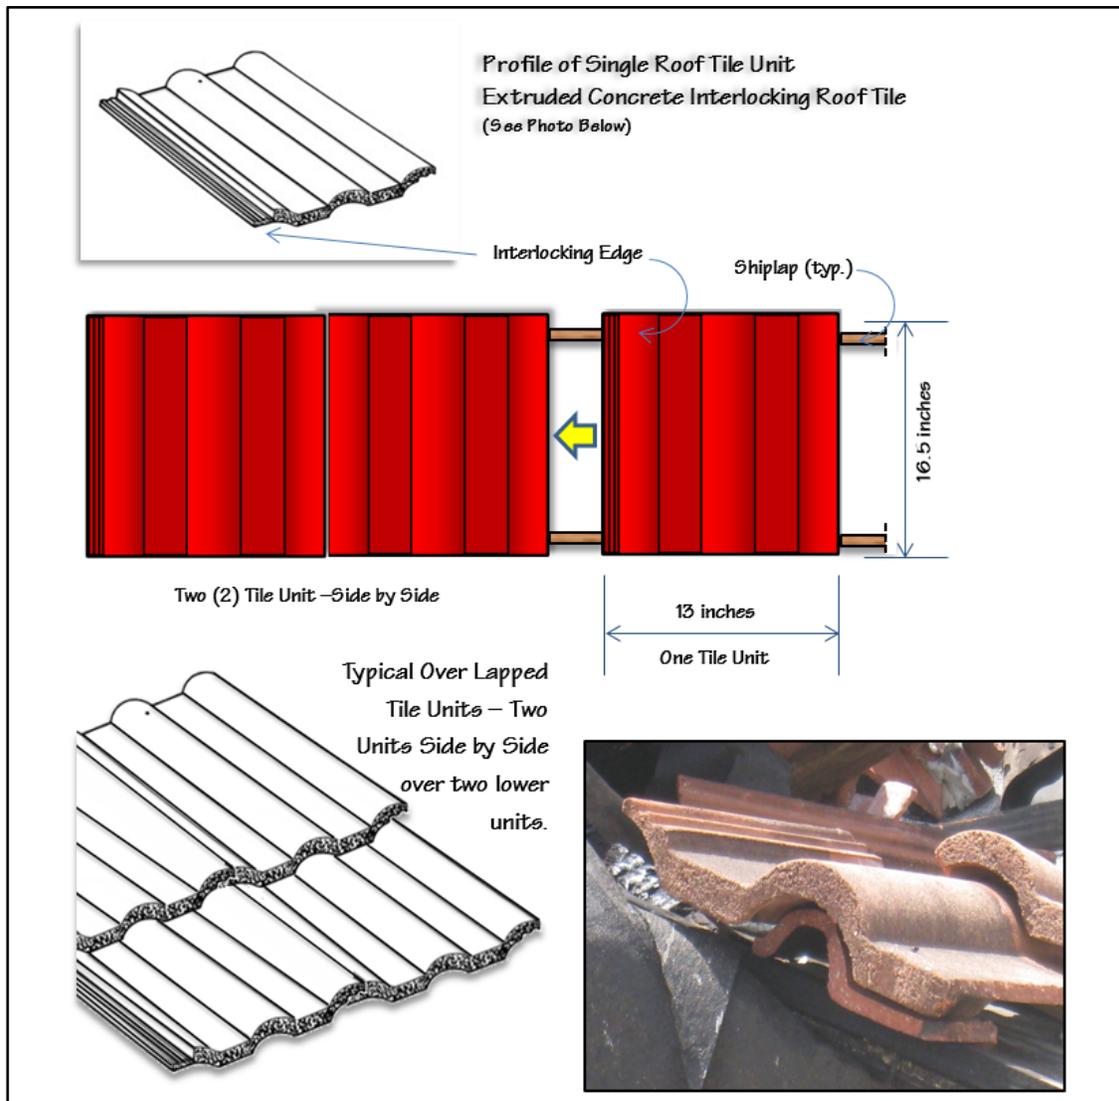
Due to the absence of historical construction records and specifications, the roofing tile was identified based on the roofing tile manufacturer imprint. This is typically found on the underside of each tile unit. A likely tile unit style was identified, which is consistent with the figures developed and specifications.

Diagram 3. The concrete roofing tile details which were on Side Alpha of the Small Banquet Room.

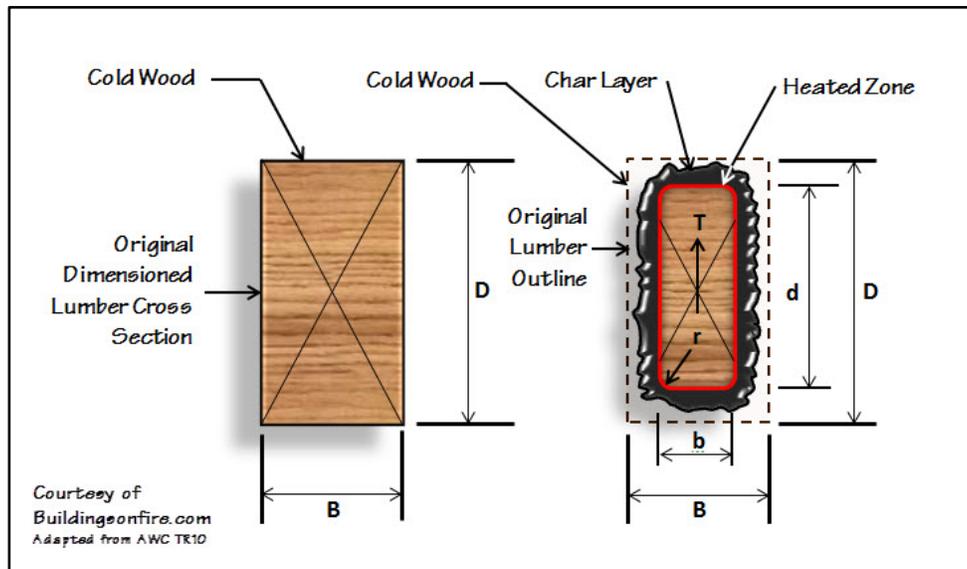
- The surface to mass ratio of the exposed wood truss members with the increased surface area results in increased consumption and degradation of the wood, leading to decreased cross sectional dimensions and decreased load-bearing capacity of the structural components. [8.9.21](#) (See Diagram 4.)

Diagram 4. Reduction in Wood Component Breadth and Depth over time, (Diagram Courtesy of Buildingsonfire.com) [Adapted from AWC Technical Report #10 (2012)]

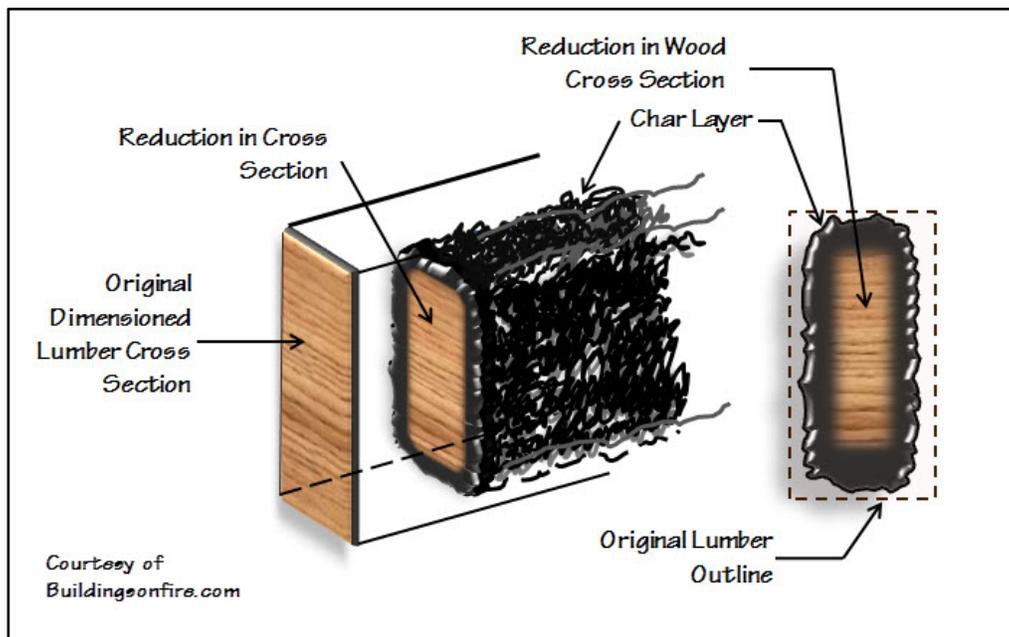
Diagram 5. Charring Effect on Wood Component and Cross Section (Diagram Courtesy of Buildingsonfire.com)

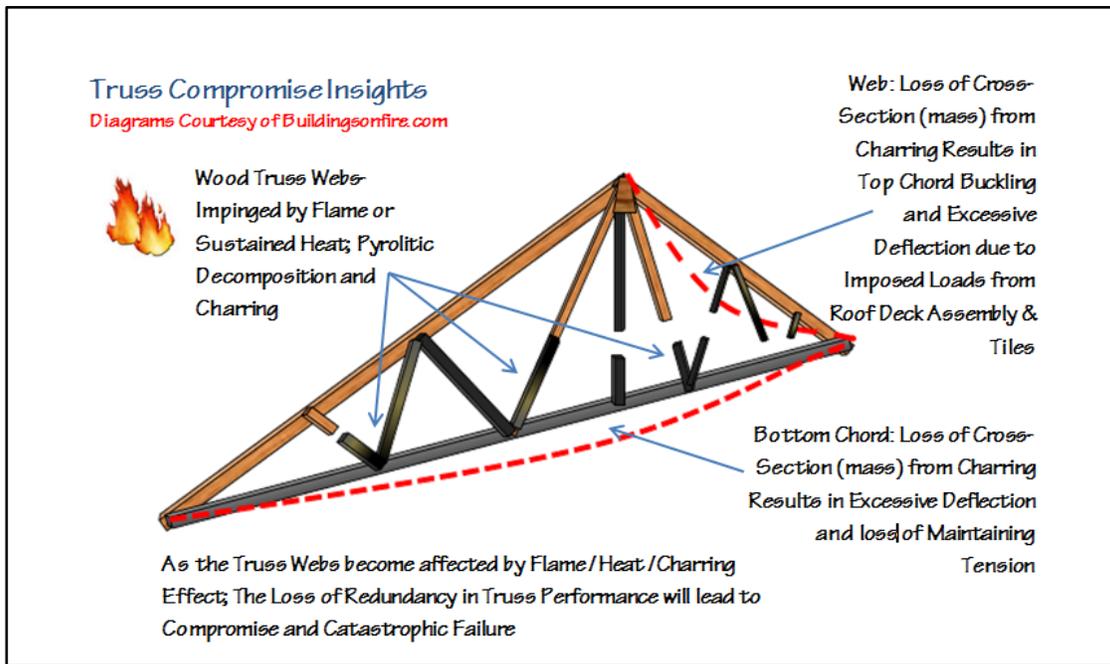
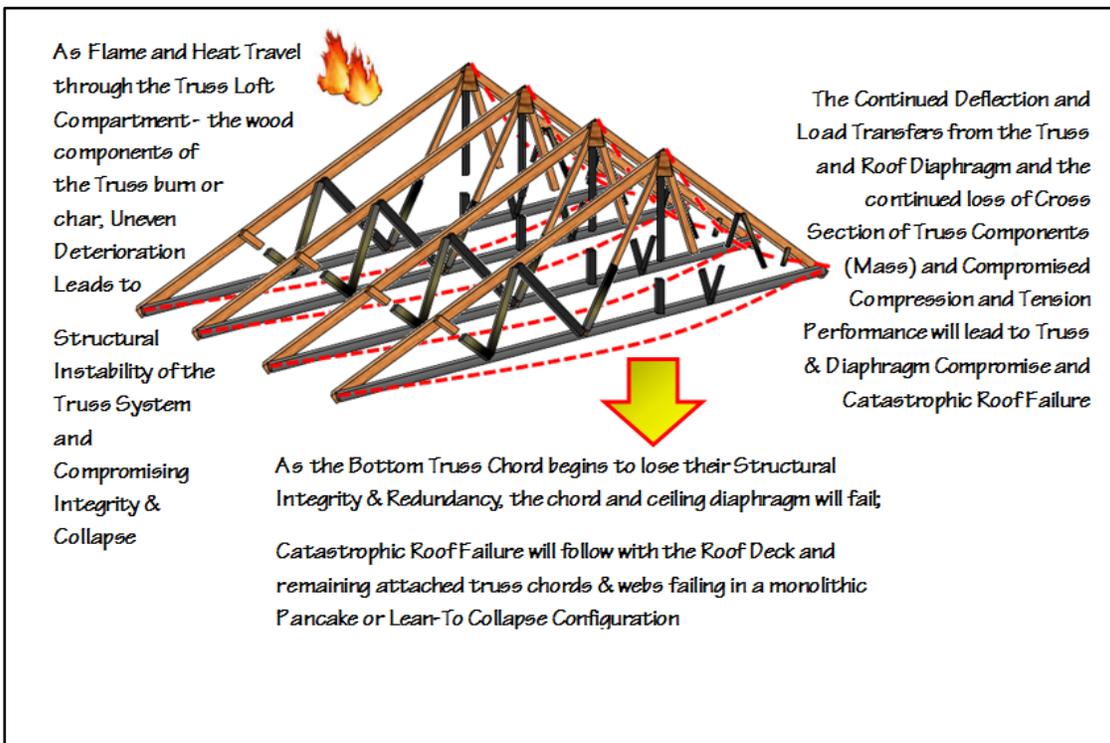
Diagrams 6 and 7. Anatomy of a Truss - Assembly Compromise and Collapse
 (Diagram Courtesy of Buildingsonfire.com)

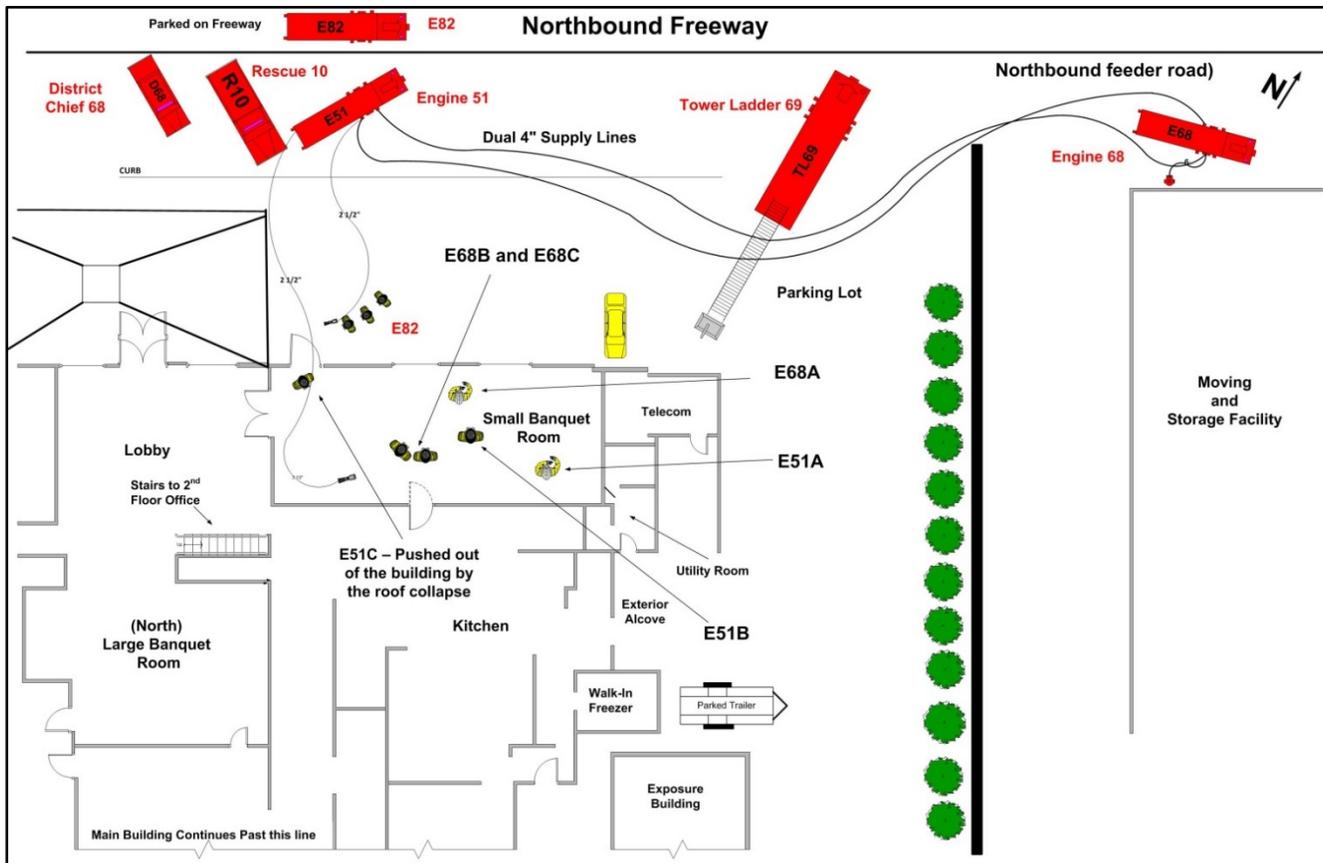
Diagram 13. The location of the officers and fire fighters of Engine 51 and Engine 68 when the roof collapse occurred in the Small Banquet Room and Kitchen area at 12:23:24 hours.

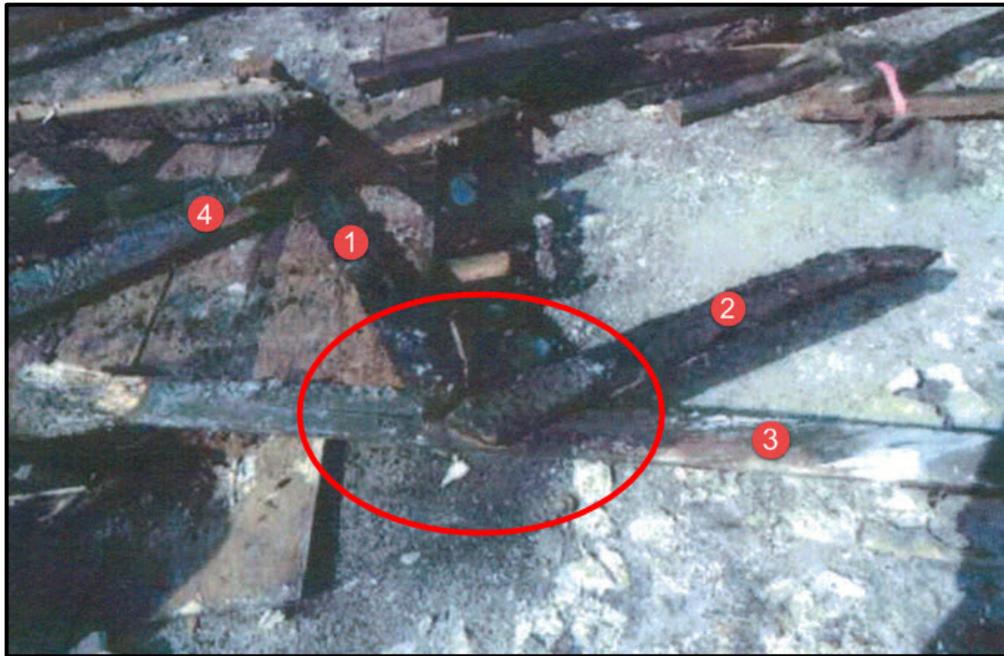
Photo 10. Bottom Truss Cord and Two-Web

- [1] 2 in. x 4 in. Wood Web;
- [2] 2 in. x 4 in. Wood Web; *Note: See loss of remaining web material*
- [3] 2 in. x 4 in. Wood Bottom Chord;
- [4] 2 in. x 6 in. Wood Top Chord;
- [5] **Circle** depicts the typical surface connection point of the truss webs as they are mechanically fastened with nails to the cord, (absent is any MCP, which is typical of most fabricated truss assemblies of that period, and today).

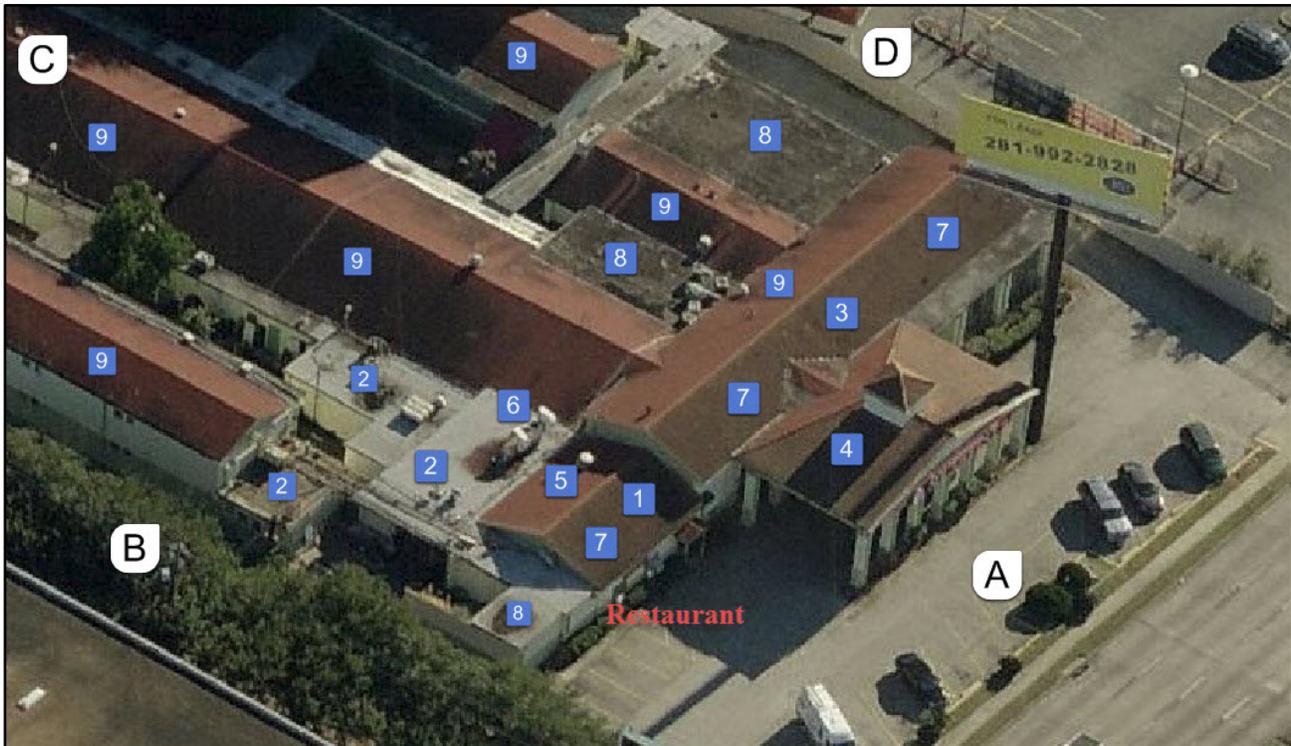
The gable roof profile of the restaurant and the main building can be seen from an aerial view which consists of extruded concrete interlocking roof tiles with shiplap as a roof covering fronting Division Alpha. (See Photo 11).

Photo 11. Pre-fire Aerial View of Building Complex (North-East Geographical/Division Alpha-Bravo)
(Bing.com Maps/ Diagram Courtesy of Buildingsonfire.com)

- [1] Restaurant Gable Roof
- [2] Kitchen Flat Roof
- [3] Main Entrance and Lobby Gable Roof
- [4] Main Portico Canopy Roof
- [5] Ventilation Fan Housing (assumed)
- [6] Roof-top mounted Mechanical Units & Ventilator/Fans (type unknown)
- [7] Extruded Concrete Interlocking Roof Tiles with shiplap as a roof covering
- [8] Flat Roof Areas
- [9] Gable Roofs
